CONDITION SURVEY, WRIGHT-PATTERSON AIR FORCE BASE, OHIO

R. D. Jackson

June 1973

Conducted by U. S. Army Engineer Waterways Experiment Station
Soils and Pavements Laboratory
Vicksburg, Mississippi

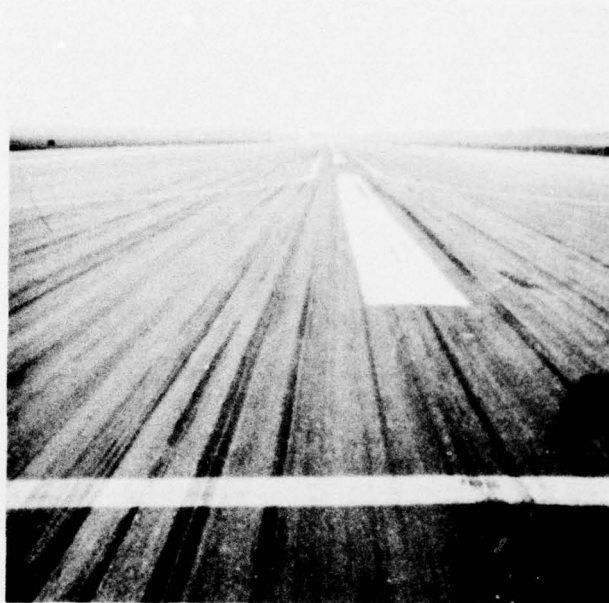
13. The first 1600 ft of the NE (22R) end of the runway (features R1A, R2B, and R3C), which was overlaid with 4 in. of tar rubber (TR) in 1971, was in excellent condition. Feature R3C, an 8400-ft-long portion of the runway interior, was in excellent condition. It was overlaid with 4 in. of asphaltic concrete (AC) in 1971. Photo 1 is a general view of the AC overlay looking southwest from taxiway 15. A general view of the TR overlay, looking southwest from 750 ft from the NE end of the runway, is shown in photo 2. Photo 3 is a closeup view of the joint between the TR and AC overlays, 1600 ft from the NE end of the runway. Feature R7A, which is 19-in. PCC, was in excellent condition,

Photo 1. General view of AC overlay of runway interior (feature R3C) looking southwest from taxiway 15

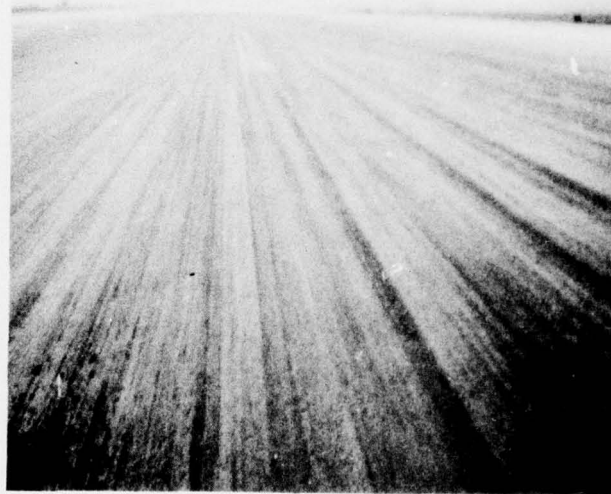
Photo 2. General view of TR overlay near NE end of runway

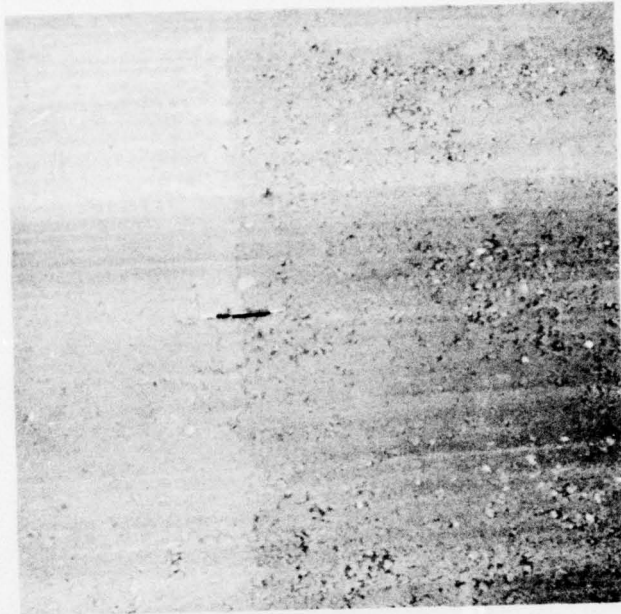
Photo 3. Closeup view of joint between
AC and TR overlays of runway

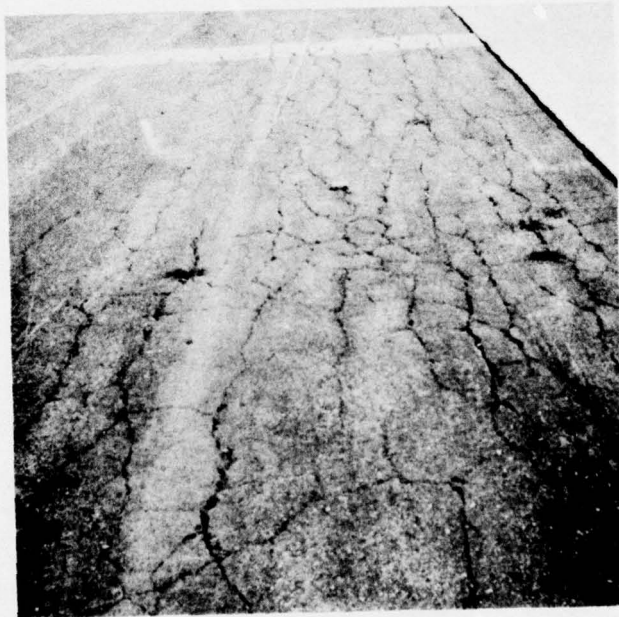
Photo 4. Poor condition of area of
shoulder pavement on taxiway 17

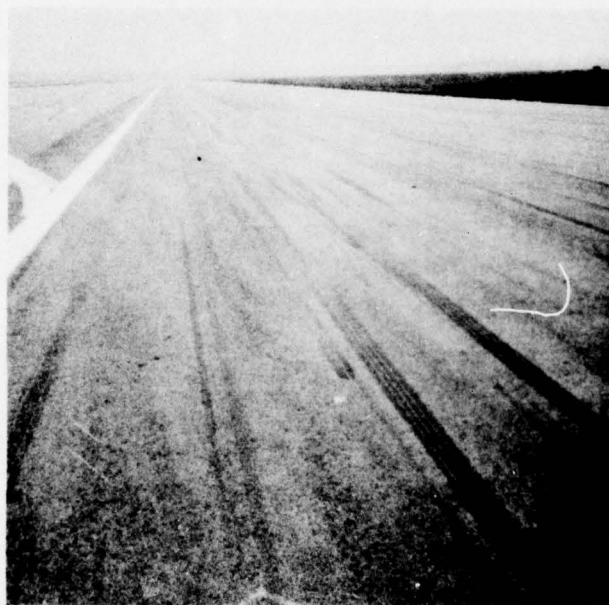
Photo 8. Good condition of taxiway 21 at
intersection with taxiway 8

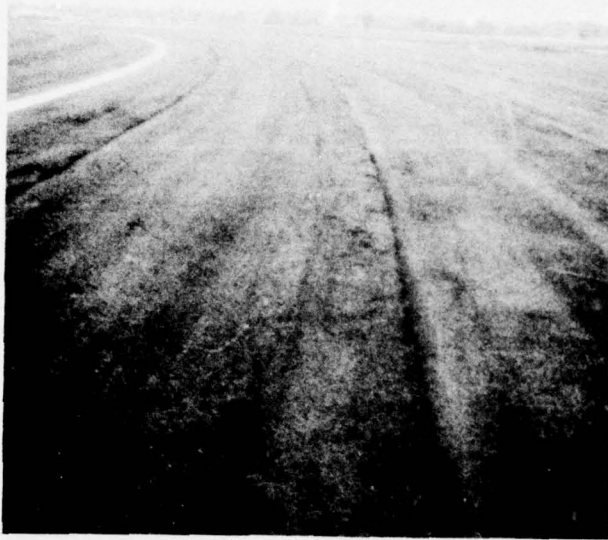
Photo 9. Paving lane joints in taxiway 10
and warm-up apron 1

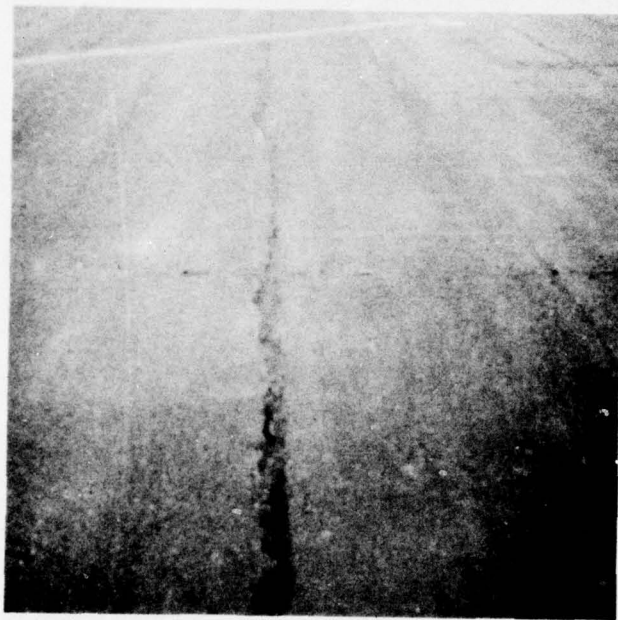
overlaid with TR or AC, except the alert hangar apron. The overlaid apron areas were in fair to very good condition. Photo 10 shows a general view of parking apron E, looking south from the base operations office. A view of parking aprons B and C is shown in photo 11. The alert hangar apron was in poor to failed condition. The SAC operational apron was in fair to good condition. The predominate major defect in this apron was longitudinal cracking, and corner spalls and pop-outs were also prevalent. Warm-up apron 2 was in excellent condition based on the percentage of slabs containing no major defects. The nose dock stubs were in conditions ranging from poor to very good.

Photo 11. General view of parking
aprons B and C
