MISCELLANEOUS PAPER S-74-25 ✓

# INVESTIGATION OF TAR-RUBBER PAVEMENT OVERLAYS

Philip J. Vedros, Jr., Ralph D. Jackson

November 1974

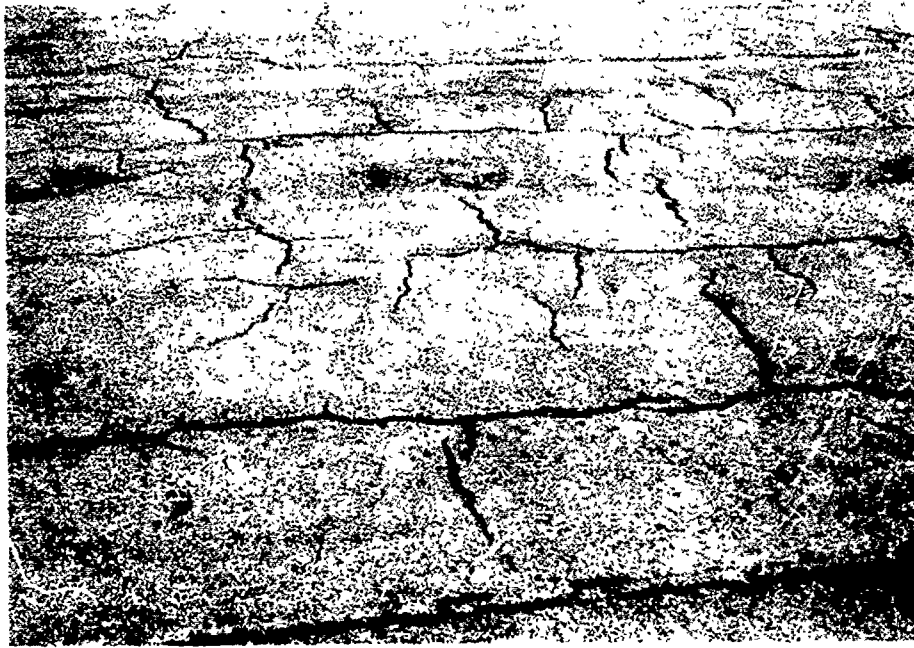
fighter-type aircraft (F-106 and F-4) have used the 1967 pavements. At the time of this investigation, the 1955 tar-rubber pavements were in poor to fair condition with considerable cracking (Photo 1) and roughness occurring adjacent to the cracks (Photos 2 and 3). The pavements began cracking approximately 2 years after placement and have progressively deteriorated over the years. Rutting was occurring in the taxiway area of the apron (Photo 4). In areas where the F-106 and F-4 aircraft had been parking on the 1967 tar-rubber pavements, the surface had depressed and ponding of fuel and hydraulic fluid in these areas had caused the surface to deteriorate to the point that removal of the pavement was necessary. At the time of this investigation, most of the 1967 tar-rubber pavements had been removed and replaced with PCC pavement. The core samples of the 1967 pavements obtained in this investigation were from small areas of pavement that had not been removed and that were not being used by aircraft.

Photo 1. Block cracking in Homestead (1955) pavement

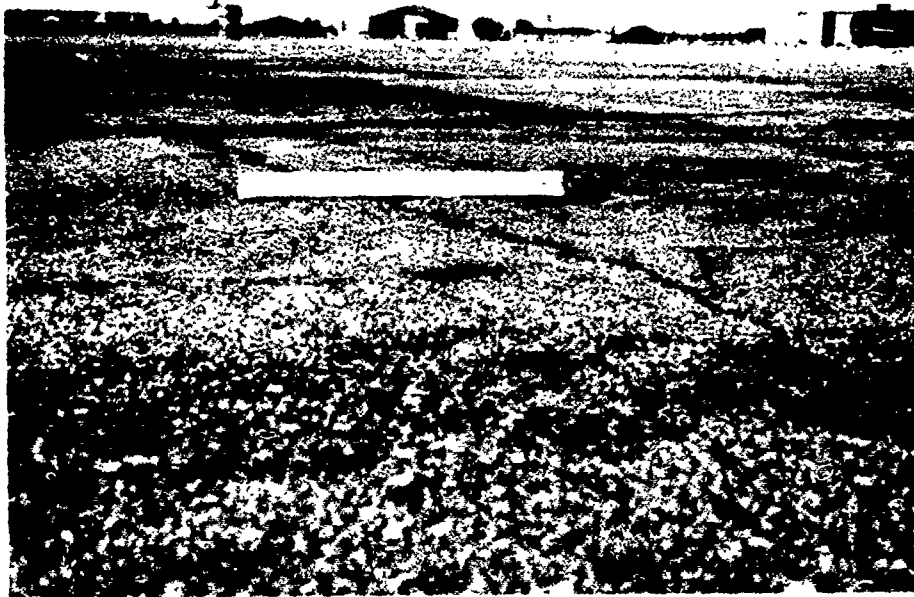
Photo 2. Unevenness on surface of Homestead (1955) pavement from cracking

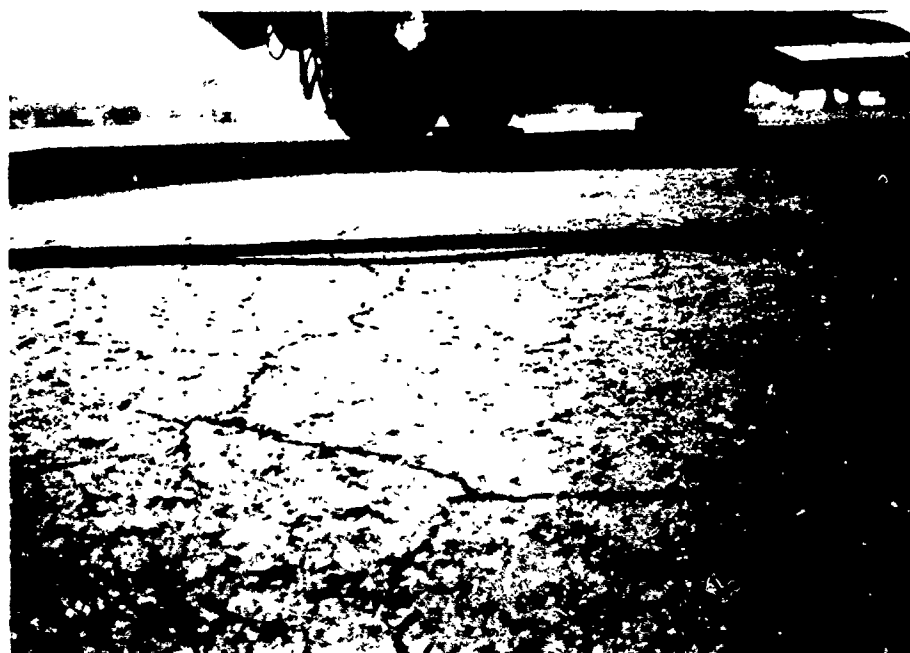
Photo 8. Ruts up to 1 in. deep in taxiway area  
of MacDill (1971) pavement

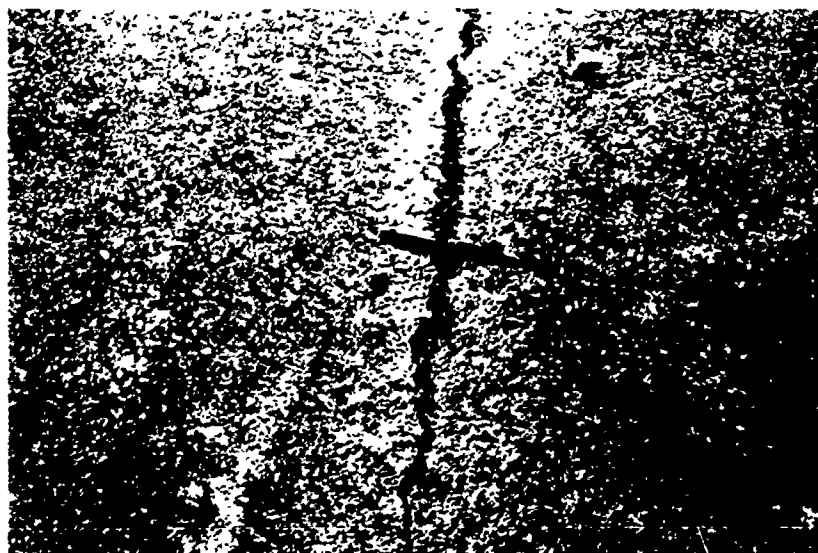
19. The parking aprons surfaced with tar-rubber had been used by C-130, C-135, and transient-type aircraft. The pavements were receiving very little usage at the time of this investigation. The pavements constructed in 1969 were located in a refueling area on the south apron. They had been sealed with a tar seal and a tar-slurry seal in 1972 (Photo 18). The seal coat had deteriorated on the surface where fuel had spilled (Photo 19). Minor random and reflection cracking was noted in this area. The 1971 pavements, which were used by C-130 aircraft from 1971 to 1974, contained reflection and shrinkage cracks (Photo 20). The 1972 pavements on the northwest apron contained reflection cracks, and, in some areas, water was seeping out of the cracks (Photo 21). The construction joints were not well sealed (Photo 22), and cores obtained

Photo 21. Reflection crack in Forbes (1972) pavement  
with water seeping from crack

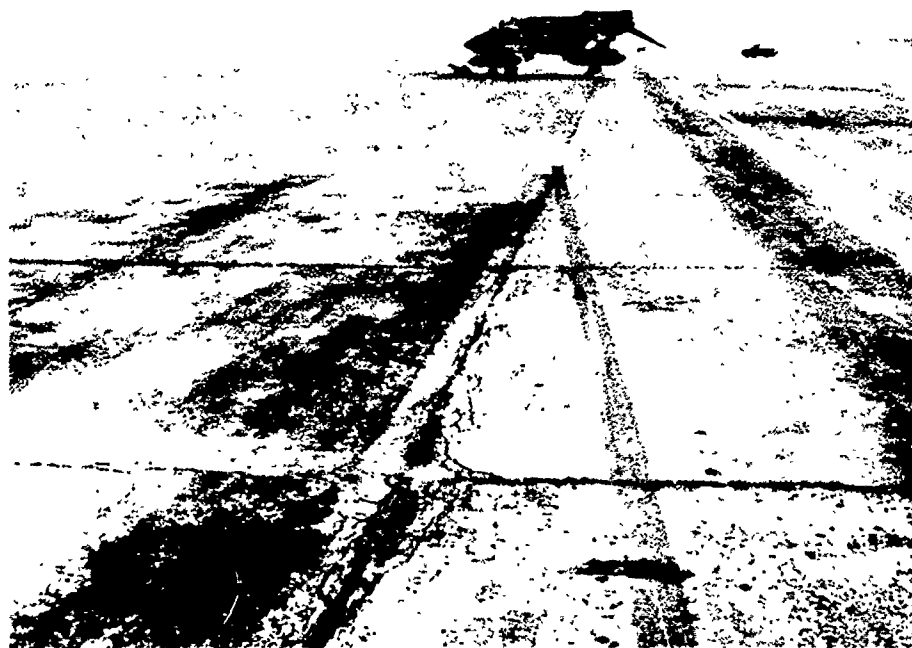
25. The pavements constructed in 1960 were located on pavements identified at the time of this investigation as taxiways 8 and 12. The outer edges of taxiway 8 had been used for parking aircraft, mainly the F-4, F-5, and T-38. The pavement in the immediate parking area was in poor condition, with deterioration in the surface from fuel spillage and high tire pressures (Photo 36). Pavements in taxiway 12 had not been

Photo 36. Outer edge of Wright-Patterson (1960) taxiway 8 used for parking of aircraft

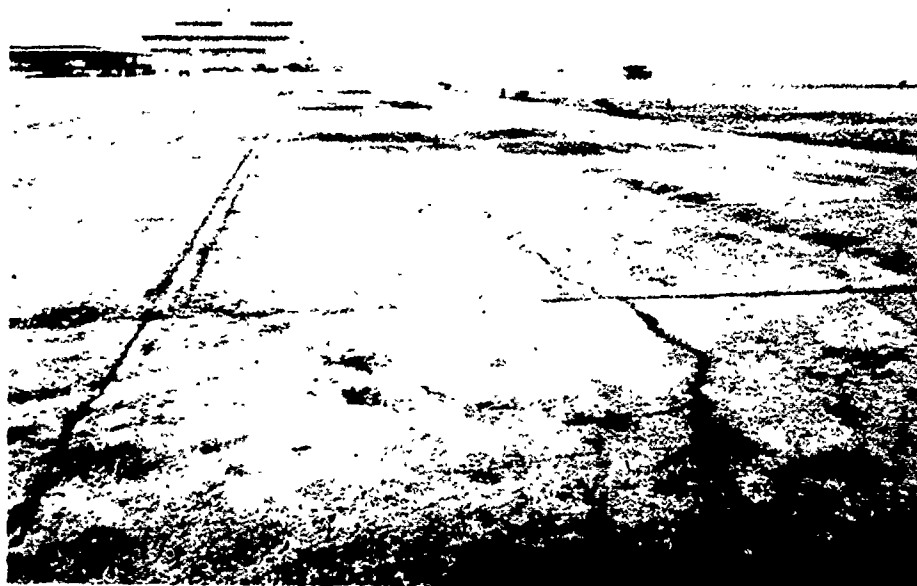
Photo 40. General deterioration of Wright-Patterson (1966)  
pavement from cracking and fuel spillage
