OBSERVATIONS
ALONG THE PIPELINE HAUL ROAD
BETWEEN
LIVENGOOD AND THE YUKON RIVER

R. Berg and N. Smith

October 1976

CORPS OF ENGINEERS, U.S. ARMY
COLD REGIONS RESEARCH AND ENGINEERING LABORATORY
HANOVER, NEW HAMPSHIRE

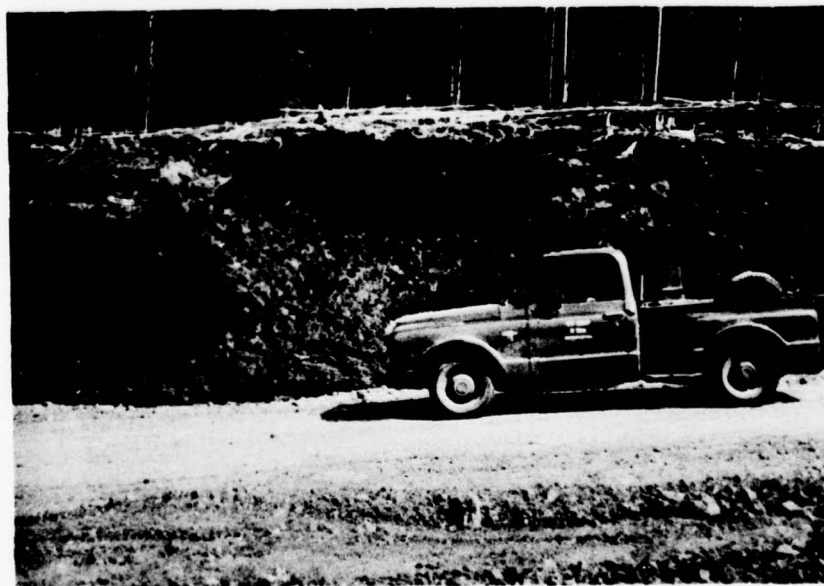
This cut slope faces southwest and the top of the slope is 8-10 ft (2.4-3.0 m) above the roadway surface. The upper portion of a massive ice mass can be observed 3-4 ft (0.9-1.2 m) below the top of the slope in Figures 9 and 10. These two photographs, taken on 26 June 1970 show that the mineral soil overlying the ice is relatively dry. Figures 11 and 12 show the grass growth from June till August 1970. Figures 13-15 show the slope on 27 May 1971. A small amount of litter from the previous years' growth of grasses is visible and the organic mat is hanging over the thawed soil; however, it has torn in some places. Figures 16 and 17, taken nearly two years later, show the remnants of a substantial growth of grass. The slope does not have a "neat" appearance, however. Figures 18 and 19 show the slope on 27 September 1974. A few small trees are visible at this time and a substantial growth of grass has occurred during the summer. Figures 20 and 21 show the slope on 14 September 1975. The trees had grown considerably since the previous year. Due to their shading effect, thus permitting less thaw and removal of subsurface moisture, the trees and grasses have assisted in making this a relatively stable slope.

9. Thawing backslope, Mile 4.5 Rt, 26 June 1970.

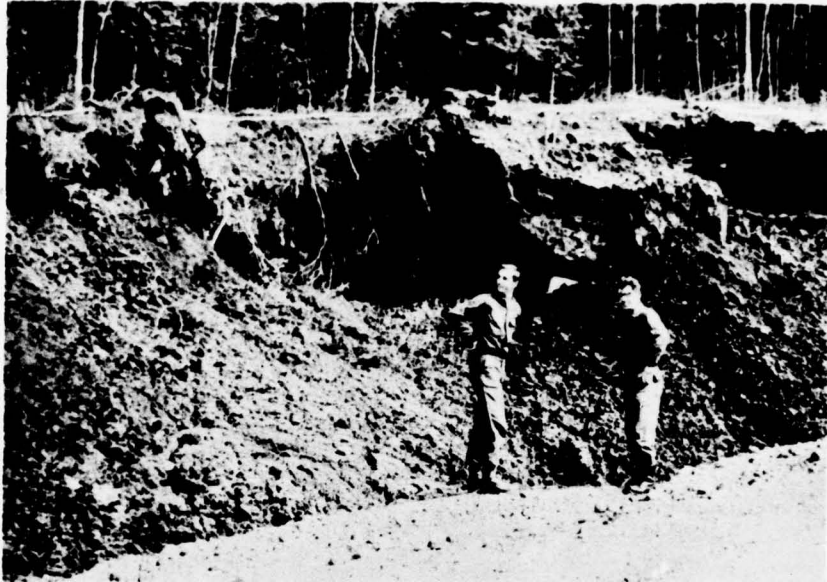
10. Organic mat overhanging part of thawing backslope,
26 June 1970.

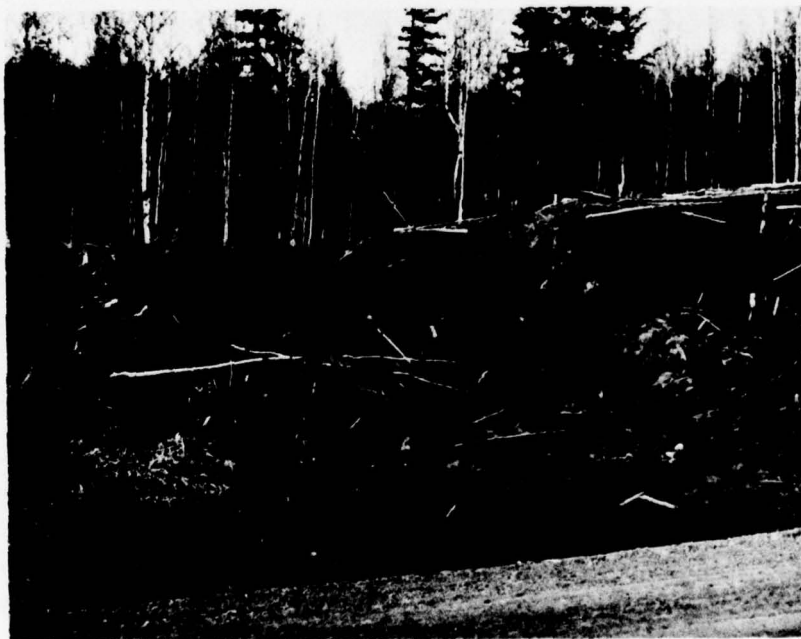
15. Close-up of most unstable portion of backslope,
Mile 4.5 Rt, 27 May 1971.

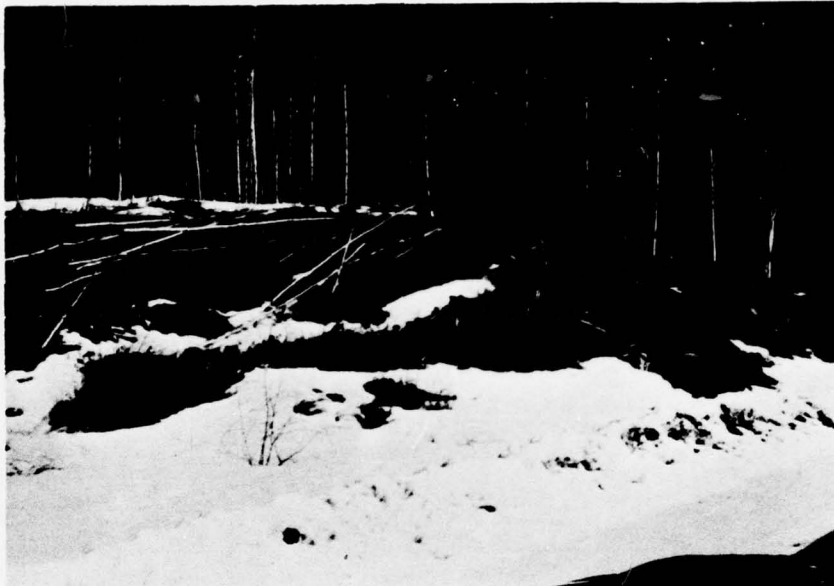
16. Southern end of backslope, Mile 4.5 Rt,
20 April 1973.

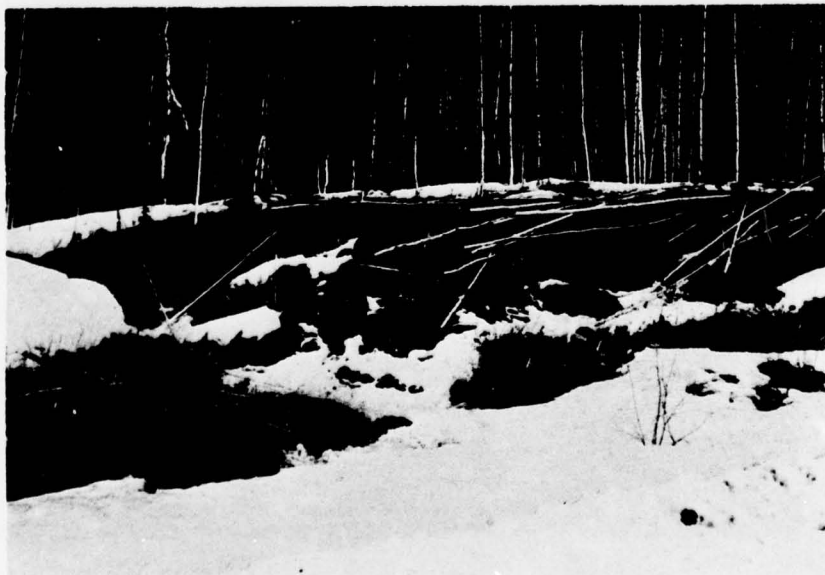
17. Center of partially snow-covered slope, Mile 4.5 Rt,
20 April 1973.

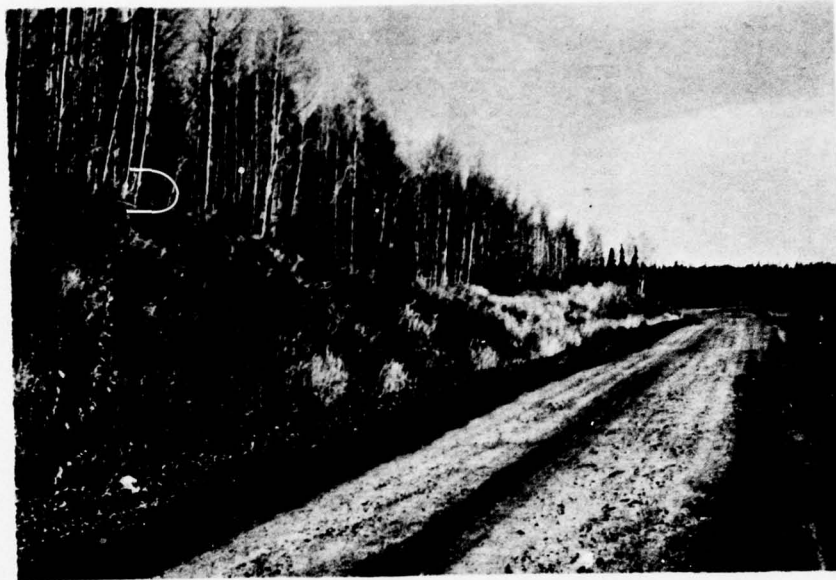
18. Southern end of backslope, Mile 4.5 Rt,
27 September 1974.

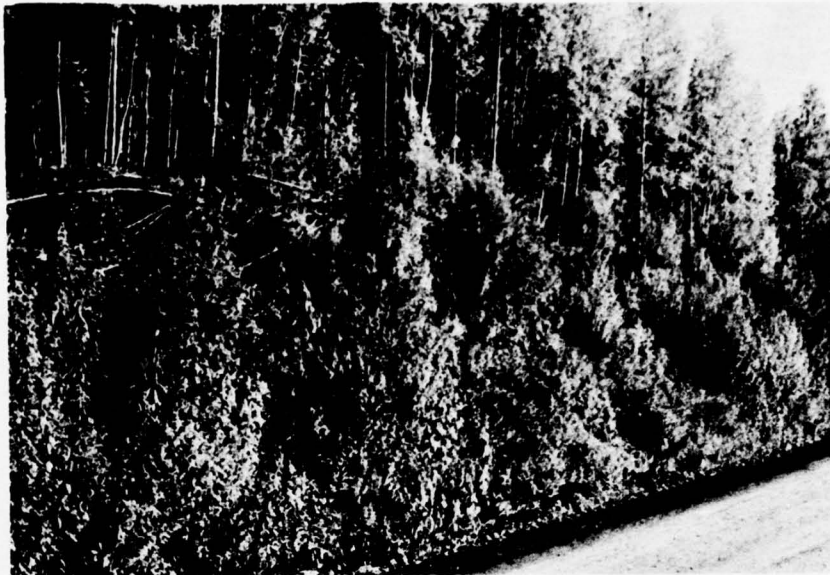
20. Southern end of backslope, Mile 4.5 Rt,
14 September 1975.

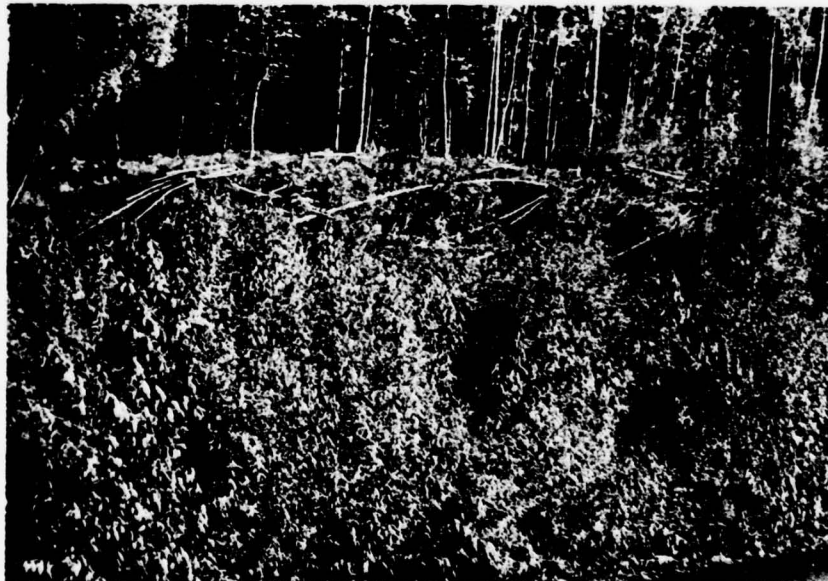
21. Center portion of backslope, Mile 4.5 Rt,
14 September 1975.

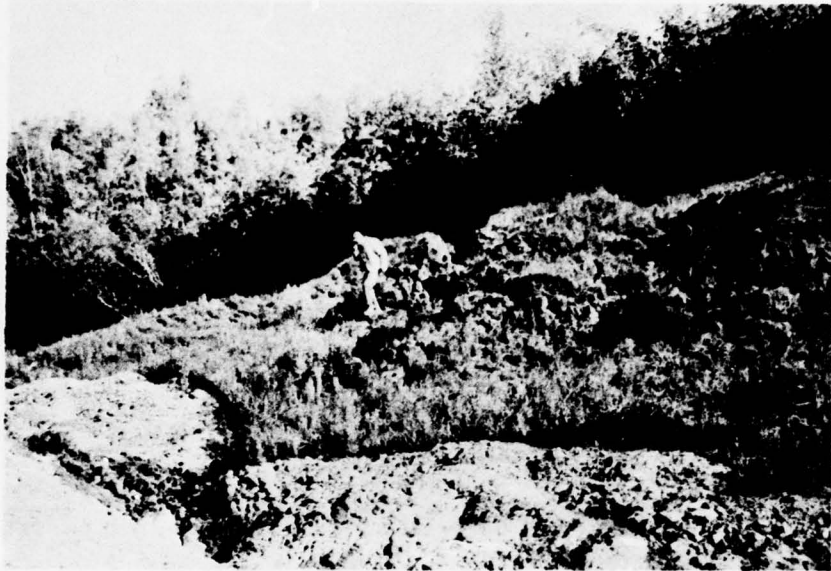
The second slope at this site developed stability problems during the second thaw season. It can be seen at the extreme left in Figure 25. It is much higher but the ice-rich soil was not exposed during construction. The photographs taken on 17 August 1971, Figures 28 and 29, show the massive movement and the disruption of the relatively heavy grass cover caused by subsurface thawing. The slope looked quite stable in September 1974 when last photographed. The grass cover had rehealed and some small trees had started to grow (Fig. 30).

28. Most unstable portion of deep cut, Mile 9.85 Rt,
17 August 1971.

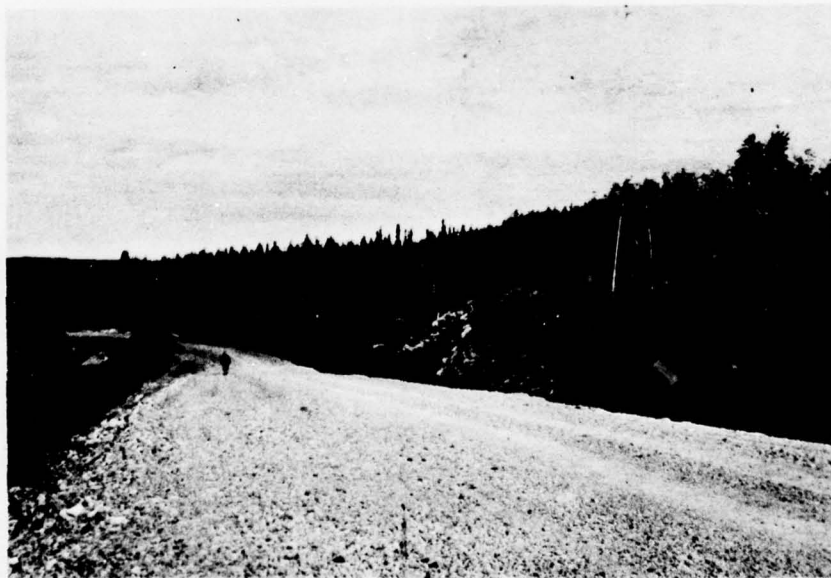
29. Overall view of deep cut, Mile 9.85 Rt, 17 August 1971.

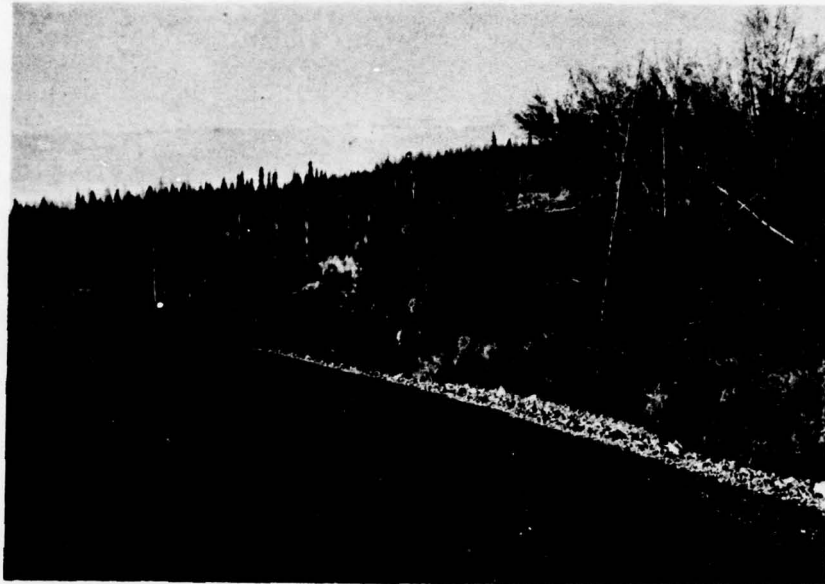
30. Overall view of stabilized deep cut, Mile 9.85 Rt,
27 September 1974.

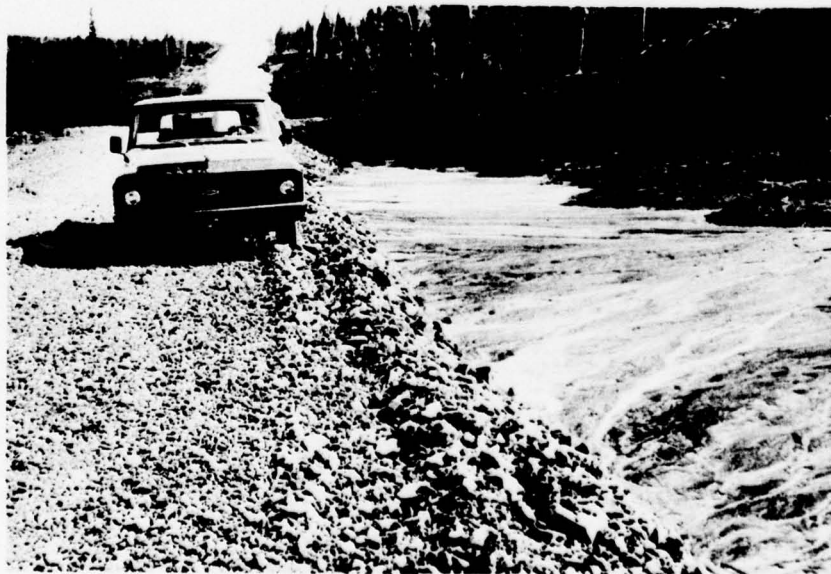
33. Backslope erosion into parallel ditch,
Mile 19.6 Lf, 26 June 1970.

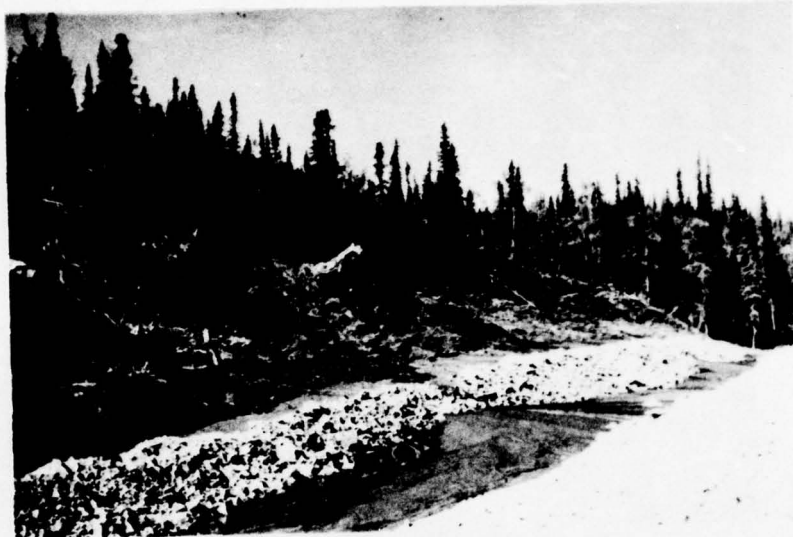
34. Seeded backslope and broken rock revetment,
Mile 19.6 Lf, 11 August 1970.

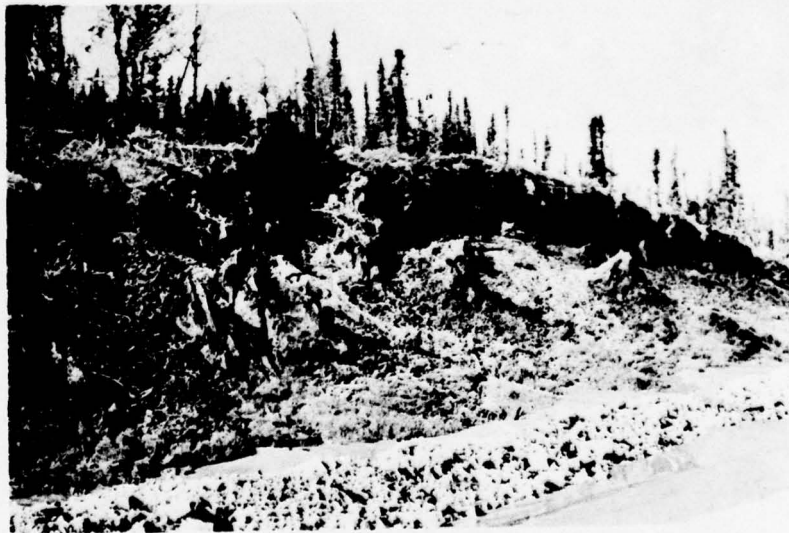
35. Thawing slope receding into limit of clearing,
Mile 19.6 Lf, 11 August 1970.

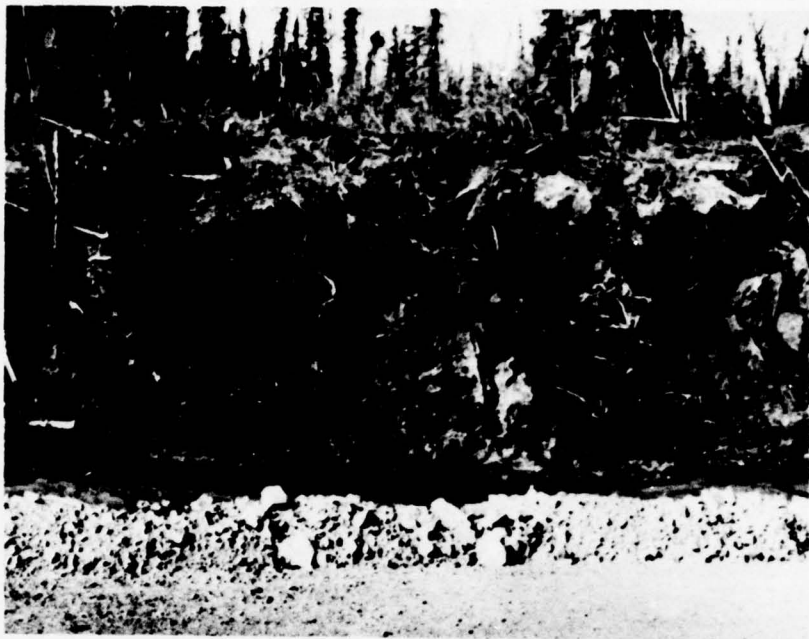
38. Close-up of overhanging vegetative mat, Mile 19.6 Lf,
28 May 1971.

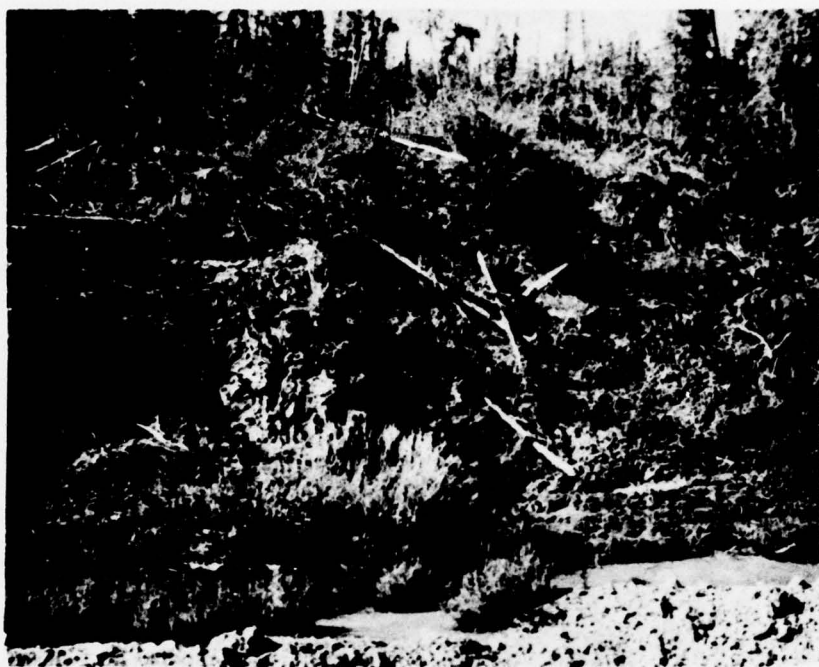
40. Close-up of grasses in ditch and continued thawing of backslope, Mile 19.6 Lf, 17 August 1971.

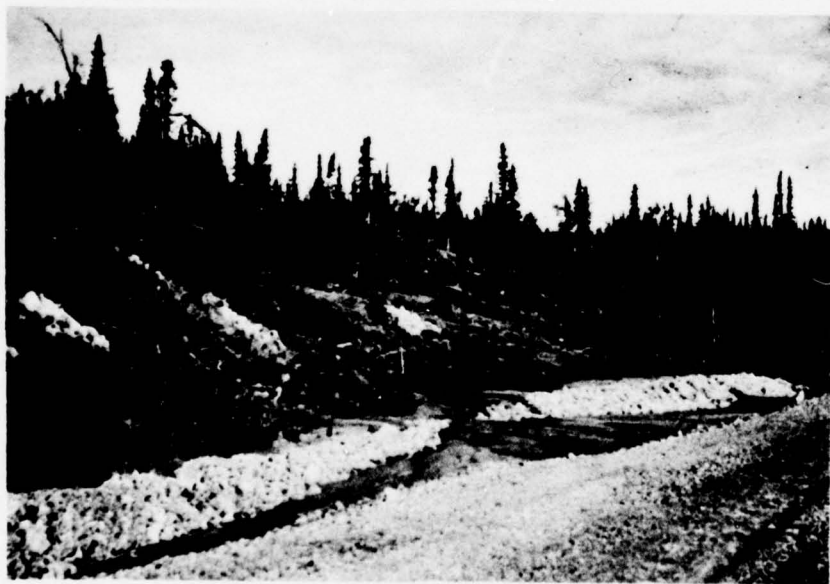
41. Overall view of slope showing toppling spruce trees, Mile 19.6 Lf, 23 June 1972.

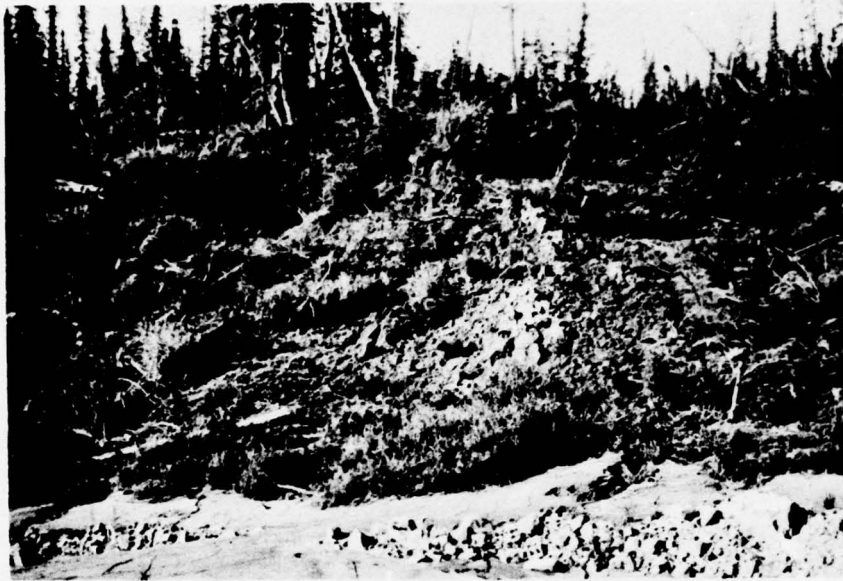
42. Grasses growing higher up the slope, Mile 19.6 Lf,
23 June 1972.

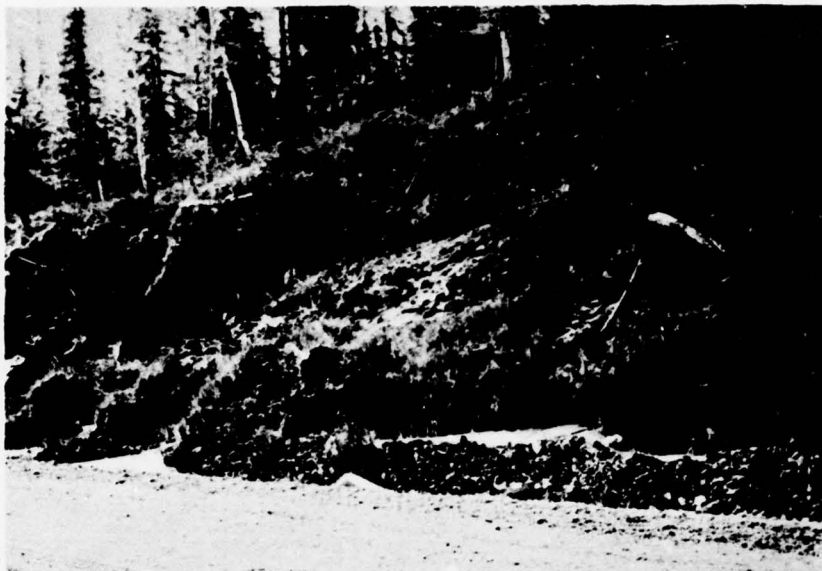
This slope faces the northeast. Figure 45 shows a large mass of ice in the cut on 23 April 1970. This slope degraded rapidly and by September 1970 a shot rock revetment had been installed in the ditch

46. Seeded backslope, overhanging mat and broken rock revetment, Mile 19.9 Lf, September 1970.

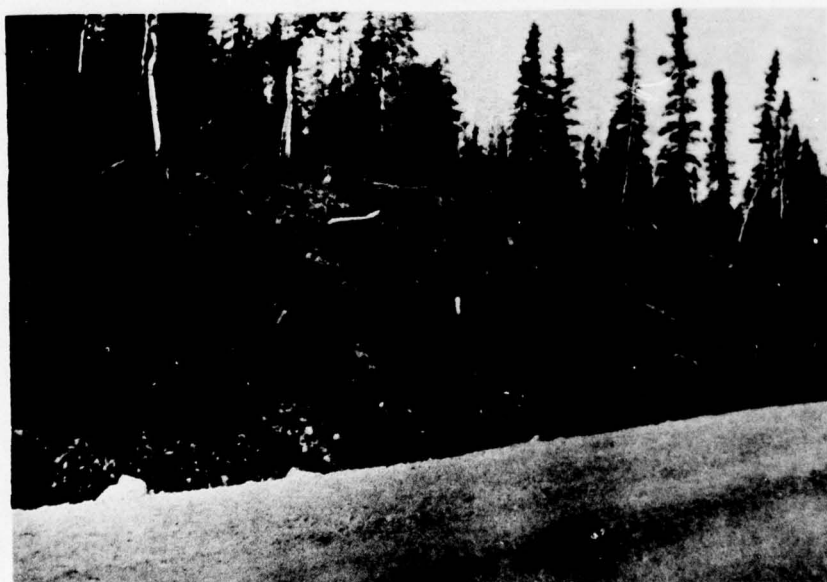
(Fig. 46). Figure 47 illustrates the organic mat hanging over the receding slope on 28 May 1971. On 17 August 1971 portions of the slope looked fairly stable (Fig. 48), while on other parts of the slope the organic mat had torn and vegetation was sparse (Fig. 49). The slope was in a similar condition in June 1972 (Fig. 50). During the summer of 1973 a major portion of this backslope was re-excavated to expose the ice-rich permafrost. An experiment was initiated to determine the effects of spraying foamed-in-place insulation on such backslopes as an alternative method for achieving slope stability. Polyurethane insulation was sprayed onto the newly exposed slope and the cleared area above the slope. Figure 51 is a photograph of the slope on 27 September 1974 and Figure 52 is a close-up of the insulation. Figures 53 and 54 show the slope on 14 September 1975. Lush grass is evident above and below the insulating layer and at a few breaks in the insulation. The surface of the insulation had degraded noticeably, but the slope did not appear to be melting and receding. It will be very interesting to observe the behavior of this slope for the next few years. Quite possibly this slope would have healed to the extent of those previously discussed if the insulation had not been applied.

47. Sloughing slope overtopping broken rock revetment, Mile 19.9 Lf, 28 May 1971.

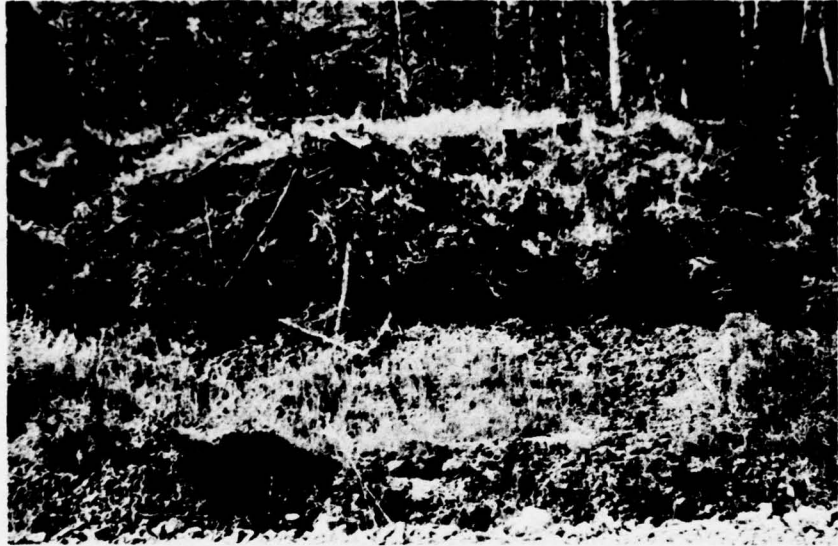
48. Part of backslope appearing fairly stable, Mile 19.9 Lf, 17 August 1971.

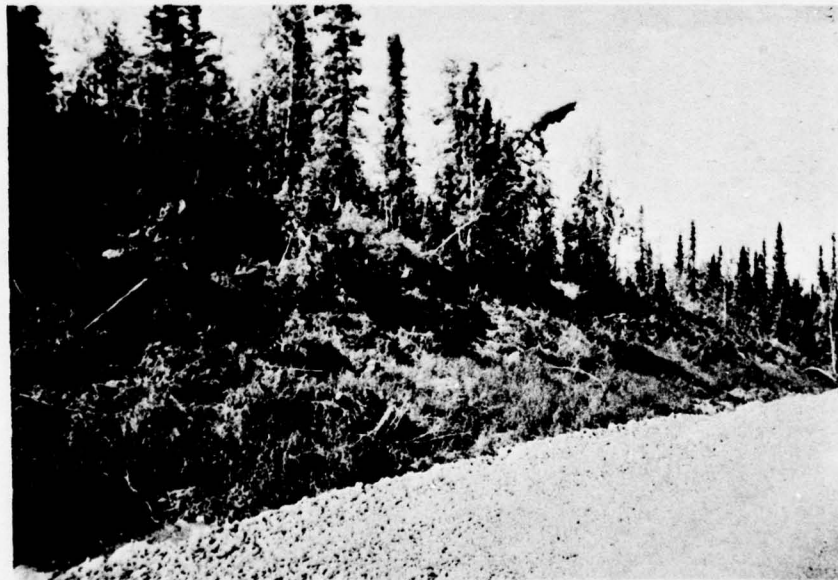
49. Overall view of backslope, Mile 19.9 Lf, 17 August 1971.

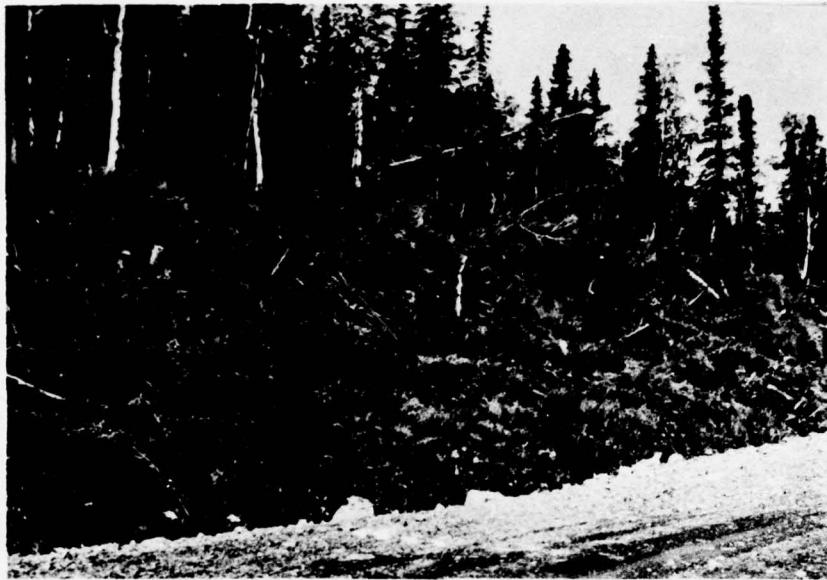
50. Overall view of backslope, Mile 19.9 Lf, 23 June 1972.

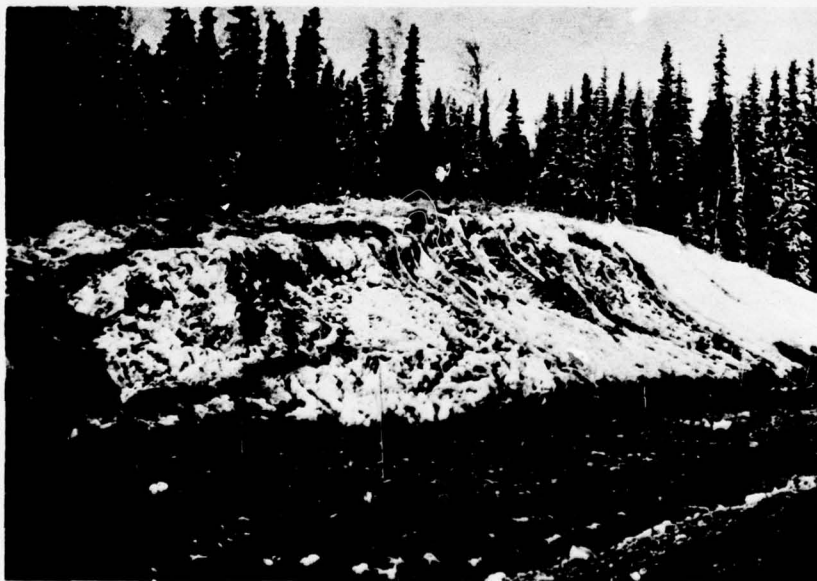
51. Insulation covering backslope, Mile 19.9 Lf, 27 September 1974.

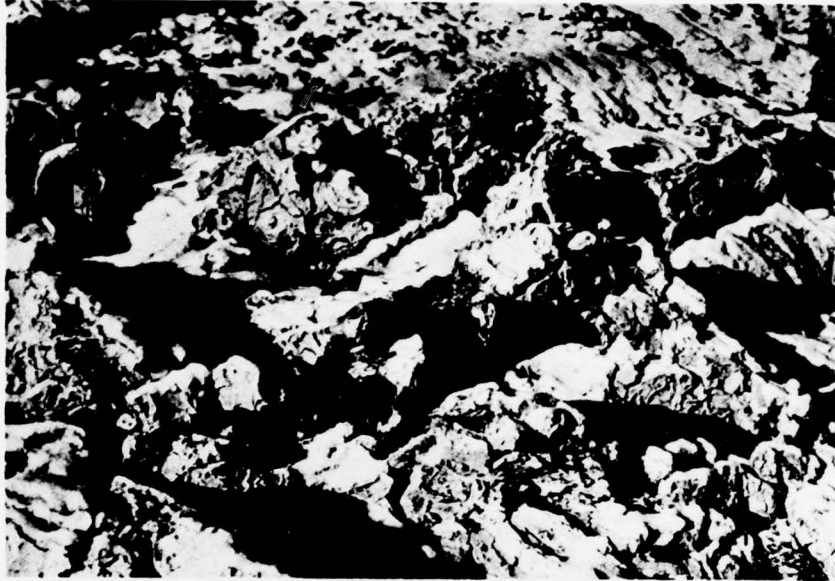
52. Close-up of insulation, Mile 19.9 Lf, 27 September 1974.

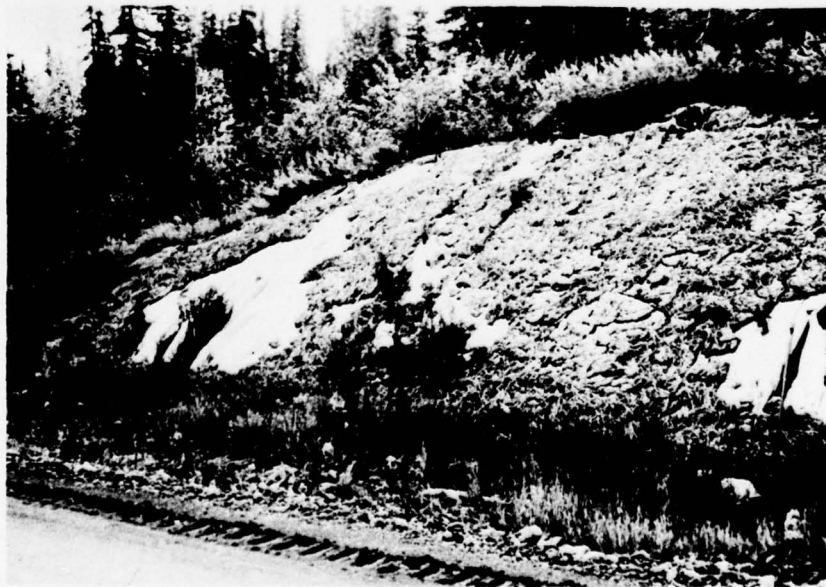
53. Insulated backslope, Mile 19.9 Lf, 14 September 1975.

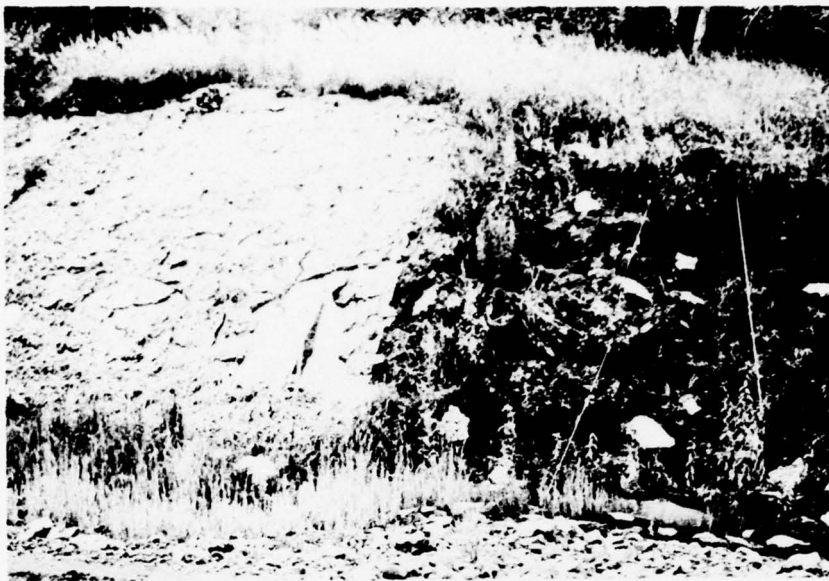
54. Insulated and uninsulated portions of backslope,
Mile 19.9 Lf, 14 September 1975.

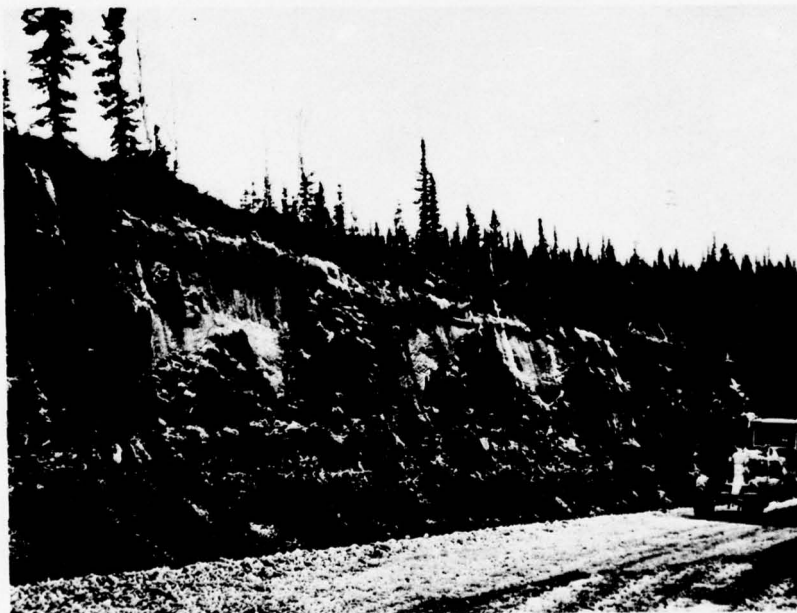
55. Frozen nearly-vertical backslope with large ice masses,
Mile 20.25 Lf, 23 April 1970.

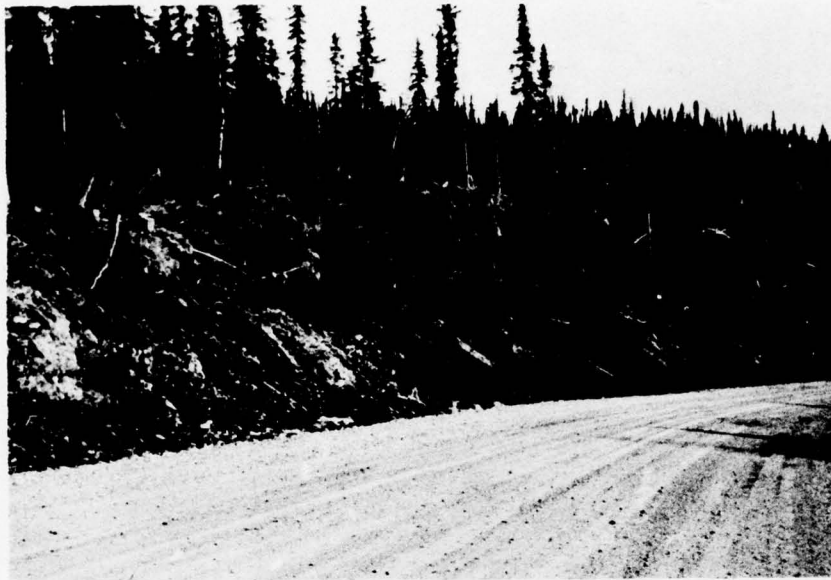
58. Overall view of slope, Mile 20.25 Lf, 28 May 1971.

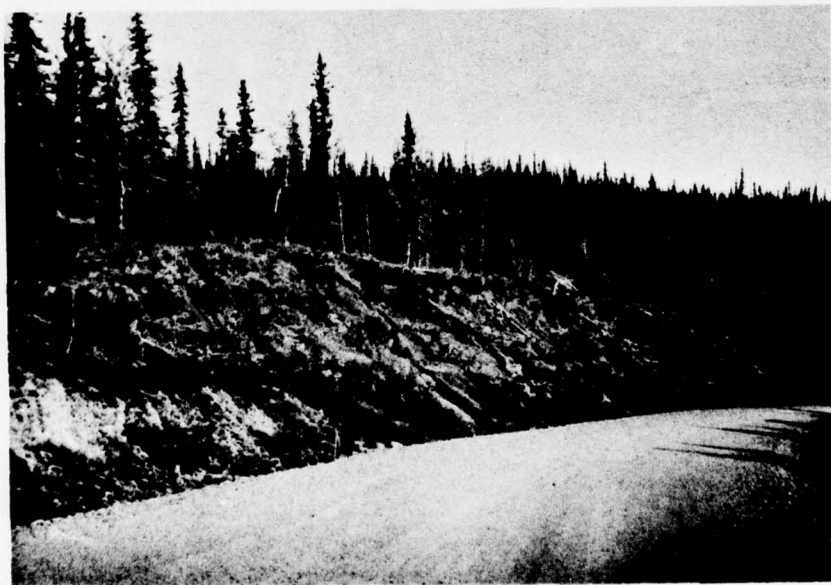
59. Overall view of slope, Mile 20.25 Lf, 17 August 1971.

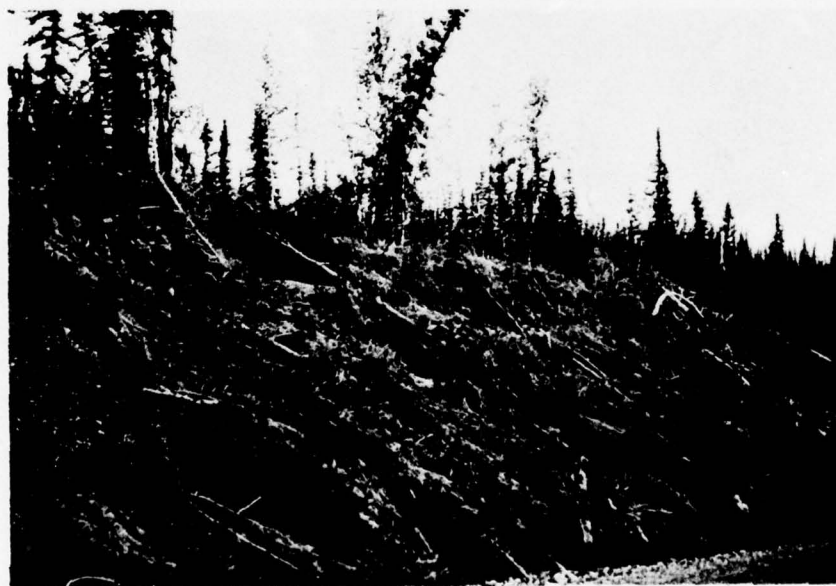
61. Overall view of slope, Mile 20.25, 23 June 1972.

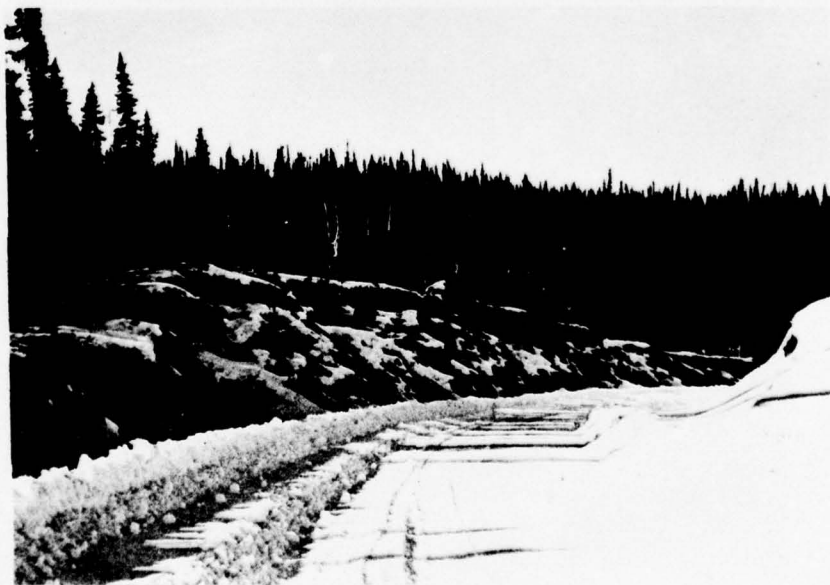
63. Snow covered slope, Mile 20.25 Lf, 20 April 1973.

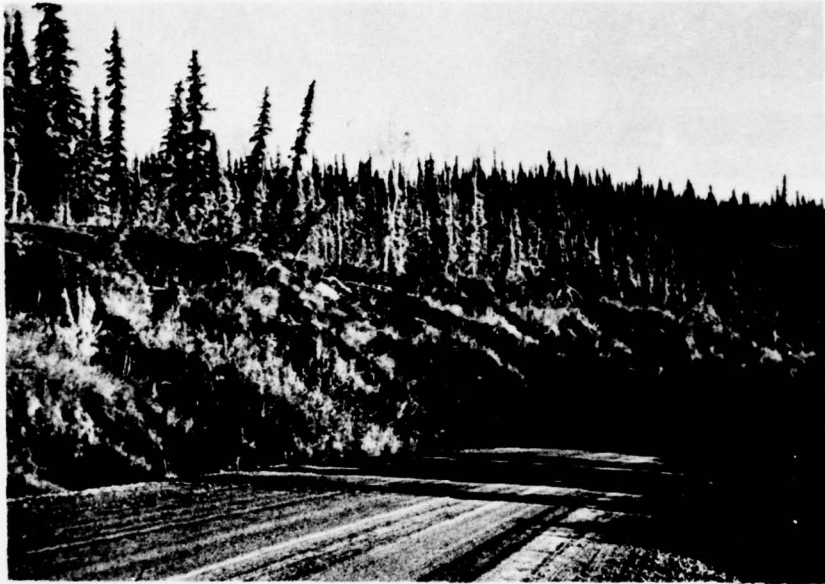
64. Small trees on slope, Mile 20.25 Rt, 27 September 1974.

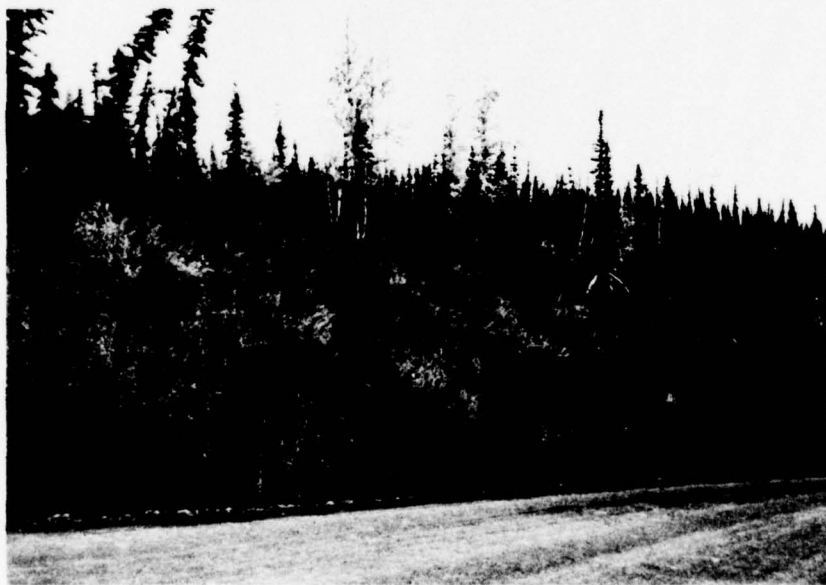
65. Slope covered with small trees, Mile 20.25 Rt, 14 September 1975.

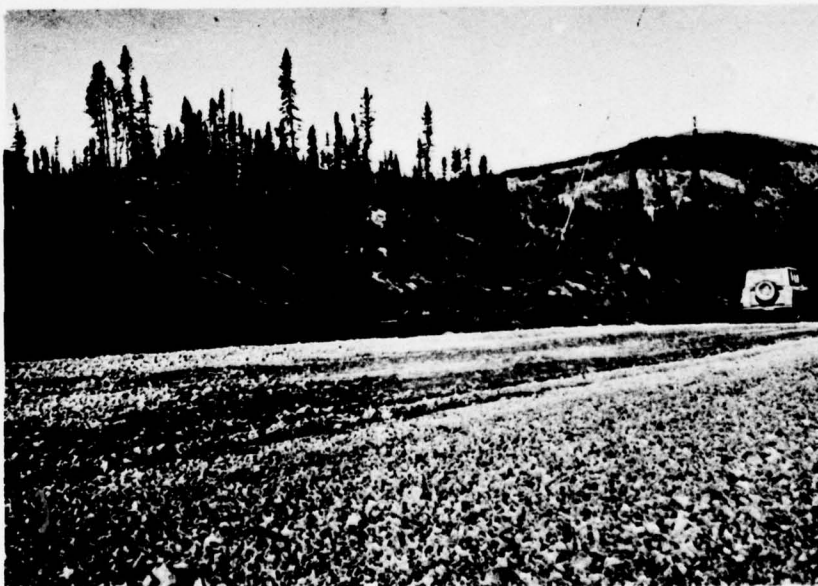
71. Grass not started on portion of backslope, Mile 22.9 Lf, September 1970.

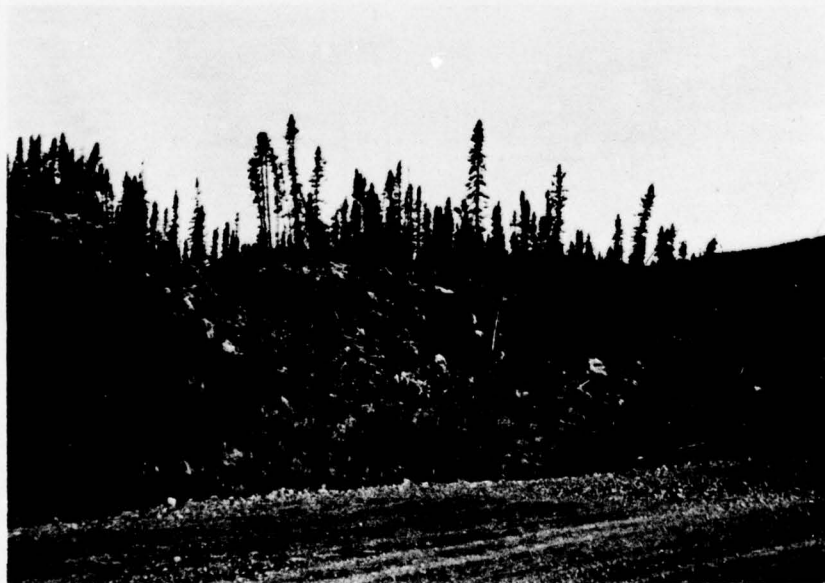
73. Continued instability of backslope, Mile 22.9 Lf, 23 June 1972.

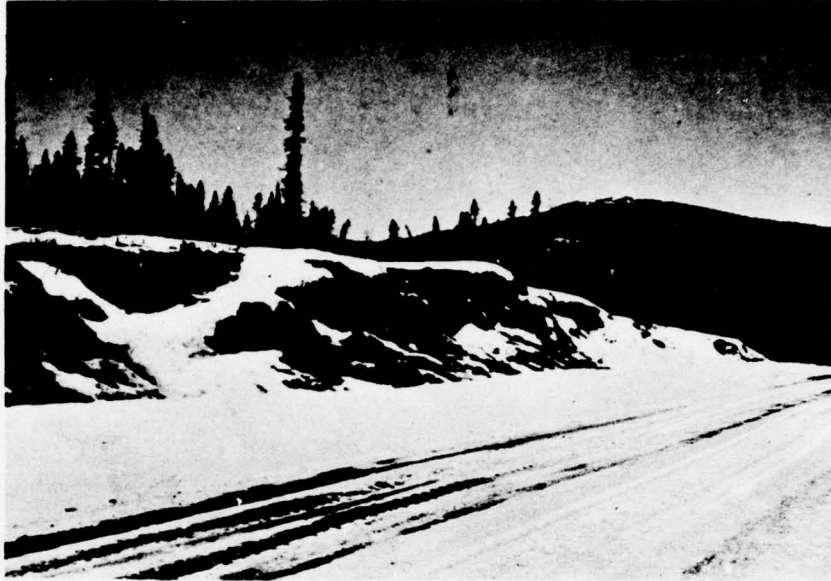
74. Snow-covered slope, Mile 22.9 Lf, 20 April 1973.

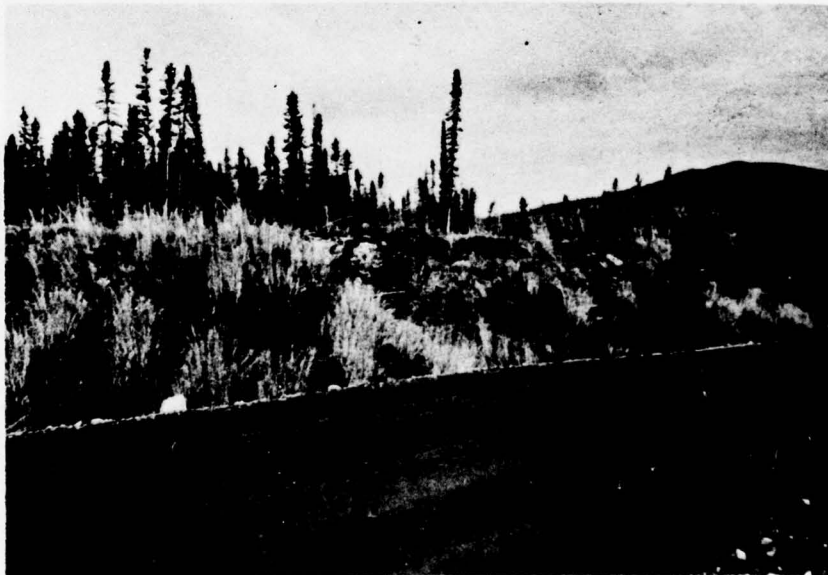
75. Grass-covered slope, Mile 22.9 Lf, 27 September 1974.

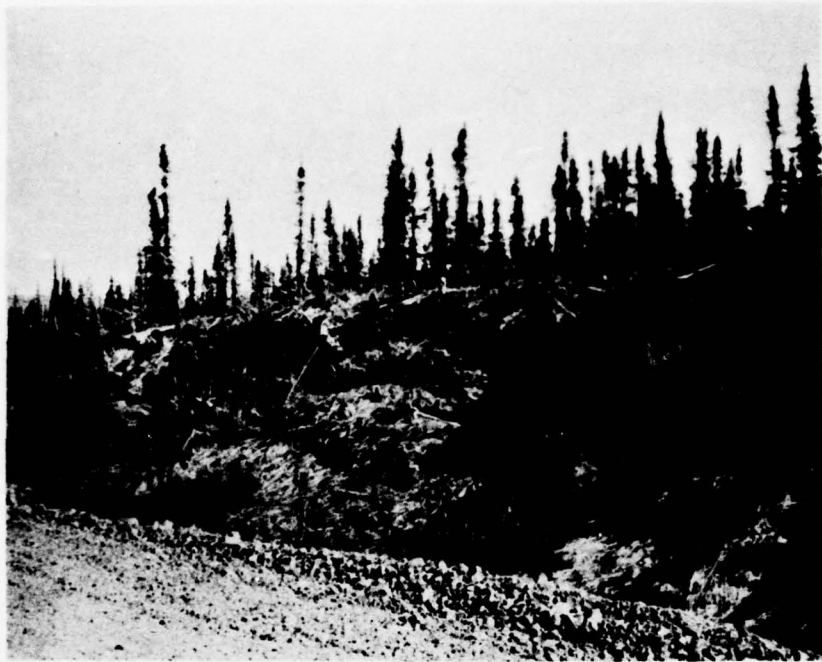
80. Center portion of slope, Mile 22.9 Rt, 17 August 1971.

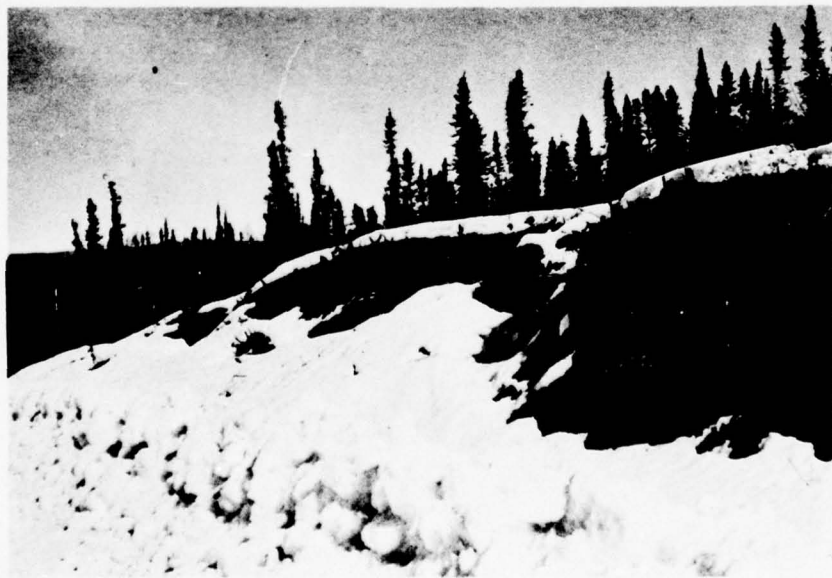
81. Backslope with snow cover, Mile 22.9 Rt, 21 April 1973.

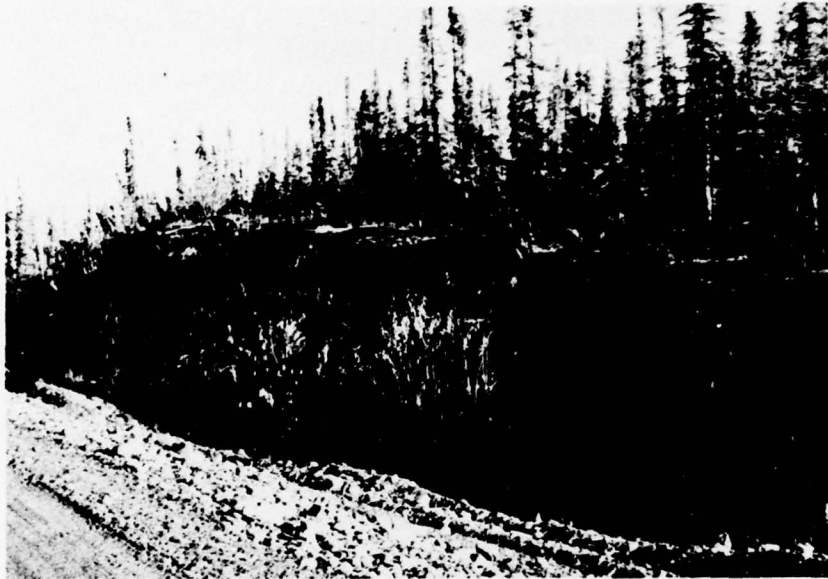
82. Backslope with small amount of grass, Mile 22.9 Rt,
27 September 1974.

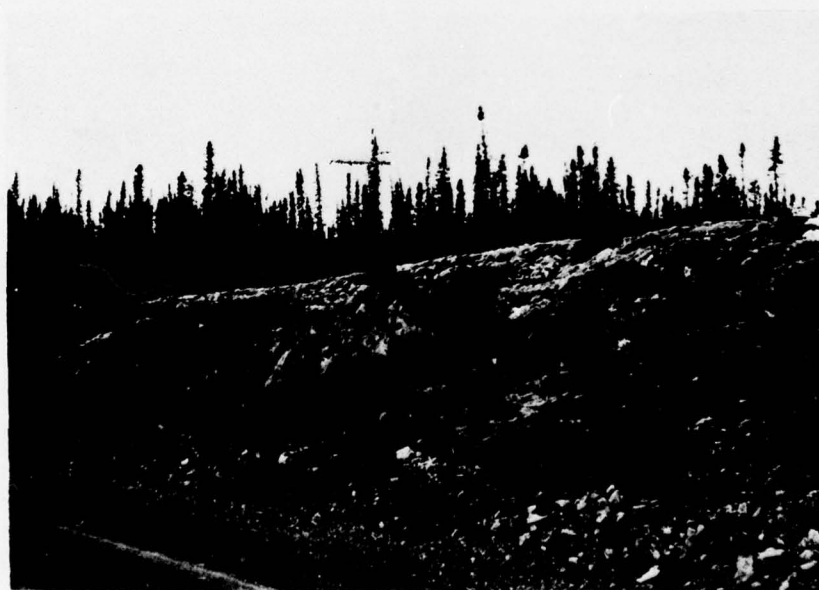
87. Overall view of backslope, Mile 23.2 Lf, 23 June 1972.

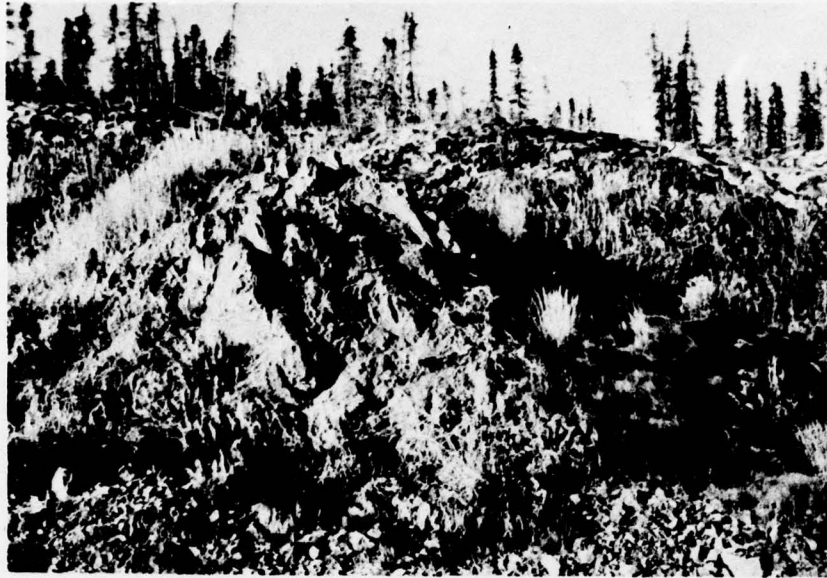
88. Close-up of vegetation and relatively dry mass of soil not supporting grass, Mile 23.2 Lf, 27 September 1974.

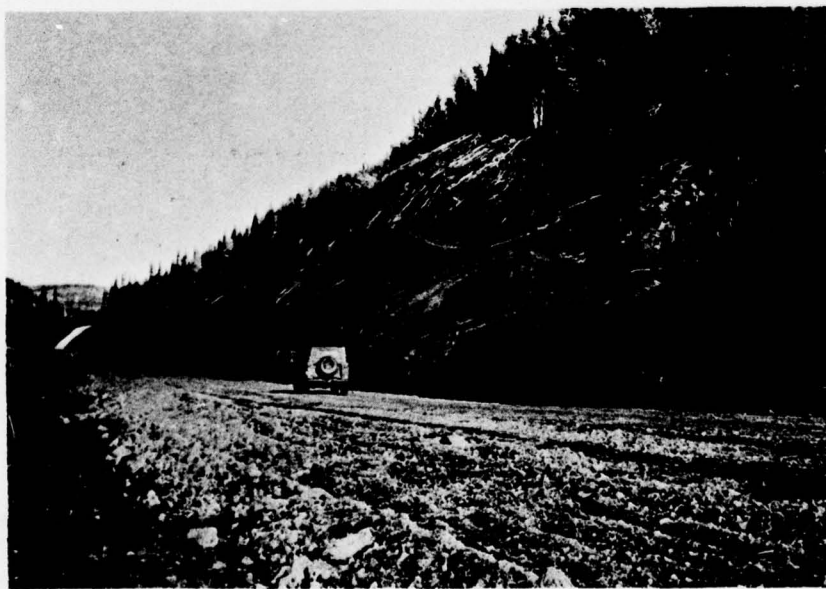
93. Overall view of backslopes, Mile 33.1 and 33.3 Rt, September 1970.
