OBSERVATIONS
ALONG THE PIPELINE HAUL ROAD
BETWEEN
LIVENGOOD AND THE YUKON RIVER

R. Berg and N. Smith

October 1976

CORPS OF ENGINEERS, U.S. ARMY
COLD REGIONS RESEARCH AND ENGINEERING LABORATORY
HANOVER, NEW HAMPSHIRE

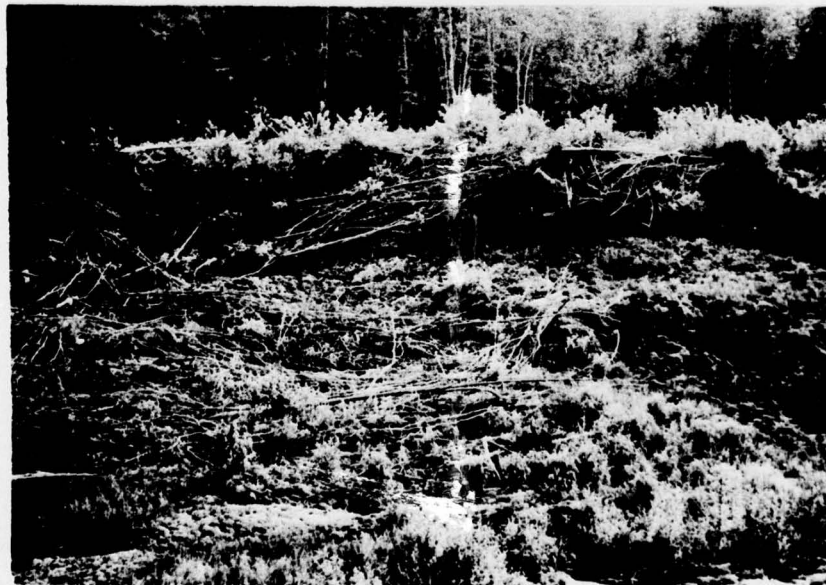
99. Fallen trees and overhanging mat, Mile 33.1 Rt, 23 June 1972.

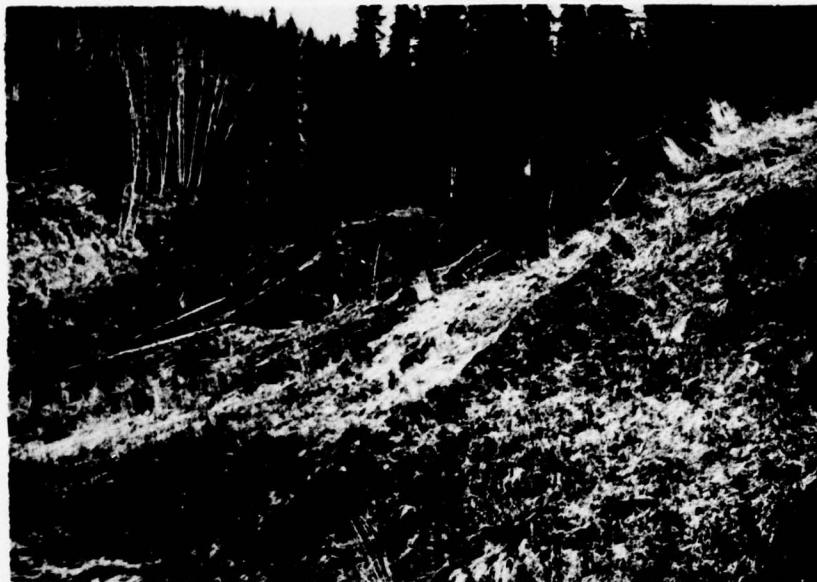
100. Grass and debris on backslope, Mile 33.1 Rt, May 1973.

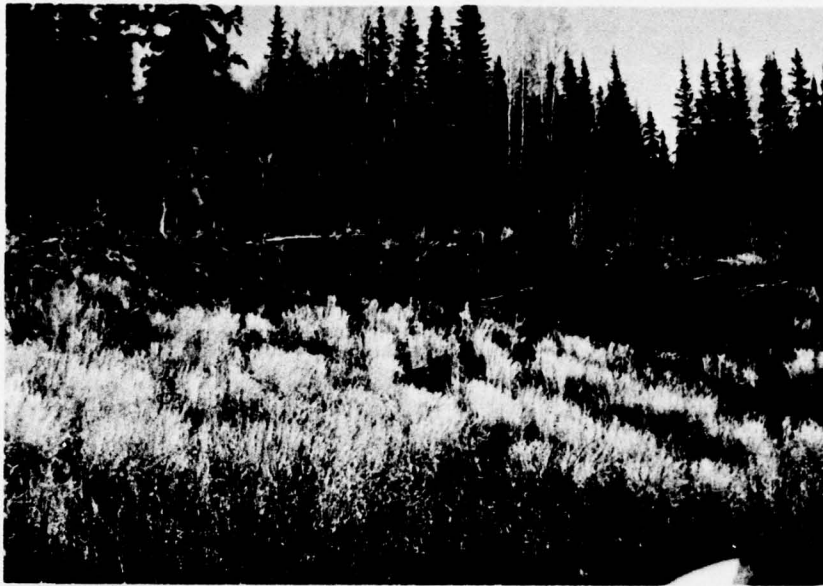
102. Relatively stable backslope, Mile 33.1 Rt, 27 September 1974.

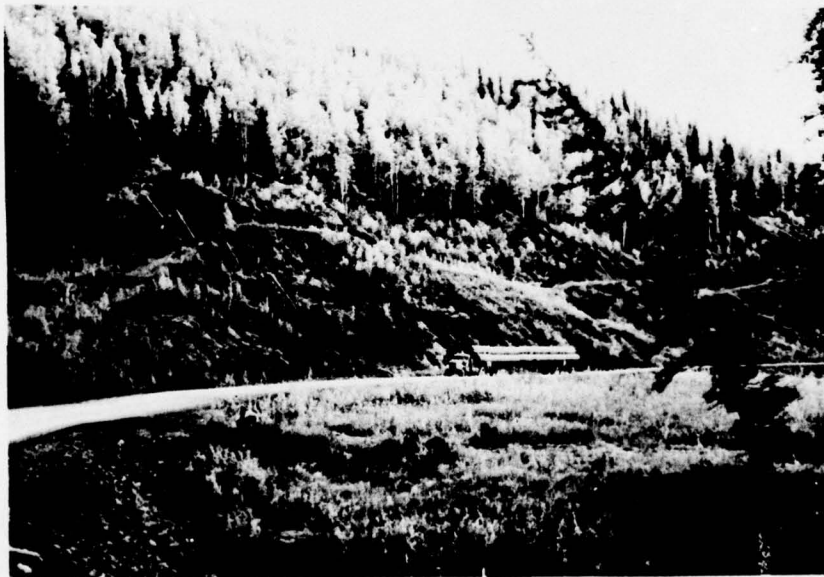
103. Overall view of backslope, Mile 33.3 Rt, 14 September 1975.

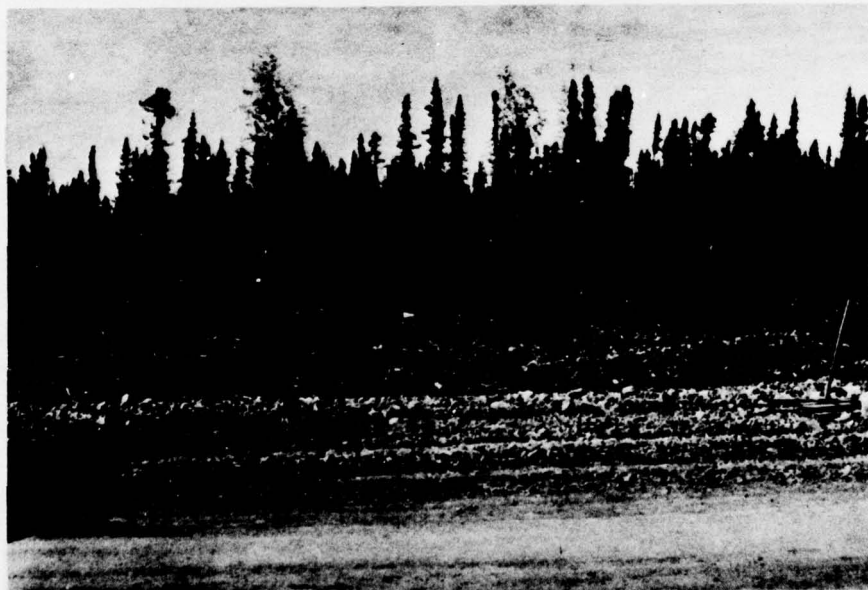
Figures 105 and 106 look left and right, respectively, at the cross section site on 27 June 1970. As seen in the photographs, trees were removed and the organic mat was stripped on each side of the road. The stripped material was replaced after constructing the embankment, and during the 1970 summer the areas were seeded.

105. Left embankment slope, Mile 16.3, 27 June 1970.

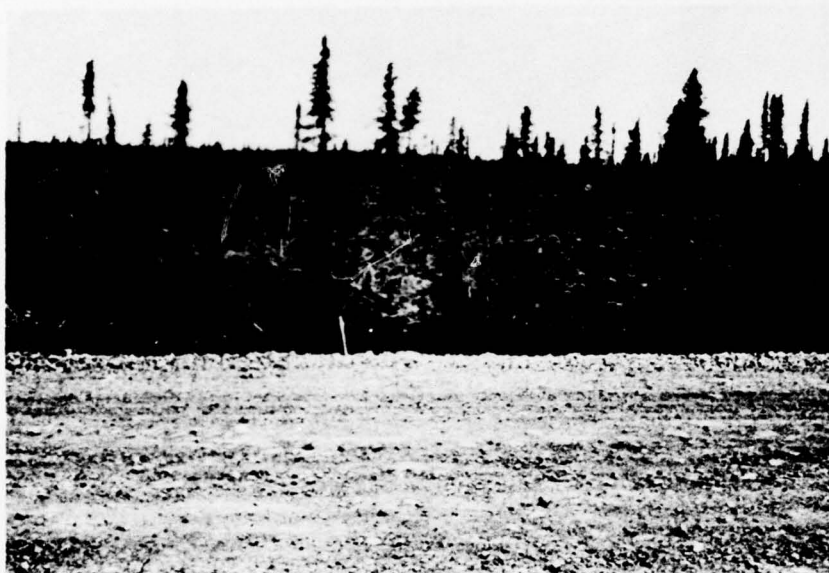
Figures 110 and 111 illustrate the conditions at the second cross-section site on 27 June 1970. This site is at station 2710+00 at about mile 50.7 (81.6 km). The finished grade elevation was 1177.5 ft (358.8 m) and the width of the roadway surface was about 28 ft (8.5 m). The section is located in a relatively flat area with very little vertical grade on the road which runs in a northwesterly direction. At this site the trees and vegetation had been disturbed for a width of only about 20 ft (6.1 m) beyond the toe of the slope on each side of the road. Figure 112 illustrates changes in cross-section levels for this section from 27 June 1970 through September 1975. The roadway centerline has subsided about 1.25 ft (0.38 m) since it was constructed. Reasons for the settlement can be inferred from exploratory borings for the pipeline in that vicinity (Fig. 113). The boring logs were taken from Alyaska (1971) and the locations were within 500 ft (150 m) of the cross-section site. Occasional to considerable amounts of visible ice were encountered in the top 3 to 6 ft (1 to 2 m) of overburden. This would easily account for the recorded settlements.

110. Left side of road, Mile 50.7, 27 June 1970.
