# Metallurgical Failure Analysis of MH-1A Reactor Core Hold-Down Bolts

J. R. HAWTHORNE AND H. E. WATSON

November 1976

NAVAL RESEARCH LABORATORY  
Washington, D.C.

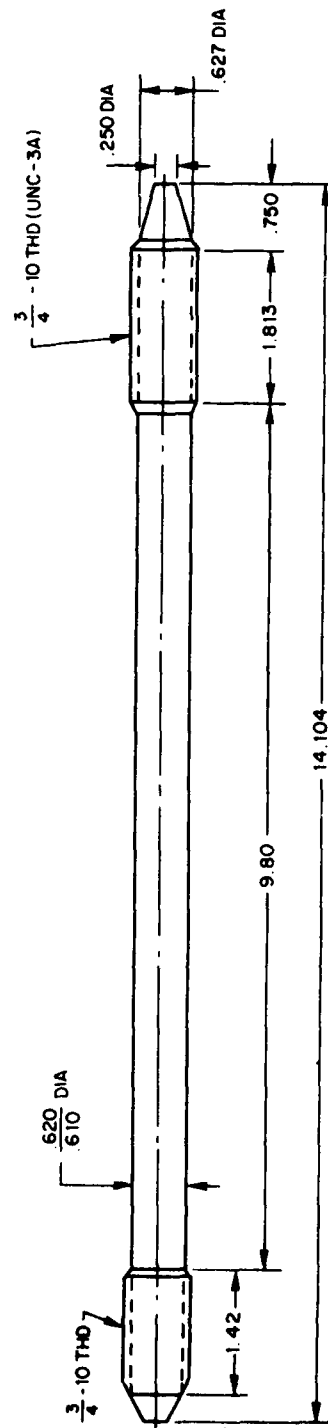
Fig. 1 — Nominal configuration and dimensions of MH-1A core hold down bolts  
(after Martin Company Drawing No. 393A4153016 — CHG B)

construction, the bolt was modified on-site by drilling a locking pin hole in the threaded end adjacent to the ring plate.

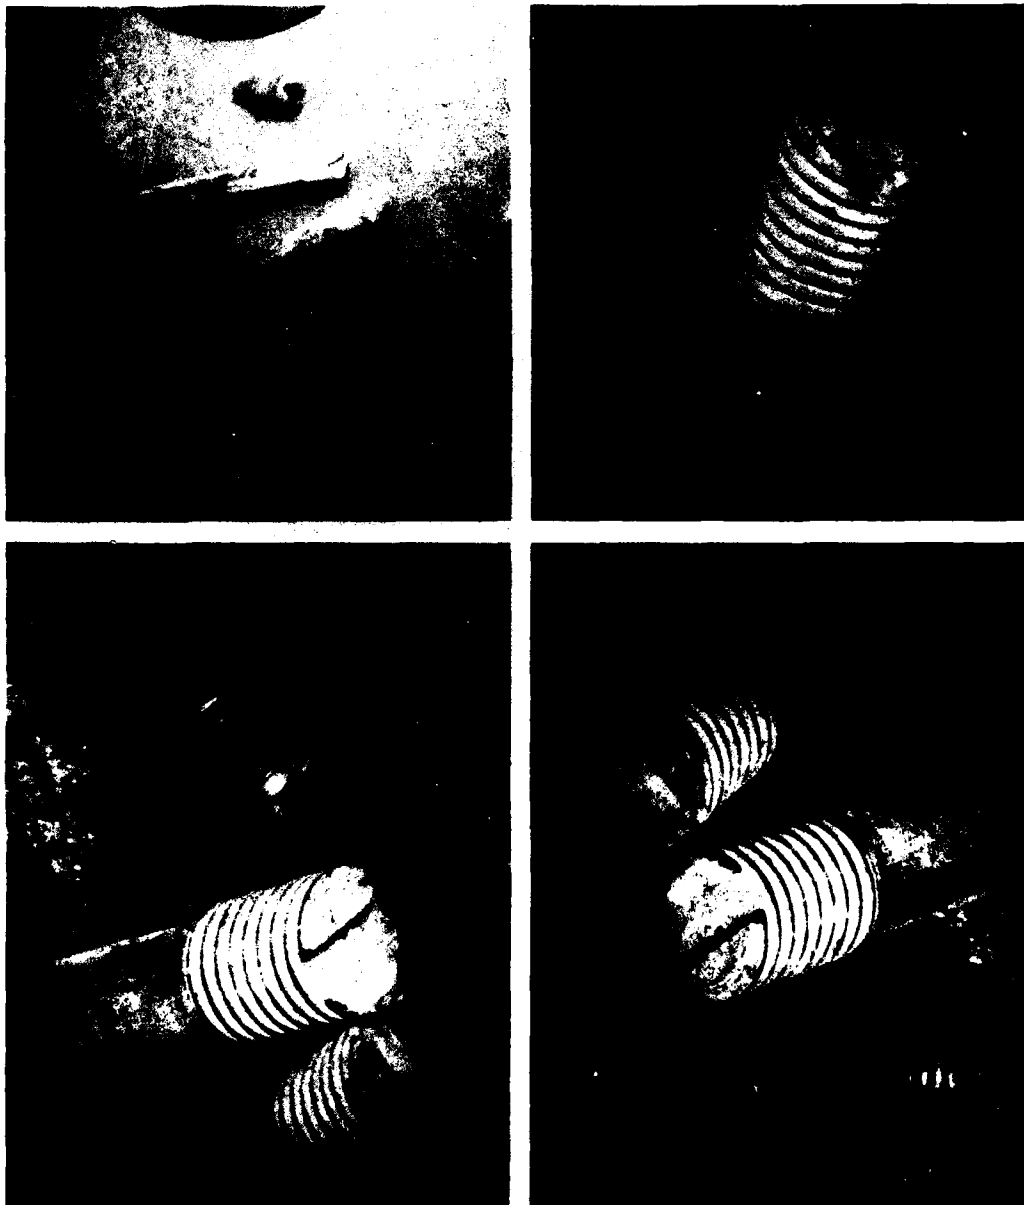
Fig. 3 — General appearance of bolts 1 and 2

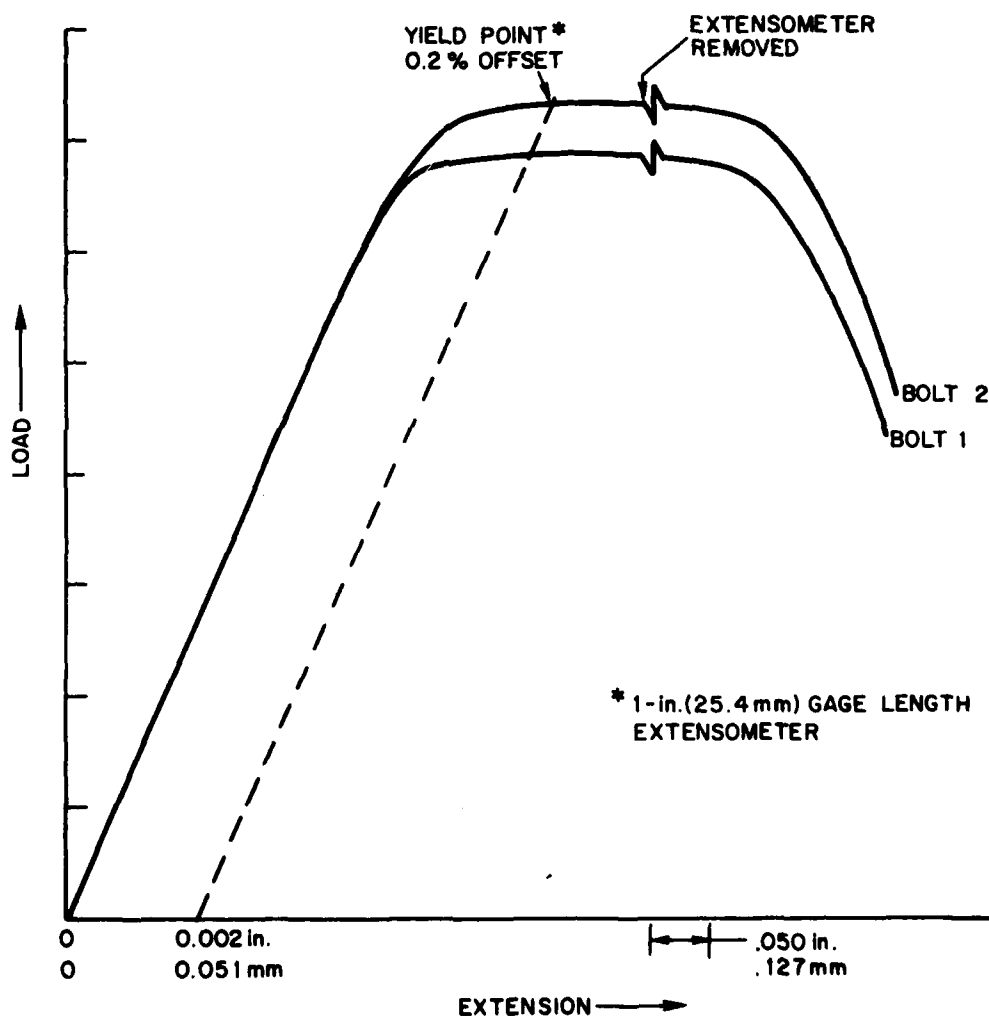
Tensile properties. Tensile properties, determined from samples removed as shown in Fig. 4, are summarized in Table 3. The properties are based on test specimens having a 0.226-in. gage diameter (5.74 mm) and a 1.250-in. gage length (31.75 mm). Specimen load-extension traces are reproduced in Fig. 6. The traces provide two important clues to the probable cause of bolt failure as discussed in the next section. Specifically, the traces describe very low material capability for uniform strain hardening and very low tensile ductility.

Fig. 6 — Tensile specimen load-extension traces. A conventional extensometer with a 1-in. (25.4 mm) gage length was used.

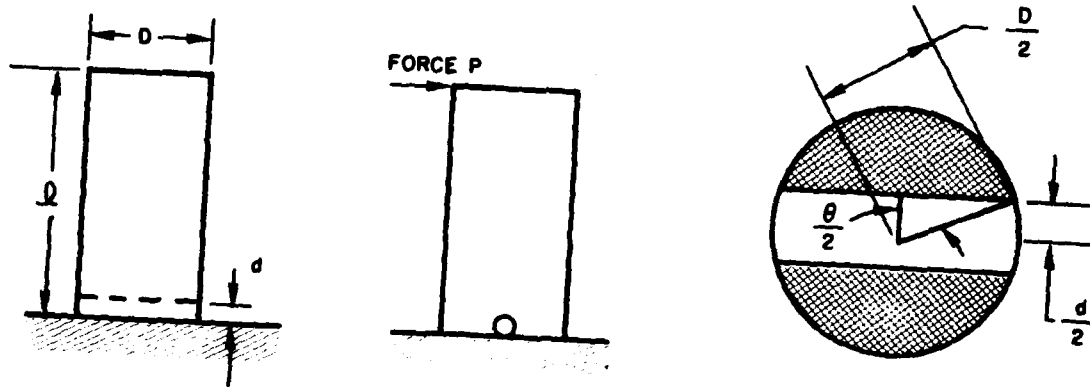
The bending force (P) required to produce net section overloading was calculated for the analysis (see Appendix A). The calculation assumes a material tensile strength of 170 ksi (1172 MPa) and application of the bending force at a point 10 inches (254 mm) above the locking pin hole centerline, i.e., 10 1/8-in. (257 mm) above the bolt ring plate. The computation indicates that plastic overload would occur when the external force reaches about 400 lb or 1779 Newtons. Because the working platform for personnel performing core operations is well above (i.e., several feet) the reactor grid plate, it is possible that bolt failure could have taken place under remotely applied forces less than 40 to 50 lb or 178 to 222 Newtons.

Fig. A-1 — Model for computation of net section stress on MH-1A bolt
