**6 AIRFIELD PAVEMENT EVALUATION,
BUTTS ARMY AIRFIELD,
FORT CARSON, COLORADO.**

AIRFIELD PAVEMENT EVALUATION

BUTTS ARMY AIRFIELD

FORT CARSON, COLORADO

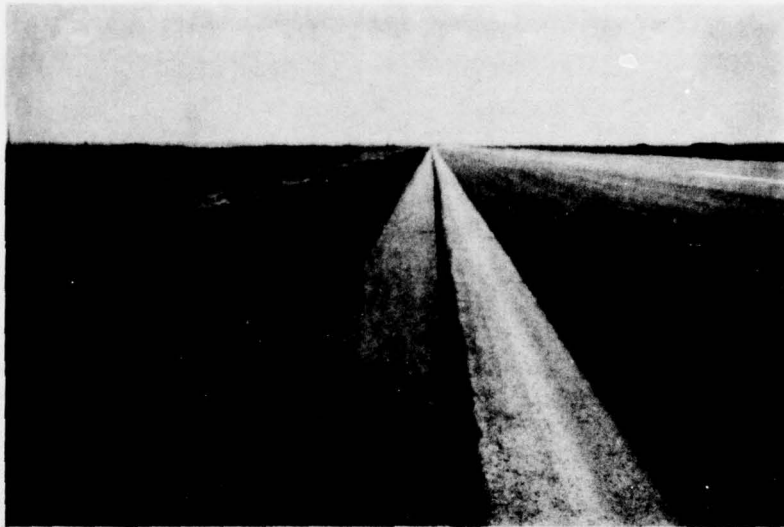
The seal placed in the hover lane covered only a 65-ft-wide area (Photos 1 and 2) of the existing 150 ft. The seal on the primary runway was also only about 65 ft wide (Photo 3).

Photo 3. Edge of primary runway indicating area that had not received hot-mix plant seal in 1973

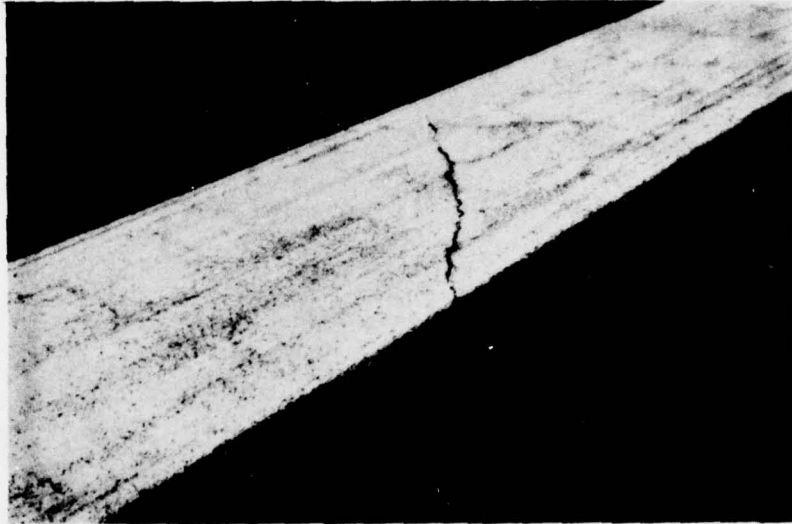
9. The general condition of the pavement surfaces at the time of the inspection (6 November 1975) was very good. The primary runway had contained cracks prior to the placement of the plant seal and these cracks had not been sealed (see Photo 4). These cracks have reflected through the plant seal (Photo 5). These cracks will eventually have to be sealed if ravelling or spalling becomes a problem. The pavement surface on the primary runway also contained some scratch marks from the skids of landing helicopters; however, this is not affecting the surface as there was no evidence of any gouging or rutting (Photo 6). The PCC parking apron was in excellent condition, with no evidence of any structural defects (Photo 7). The area of the hover lane that had not received plant seal contained some shrinkage cracks (Photo 8). One area at the southeast end of the hover lane that had been overlaid with the plant seal was rutted by the skids of a Cobra helicopter (Photo 9). The plant seal had probably not cured sufficiently when it was used by the helicopter for landing. The crosswind runway was also in very good condition (Photo 10). This runway is used mainly for landing helicopters and has many skid marks on the surface; however, the skids are not damaging the pavement. This runway does not contain the shrinkage cracking evidenced on the primary runway.

Photo 5. Reflection crack in surface of primary runway

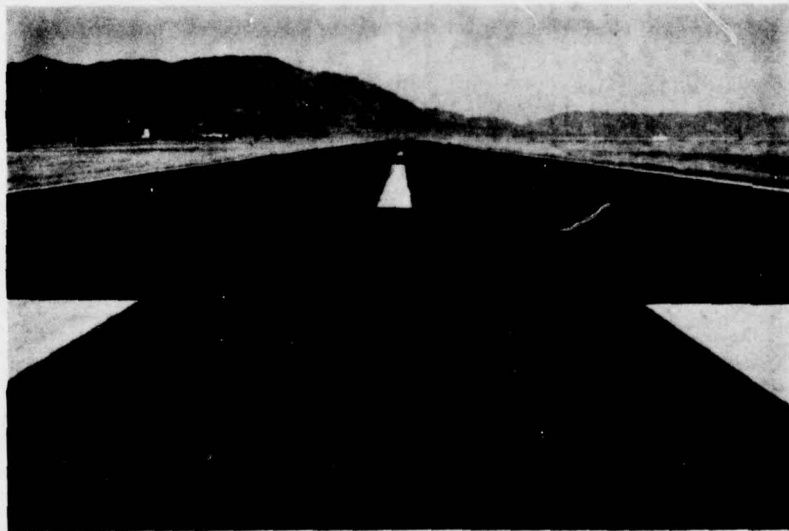
Photo 6. Primary runway with skid marks from landing helicopters
