AFAPL-TR-76-58

LIFE TEST OF A DYNAVECTOR ROTARY ACTUATOR FOR AIRCRAFT HYDRAULIC SYSTEMS

OCTOBER 1976

TECHNICAL REPORT AFAPL-TR-76-58
FINAL REPORT FOR PERIOD JULY 1971 Thru MARCH 1976

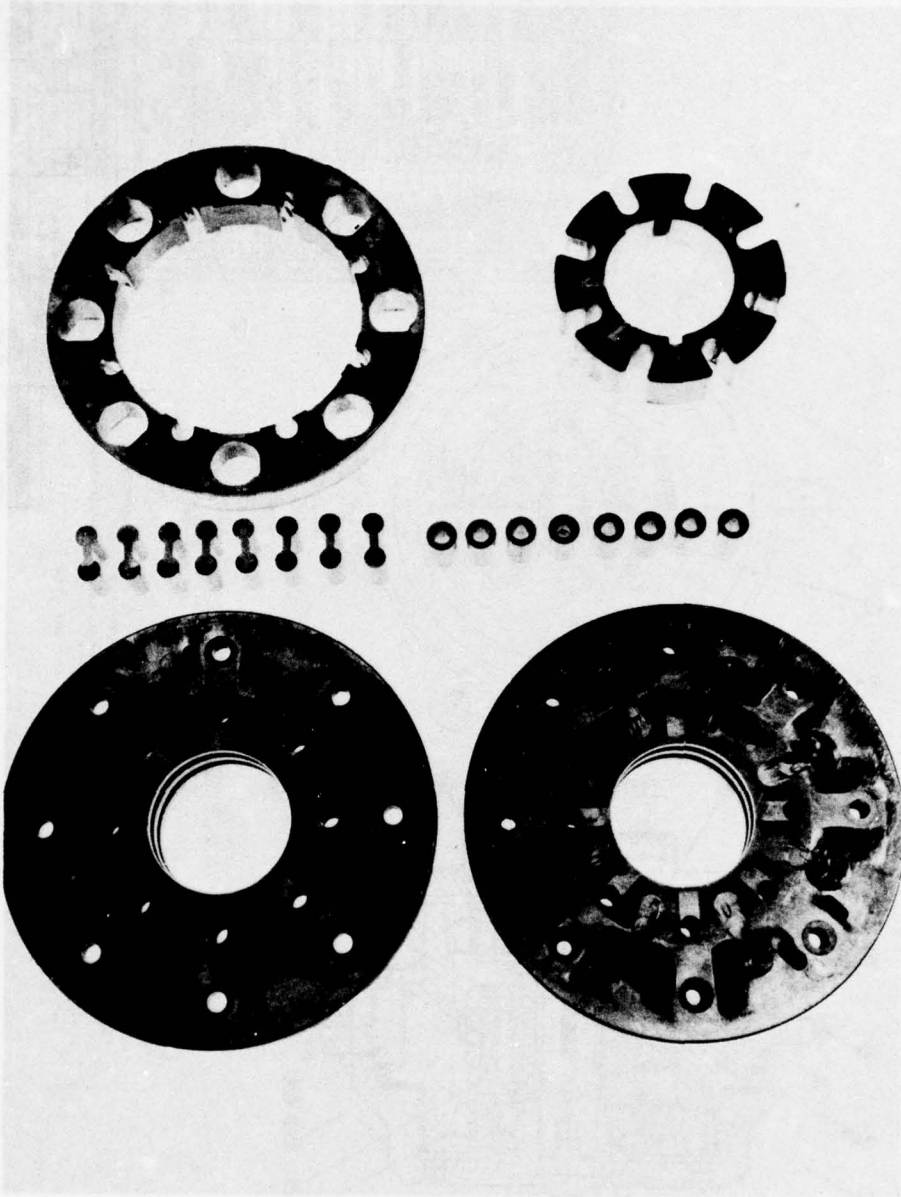
f. Motor - No sign of significant wear was found on any of the motor parts as shown in Photos 2 and 3.

Figure 2. Exploded View of Motor After Tests

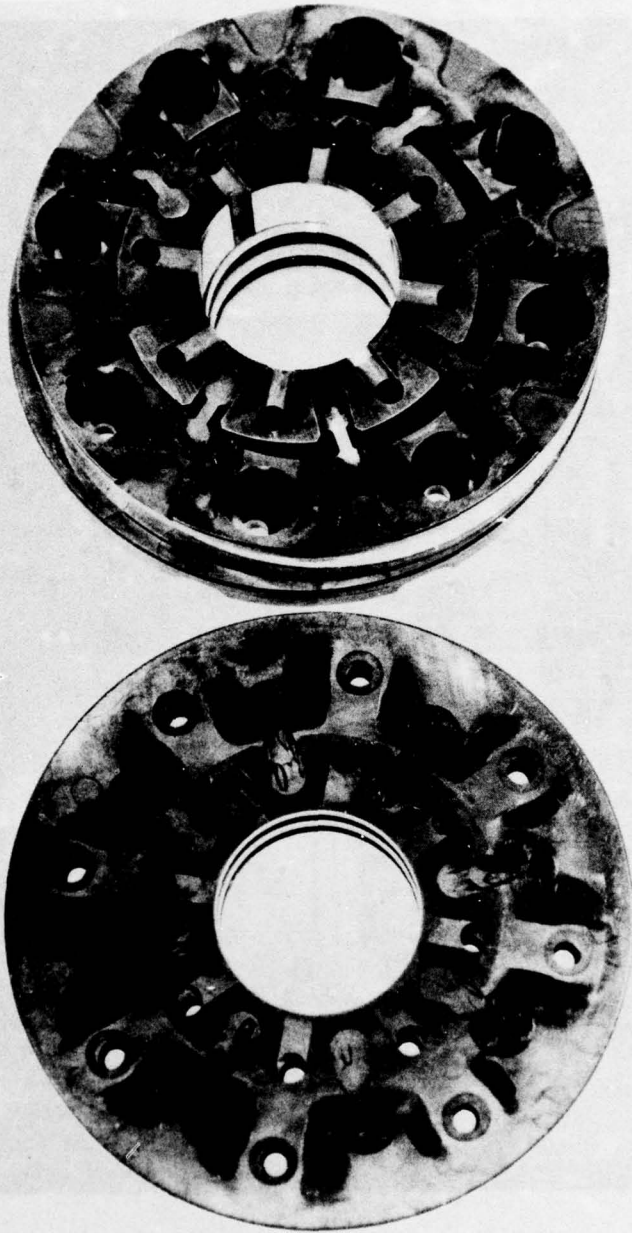
Figure 3. Partial Assembly of Motor After Tests

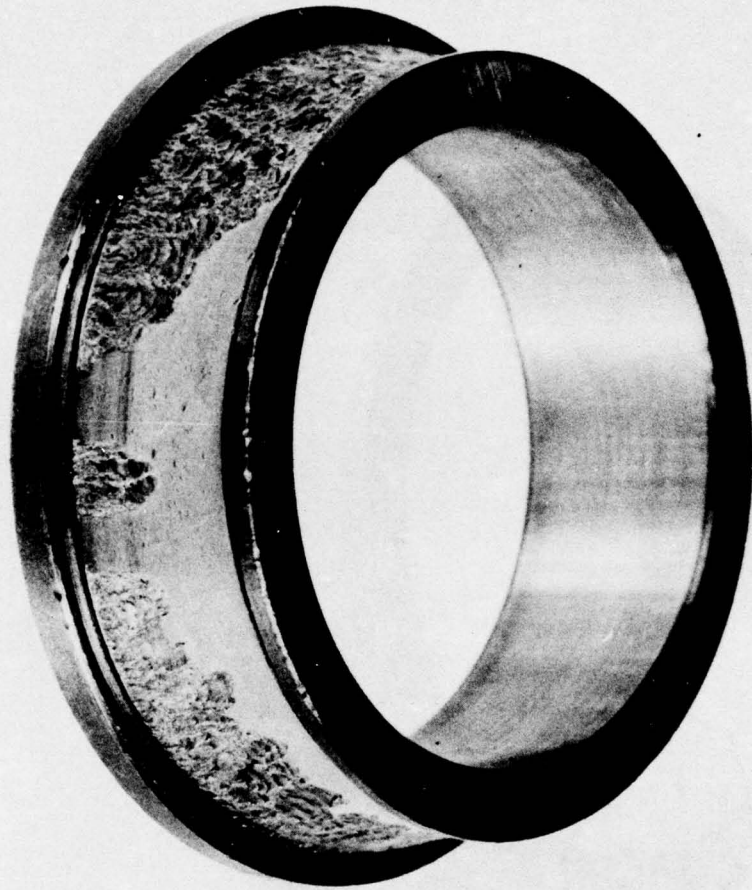
The actuator was then installed in the test system with an aircraft-type piston pump and an electro-hydraulic servo valve. This system is described in Section III. The actuator was cycled at a rate of 24 cycles/min from 50,000 in-lb in one direction to 50,000 in-lb in the other direction and return for 50,000 cycles. This corresponded to $\pm 7.5^\circ$ of rotation of the actuator. The cycle rate was then reduced to 12 cycles per minute and the load increased to 100,000 in-lb. This corresponded to $\pm 15^\circ$ of rotation. After 3400 cycles the actuator became extremely erratic. Disassembly revealed failure of a tapered roller bearing (TIMKEN #29586 cone and #29522 cup) that was in the upper part of the actuator (see Figures 11 and 12). A similar bearing in the lower part indicated some distress but not as severe damage. Based on contact with both Bendix and Timken, it was determined that the probable cause of failure was improper preload of the bearing during assembly. The remainder of the actuator was in good condition.

Figure 11. Failed Timken Bearing After Run No. 2

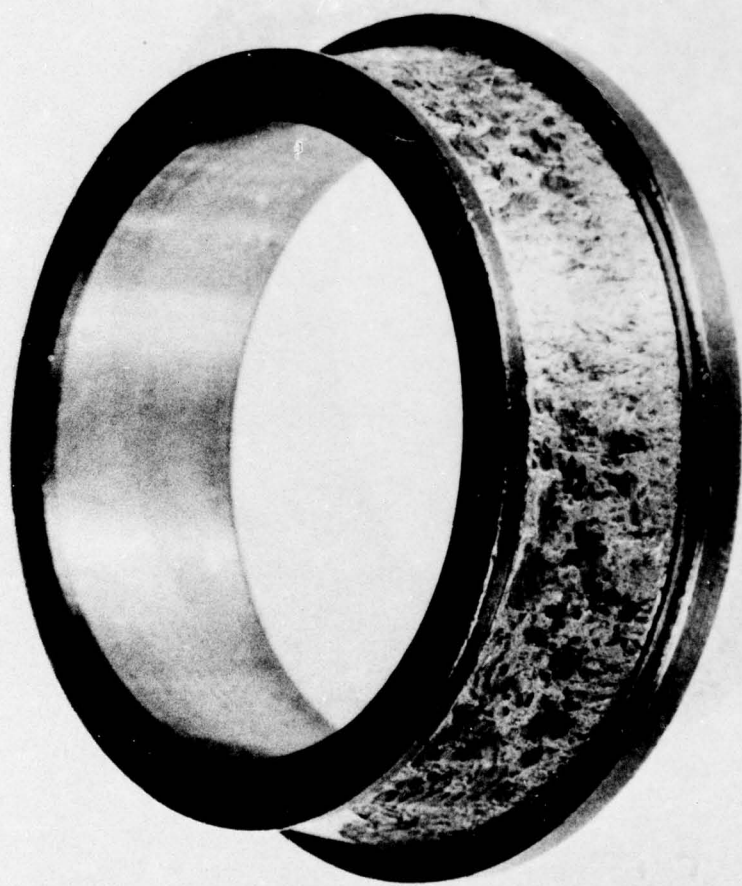
Figure 12. Failed Timken Bearing After Run No. 2

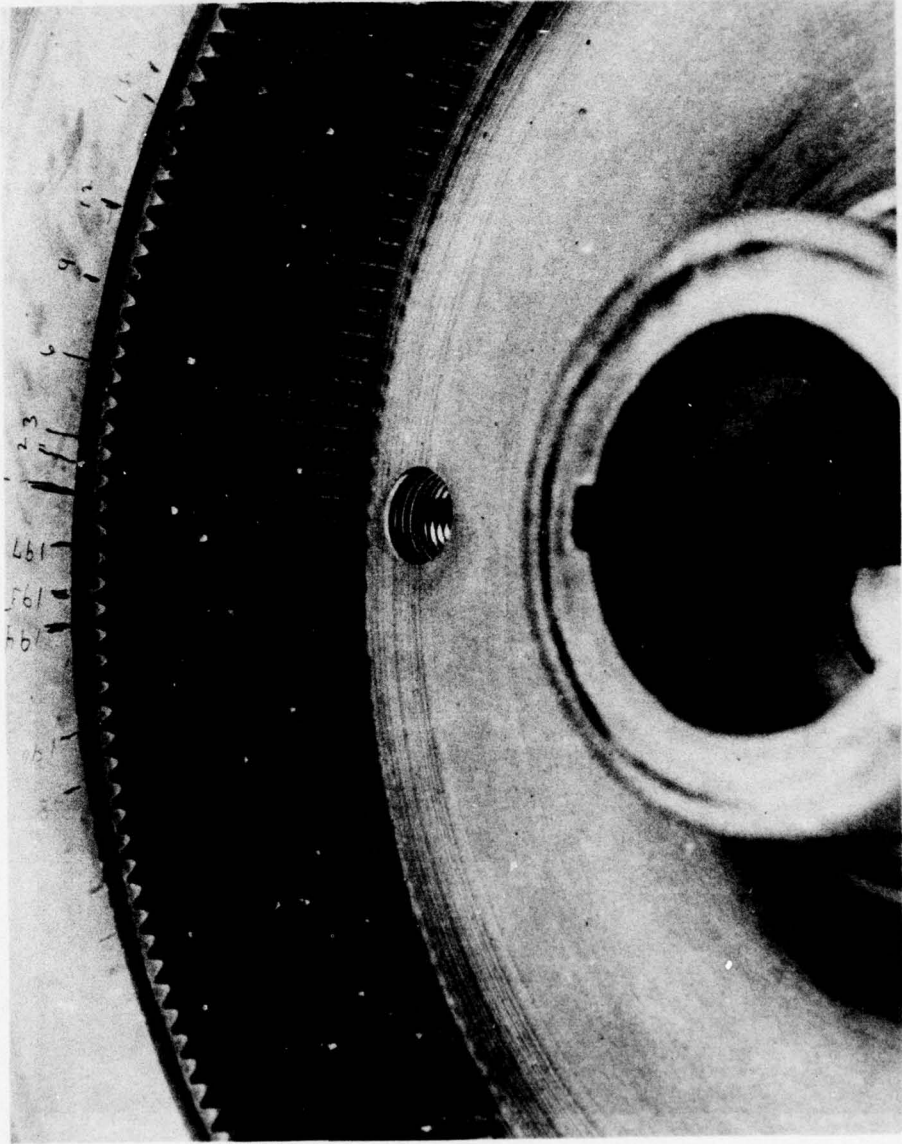
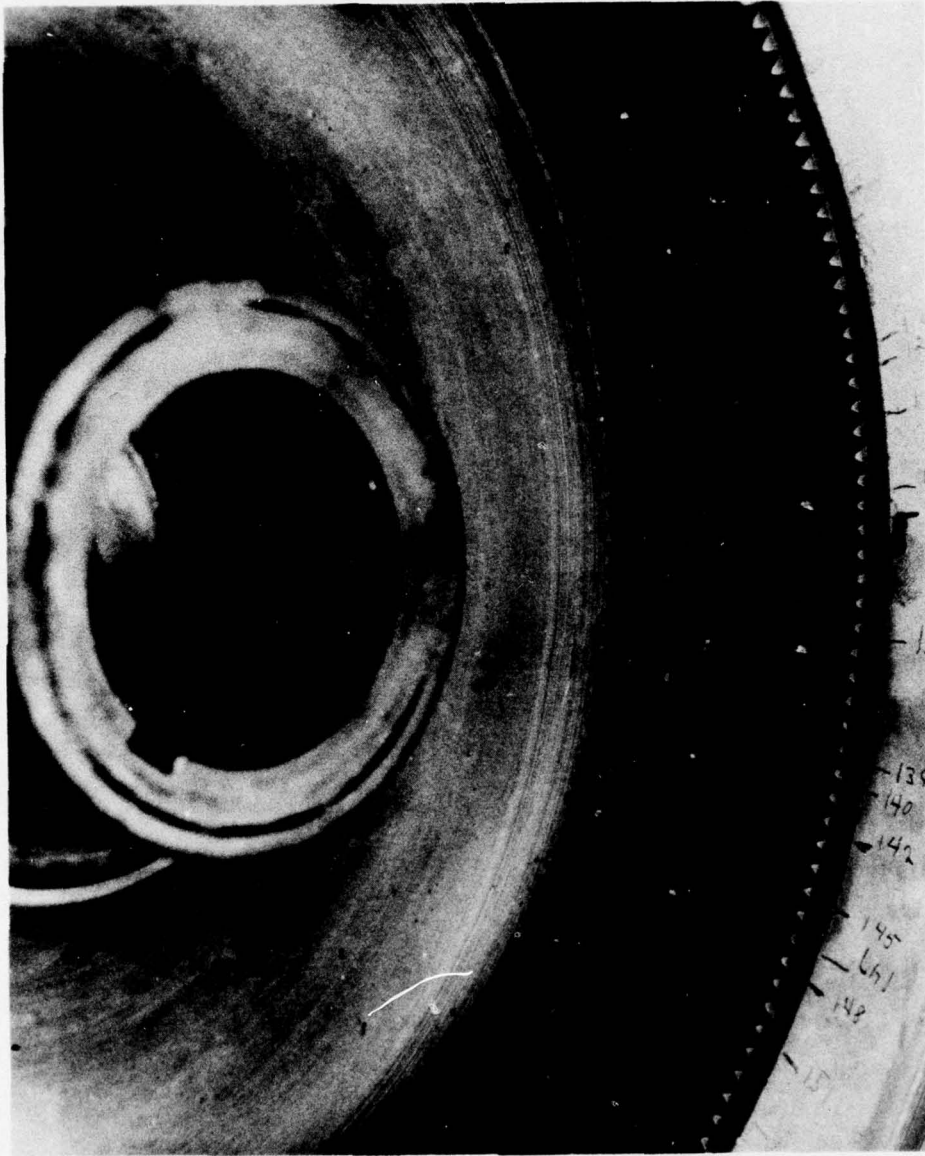
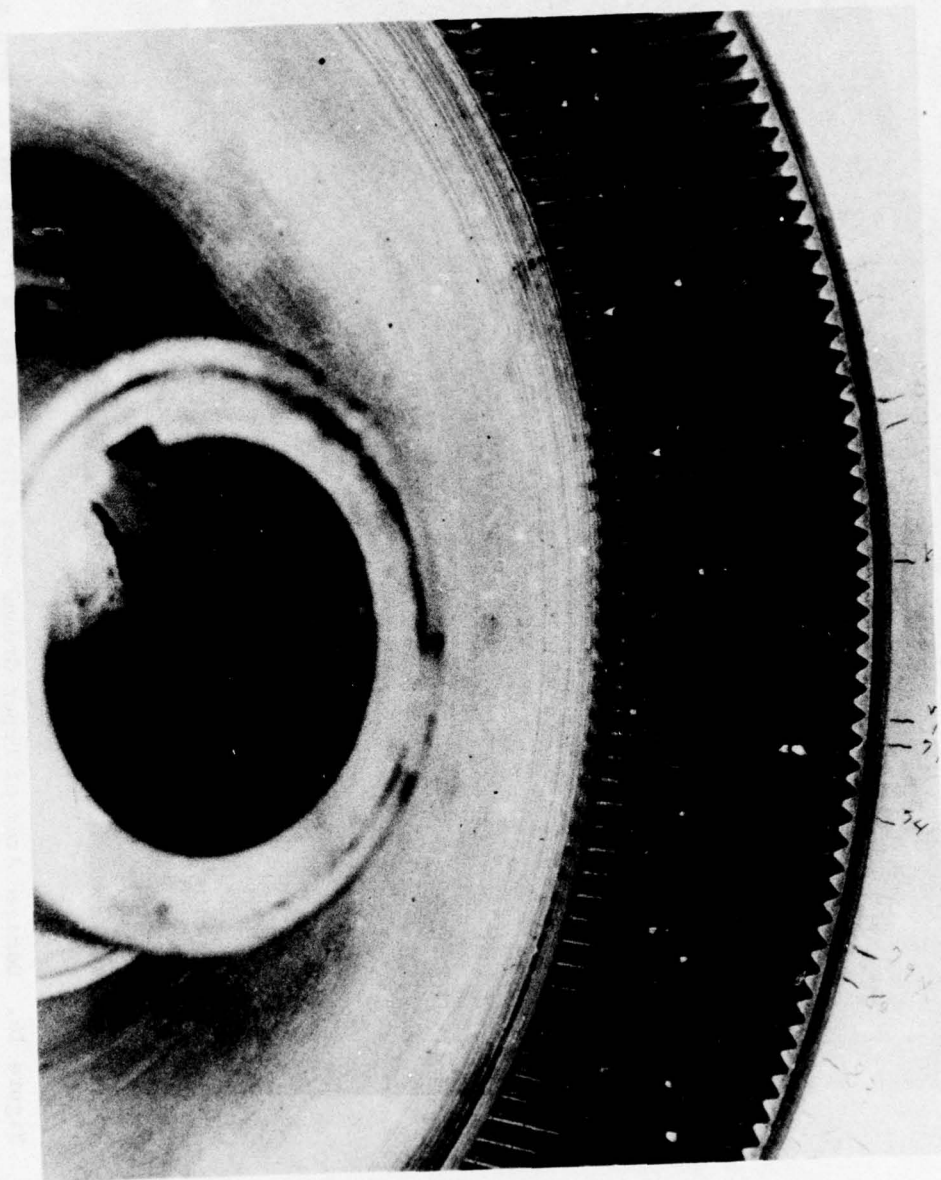
was provided to the bearings. A magnetic pickup was installed in the case drain line to indicate failure of the actuator. The testing was then resumed with the same test cycle as conducted in runs 2 and 3. After 68,000 cycles at ± 50 in-lb load, chips were found in the magnetic pickup. Again testing was stopped and the actuator disassembled. The Timken bearings were in good condition. The chips were now coming primarily from the lower ground gear. The debris from the previous bearing failure had resulted in distress to this gear and the load was then causing chipping of the gear teeth in the areas of distress. Figures 13 thru 15 show the gears after this test. As can be seen from the photos shown in Figures 16 thru 18, the lower gears indicate the most damage. This further substantiates the premise that the bearing failure debris initiated the chipping of the gear teeth. A photo (Figure 19) of the ring gear and of the output gear (Figure 20) taken after this test indicates some signs of debris but no chipping of gear teeth.

Figure 13. Lower Ground Gear After Run No. 4 (Teeth No. 70 Thru No. 20)

Figure 14. Lower Ground Gear After Run No. 4 (Teeth from Approx No. 110 Thru No. 155)

Figure 15. Lower Ground Gear After Run No. 4 (Teeth No. 40 Thru No. 88)

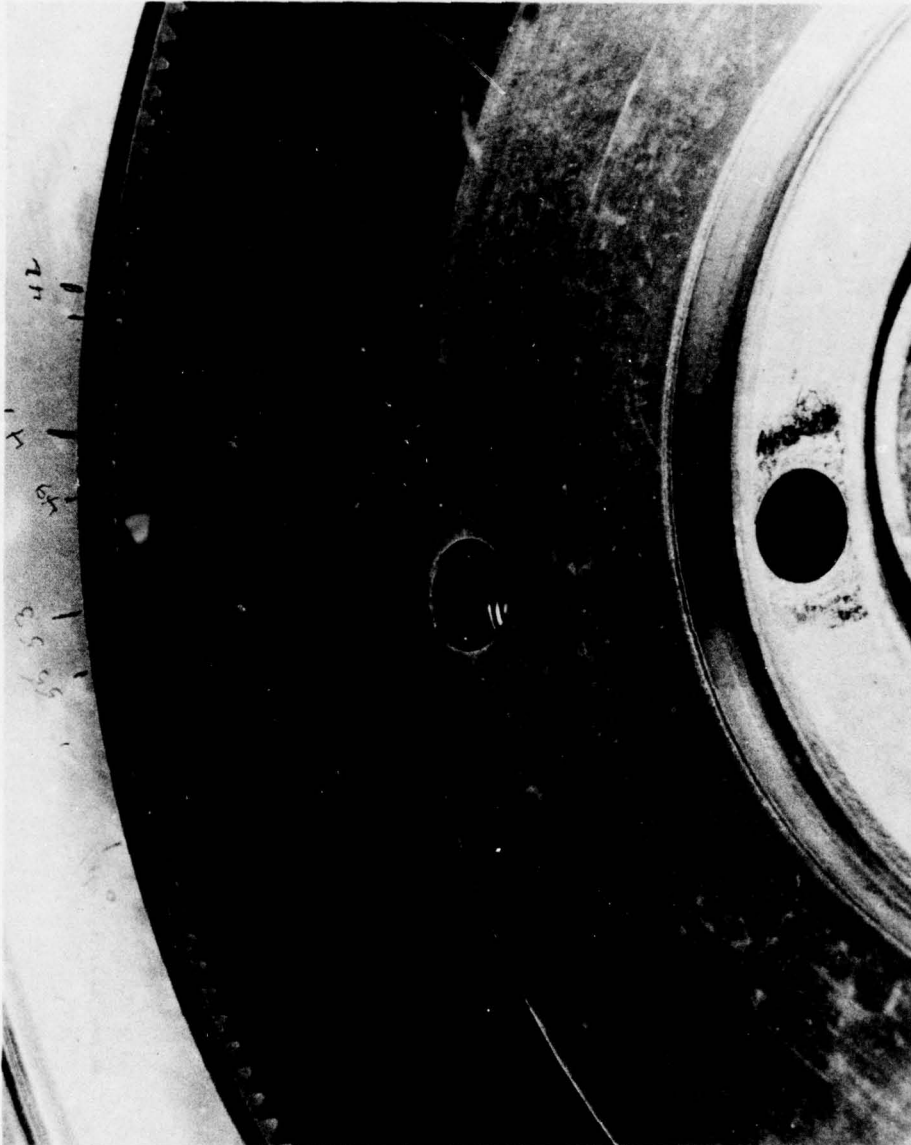
Figure 16. Damaged Area of Upper Ground Gear After Run No. 4 (Teeth No. 42 Thru No. 55)

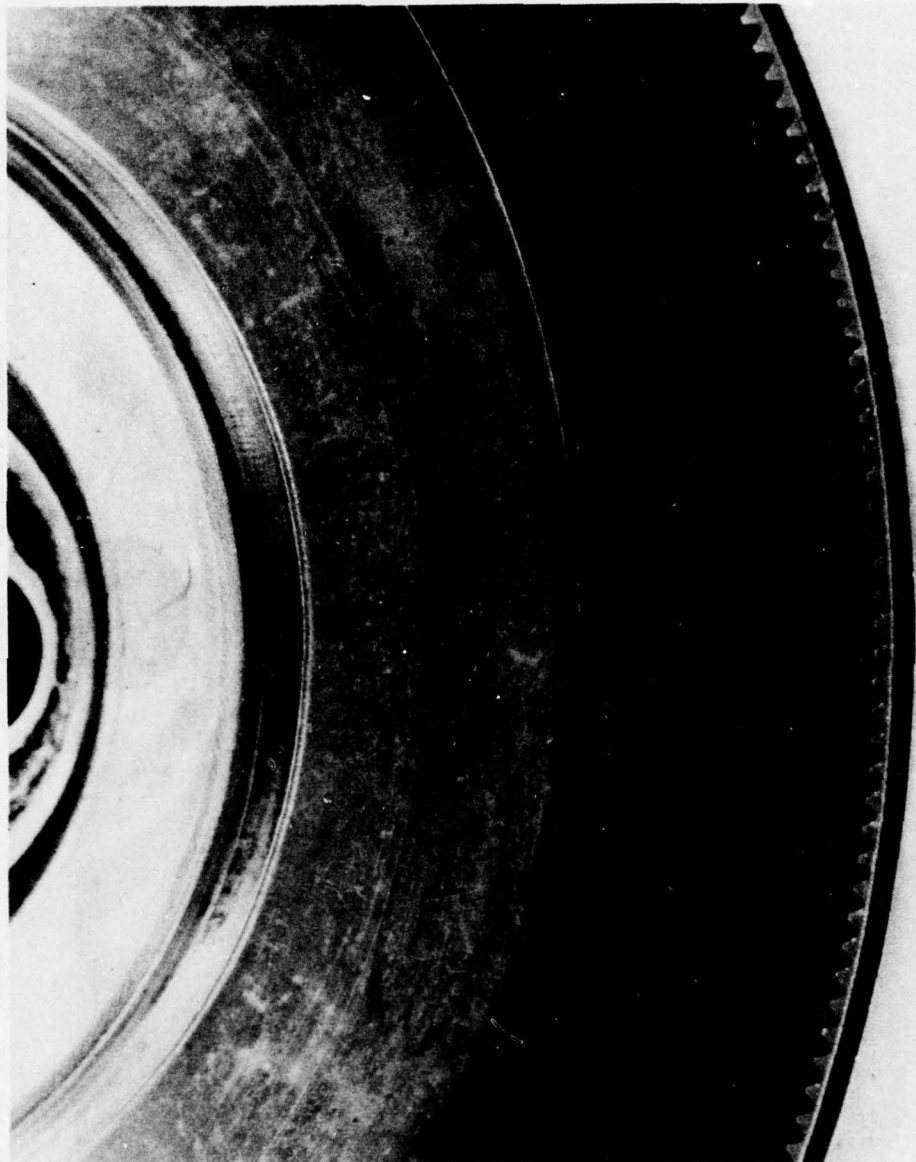
Figure 17. Undamaged Area of Upper Ground Gear After Run No. 4

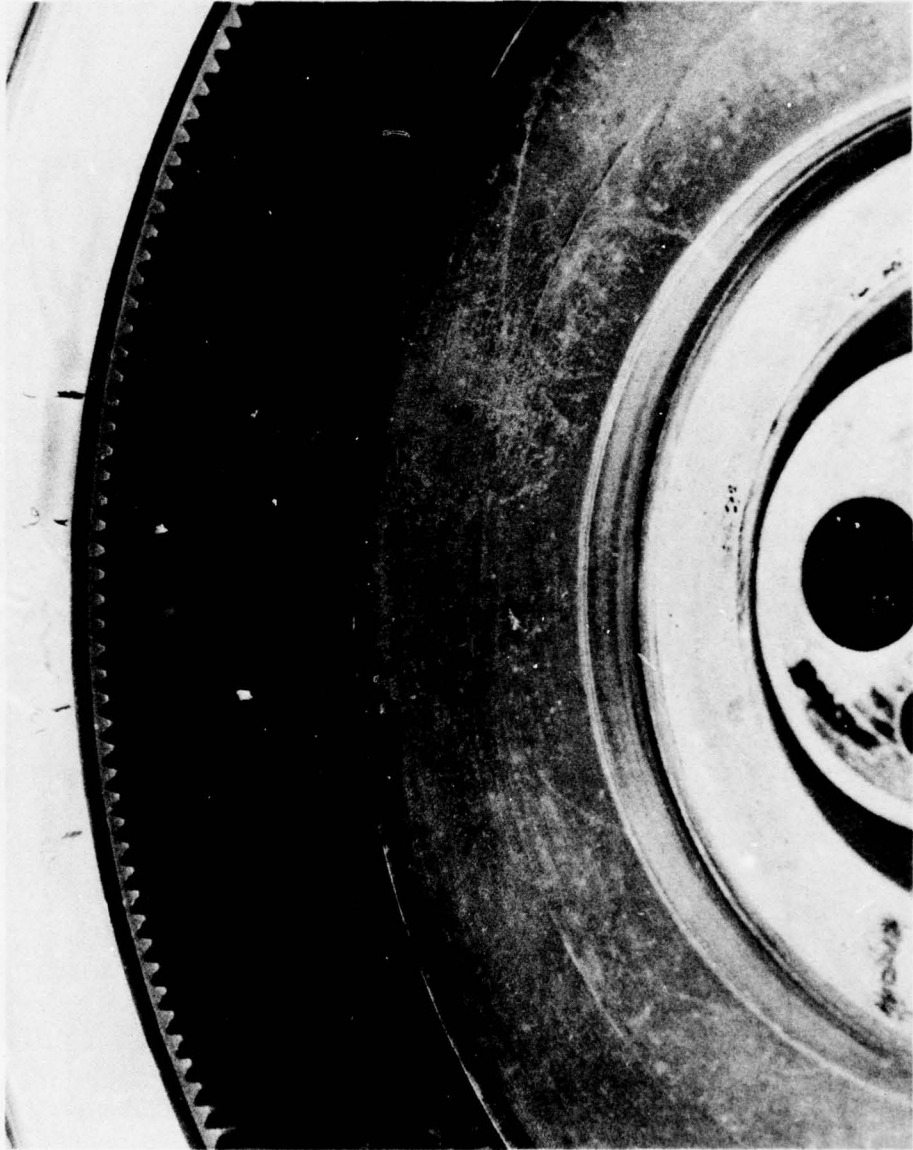
Figure 18. Damage to Teeth No. 1, 6, and 13 of Upper Ground Gear After Run No. 4

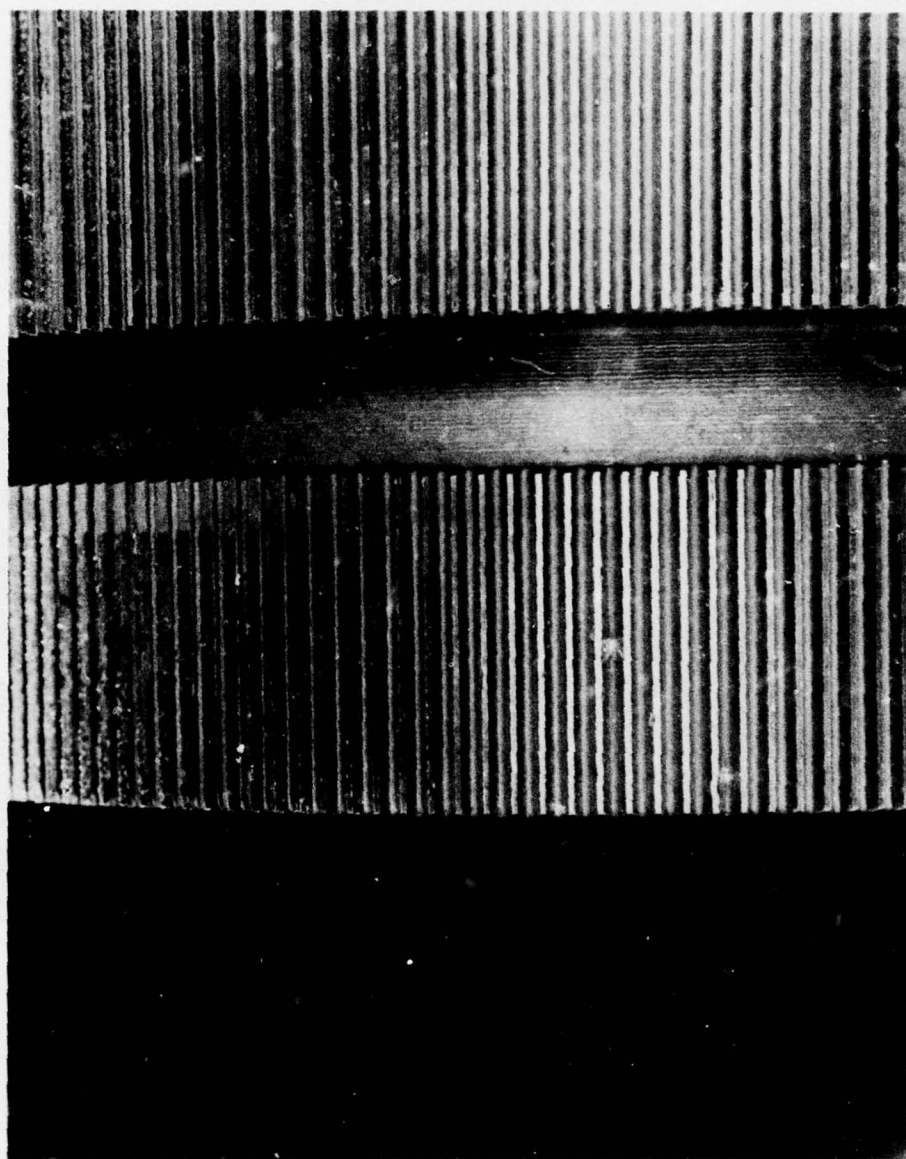
Figure 19. Ring Gear After Run No. 4

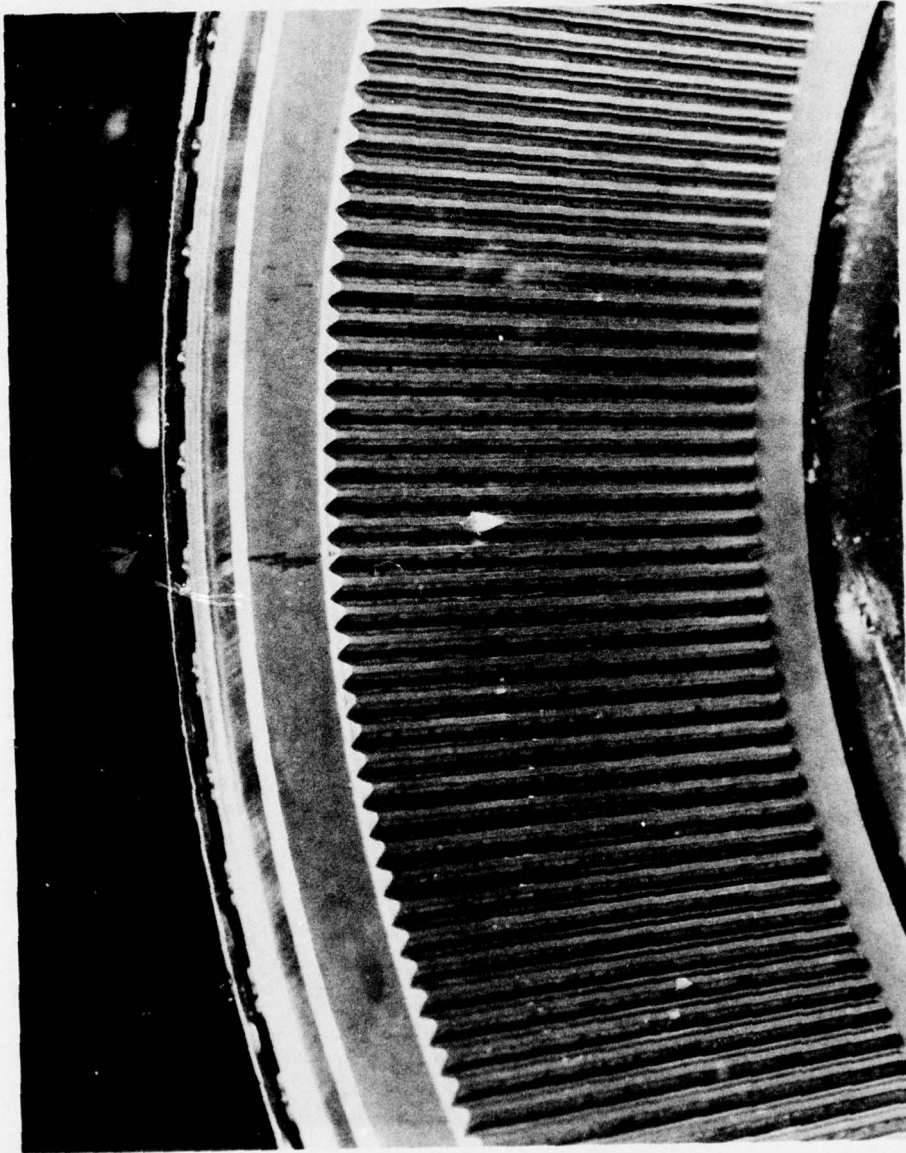
Figure 20. Output Gear After Run No. 4

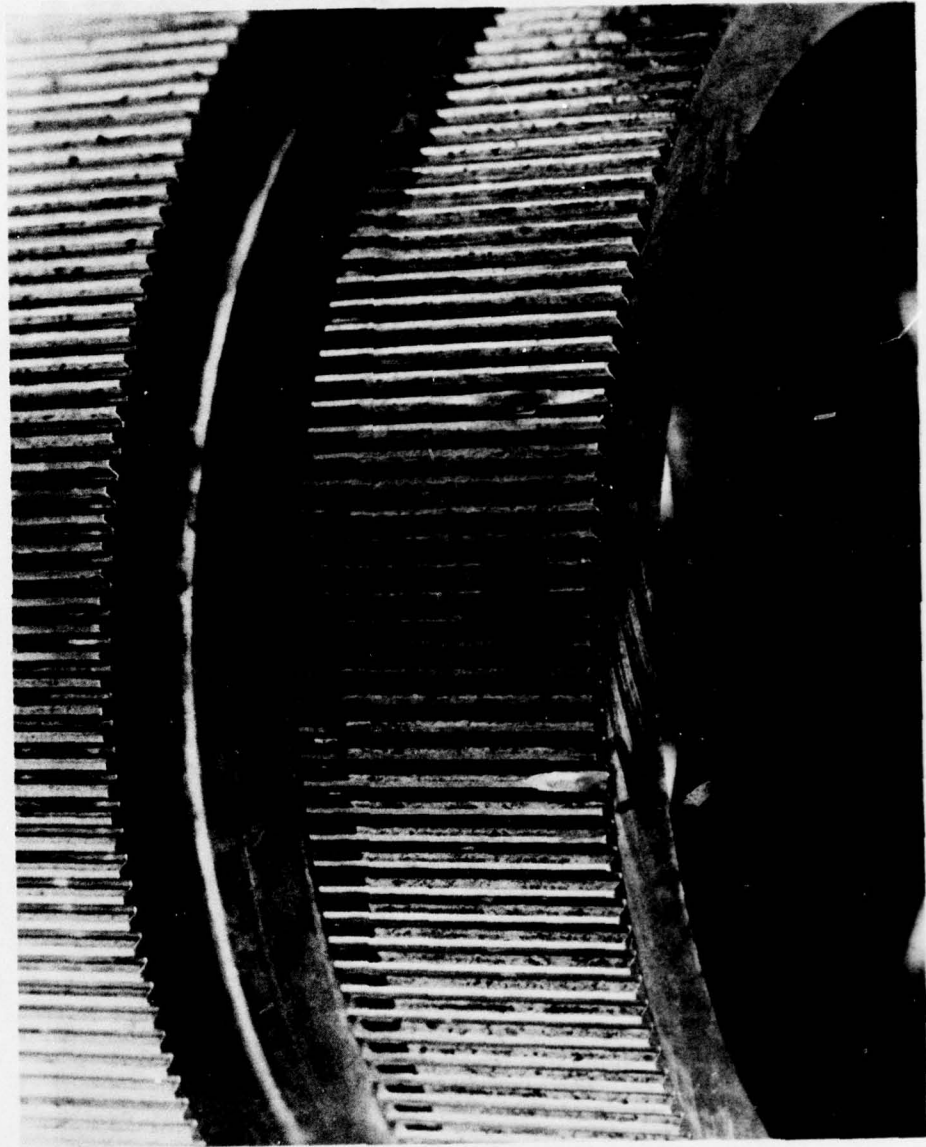
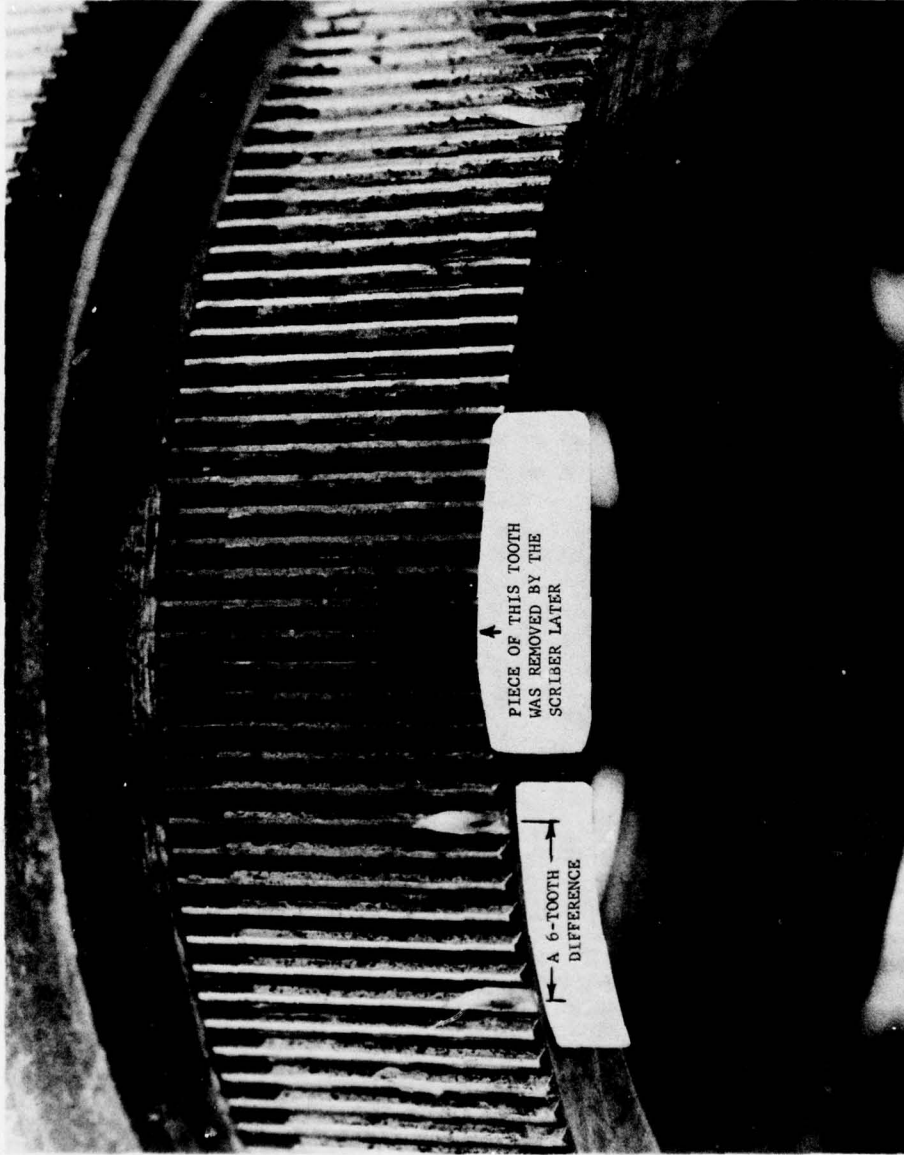
condition, an electrical power failure occurred in the laboratory. This caused the actuator to go hard over. The technician reported that the actuator went to approximately 25° before it stopped and an extremely loud noise was evident. When the test was resumed, large chips were found in the magnetic pickup. The actuator was disassembled and large pieces of gear teeth were missing from the various gears. The shock and high load experienced when the actuator went hard over caused failure of the teeth. A detailed discussion of findings of the inspection of the actuator parts is contained in the next section of the report. The major damage was still evident in the lower gears which again indicates that the teeth were weakened by the debris from the previous bearing failures. The damage was too severe to continue testing.

a. Ring gear, Bendix Part #2175530 - The gear teeth that mesh with the lower ground gear had five pieces of teeth missing as shown in Figures 21 and 22. The teeth with missing pieces as shown in Figure 22 are separated by six teeth or a multiple thereof. Since there is a six-tooth difference between the ring gear and ground gear, this indicates that a piece of tooth must have lodged itself onto one of the teeth and caused other teeth failures when the gears were in mesh. Other teeth that were a multiple of six teeth away from the failed teeth also had deformation to indicate this contact. In fact, a similar piece of tooth (see Figure 22 for location) was removed by applying light pressure with a scribe.

Figure 21. Ring Gear After Run No. 6 (Lower Gear)

Figure 22. Ring Gear Teeth Damage After Run No. 6 (Lower Gear)

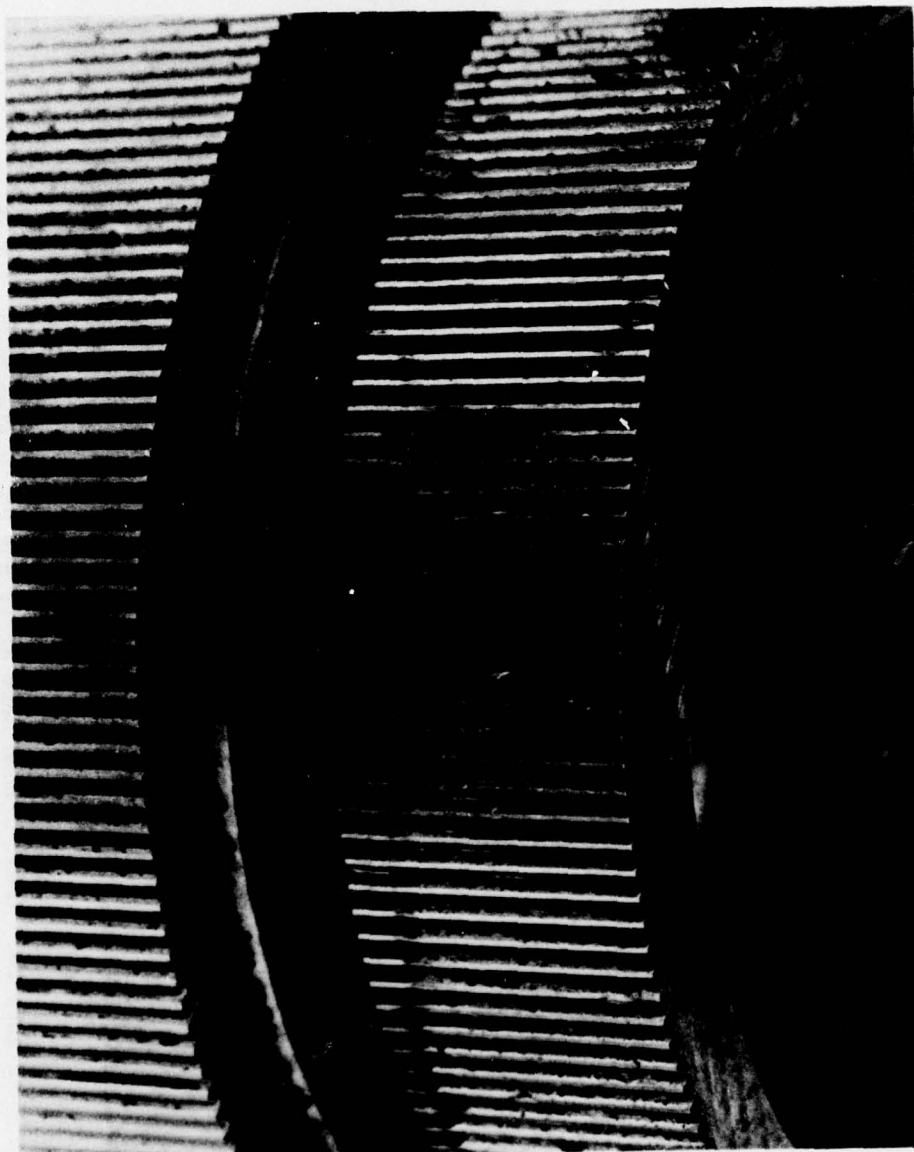
The gears (see Figure 23) that engage the upper ground gear and the output gear had not experienced any significant damage since the last inspection after run number 4.

Figure 23. Upper Portion of Ring Gear After Run No. 6

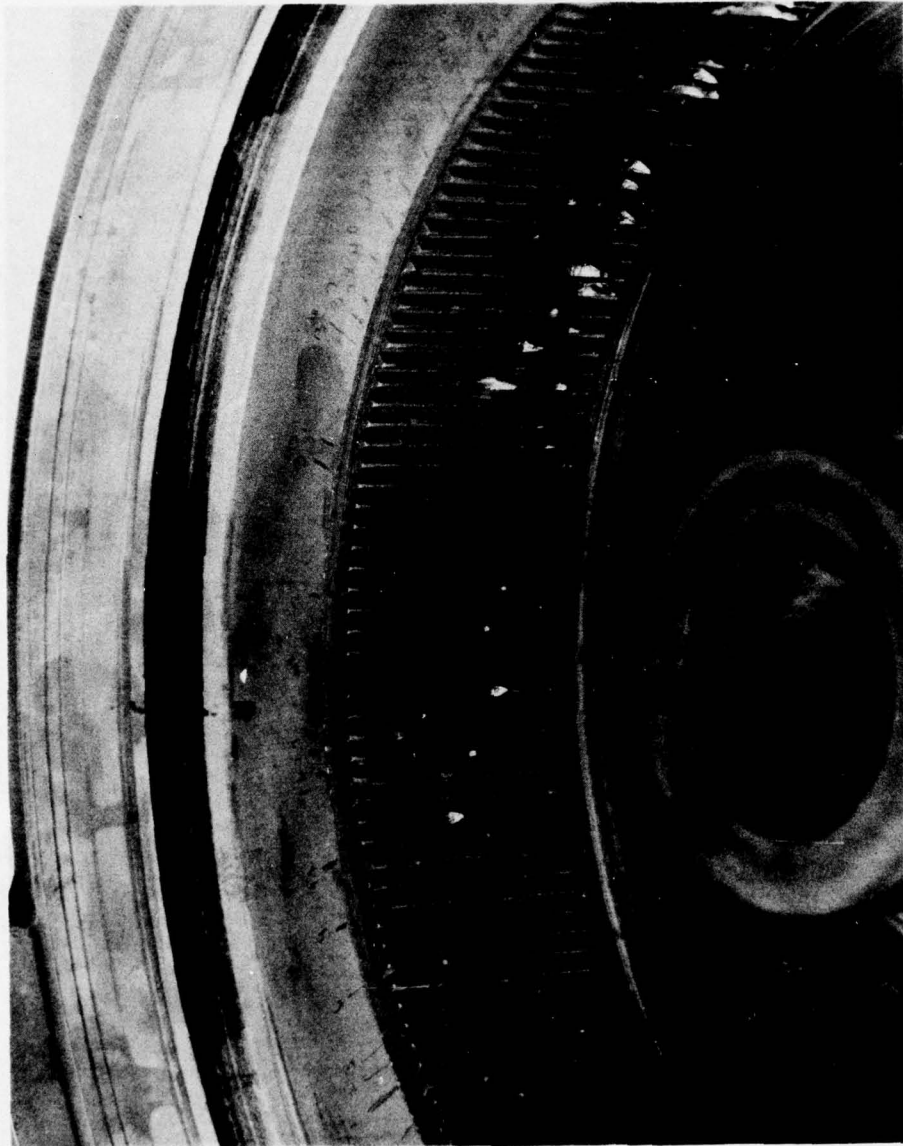
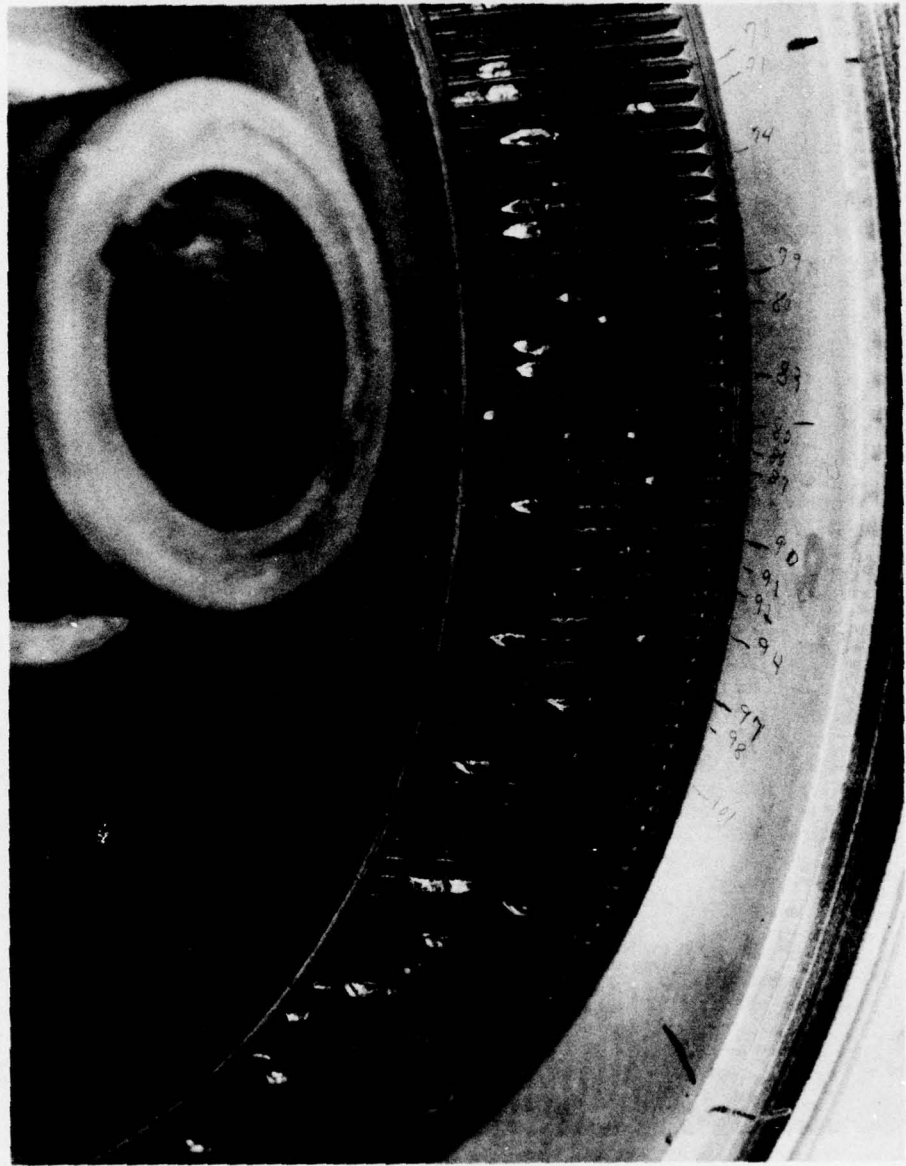
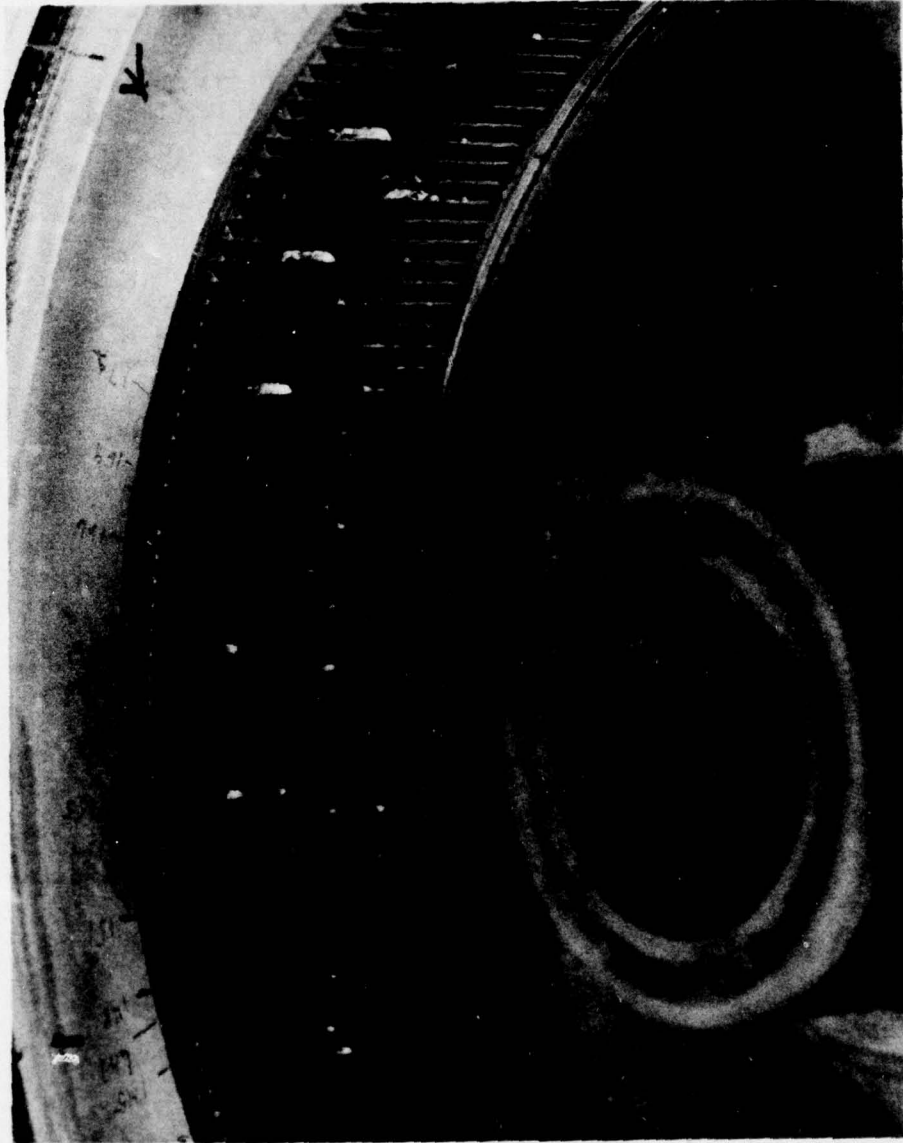
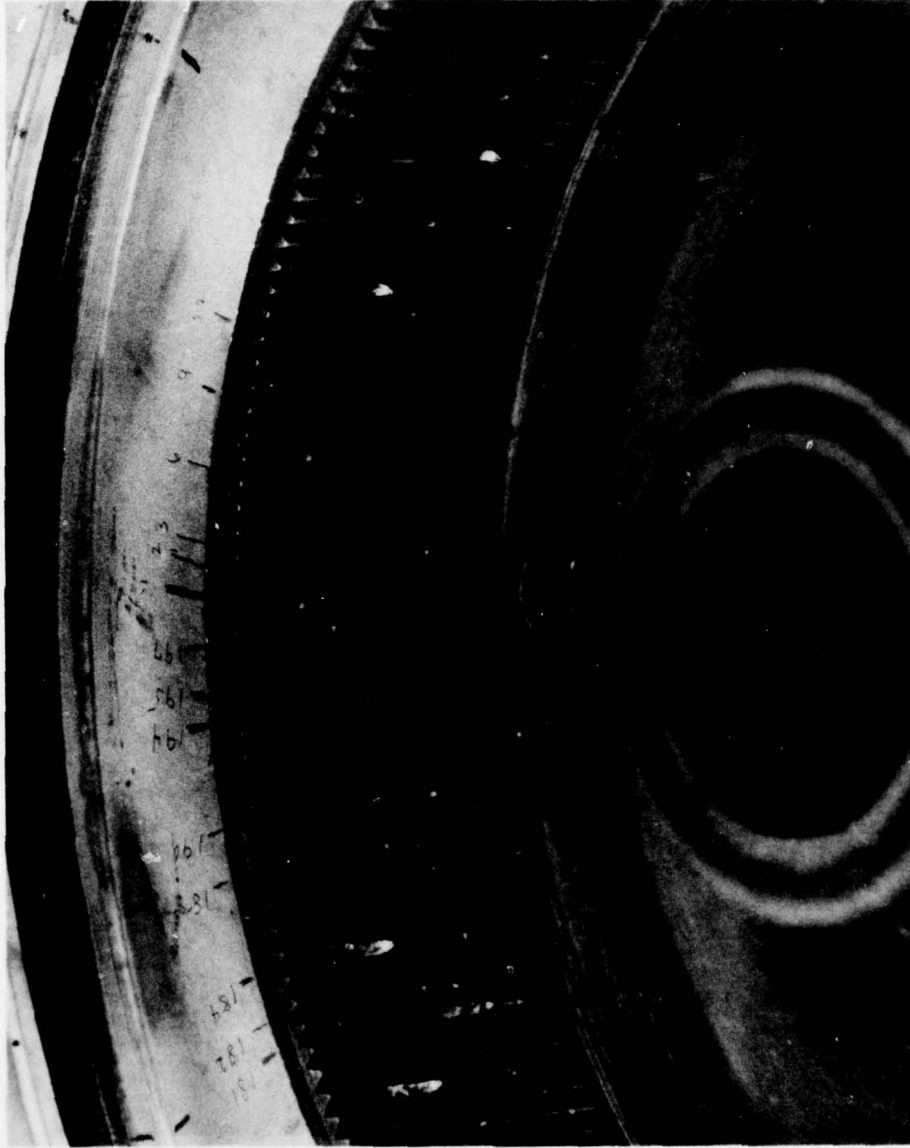
b. Lower ground gear, Bendix Part #2175525 - This gear had extensive damage to the gear teeth as shown in Figures 24 thru 28. As could be expected, the most damage occurred at the lower side of the gear where the damaged ring gear teeth meshed with this gear. This damage occurred at the lower side of the gear where the missing ring gear teeth meshes with this gear. This damage occurred for about one half of the gear's circumference. There are also some cracks on some of the remaining teeth which indicates failure was imminent. The numbers shown on the photos at the top of the teeth were used for denoting damage after run number 4. The damage that

occurred during run number 6 can be easily distinguished by comparing the photos of run number 4 (Figures 13 thru 16) with the photos (Figures 24 thru 28) of the gear after tests are completed.

The gear teeth failure was considered to be caused by the debris from the failed bearings; however, some additional actuator testing will be required to definitely prove this. This testing as mentioned in Section V will be accomplished under other efforts now being conducted.

Figure 24. Lower Ground Gear After Run No. 6 (Teeth No. 1 Thru No. 60)

Figure 25. Lower Ground Gear After Run No. 6 (Teeth No. 67 Thru No. 120)

Figure 26. Lower Ground Gear After Run No. 6 (Teeth No. 106 Thru No. 160)

Figure 27. Lower Ground Gear After Run No. 6 (Teeth No. 100 Thru No. 190)

Figure 28. Lower Ground Gear After Run No. 6 (Teeth No. 177 Thru No. 20)
