AFAPL-TR-76-58

LIFE TEST OF A DYNAVECTOR ROTARY ACTUATOR FOR AIRCRAFT HYDRAULIC SYSTEMS

OCTOBER 1976

TECHNICAL REPORT AFAPL-TR-76-58
FINAL REPORT FOR PERIOD JULY 1971 Thru MARCH 1976

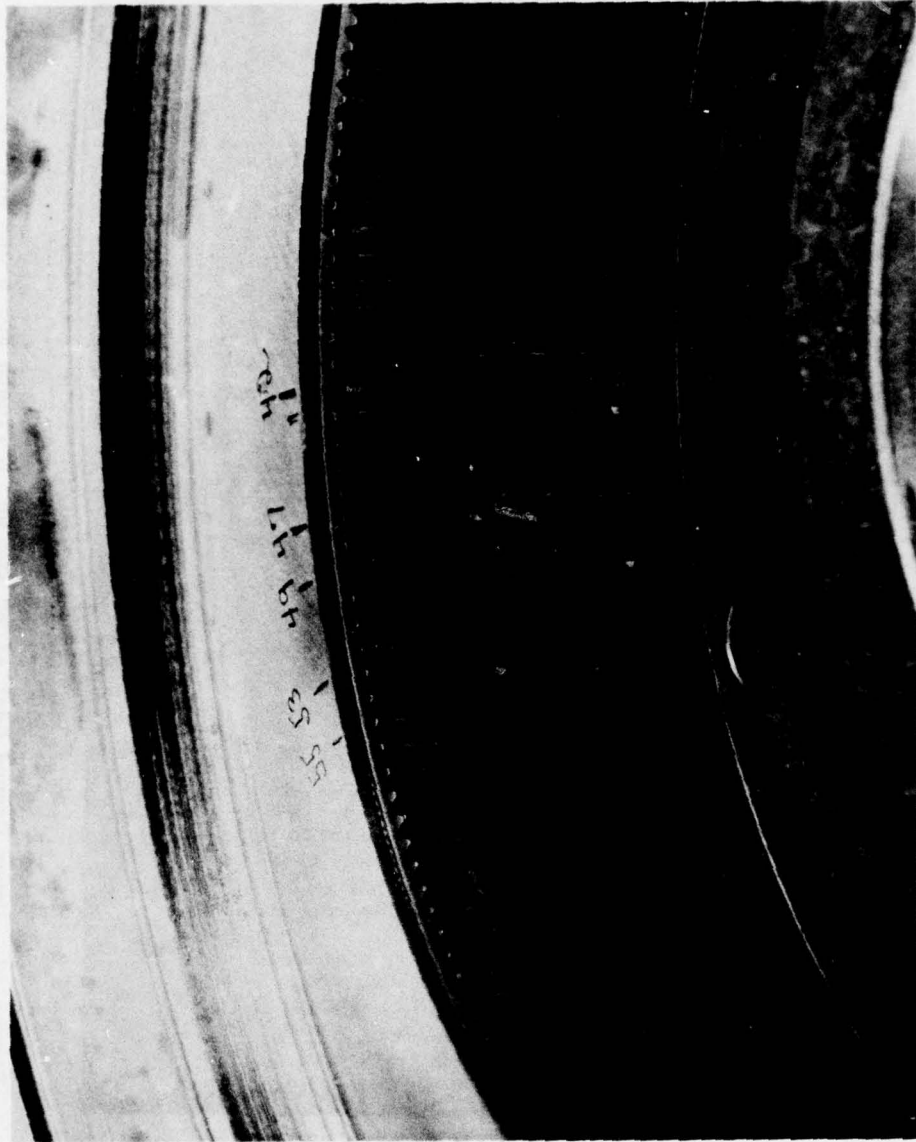
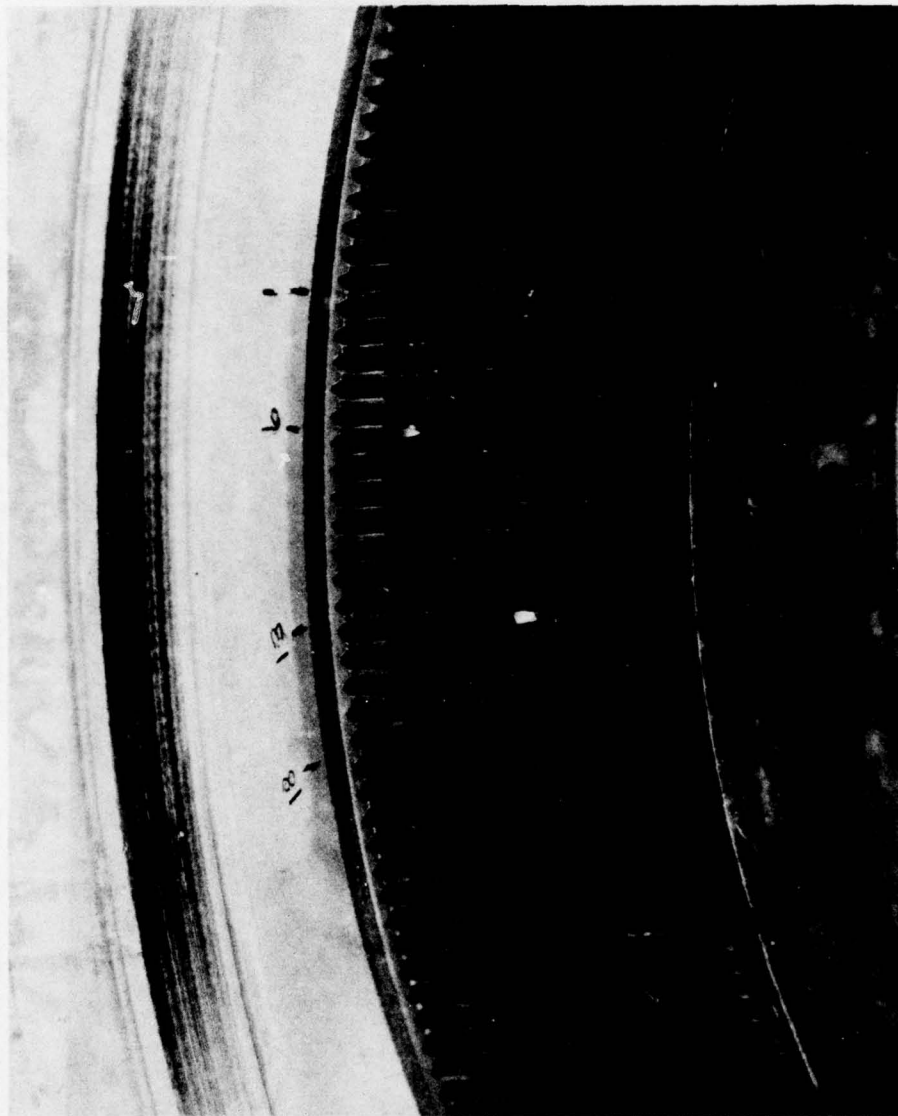
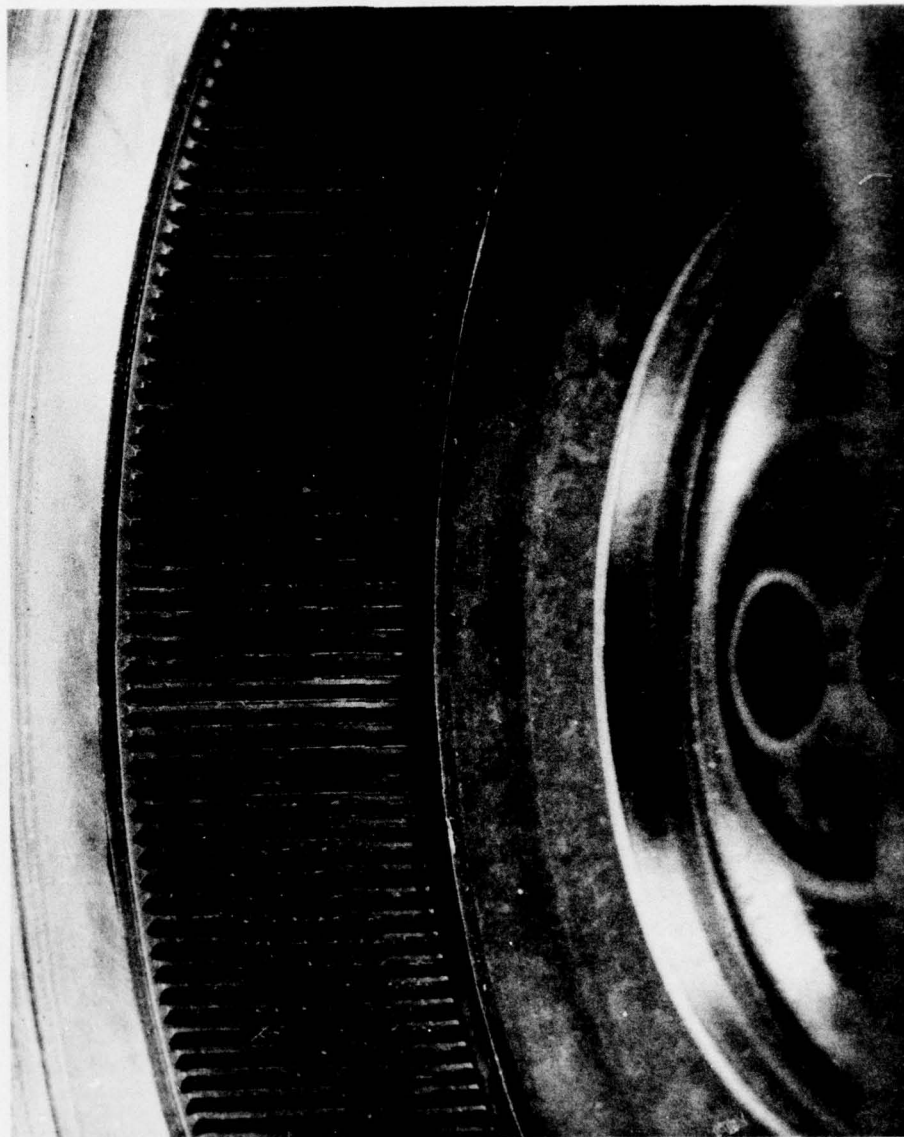
c. Upper ground gear, Bendix Part #2175526 - There was no additional damage or sign of wear found on this gear since the inspection after run number 3 as shown in Figures 29 thru 31. The previous photos of the same area of the gear are shown in Figures 17 and 18.

Figure 29. Upper Ground Gear After Run No. 6 (Teeth No. 42 Thru No. 55)

Figure 30. Upper Ground Gear After Run No. 6 (Teeth No. 6 and No. 13)

Figure 31. Upper Ground Gear After Run No. 6 (Undamaged Area)
