4. TITLE (and Subtitle) USAGE OF LANDING MAT AS OVERLAY ON ASPHALT RUNWAY DURING MILITARY FIELD EXERCISES		5. TYPE OF REPORT & PERIOD COVERED Final Report

7. AUTHOR(s) Hugh L. Green		6. PERFORMING ORG. REPORT NUMBER
9. PERFORMING ORGANIZATION NAME AND ADDRESS U. S. Army Engineer Waterways Experiment Station Soils and Pavements Laboratory P. O. Box 631, Vicksburg, Miss. 39180		10. PROGRAM ELEMENT, PROJECT, TASK AREA & WORK UNIT NUMBERS Project No. 1T162112A528, Task 04

USAGE OF LANDING MAT AS OVERLAY ON ASPHALT RUNWAY  
DURING MILITARY FIELD EXERCISES

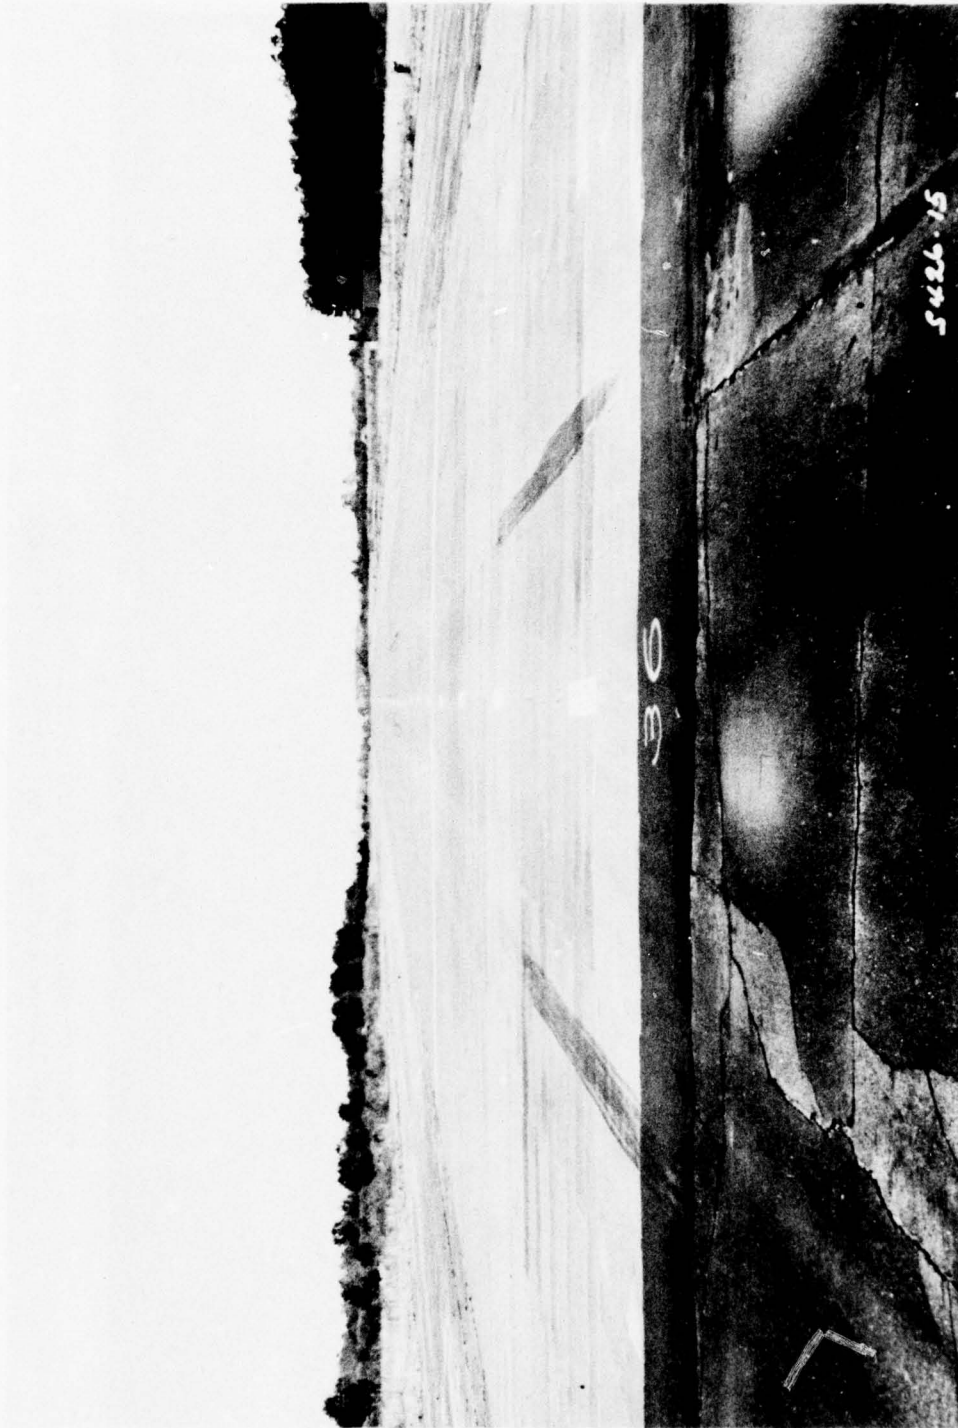
Incl 3

South end of landing mat runway looking north, with cold mix  
asphalt approach in foreground

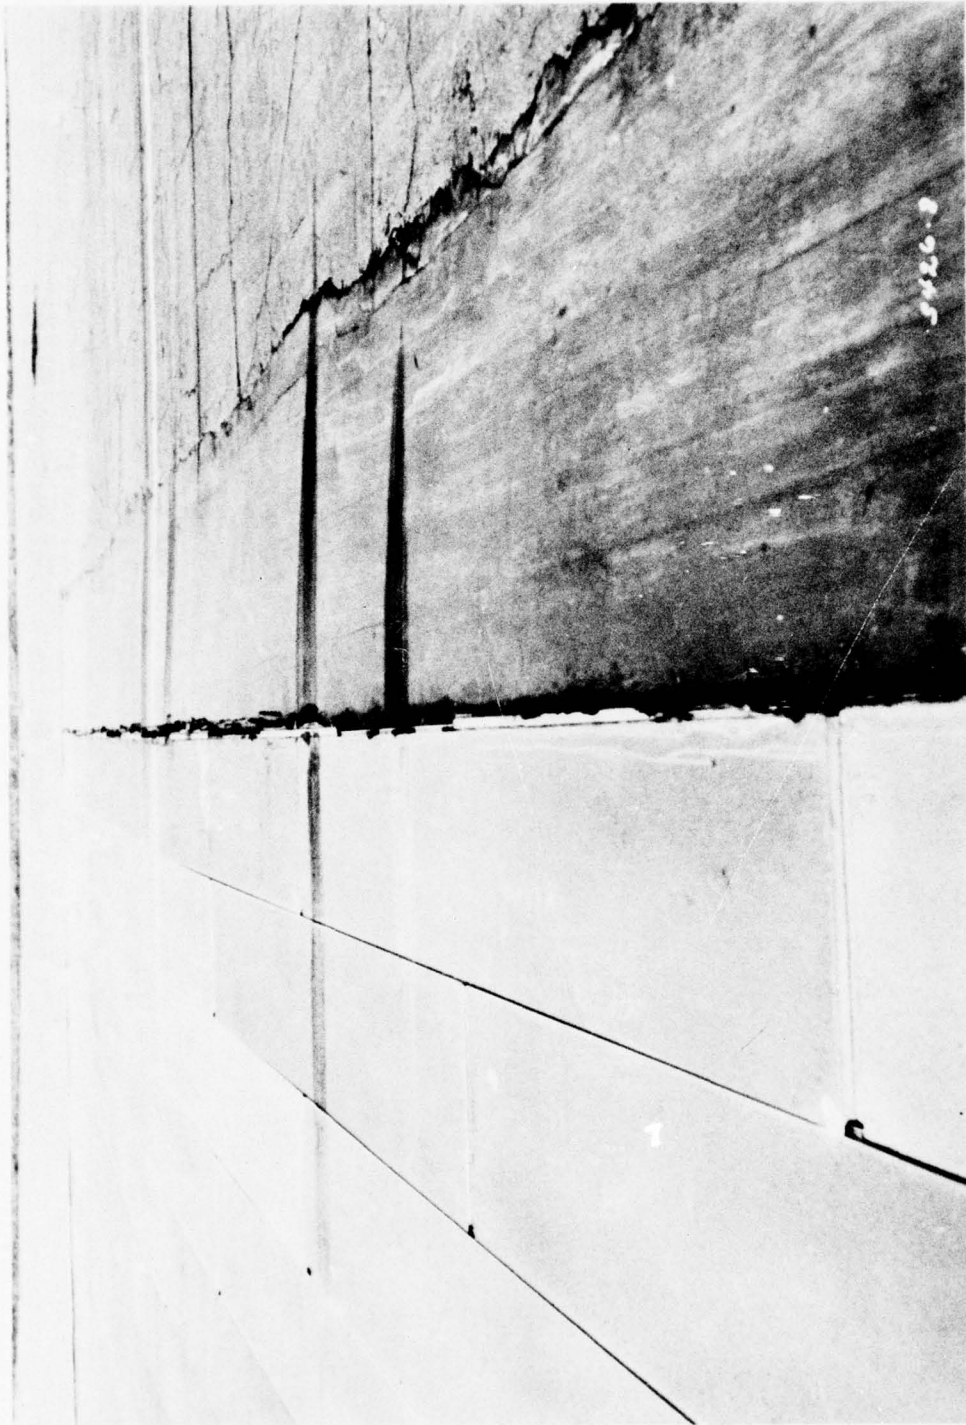
Incl 6

North end of landing mat runway showing transition between mat and asphalt. Aircraft skid marks are visible showing premature touchdown

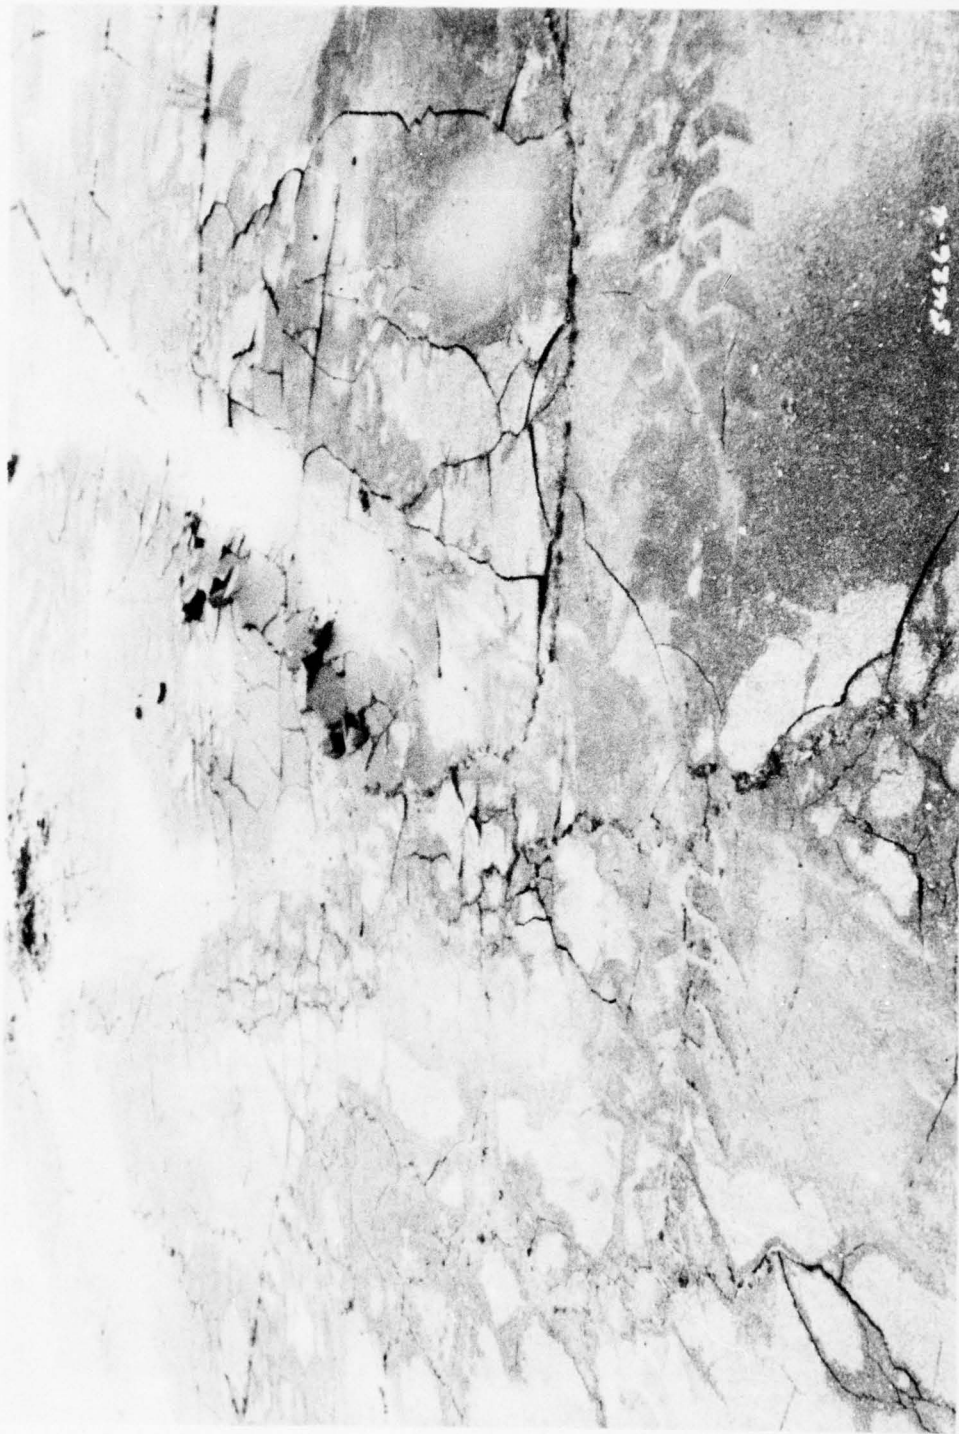
Incl 9

Rutted and broken asphalt in overrun area on south end of runway 18-36

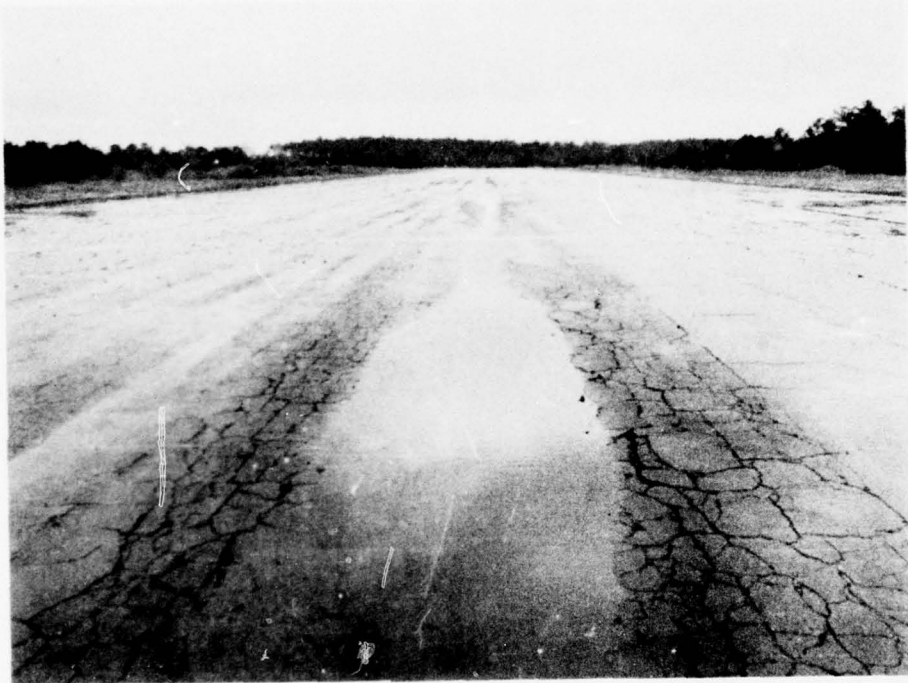
Incl 11

Deteriorating asphalt on runway 27-90

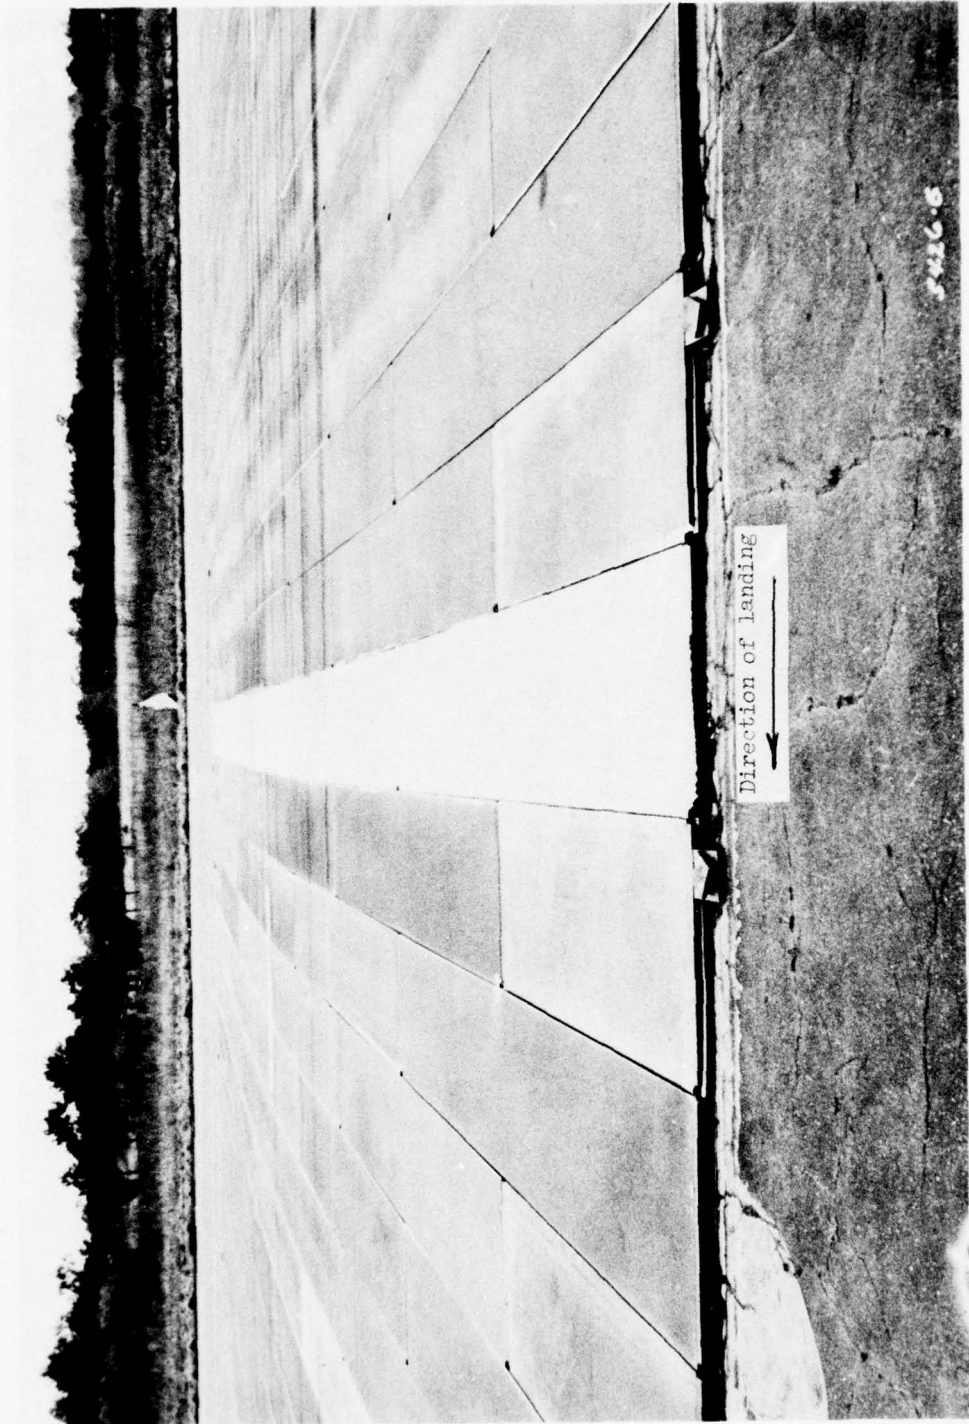
Bow line visible at sta 5+00

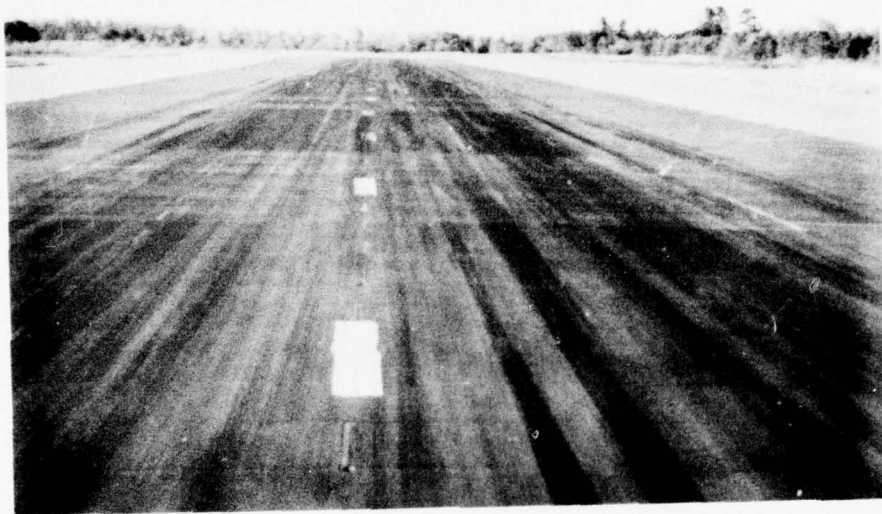
area prior to takeoff, thus creating three movements on the runway per sortie. Inclosure 18 shows skid marks on the mat runway in the touch-down area indicating the intensity of landings occurring in this area. Heavy rainfall caused some pumping of the sand blanket beneath the matting placed over the drainage culverts on runway 05-23. To correct this situation, the matting was removed, sand redistributed, and mat replaced and lengthened to cover an area 60 ft wide and 146 ft long. No failures were present, although the pad surface became somewhat wavy. This situation probably could have been eliminated by use of membrane beneath the mat or by use of a clay soil blanket underlay; however, only native sand was available in this vicinity as borrow material. The mat movement along the runway edges resulted in slightly irregular edges and caused the anchors to initially bind at panel joints and then to be pulled up slightly as movement continued. To alleviate a possible bow-wave condition and prevent anchors from protruding above the runway surface, the anchors in the area of mat movement were relocated approximately 1 ft and redriven. The anchor holes were observed to contain water due either from rainfall or the high water table.

View looking north at sta 5+00 showing skid marks in touchdown area

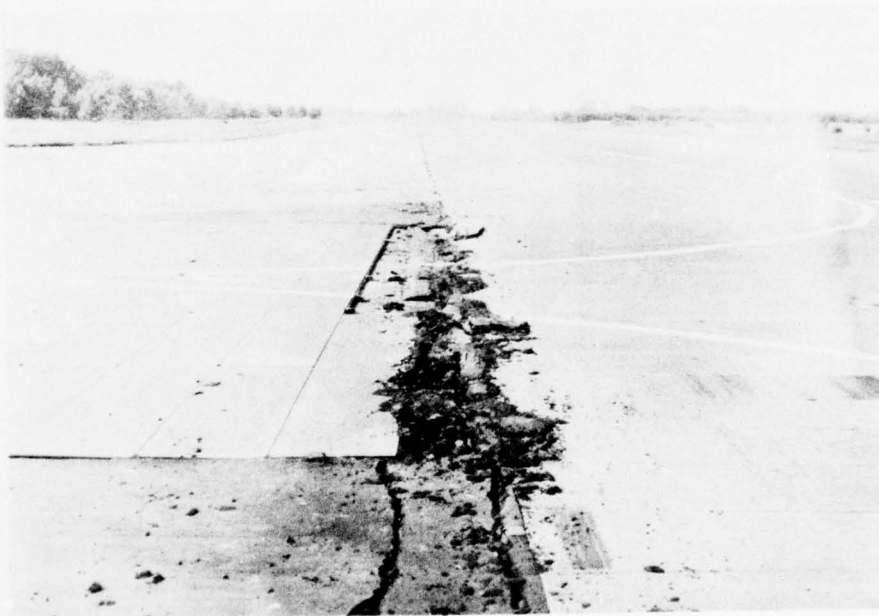
6. Prior to traffic there was a 23-in. gap at position 5 (Incl 1) which was filled with asphalt. As landings progressed the gap closed and after 250 operations the connecting taxiway mat began to ride up onto the asphalt filler. A run of the connecting taxiway mat was removed and the edge of the mat was anchored. At the end of the exercise, a 14-in. void area was noted between the connecting taxiway mat and the asphalt filler. One anchor plate was broken off and laying in the void area and numerous chunks of loose asphalt were noticed at position 5 (Incl 2b ).

- b. Void area and loose asphalt at the junction of the connecting taxiway loop and the runway

locations to prevent a potential hazard to aircraft since deteriorated asphalt could be ingested into the engines or struck by the propeller blades of the C-130 aircraft.

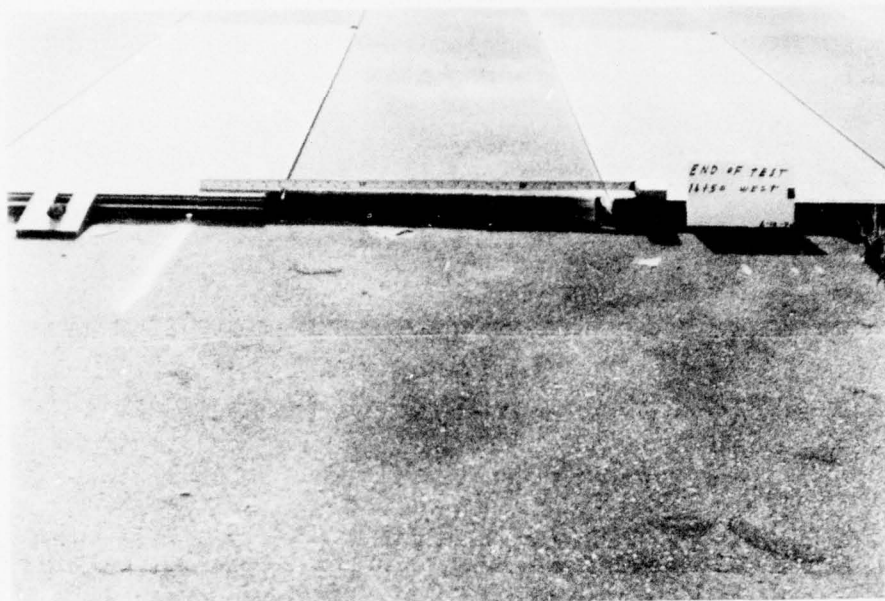
a. 30-in. mat movement on the west side of the airfield at sta 16+50

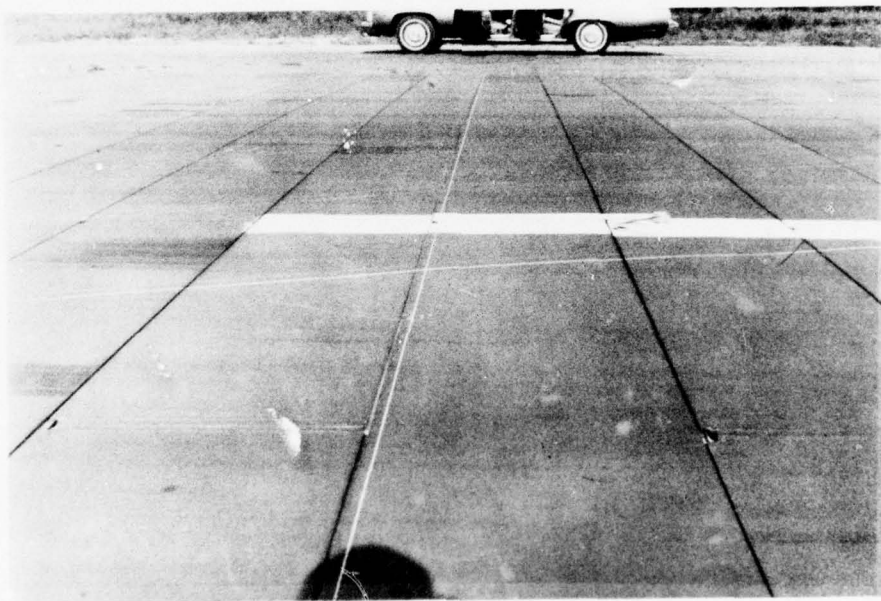
b. Bow line measurement of 1-1/8 in. at sta 16+50

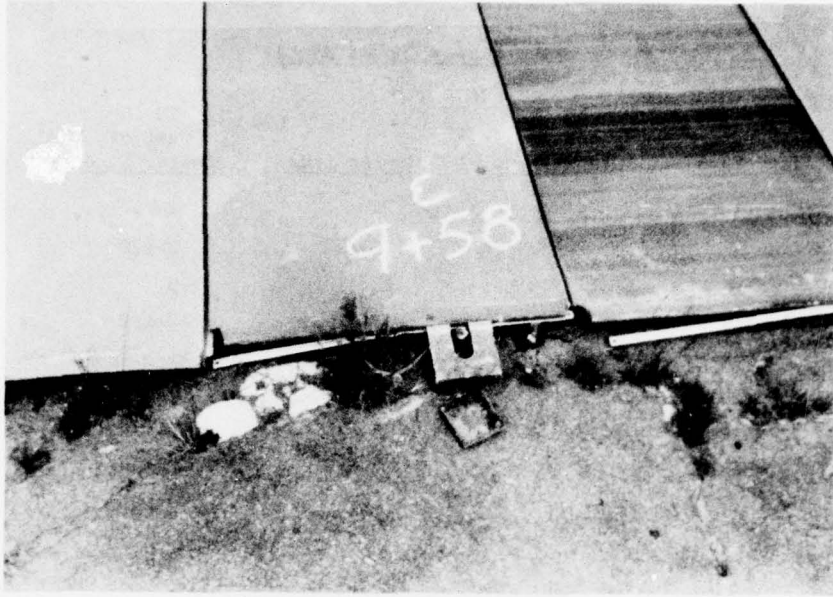
a. Failed anchor head

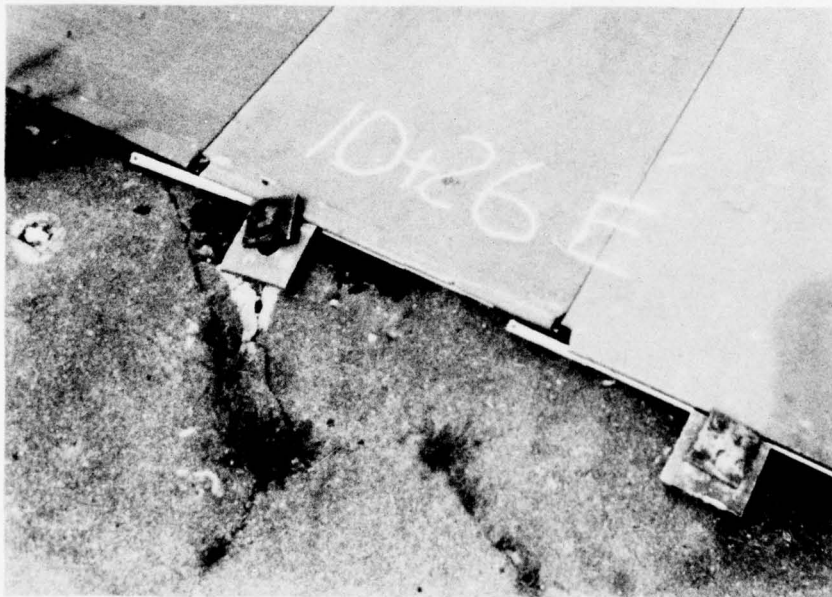
Incl 4

b. Anchor sheared asphalt

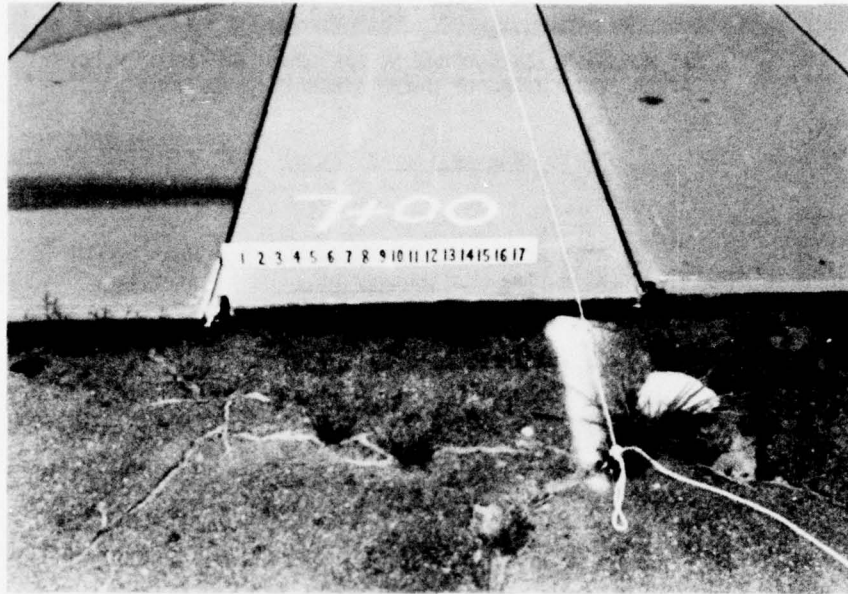
a. Mat moved 20 in. along east edge

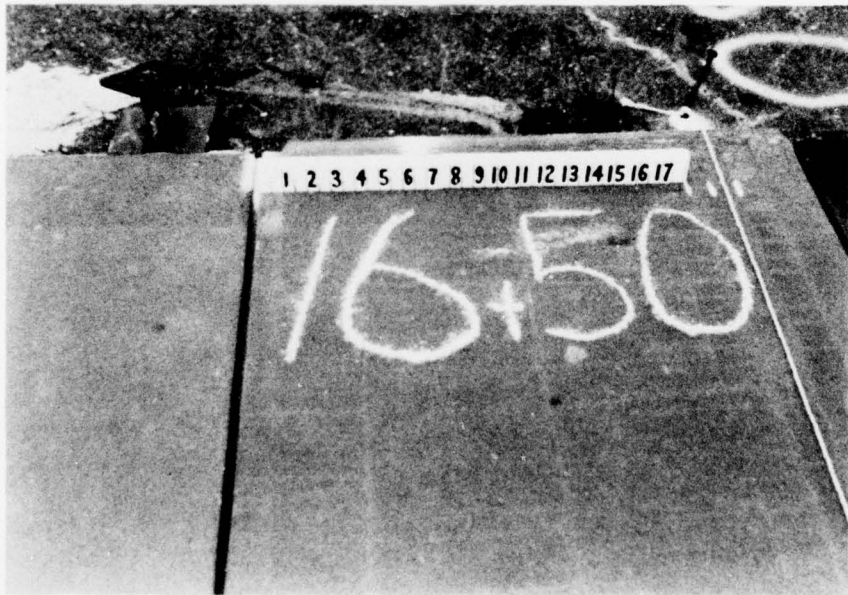
b. Mat moved 19-3/4 in. along west edge  
Runway moved south (left) after 300 sorties

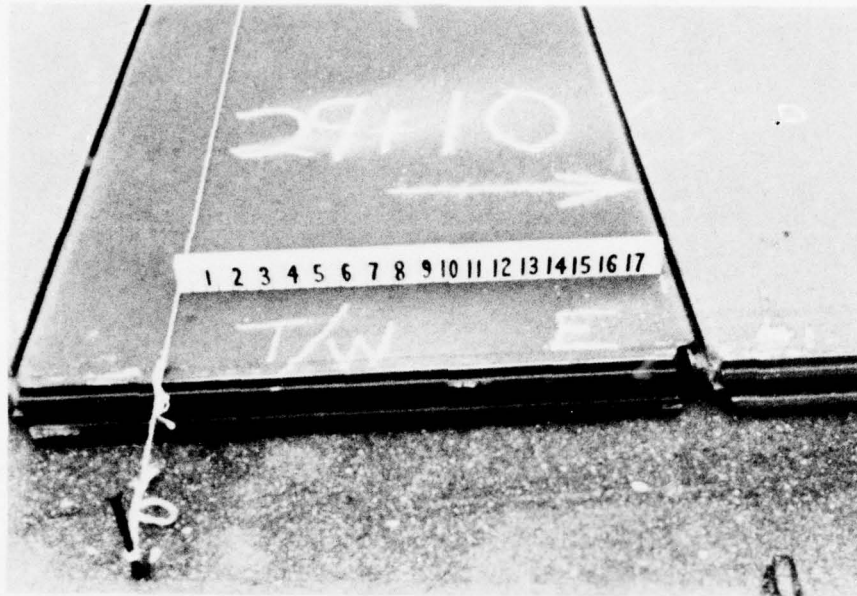
a. East edge of taxiway moved north 18-3/4 in. (right) after 300 sorties

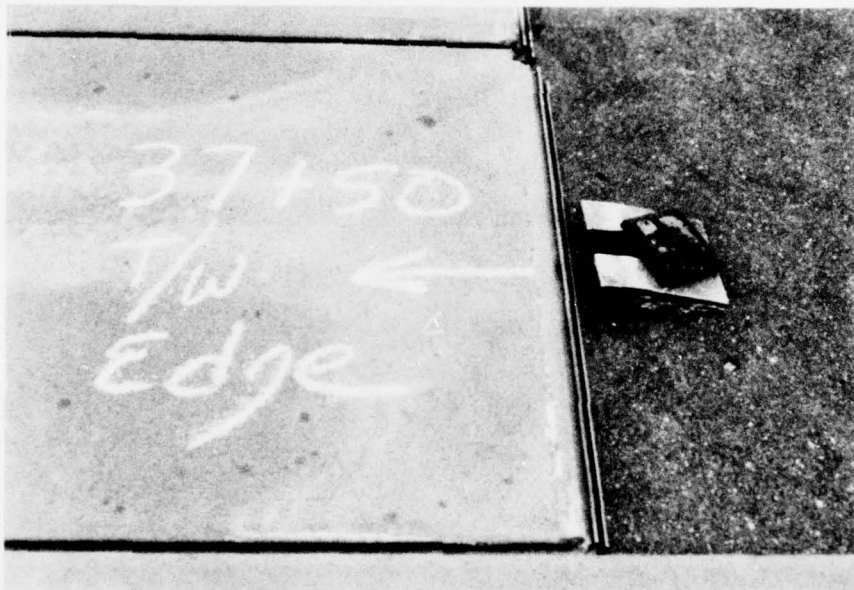
b. Radius mat shifted west away from anchor  
Taxiway shifting at 300 sorties

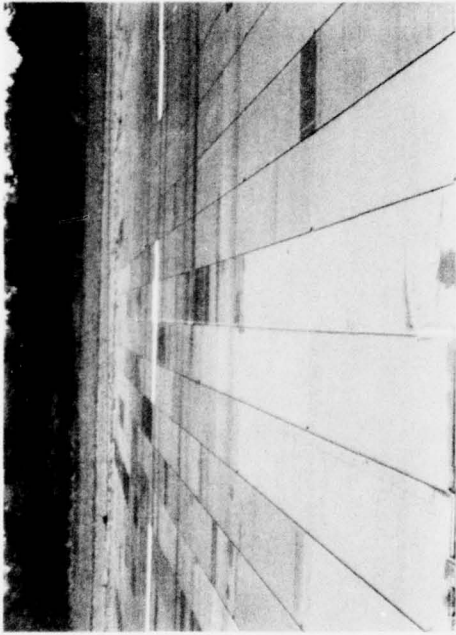
Photo 5. Bow in mat at Sta 10+00

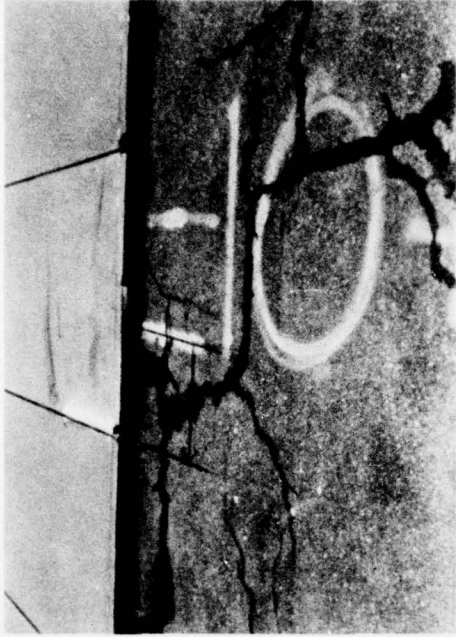
Photo 6. Mat movement at east edge of runway,  
Sta 10+00

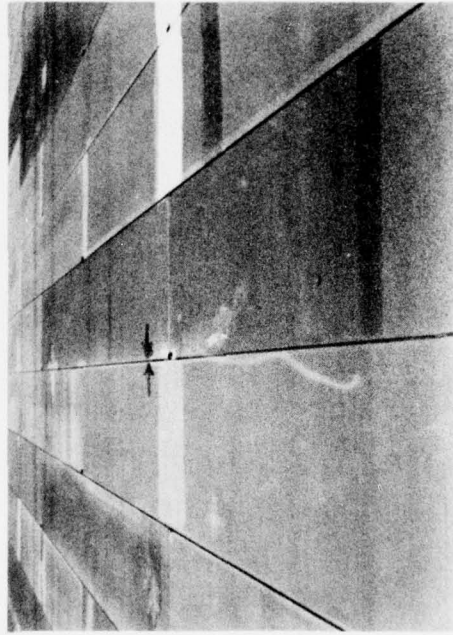
Photo 7. Slack removed in mat joints in runway at  
the completion of operations

c. Two pieces of motorized equipment should be used in parallel spaced at approximately third points on the runway/taxiway width to tension the mat and to remove any looseness in the male-female connector joints.

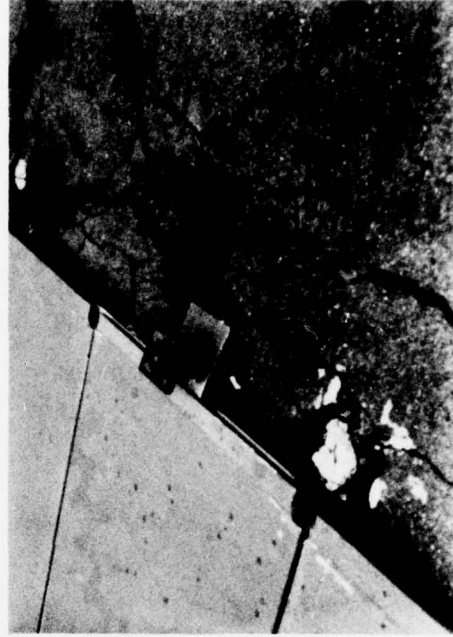
Photo 8. Loose anchor at east edge of runway in  
maximum braking area

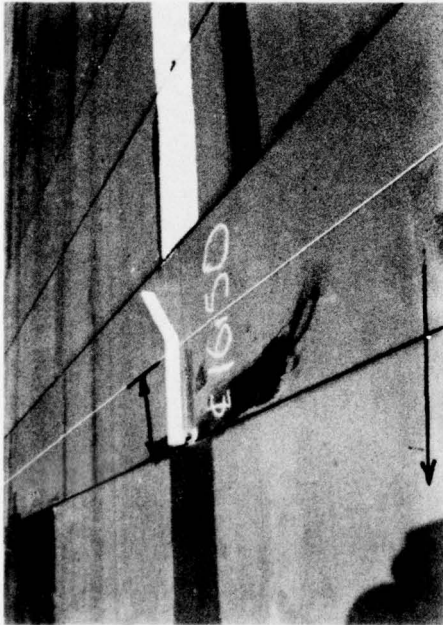
Photo 9. Mat movement at center line of runway,  
Sta 16+50

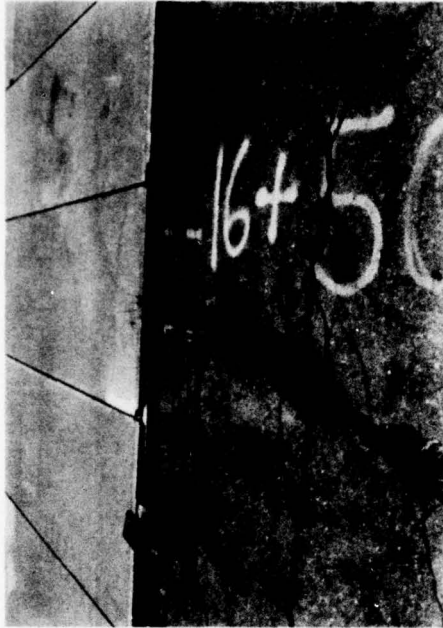
Photo 10. Mat movement, east edge of runway,  
Sta 16+50

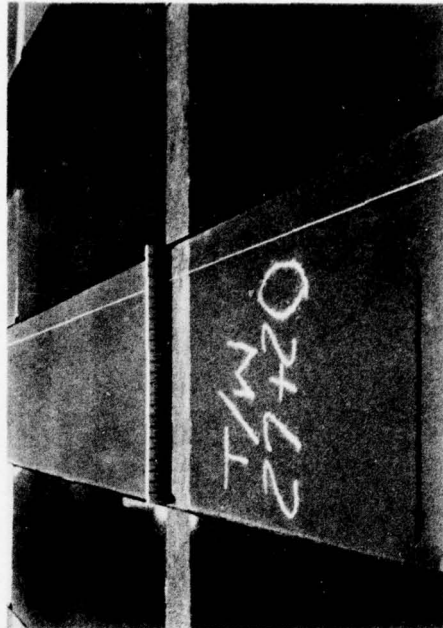
Photo 12. Mat movement at center line of parallel  
taxiway at south end of runway
