GROUND SUPPORT EQUIPMENT DEPARTMENT
NAEC-GSED-106 SEPT 1976
CODE IDENT. NO. 28638

CONTROL OF CORROSION
IN
GROUND SUPPORT EQUIPMENT

INTERIM REPORT

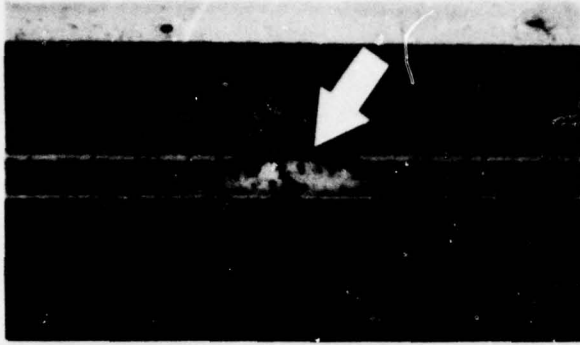
5.5.17.6. Exfoliation is a form of intergranular corrosion. It manifests itself by lifting up the surface grains of a metal by the force of expanding corrosion products occurring at the grain boundaries just below the surface. It is visible evidence of intergranular corrosion and is most often seen on extruded sections where grain thickness is less than in rolled forms. Intergranular corrosion is an attack on the grain boundaries of a metal or alloy. A highly magnified cross section of any commercial alloy will show its granular structure. This structure consists of quantities of individual grains, and each of these tiny grains has a clearly defined boundary which chemically differs from the metal within the grain center. Frequently the grain boundaries are anodic to the main body of the grain, and when the grain boundaries are in this condition and in contact with an electrolyte, a rapid selective corrosion of the grain boundaries occurs. An example of intergranular or grain boundary corrosion is that which occurs when aluminum alloys are in contact with steel in the presence of an electrolyte. The aluminum alloy grain boundaries are anodic to both the aluminum alloy grain and the steel. Intergranular corrosion of the aluminum alloy occurs. An example of exfoliation as experienced on GSE is shown in Figure 5-6 picturing the rail of a T-58 Engine Transport Trailer at AIMD, North Island, San Diego. Evidence of pitting may also be seen in this figure. Figure 5-7 shows extensive exfoliation of structural members from an E2A Aircraft Lifting Sling from the NARF, North Island, San Diego, which had to be "surveyed" because of corrosion. This is the first item of GSE encountered on Both East and West Coast NAS/MCAS

Figure 5-6. T-58 Engine Transport Trailer Exfoliation

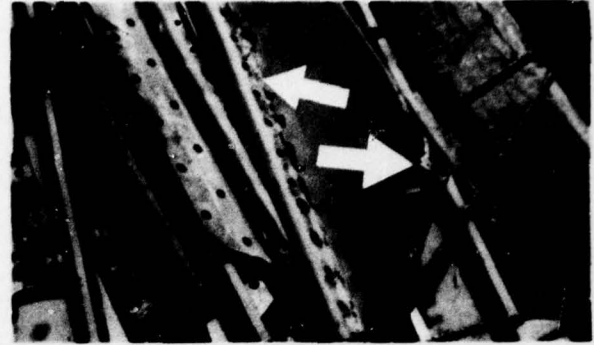
Figure 5-7. E2A Aircraft Lifting Sling Exfoliation

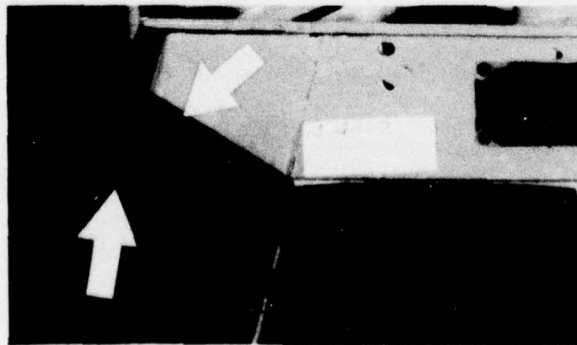
Figure 5-9. Typical Delamination - Advanced Corrosive State - Identified by Key No. 1

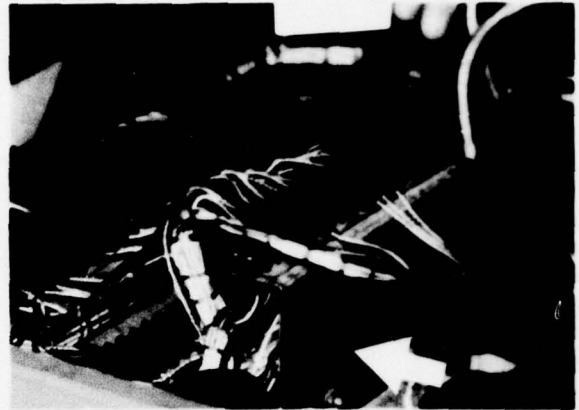
Figure 5-23. Electrical Compartment Corrosion of Terminal Strap Support Bracket

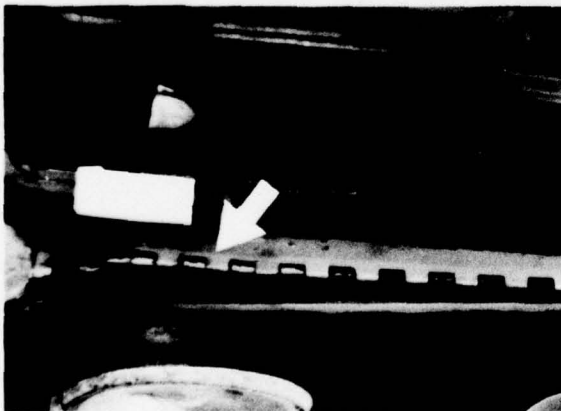
Figure 5-26. SATS Weapons Loader - Bent Hinge on Engine Compartment Cover

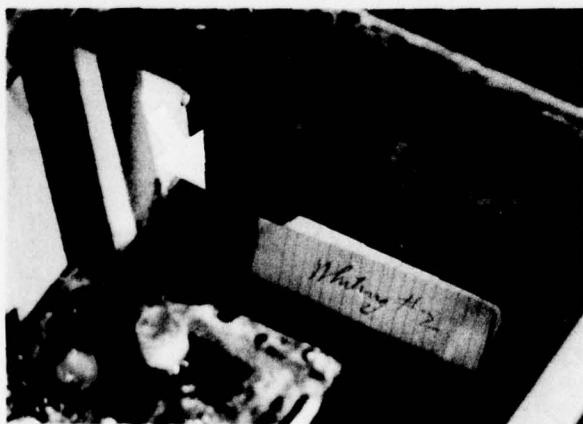
5.6.2.11. Acid attack is another category of corrosion frequently encountered in GSE. The sides and bottom of battery compartments are usually coated, however, adjacent access doors are generally heavily attacked by the acid fumes, see Figure 28. Even with acid resistant coatings and plastic battery boxes tie down devices are frequently heavily attacked as well as battery compartment access doors, see Figures 5-32, 5-33, and 5-34.

Figure 5-32. Tow Tractor Battery Compartment - Acid Induced Corrosion

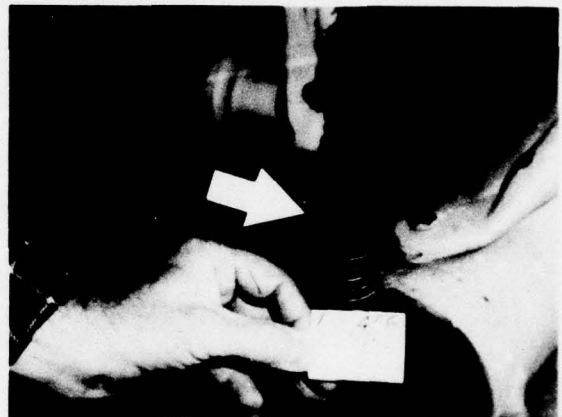
Figure 5-37. AERO 51-B Munitions
Handling Trailer - Exposed
Screw Unprotected

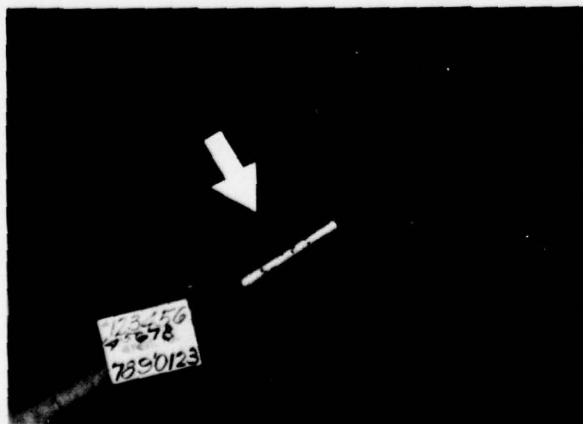
5.6.2.17. Pitting of piston rods was much in evidence on GSE which remained for extended periods in "open skies" storage in near ocean atmosphere. An example is of the lift cylinder piston rod of an Aero 33D Bomb Truck in the storage yard at Key West, Figure 5-44. Many aircraft jacks from the full environmental range of their use were found to be similarly attacked by pitting corrosion. Hand rails of maintenance stands, tow bar handles, arm rests, in fact most areas where acid from hand contact exists on GSE show considerable pitting. The arm rest on a TA-75 Aircraft Tow Tractor, Figure 5-45, is typical of many such instances of pitting corrosion, (Key No. 17).

Figure 5-44. Aero 33-D Bomb Truck - Pitting Corrosion on Piston Rod

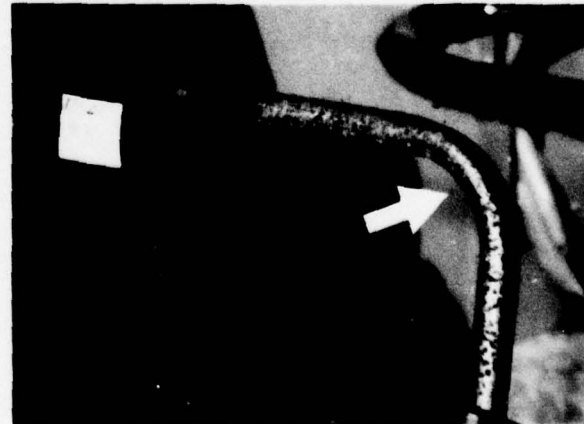
Figure 5-45. TA-75 Aircraft Tow Tractor - Pitted Arm Rest
