TECHNICAL REPORT NO. 76-8

SEMIANNUAL REPORT, PROJECT T/4703  
SPECIAL DATA COLLECTION SYSTEMS

JANUARY THROUGH JUNE 1976 .

**TELEDYNE  
GEOTECH**

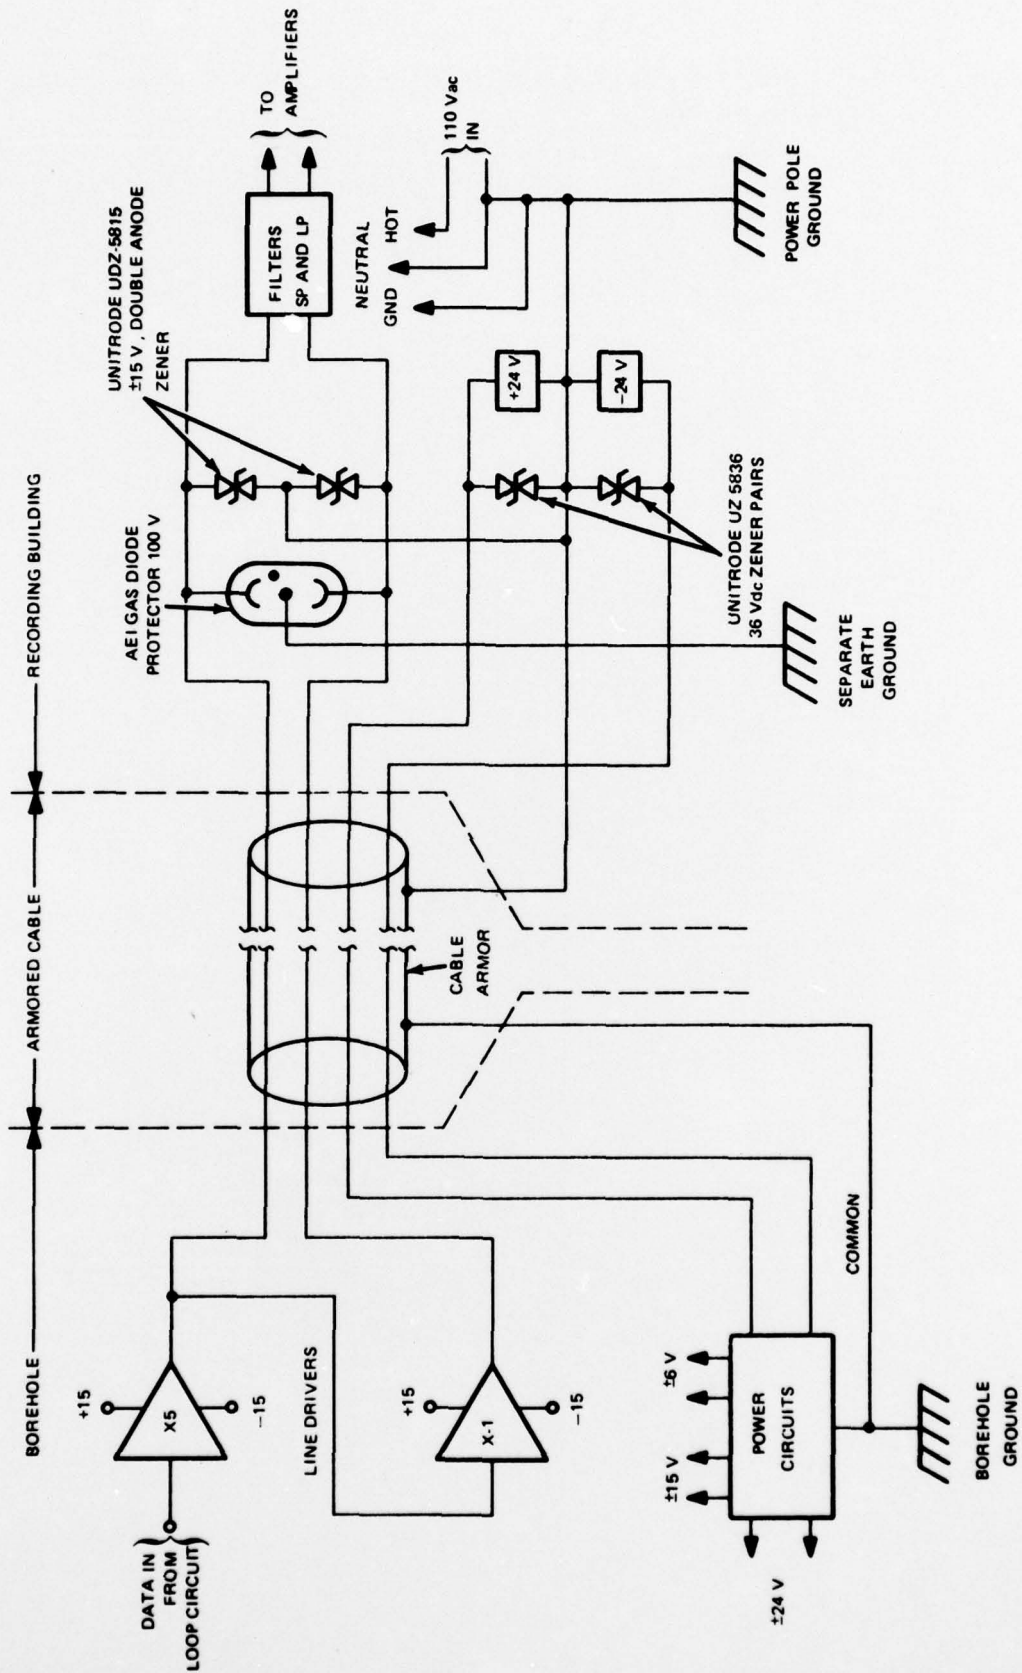
Figure 3. Simplified schematic diagram of basic KS data and power circuitry showing lightning protection devices as installed at Franklin, West Virginia and Houlton, Maine sites

On arrival in Garland, the damaged system was immediately inspected in order to determine the extent of the damage and to determine an explanation for the failure. The electronics section was found to have six of the eight line driver operational amplifiers shorted. When these were replaced, all digital circuitry and power circuits operated normally. Preliminary checks of the mechanical section showed that no major damage was done to the modules. At the end of this period, the electronics section had not been fully tested to determine whether there was any further damage which could cause system noise. The complete system will be fully tested to normal specifications during July and August.

Figure 3 is a sketch showing the basic circuitry with its lightning protection. Note that each data circuit is protected both by double anode Zeners from both sides of the line to signal common and by an AEI gas diode protector whose common terminal is connected to a separate earth ground near the protector box. The Zener diode protection on the dc power lines was added as a result of lightning damage to the downhole power supply at Pinedale, Wyoming in 1974. Analysis of the failure at FN-WV has lead to the following conclusions:

- a. The AEI protector probably did not fire because its 100 V + firing voltage would have resulted in far worse damage than that experienced;
- b. The lightning surge did not come through the  $\pm 24$  V power line to the KS because the power supply was undamaged as was other circuitry which it supplies;
- c. Damage to the line driver operational amplifiers resulted from excessive voltages on their output terminals;

d. High voltage pulses did not pass through the filters because none were damaged;

e. Damage to the line drivers most likely occurred due to conduction of the lightning protection diodes. It is theorized that the lightning caused a high voltage potential between the borehole and power pole grounds and neither the earth nor the cable armor had sufficiently low resistance to keep it within safe limits; the UDZ-5815 Zeners conducted heavily when the uphole ground potential exceeded 15 volts, allowing the voltage on the operational amplifier outputs to exceed maximum ratings.

As a result of these findings, the following will be implemented and is recommended for all KS sites:

- a. Remove all lightning protection devices on the four KS data lines, because filter circuits provide adequate isolation from external sources;
- b. Retain diode protection on power and calibration lines leading downhole;
- c. Connect a heavy ground line (#4AWG copper or heavier) between the borehole casing and the common ground point at the recording facility. Also, ground the cable armor to the bus at the wellhead.
