ADHESIVE BONDED AEROSPACE STRUCTURES STANDARDIZED REPAIR HANDBOOK

*BOEING COMMERCIAL AIRPLANE COMPANY
P.O. BOX 3707
SEATTLE, WASHINGTON 98124*

MAY 1976

PHASE III REPORT FOR PERIOD 1 JANUARY 1975 THROUGH 30 SEPTEMBER 1975

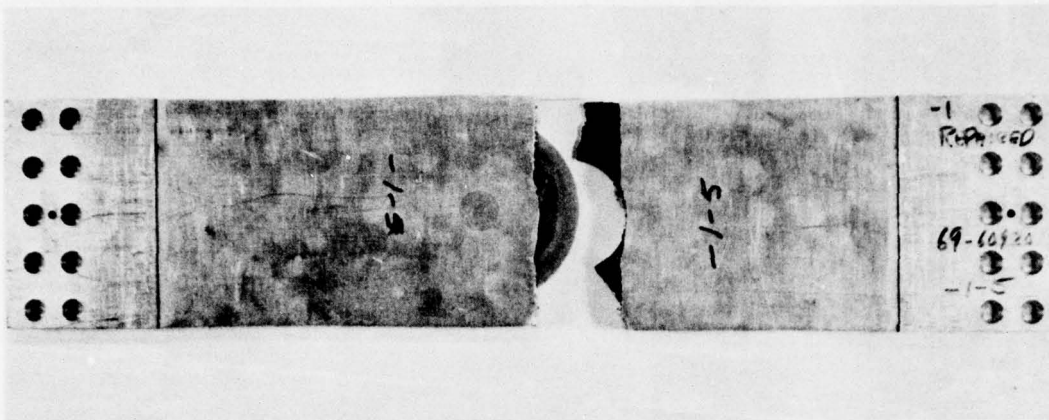
The test value for the repaired aluminum tensile specimen (1-5) bonded with AF127-3 adhesive was 6% lower than the control. The failing load for the specimen represents a stress of 62,300 psi in the aluminum. The metal showed appreciable necking at this stress, and the skin essentially peeled from under the patch. The failed specimen is shown in figure 7.

Figure 7.—Repaired Aluminum Specimen After Tensile Test—AF127-3 Adhesive

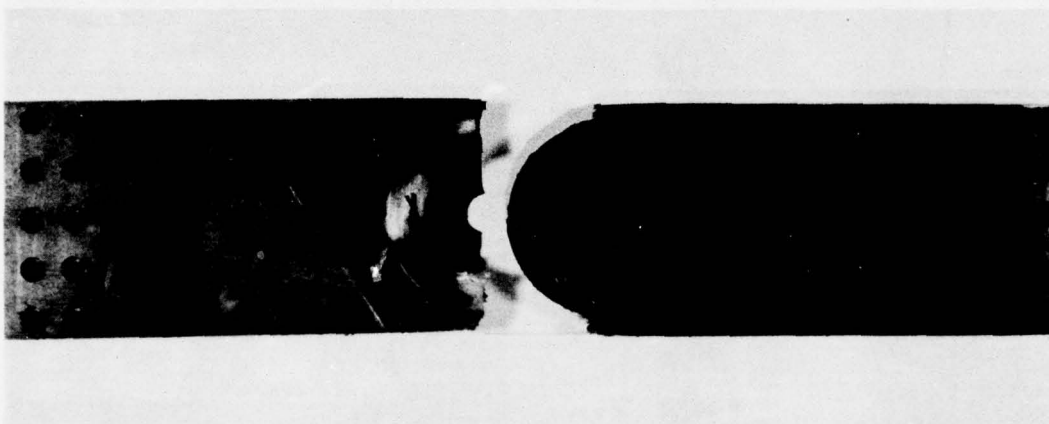
The repaired titanium tensile specimen (3-5) also failed low: i.e., 12% below the control. The failed specimen is shown in figure 8. The stress in the annealed 6Al-4V titanium was in excess of 130 ksi; the metal was beginning to yield. FM400 adhesive is quite brittle and will tolerate very little plastic metal deformation prior to failure. Also, at failure the load was 1570 lb/in. of skin width. This is probably not unrepresentative of the strength of an FM400 bond to hand-cleaned titanium. No tests were made on titanium during Phase II; however, the strength of FM400 on tank-cleaned aluminum was approximately 2000 lb/in. It was appreciably less on hand-cleaned aluminum (ref. 1).

Figure 8.—Repaired Titanium Specimen After Tensile Test—FM400 Adhesive

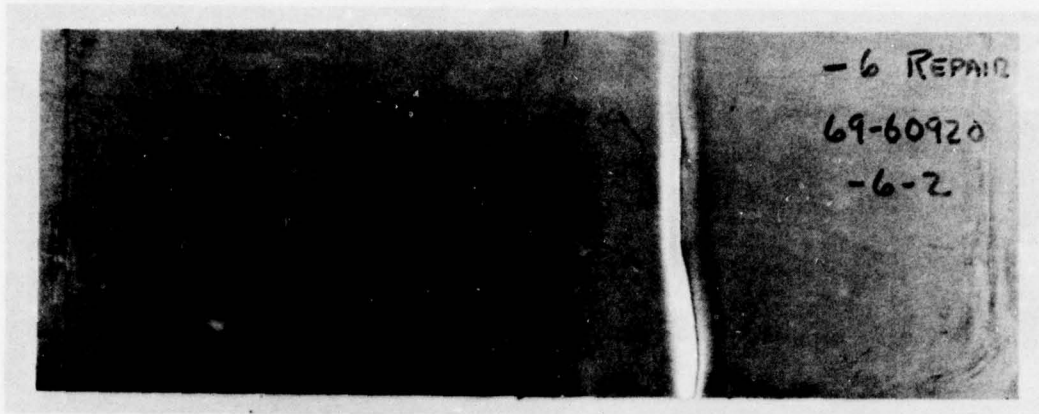
Figure 10.—Titanium Compression Repair Specimen After Test

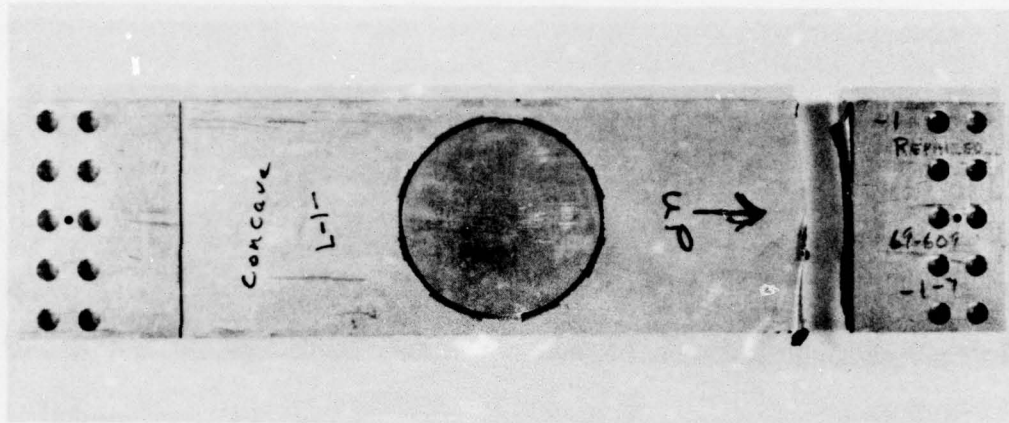
Results of the fatigue tests are given in table 7. The first of the control specimens was used to adjust the load to obtain failures in the desired cycle range; i.e., approximately 50,000 to 100,000 cycles. After an initial load adjustment, the aluminum specimens were tested with a maximum skin stress of 22 ksi. The results indicated that the repair did not degrade the fatigue properties. Failures were in the base metal. Typical failures are shown in figures 11 and 12.

Figure 11.—Typical Fatigue Failure—Repaired Aluminum Specimen—AF127-3 Adhesive

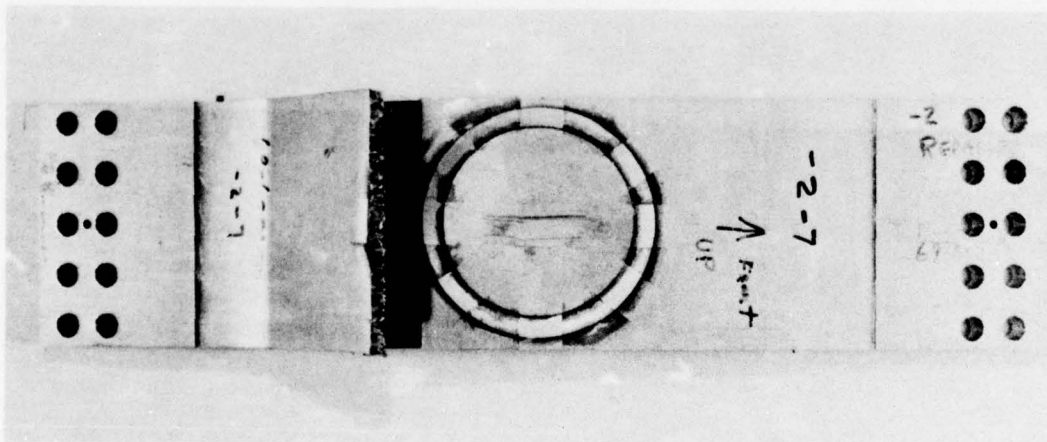
Figure 12.—Typical Fatigue Failure—Repaired Aluminum Specimen—AF130 Adhesive

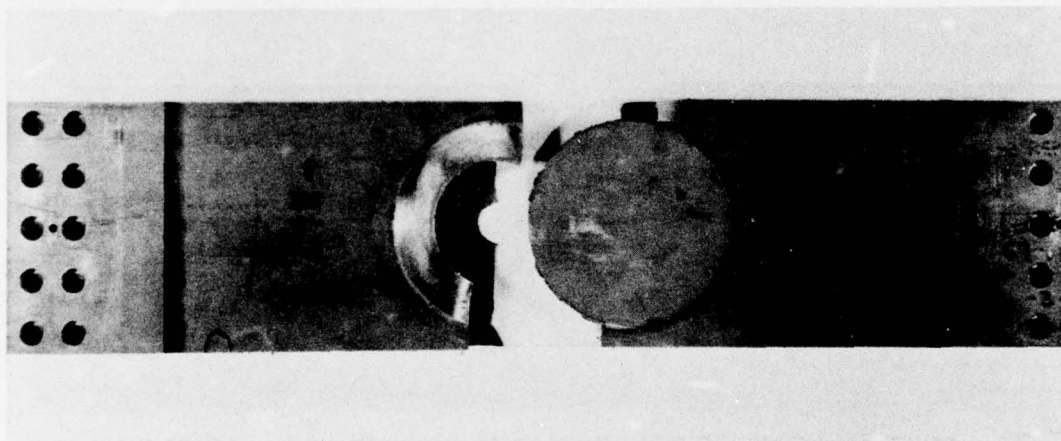
The 60-ksi stress was then used for the repaired specimens. The first specimen failed in the base metal on the initial cycle. This is shown in figure 13. The remaining two specimens failed in the repaired area after short cyclic lives; i.e., 1000 and 3000 cycles. The failed specimens are shown in figures 14 and 15.

Discounting the failure of the first of the repaired specimens on the base metal, the cyclic lives of the remaining two repaired titanium specimens were considerably lower than those of the controls. The failures were adhesive (i.e., in contrast to cohesive) from the skin surface. The data indicate that additional work is required on hand-surface preparation methods for titanium if effective repairs are to be accomplished.

Figure 14.—Repair Area Failure—Titanium Fatigue Specimen (3-7)

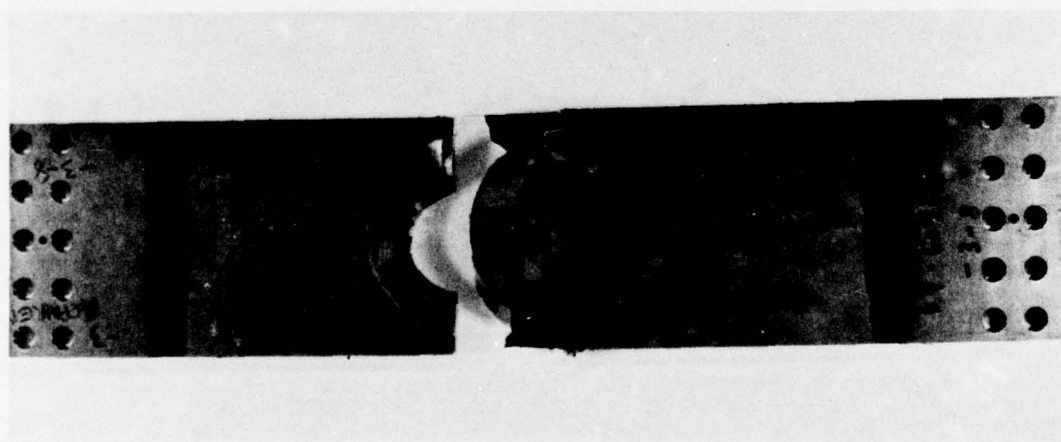
Figure 15.—Repair Area Failure—Titanium Fatigue Specimen (3-8)

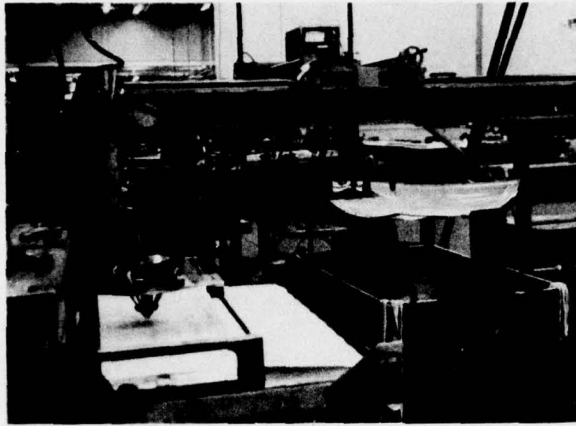
Figure 46.—Inspection of the Repaired C-141 APU Access Panel—Water Coupled Through Transmission Ultrasonics

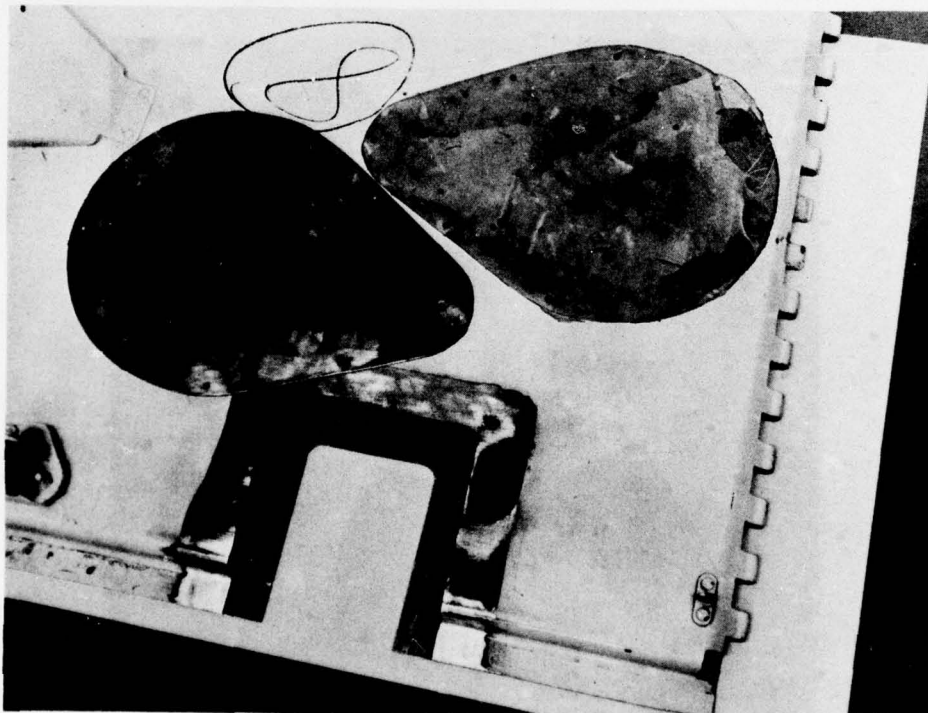
Figure 49.—Removal of Delaminated Doubler and Simulated Edge Damage

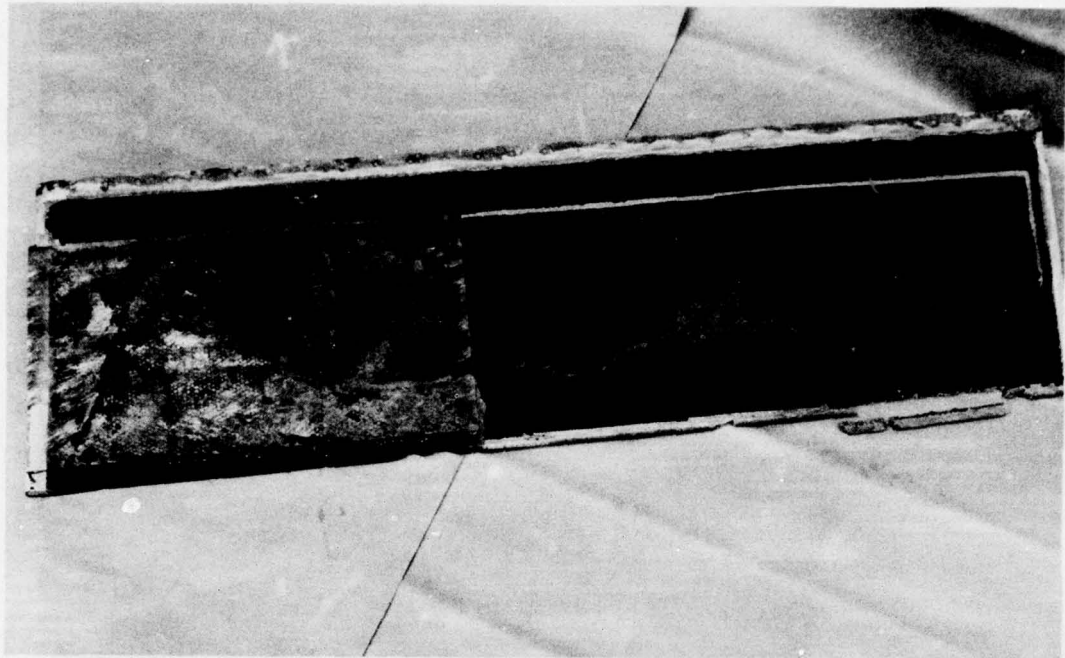
Figure 64.—Interior Condition of C5-A Aileron Trailing Edge Panel Prior to Repair

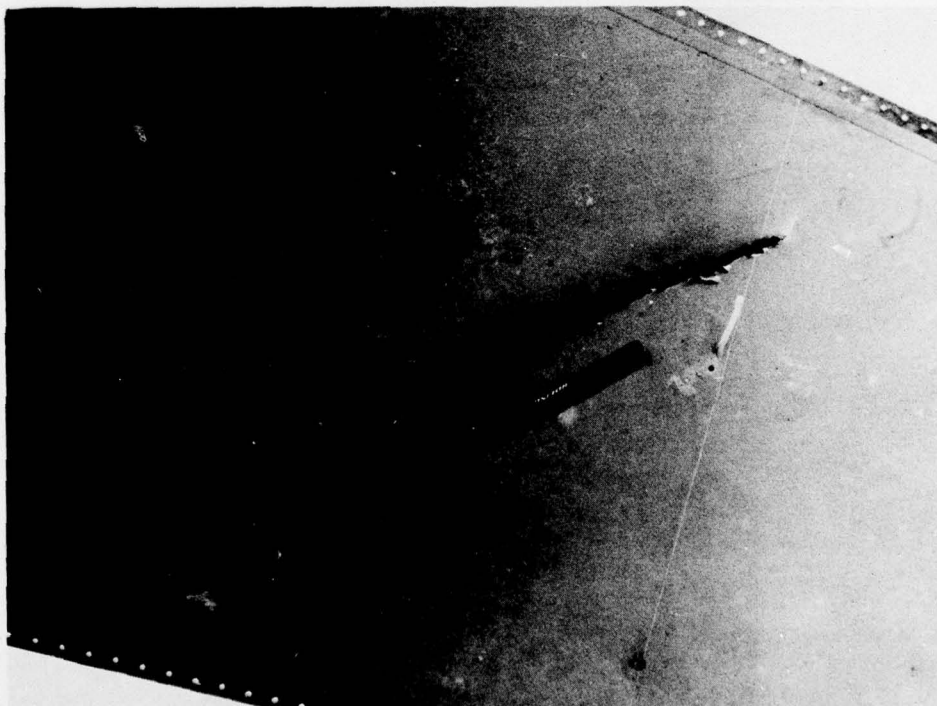
Figure 73.—Closeup of Damage to the A-6 Fin Panel Interior Surface
