# CRREL ROOF MOISTURE SURVEY

Pease AFB

Buildings 33, 116, 122 and 205

January 1977

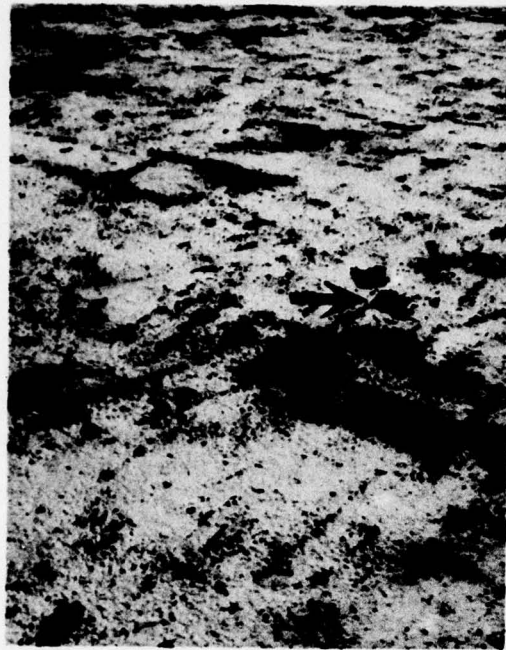
As shown in Figure 1, the surface of the aluminized roof is uneven and discolored. Surface texture differences are even more pronounced on the southerly portion of the roof where both aluminized and non-aluminized coatings have been applied. The thermal image of the roof is also confused, as shown in the Figure 2 thermogram. The light-colored

Figure 1. Daytime photograph of a portion of the northerly roof, Building 33. The arrow points to the location of sample A.

It is understood that leaks persist. Based on a visual examination of the flashings and the fact that no large wet anomalies were detected by the infrared camera, it is felt that the leaks are probably associated with the flashings. It may be possible to resolve these leaks by careful examination and patching of the flashings. However, if such maintenance fails to stop the leaks, the membrane and insulation should be removed and replaced over the entire roof.

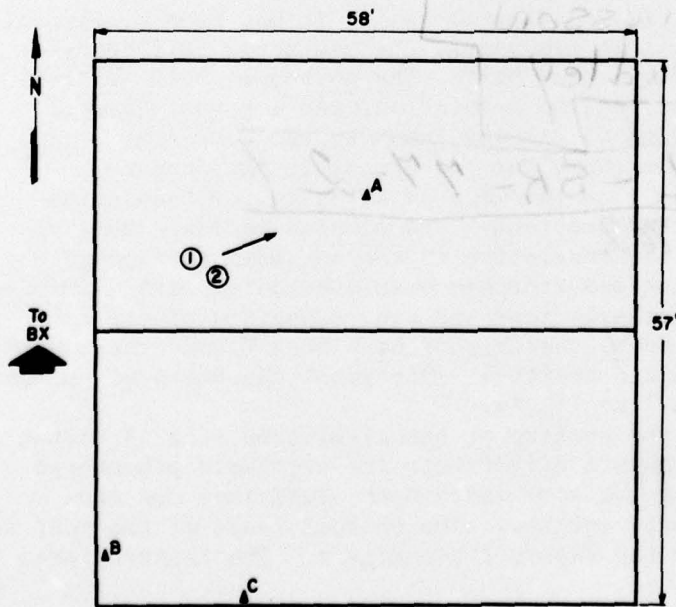
Figure 3. Plan view of Building 33. The water content of the insulation at sample A was 2%. Samples B and C were taken by WES in 1975. The WES samples indicate that some moisture may have entered the insulation in the southern portion of the roof. The arrow indicates the viewing direction and location of subjects in Figures 1 and 2.

areas on the thermogram could represent areas of wet insulation on a normal gravel-covered roof. However, the varying emissivity of the discolored aluminized coating on this roof is believed responsible for the blotchy nature of the roof's thermal image. Sample A, taken on this roof where shown in Figure 3, showed the insulation to be essentially dry. Its water content was 2%.\*

Although the patched and overcoated roof of *Building 33* is visually in poor shape, the insulation appears to be dry over most of the roof. The leaks are probably associated with flashing flaws. Perhaps another attempt should be made to prevent leaks, but this time flashing repairs should be made rather than flood-coating the entire roof. If leaks persist, all the insulation and built-up membrane on this small roof should be removed and replaced.

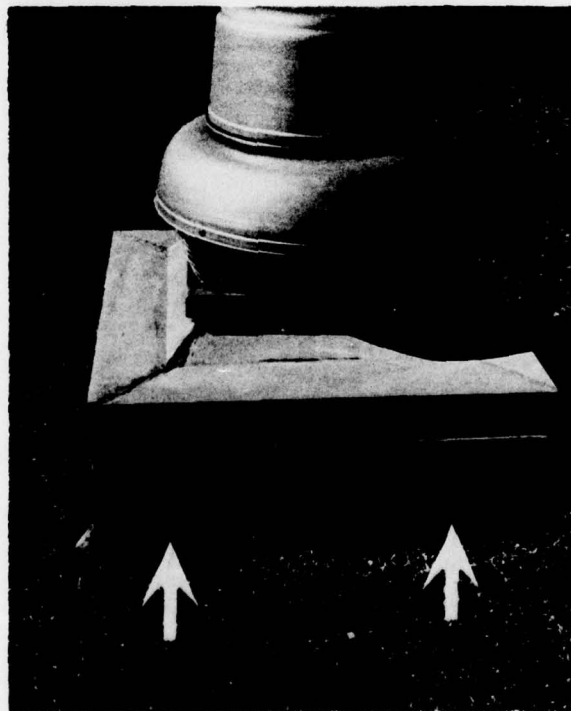
Although there have been no significant problems with the roof of this building, past visual examinations by the base Civil Engineering Division and CRREL indicate that the membrane has a few blisters, felts are exposed along the perimeter, flashings need repair (Fig. 4), and two large membrane buckles are present.

Figure 4. Arrows point to flaws in a vent flashing, Building 116.

Although no wet insulation was detected with the infrared camera, the roof is deteriorating. Steps should be taken to correct the above-mentioned roof deficiencies before water finds its way into the insulation, necessitating expensive repairs.

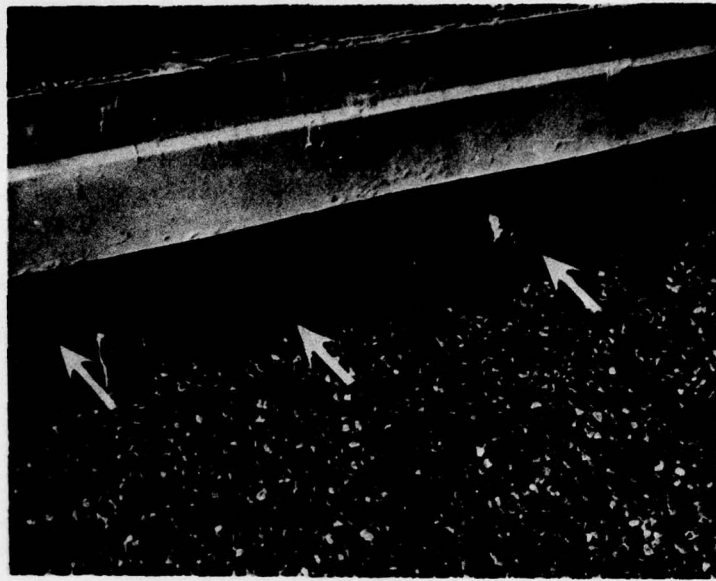
Figure 5. Arrows point to flashing flaws at the firewall, Building 116.

The main roof is subdivided by a masonry firewall. The firewall flashing is split in several places, as shown in Figure 5. A plan view of this roof is shown in Figure 6. The main roof consists of a gypsum deck,  $1\frac{1}{2}$  in. of glass fiber insulation, and a gravel-covered built-up membrane about  $\frac{3}{8}$  in. thick. A ridge runs the long dimension of the main roof at its centerline. From the ridge the roof slopes noticeably to its eaves. Internal drains are located near the eaves. The smaller roofs are lower than the main roof and are essentially flat.

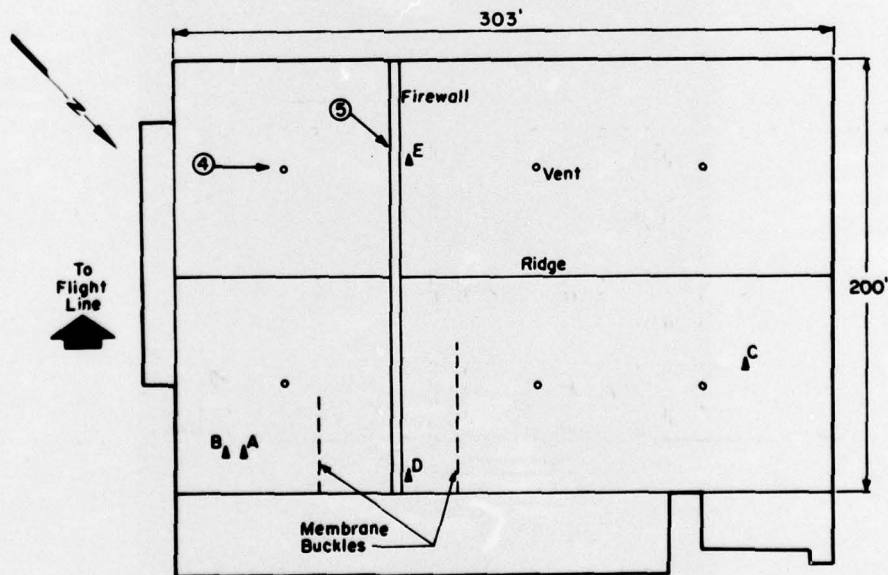
Figure 6. Plan view of roof of Building 116. The water content of the insulation at samples A, B and C (taken in Sept 1975) was essentially 0. Samples D and E were taken by WES in 1975. Sample D was dry, but some moisture was detected in sample E. Arrows indicate the viewing direction and location of subjects in Figures 4 and 5.

Building 116 was surveyed on two separate occasions: 10 September 1975 and 14 October 1976. A few faint anomalies were detected in 1975. They were sampled where shown in Figure 6. Each of samples A, B and C had a water content of 0%. Samples D and E were taken by WES in 1975. Sample D was dry, but a small amount of moisture was detected in sample E. The 1976 resurvey indicated that no new anomalies had developed since 1975.

The roof of *Building 116* is in fairly good condition. It does not need replacement, but comprehensive repair of flashings is required to prevent rapid deterioration.

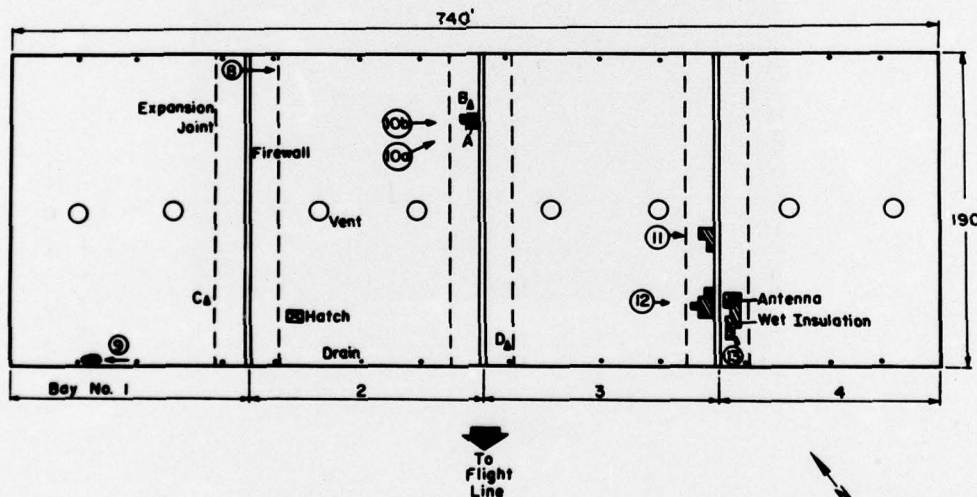
Figure 7. Plan view of Building 122. The insulation of samples A and B had water contents of 318% and 0%, respectively. Samples C and D, taken by WES in 1975, were both dry. The arrows point to the viewing direction and location of subjects in Figures 8-13. Wet areas have been outlined in white spray paint on the roof.

The overall thermal appearance of the roof when viewed with the infrared camera was good. However, five small moisture-caused anomalies were detected. They are cross-hatched on Figure 7. The perimeter of each anomaly was marked with white spray paint for future reference. The anomaly marked in bay 1 is shown in Figure 9. Water quite likely entered this area through a flaw in the membrane at the vent penetration or at the drain shown in Figure 9.

The roof of *Building 122* contains five small wet areas. The penetrations and flashing flaws associated with each wet area should be repaired, but because of the age and condition of the roof, it does not seem necessary to remove the wet insulation and replace it with dry insulation and a new membrane in those small areas. Because the membrane is badly blistered, a new roof will probably be required within five years. However, since most of the insulation is dry and leaks are not a problem, it seems premature to replace all the insulation and the membrane at this time. Annual checks with the infrared camera are recommended.

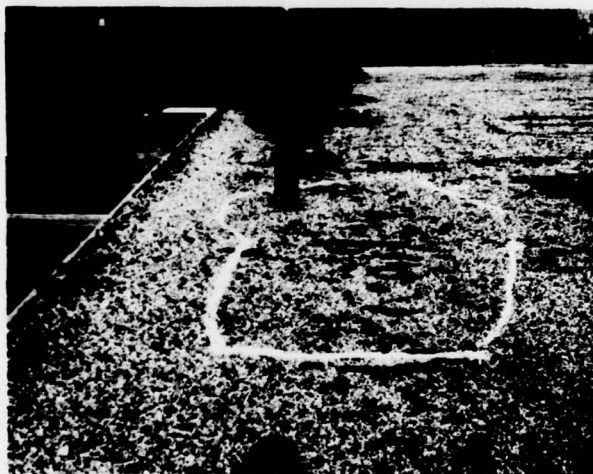
*Figure 9. Area in bay 1, Building 122, that showed up bright in the infrared camera. Its boundary was marked with spray paint.*

Flaws associated with the five wet areas on this roof should be repaired as soon as possible. Since the areas are small, the thermal implications of leaving the wet insulation in place are also small. If the roof membrane were not blistered it would be suggested that the five

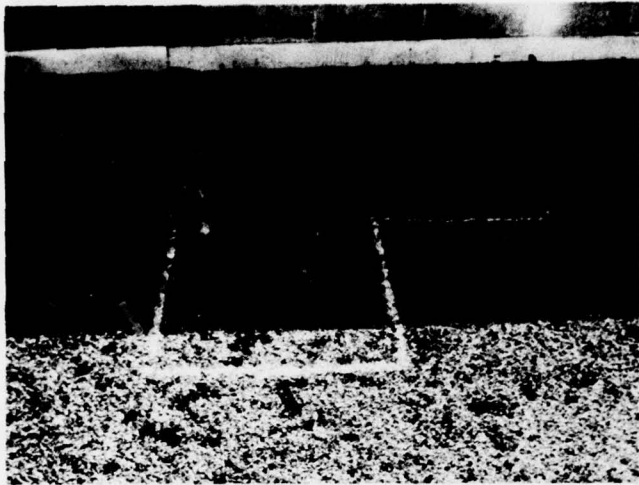
A conventional photograph and a thermogram of the anomaly in bay 2 are presented in Figure 10. Flaws in the firewall flashing are quite likely responsible for this problem. Similar flaws probably are also responsible for the two wet areas detected in bay 3 (Fig. 11 and 12). Samples A and B were taken inside and outside of the bay 2 anomaly to verify that wet insulation was present. The insulation outside the anomaly was dry (water content 0%). Within the anomaly a water content of 318% was measured. Samples C and D were taken by WES as shown in Figure 7. They were both dry. A photograph and thermogram of the bay 4 anomaly are presented in Figure 13. The wet area was located at a TV antenna at the base of which a hole had been drilled through the roof to permit access for the antenna wire.

*Figure 11. One of two spray-painted anomalies in bay 3, Building 122.*

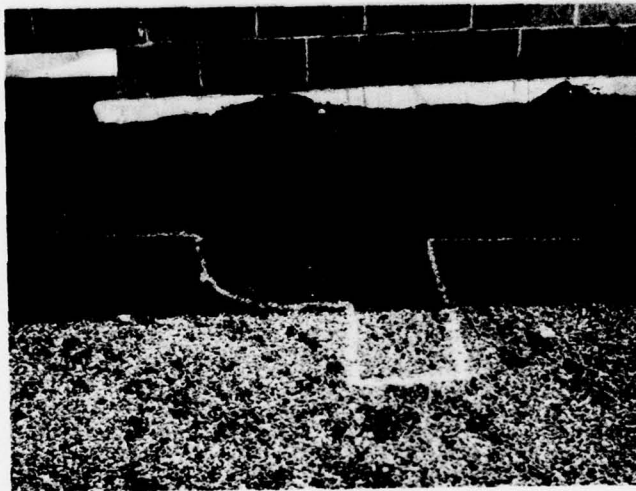
*Figure 12. Second spray-painted anomaly in bay 3, Building 122.*

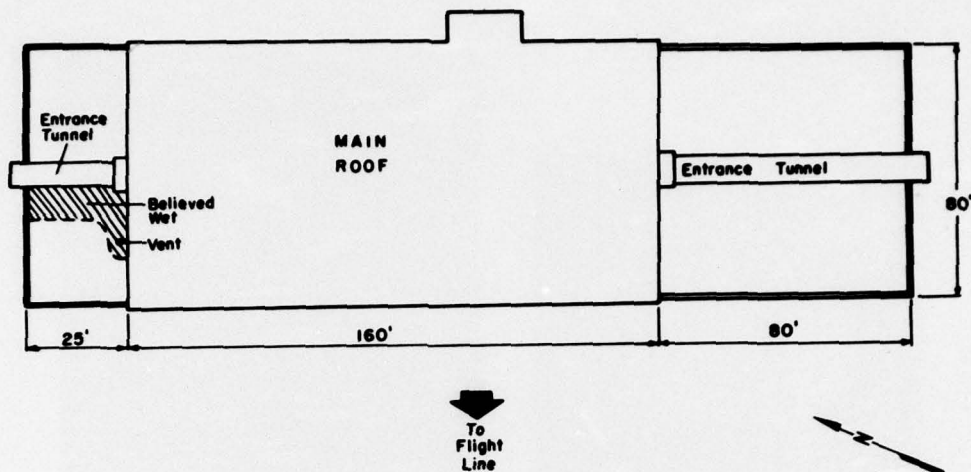
Several anomalies were detected with the infrared camera. All but one were traced to mounds of gravel up to 3 in. deep on the roof. The one anomaly not associated with a gravel mound was on the northwest low roof. Although no samples were permitted on this roof, there can be reasonable confidence that the area cross-hatched in Figure 14 contains wet insulation. However, insulation in the cross-hatched area in Figure 14 should be sampled to verify the infrared findings. Since the wet area is quite large, it is suggested that the membrane and insulation be removed and replaced over the entire northwest low roof.

Figure 14. Plan view of Building 205. The main roof is one story high while the four side roofs are about 2 ft below ground level. They are separated from the ground by a perimeter wall which projects a few inches above grade.

A large portion of the northwest low roof of *Building 205* is expected to contain wet insulation. Replacement of the northwest low roof seems justified. However, a sample should be taken there before contracting for replacement of the insulation and membrane to verify infrared findings. Perimeter flashings and other penetrations should be comprehensively repaired on the other three low roofs.
