EVALUATION REPORT 8-65

EVALUATION OF THE LINDE FLOW WARNING DEVICE

BUREAU OF SHIPS  
PROJECT F011-06-03 TASK 3380

30 DECEMBER 1965

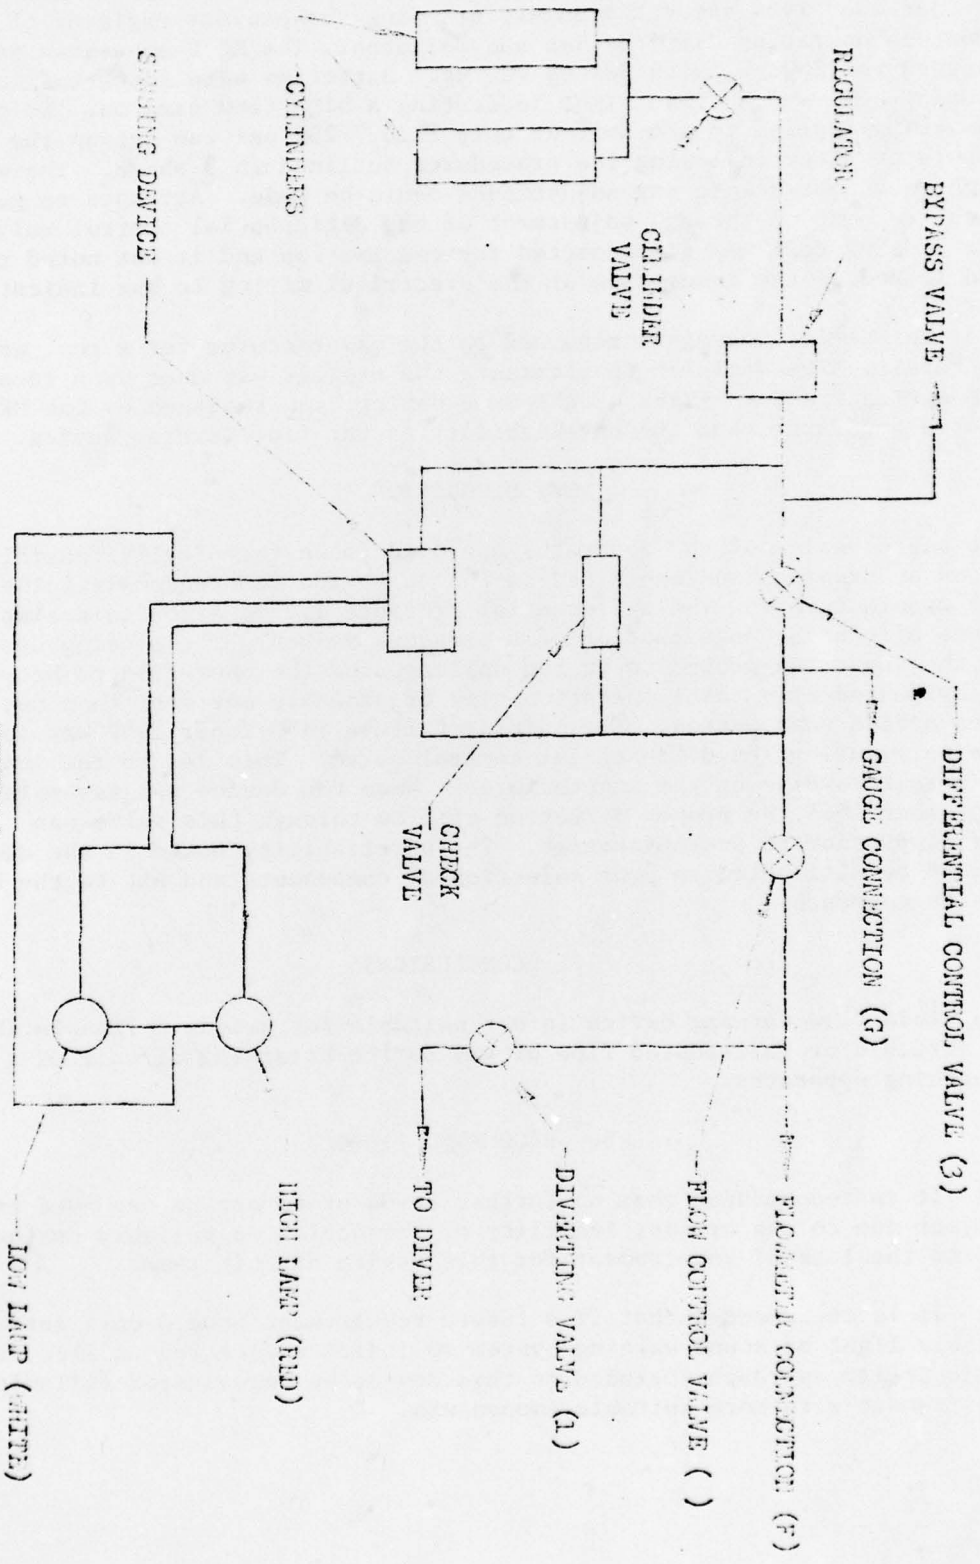
FIGURE 1. SCHEMATIC DIAGRAM : REGULATOR & BREATHING DEVICE

2.1 The warning device is schematically illustrated in figure 1. Photographs are provided in figures 2, 3, 4 and 5. The flow warning device consists of a differential control valve, a flow control valve, a check valve, an aneroid sensing device, a battery pack and red and white warning lights.

5.2 The warning device was returned to the Linde Co. for inspection and repair. It was found that the aneroid had been collapsed due to the shutting of the adjusting valve and resultant increased pressure differential. The aneroid was replaced and the check valve shown in figure one was placed in the circuitry. This valve was designed to open when the pressure differential reached 28-30 psi, to prevent damage to the aneroid due to closing of the differential control valve.
