**OPERATIONAL TEST II (OT II)  
OF  
EMERGENCY REPAIR SHELTER  
FOR THE  
CH-47 HELICOPTER**

**Test And Evaluation Division  
Deputy For Developments**

**United States Army Aviation Center**

11 26 SEPTEMBER 1974

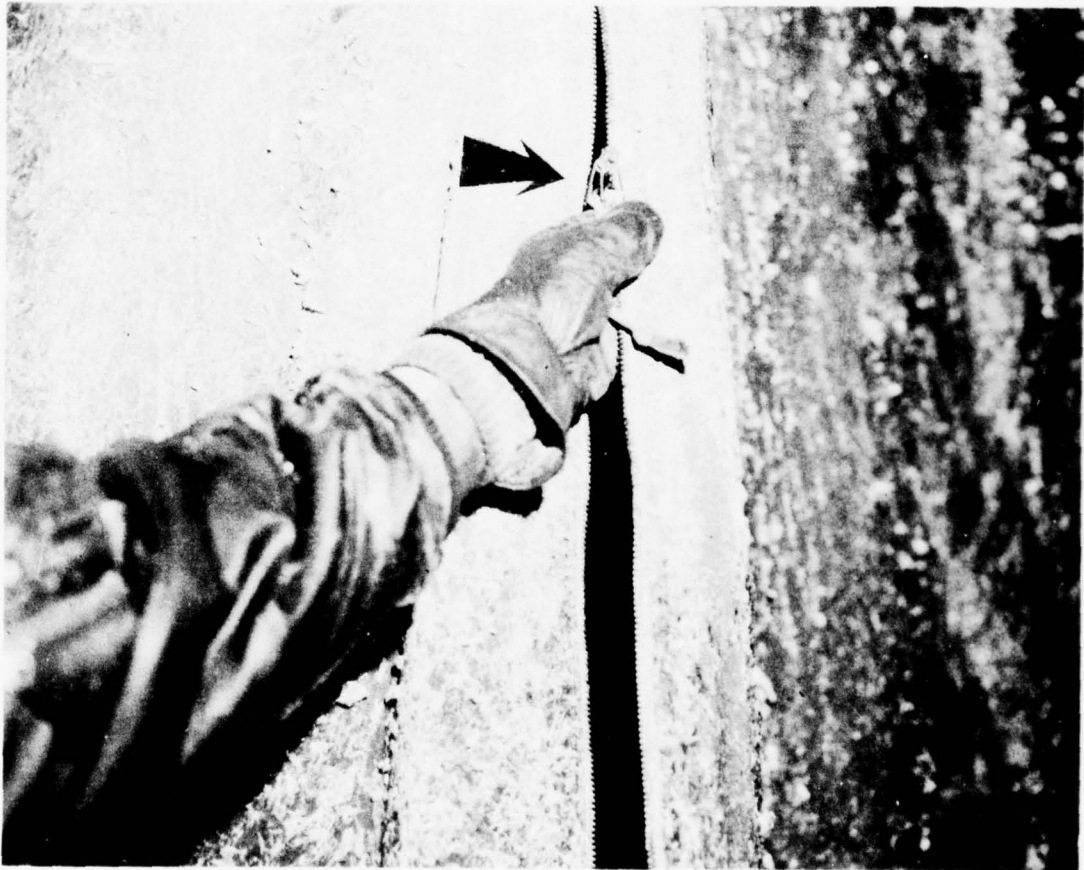
Figure 1

(1) The zippers in the intermediate shelter wall were damaged after the freezing rain test; this was considered a deficiency because the shelter could not be closed and would not retain heat. The modified shelter had a flap cover over the zipper to help prevent water from entering the zipper and freezing; however, the modified shelter was not tested in freezing rain. (Para 2.4.1.1.)

c. The zipper on the intermediate shelter wall containing the APU and heater sleeves came apart above the slider (Appendix I, Fig 1). This damage occurred at 0°F and after the freezing rain test (5 hours) which included approximately 1/4 inch ice accumulation on the shelter. The zippers on the other three shelter walls either pulled out or came apart above the slider when erecting the same shelter at -65°F.

ZIPPER FAILURE ON ICE FROZEN SHELTER

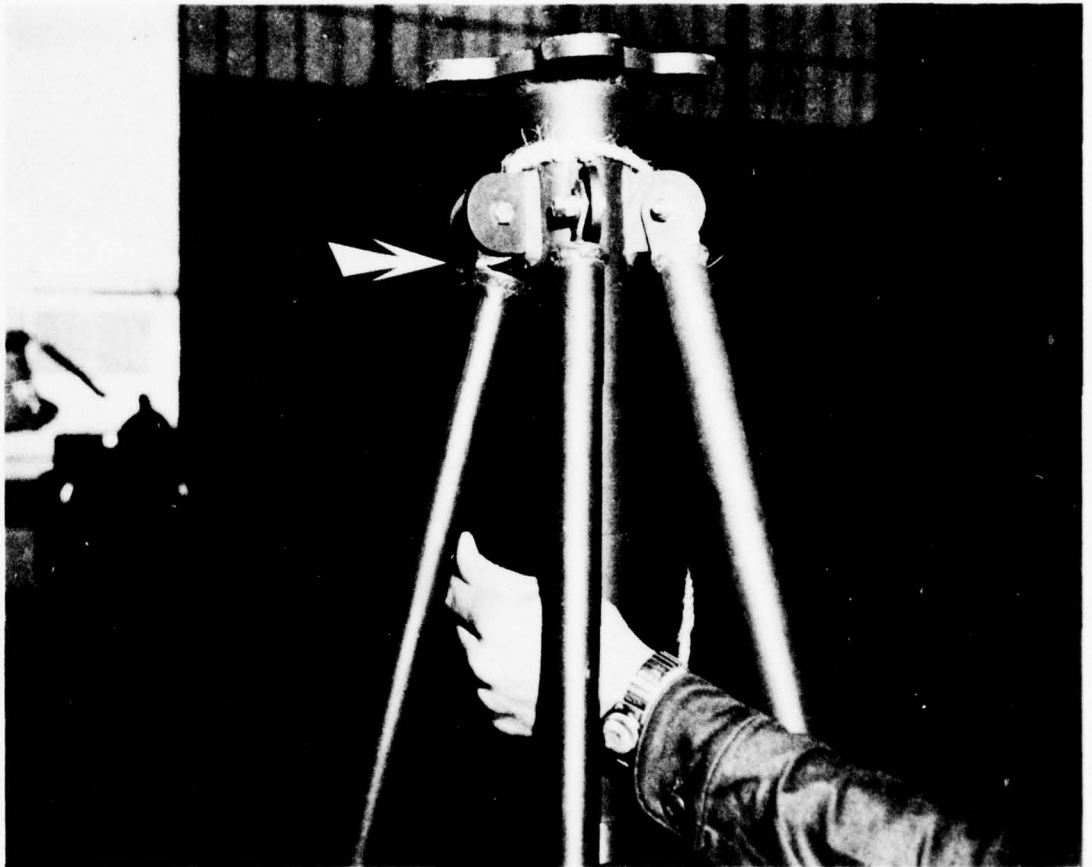
Figure 2

(2) After 12 erecting/striking cycles, all the rib frames in the top shelter section were bent at top and bottom attachment points. One top attachment rib frame was broken. This was considered a shortcoming. U.S. Army Natick Laboratory modified the rib frame. However, only four cycles were accomplished prior to test completion. Therefore, the durability of the modified rib frame was not determined. (Para 2.4.1.1.3,d).

d. After 12 erecting/striking cycles, all rib frames were bent at the top and bottom points where they attach to the center pole. One top attachment rib frame was broken (Appendix I, Fig 2). This necessitated the frame to be modified for additional strength.

SHELTER TOP RIB FRAME BROKEN ATTACHMENT POINT

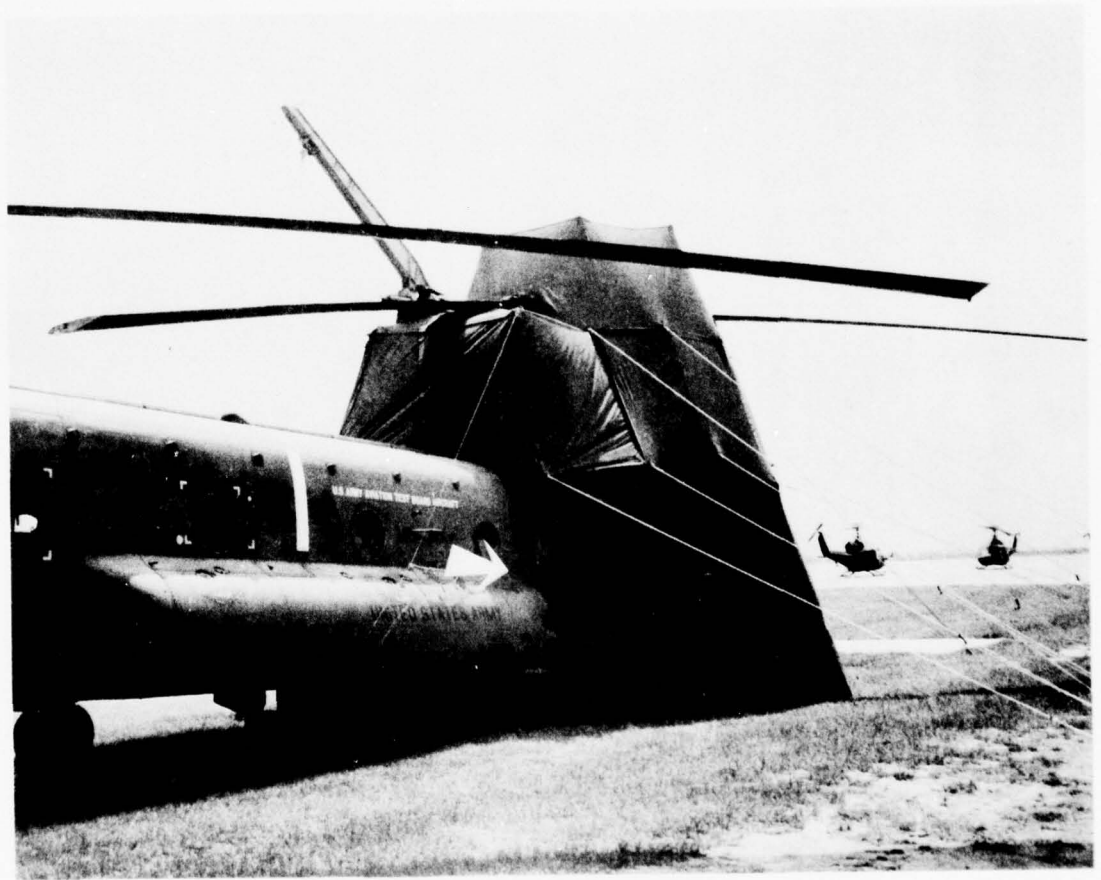
Figure 3

CLOSE FIT OF SHELTER TO AIRFRAME

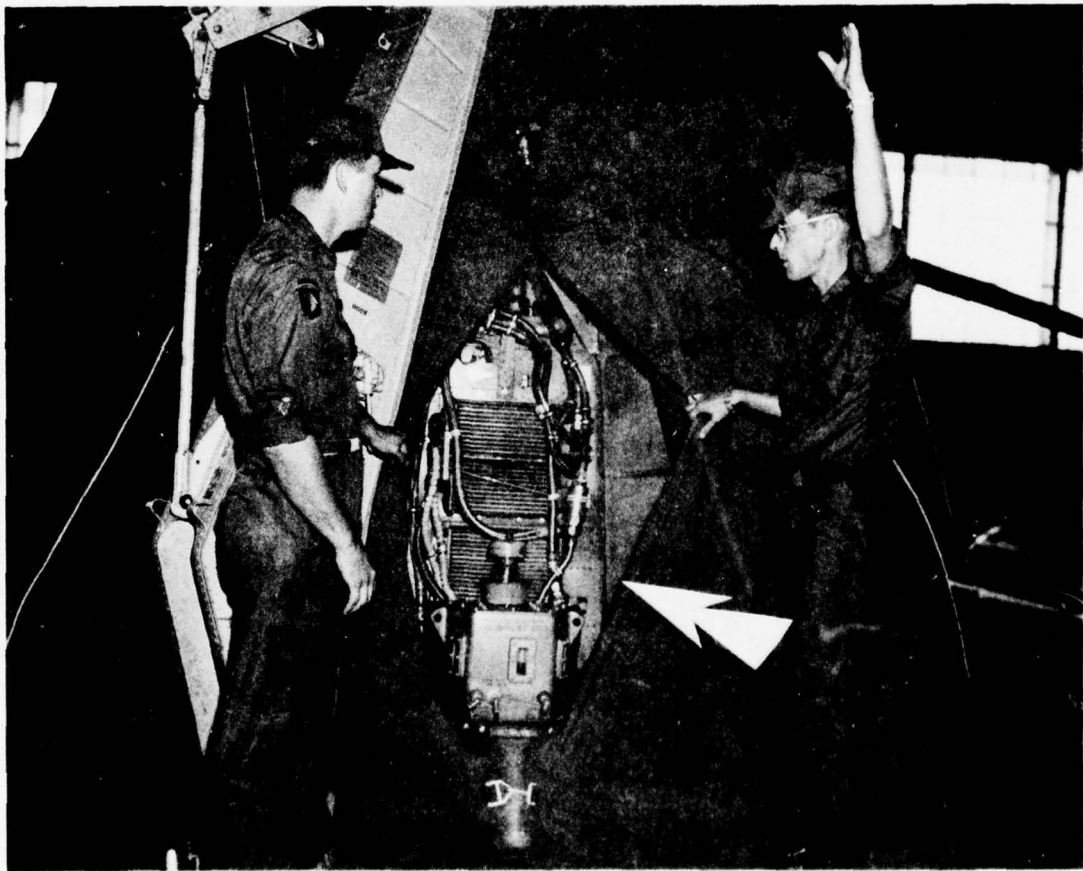
Figure 4

(1) Entrance to the shelter in the vicinity of the combining transmission was restricted, especially for personnel wearing arctic clothing (Appendix I, Fig 4).

UNMODIFIED AFT SHELTER AT MIDCASE AREA

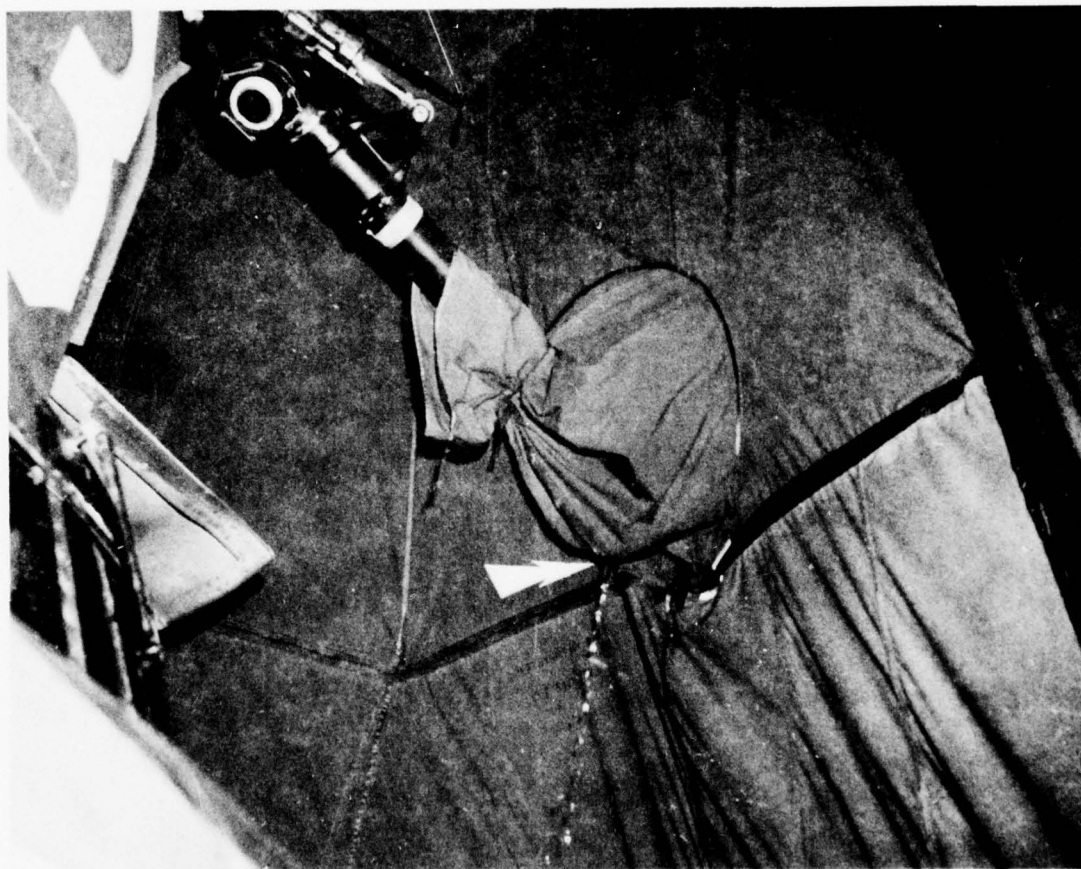
Figure 5

WATER LEAK AROUND BLADE OPENINGS

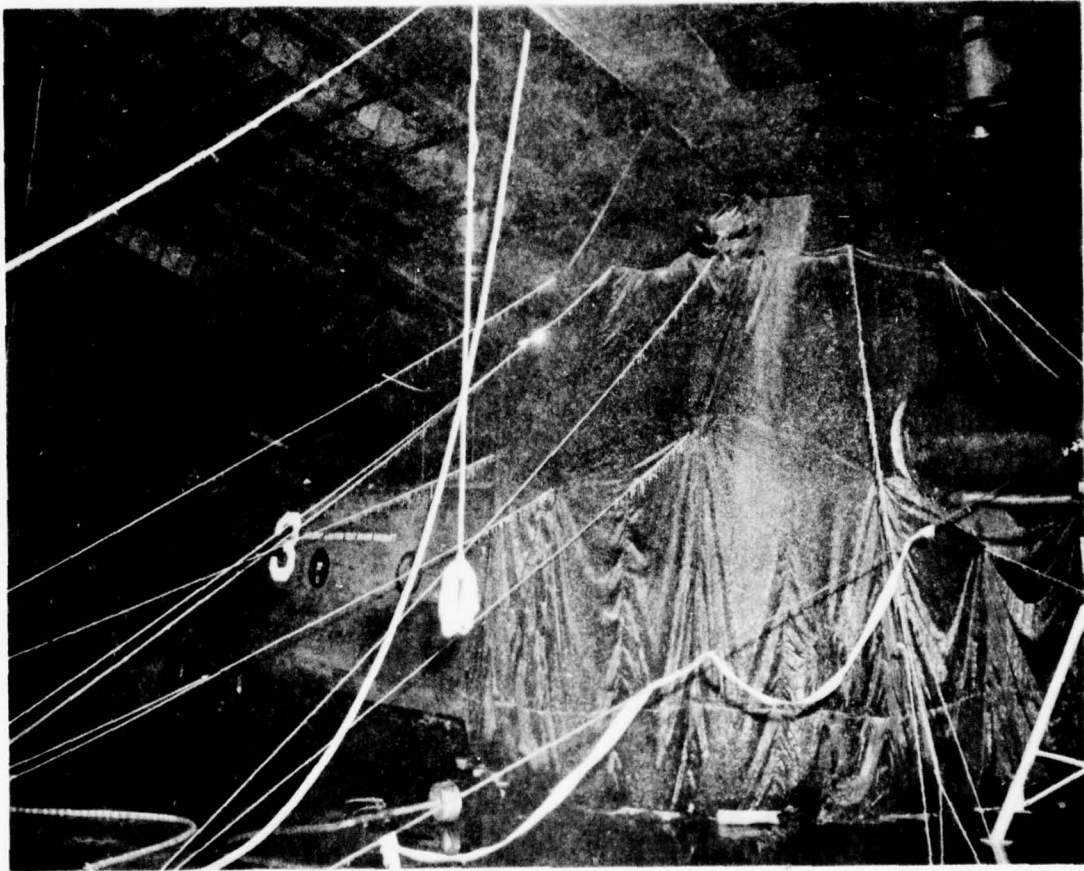
Figure 6

ICE TEST OF FRONT AND REAR SHELTERS

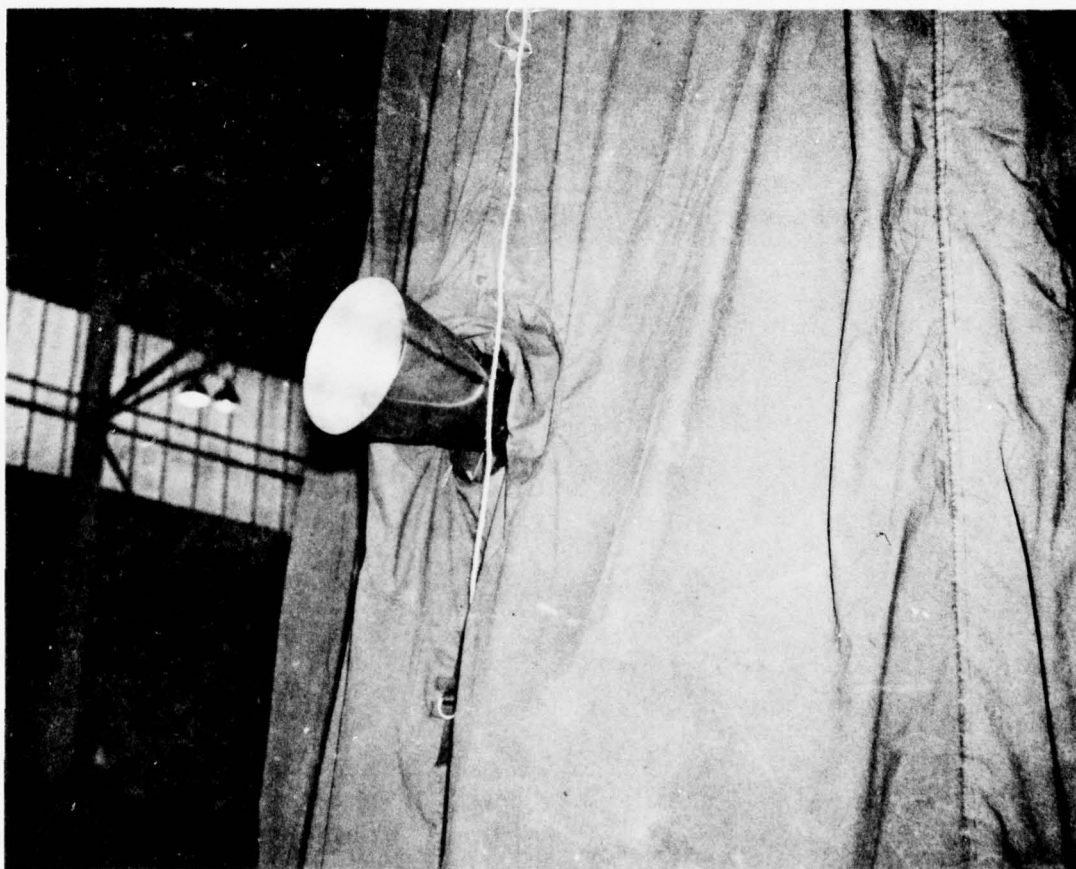
Figure 7

APU EXHAUST THROUGH AFT TENT WALL

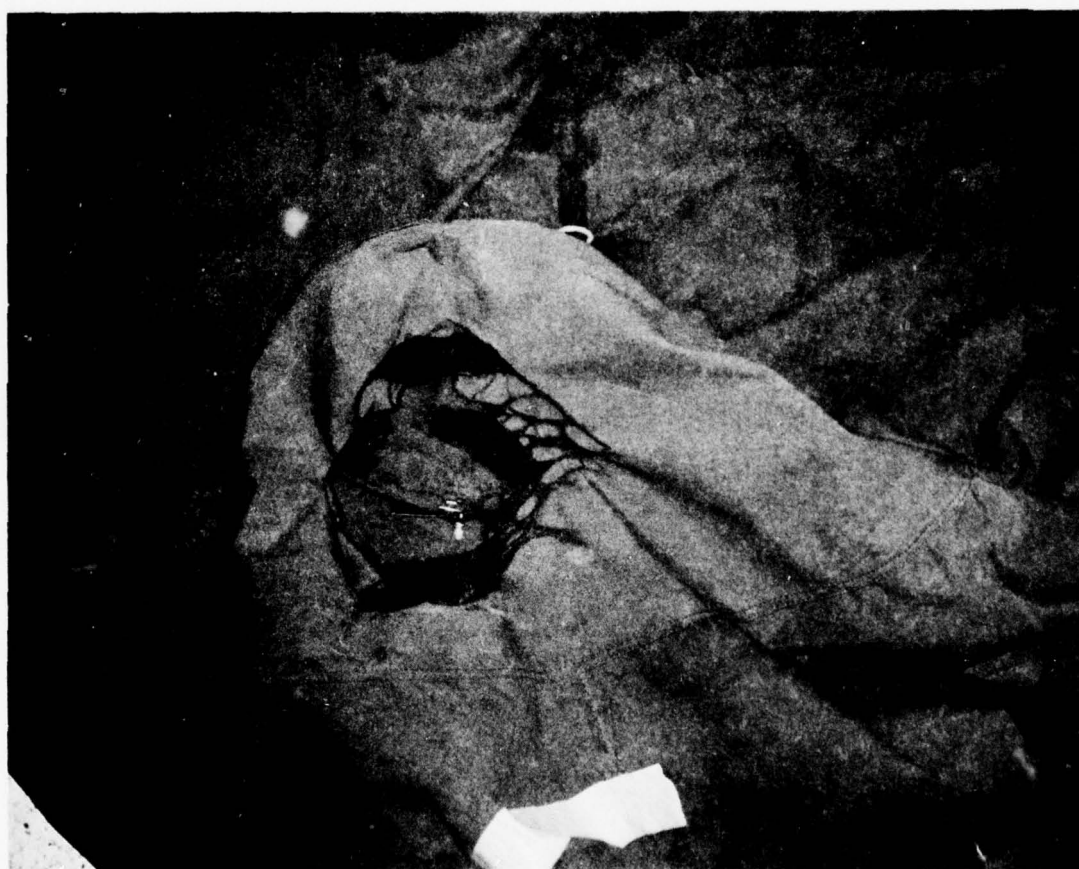
Figure 8

h. The shelter material around the APU exhaust charred and melted but did not burn. This area was modified with nonflammable heat resistant material around the APU exhaust vent (Appendix I, Fig 8).

CHARRED CANVAS AROUND APU EXHAUST

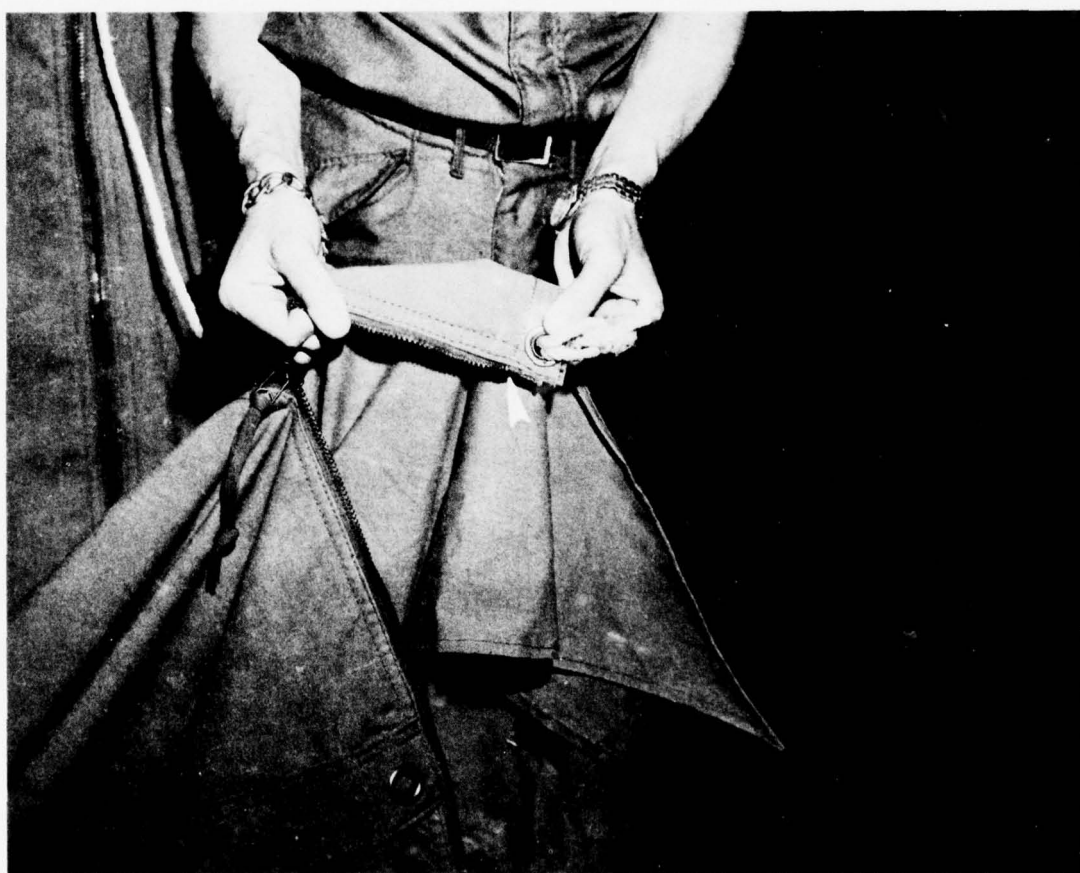
Figure 9

b. A total of 59 missions were attempted during the test, and two mission failures occurred. The first failure occurred at 102 cumulative erected hours. The zipper on the intermediate shelter wall which contained the APU and heater sleeves came apart during shelter striking at an ambient temperature of 0°F. This occurred after a freezing rain test of 5 hours duration during which approximately 1/4 inch of ice accumulated on the shelter. The entire rear wall of the shelter was replaced due to the broken zipper. (Appendix I, Fig 9).

CANVAS ZIPPER FAILURES

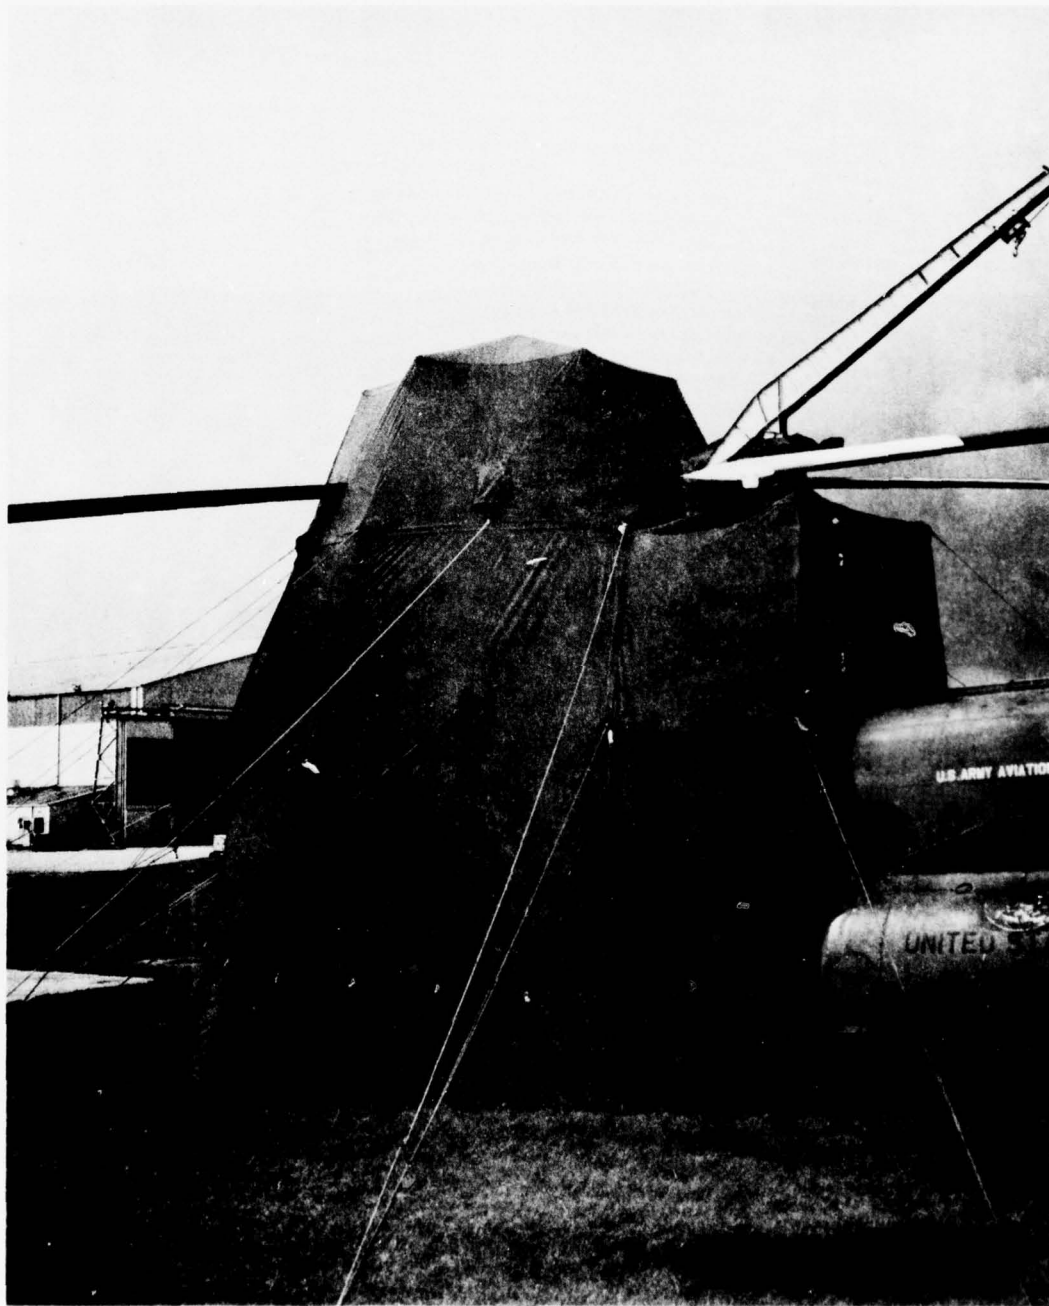
Figure 10

MODIFIED REAR SHELTER

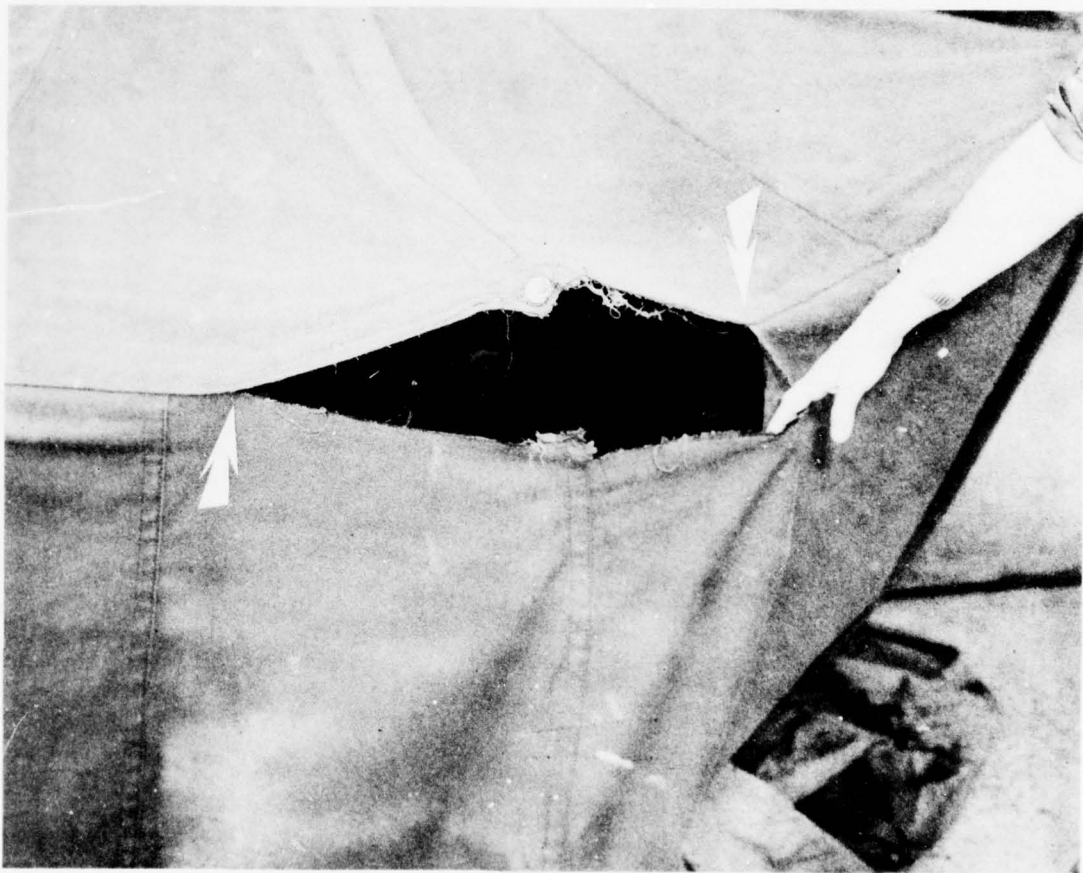
Figure 11

a. The shelter fabric was lightweight, water-resistant, and wind-resistant. During the rain test, water leaked around the zipper seams, but did not leak into the work area. After modification (i.e., incorporation of flaps over the zippers), no leakage was noted around the zippers during a 1/2 inch rainfall. The top shelter section tore under heavy wind at the shelter frame to fabric attachment point along the seam area. (Appendix I, Fig 11).

SHELTER TOP FRAME CANVAS RIPPED AT SEAM
