BEHAVIOR OF SAND-ASPHALT GROINS
AT
OCEAN CITY, MARYLAND

Miscellaneous Paper No. 2-59

May 1959

099320
BEACH EROSION BOARD
OFFICE OF THE CHIEF OF ENGINEERS

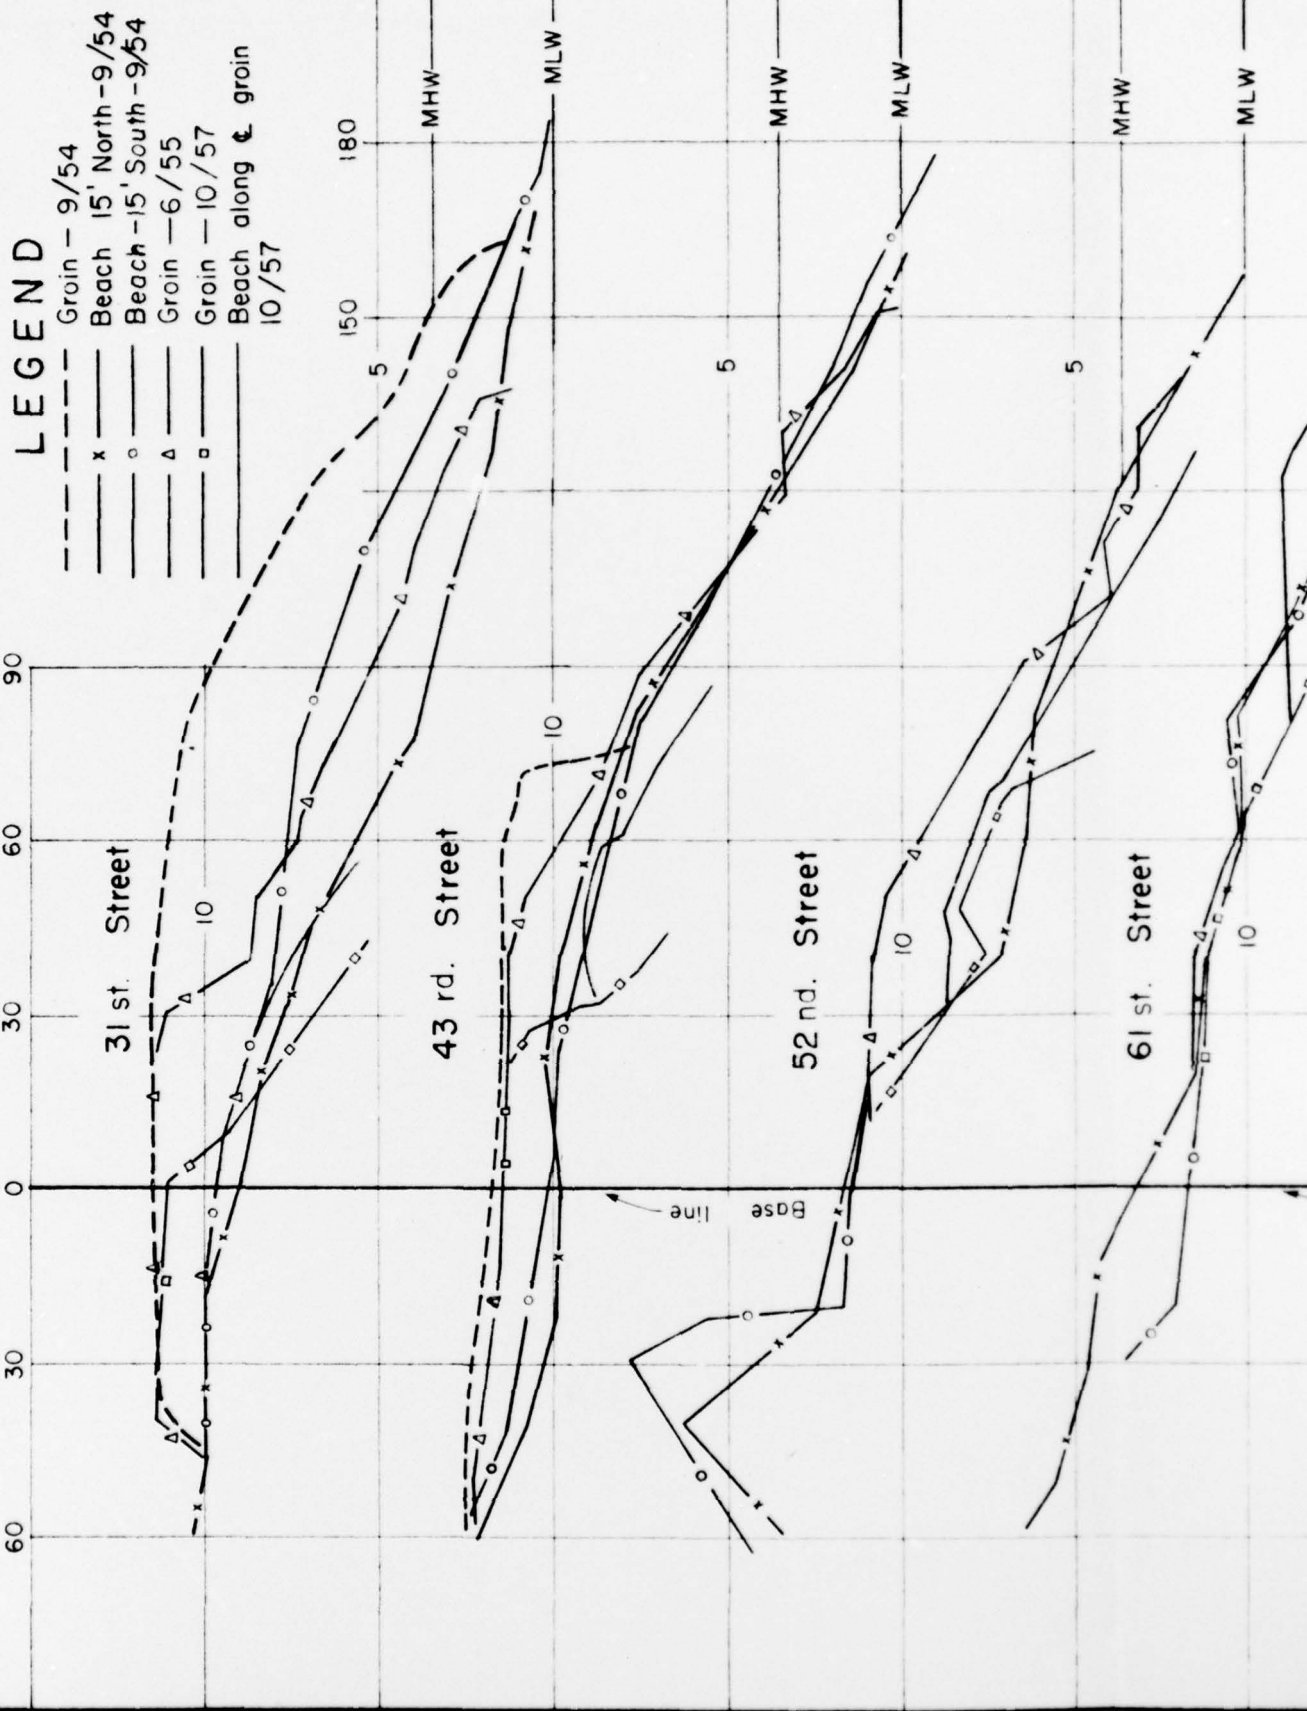
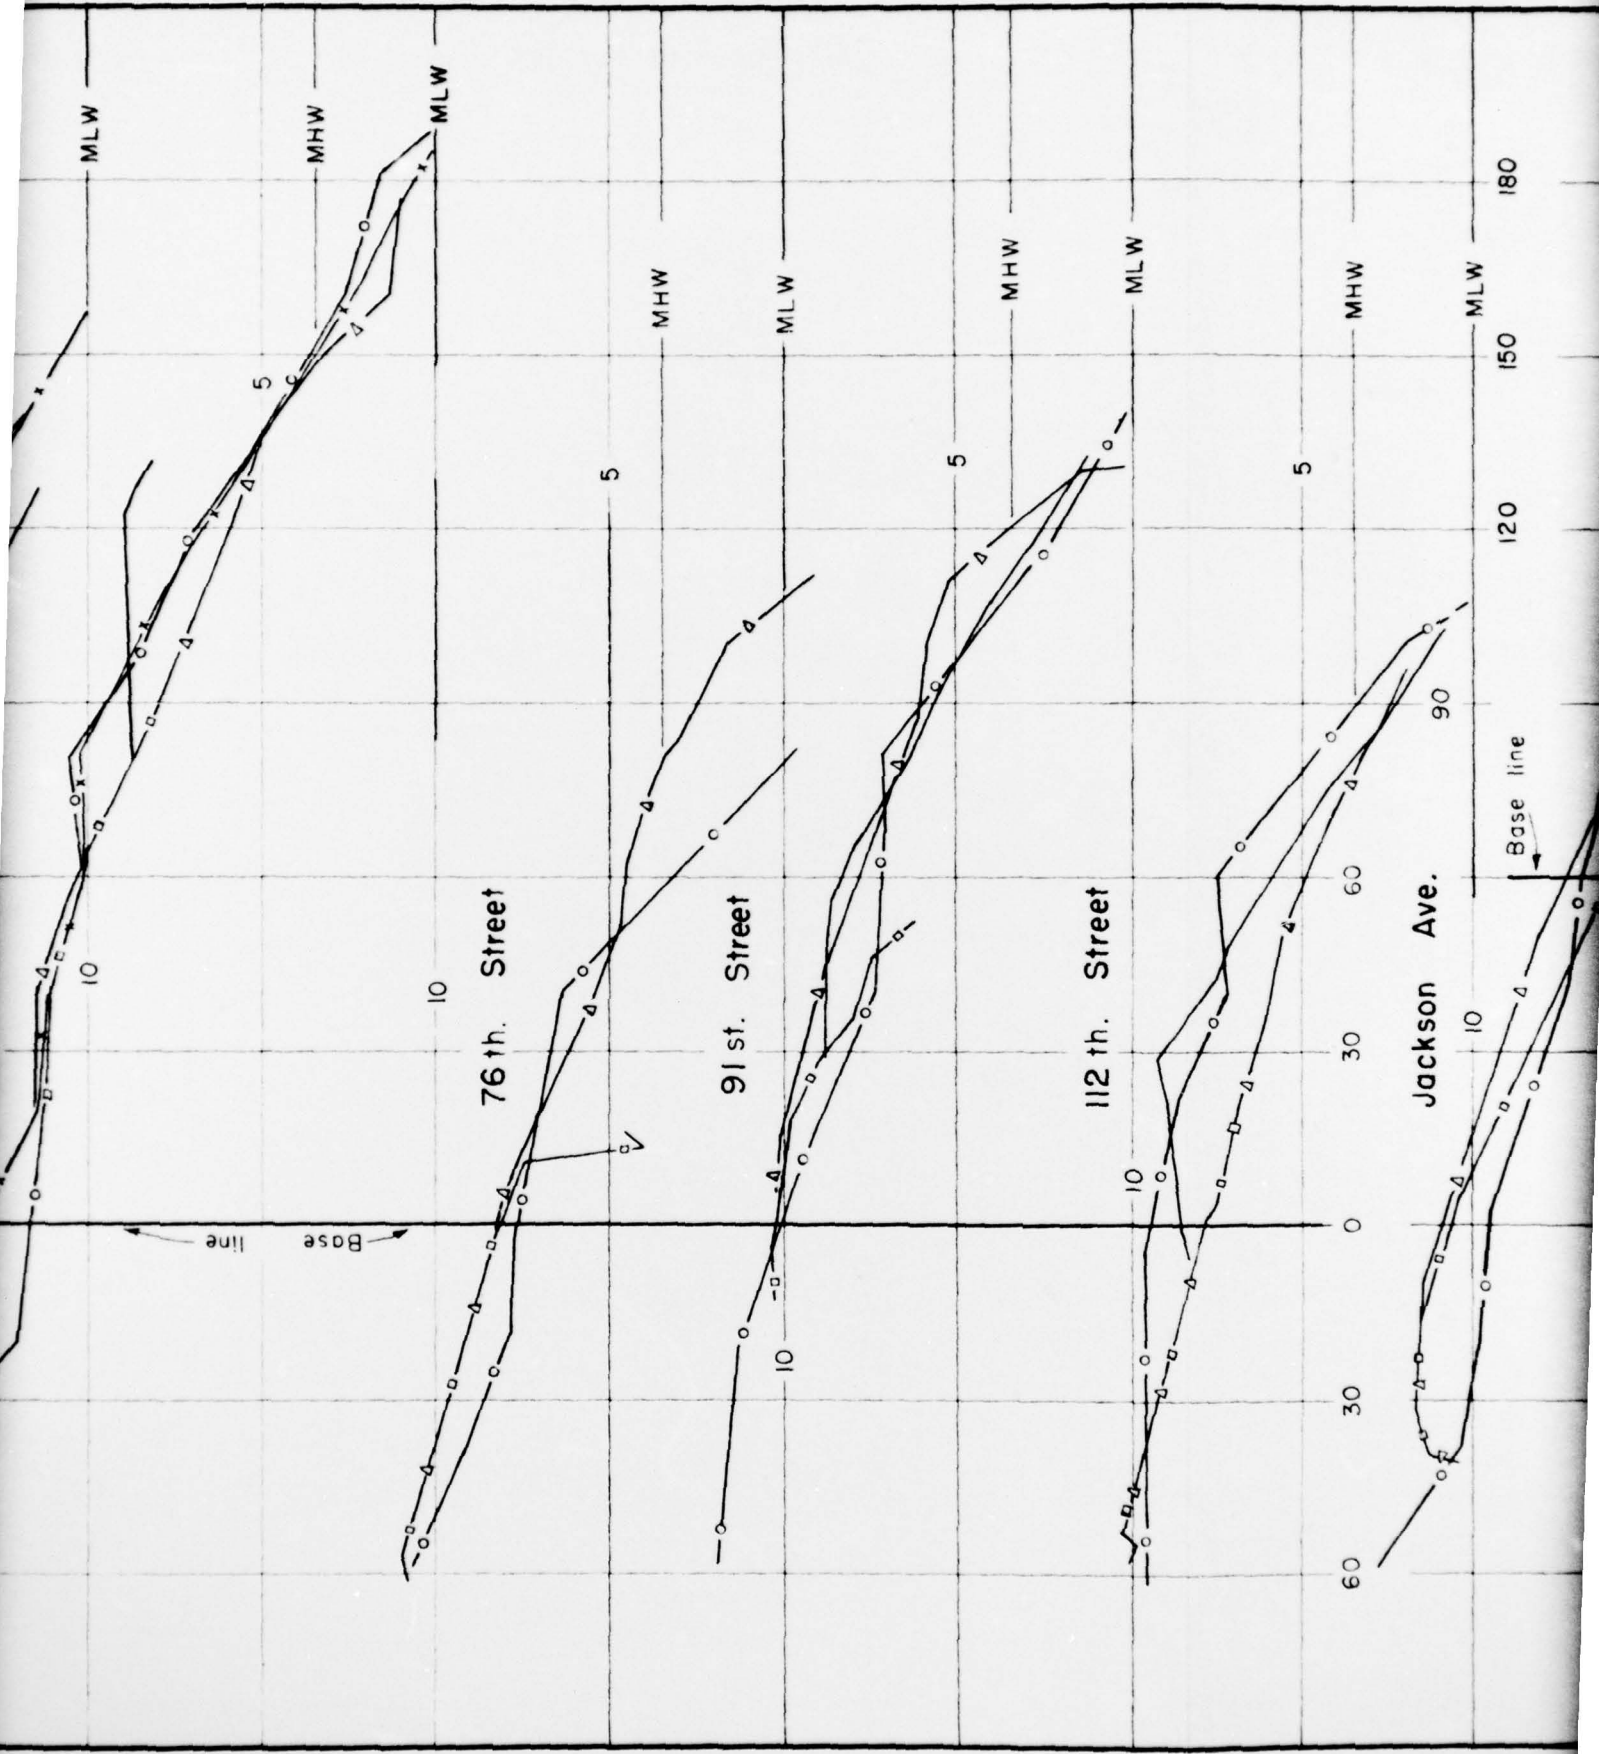
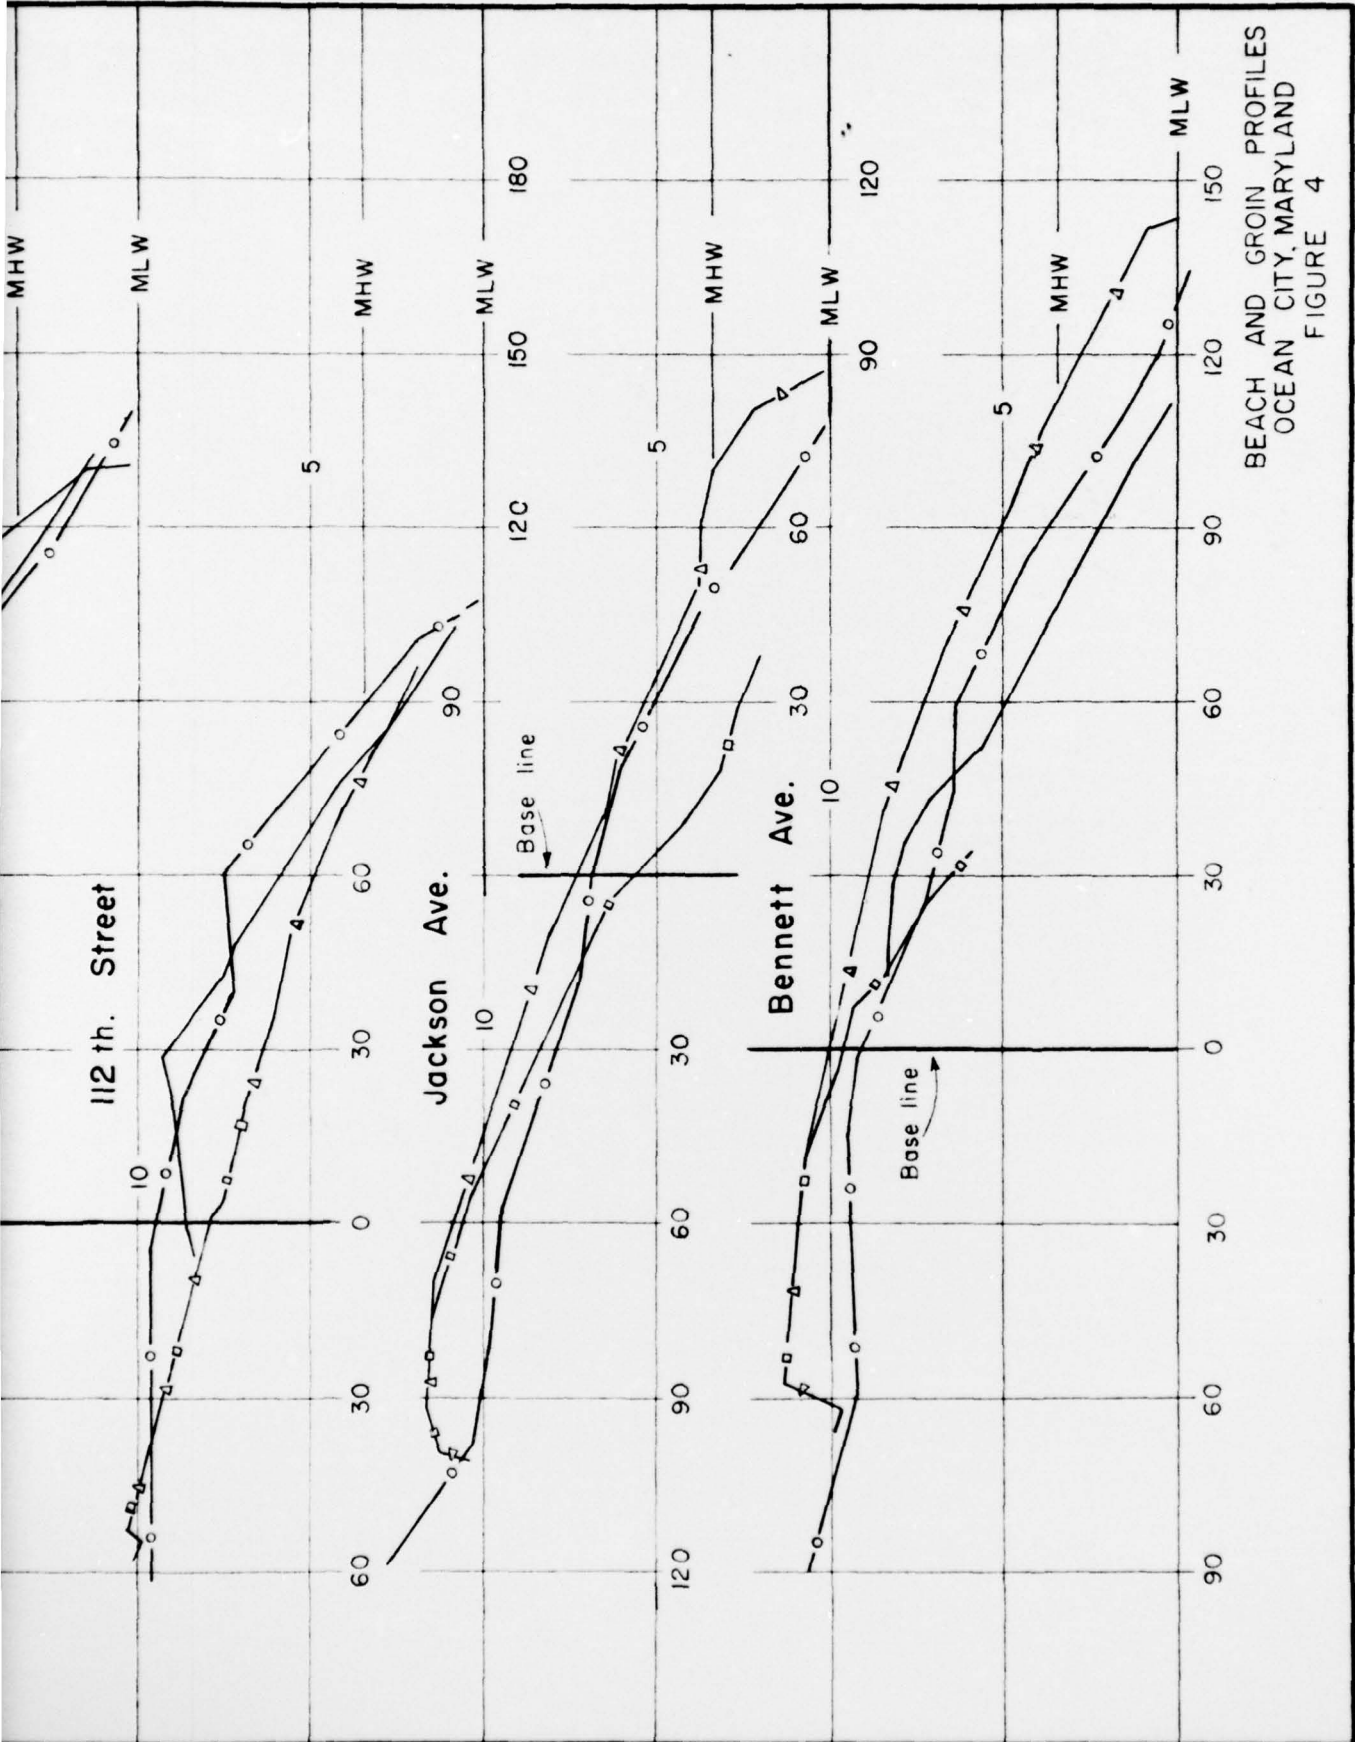
BEACH AND GROIN PROFILES
 OCEAN CITY, MARYLAND
 FIGURE 4

The September 1954 profiles of the 31st Street groin, shown on figure 4, indicated the severe exposure of the groin above the beach level. The 43rd Street groin had not been completed at the time of the survey and the remaining groins indicated on the figure had not been started. Photograph 1, figure 5, shows the breaching type of damage that occurred to the 31st Street groin as the result of the two hurricanes.

A comparison of the groin profiles on figure 4 for October 1957 and June 1955, indicates that in most cases the seaward end had been destroyed or had disappeared below the beach surface. The groins have

progressively settled with a few exceptions from the seaward toward the landward end. In some cases this settlement exceeded 4 feet, thus making the groins ineffective to retain the desired beach width. Data on the condition of the groins in October 1957, summarized in table 3, indicate that only 35 percent of the total length of the groins remained within 1 foot and 40 percent within 2 feet of the June 1955 profiles. A comparison of the beach profiles for September 1954 and October 1957 indicated that there had been a general recession of the high and low water shore lines during this period.

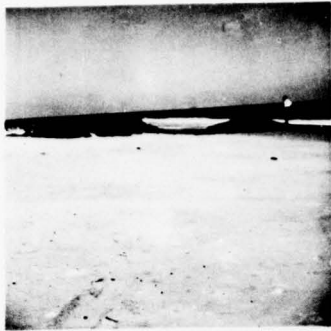
1
31st Street
Sept. 1954

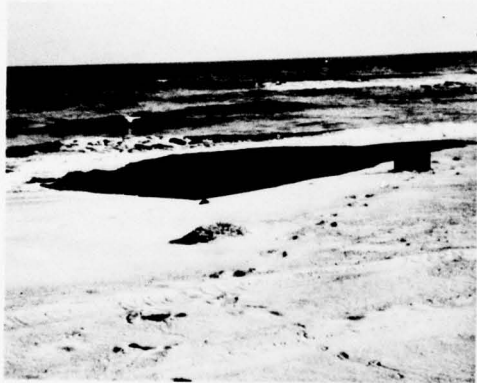
3
52nd Street
Oct. 1955

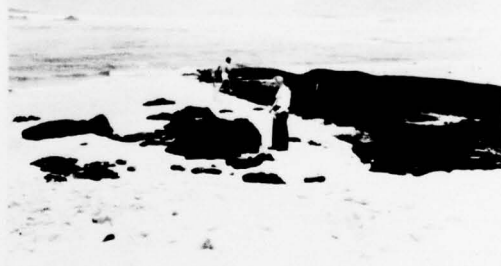
An analysis of photographs revealed that in September and October 1955 thirteen of the forty-three groins were barely exposed or not exposed at all in the tidal zone. The remaining groins showed signs of deterioration in three distinct forms: (1) Breaching, that is, the beach had eroded in the tidal zone, leaving a void or gap as seen in photograph 1, figure 5. This breaching varied between 10 and 40 feet in length. (2) End raveling, that is, the seaward end developed cracks as the result of undercutting and settlement, and wave action broke off and carried away the pieces. This type of deterioration is graphically shown in photographs 2 and 3, figure 5. (3) Side raveling, that is, the asphalt broke off one side of the crown or apron as the result of wave action undercutting the side or splitting along the longitudinal temperature cracks in the crown. The apron undercutting type of side raveling is seen in photograph 4, and the crown side raveling is shown in photograph 5, figure 5.

4
40th Street
July 1956

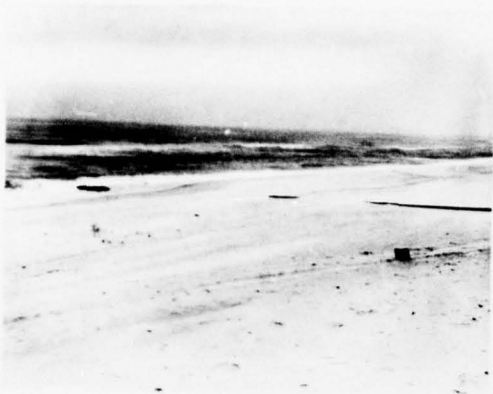
6
76th Street
June 1956

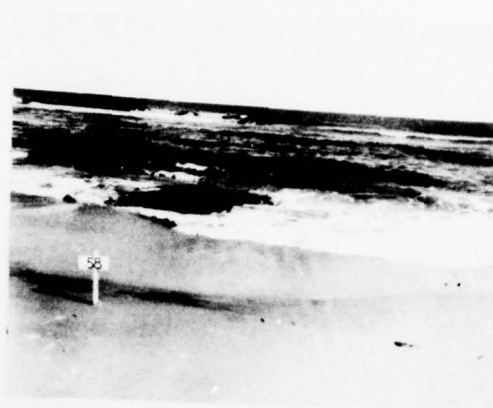
7
58th Street
Oct. 1957

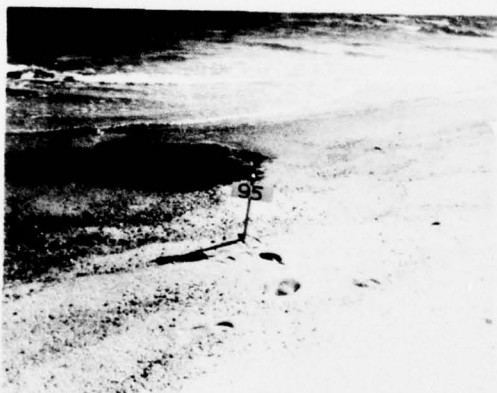
8
95th Street
Oct. 1957

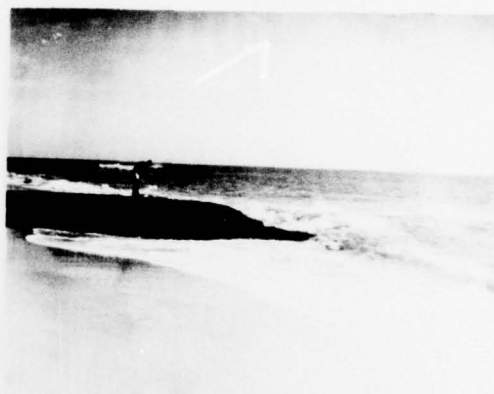
9
76th Street
Oct. 1957

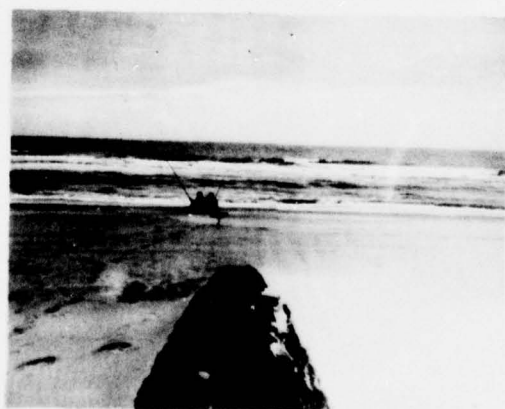
The latest observations were made in October 1957 when profiles and photographs were taken. The photographs indicated that thirty-eight of the groins were not exposed in the tidal zone but four of these groins had minor exposed portions of asphalt only at extremely low tide (-1 foot MLW, see photographs 7 and 8, figure 5). Only five groins were exposed in the foreshore area and these ranged from barely visible to 3 or 4 feet of height exposed above the beach surface. Photograph 9, figure 5, shows the severe exposure of the groin at 76th Street (a comparison of photographs 6 and 9 shows the extent of the erosion to this groin in the 16-month period), whereas photograph 10, figure 5, shows the typical groin that was not exposed in the tidal zone.

10
Bennett Ave
Oct. 1957
