# Air Carrier Cabin Safety

## A Survey

December  
1976

Federal Aviation  
Administration  
Office of Aviation Safety  
Washington, D.C.

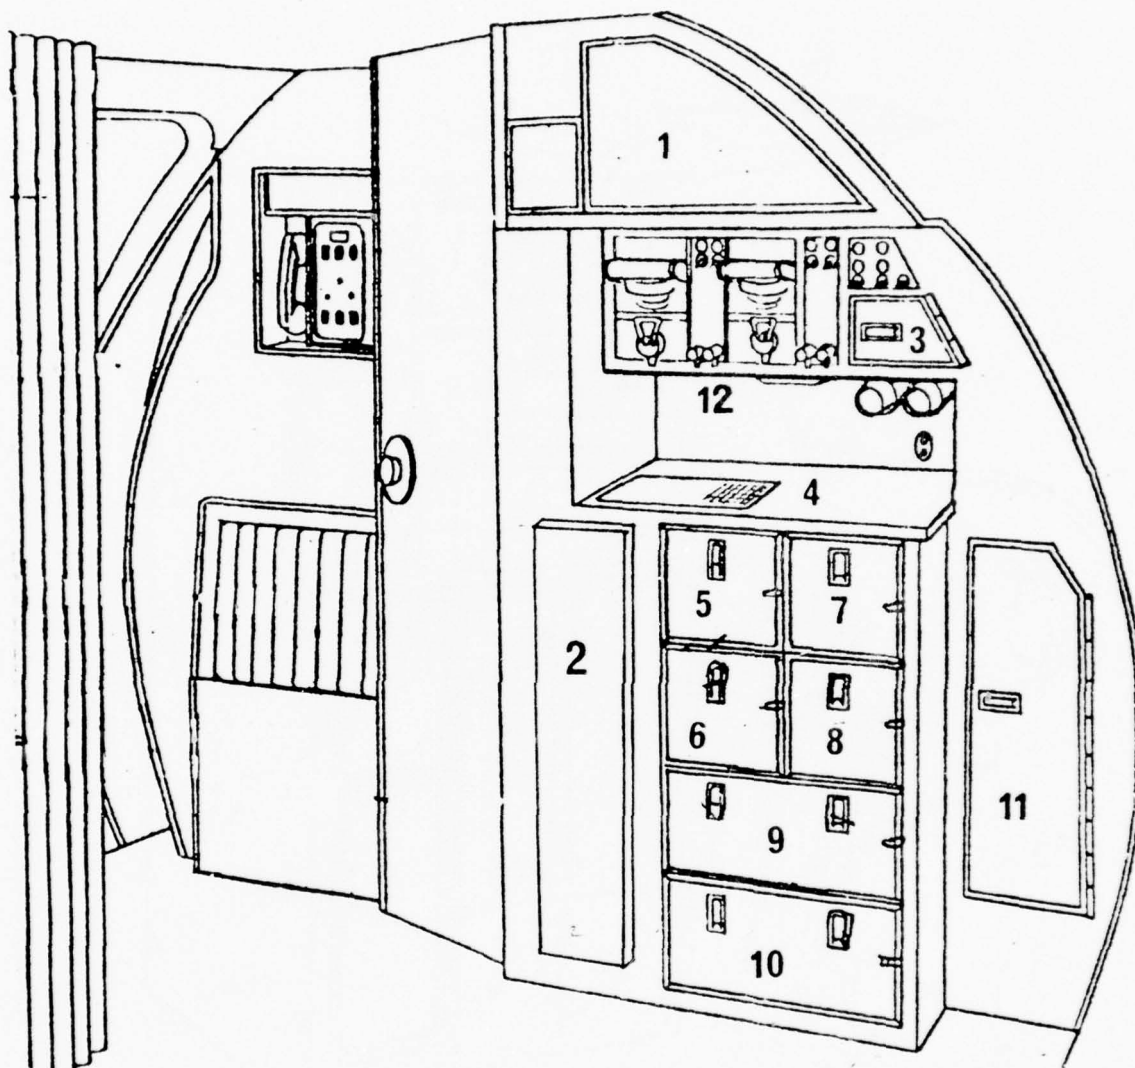
GALLEYS NOS. 1 AND 2

FORWARD PASSENGER ENTRYWAY, COATROOM AND GALLEY UNIT #1  
(LOOKING FORWARD)

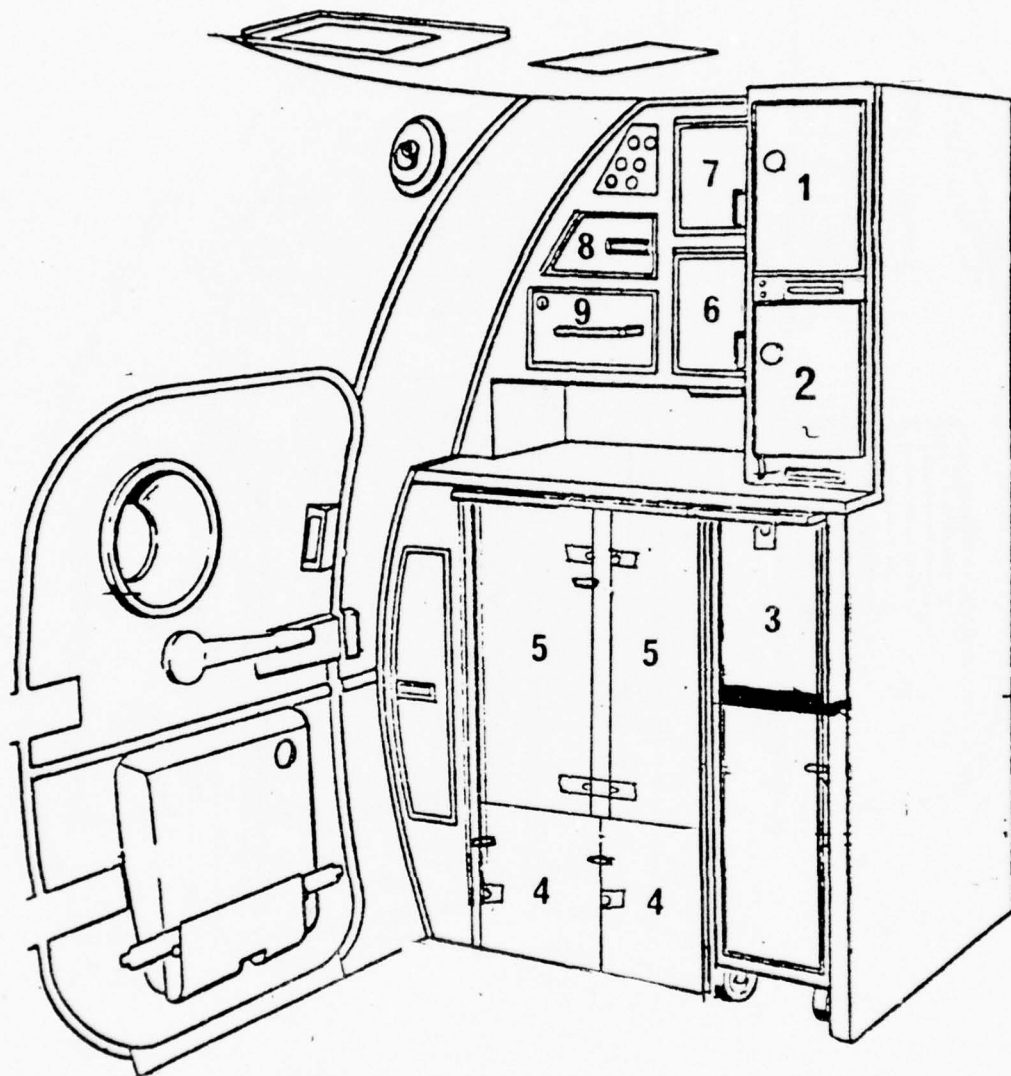
SERVICE ENTRYWAY AND GALLEY UNIT #2  
(RIGHT SIDE, LOOKING AFT)
