AD-A038 416

COLD REGIONS RESEARCH AND ENGINEERING LAB HANOVER N H F/6 13/2
REVEGETATION AND EROSION CONTROL OBSERVATIONS ALONG THE TRANS-A--ETC(U)
MAR 77 L JOHNSON, W QUINN, J BROWN

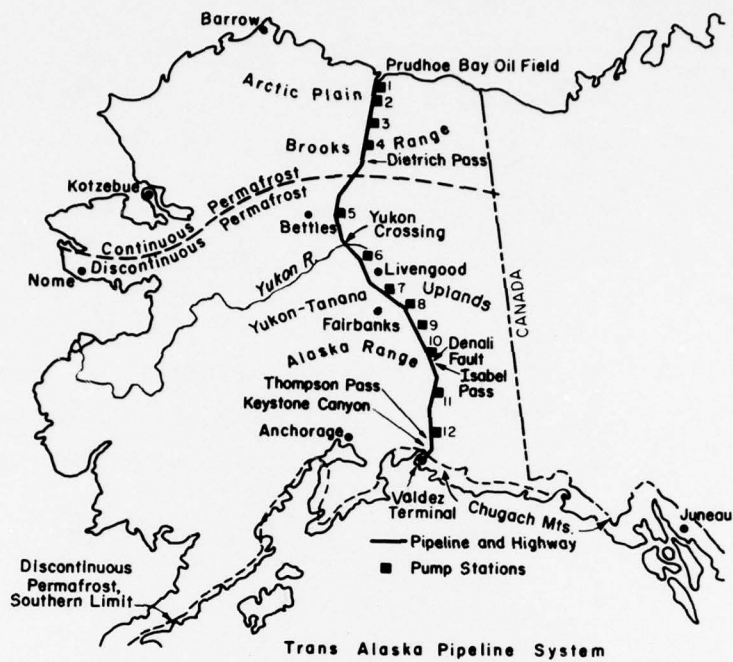
Figure 4. Map of Alaska indicating route of trans-Alaska pipeline system, including pump stations, major and specific physiographic and geomorphic features along the route, and the boundary between the continuous and discontinuous permafrost zones.

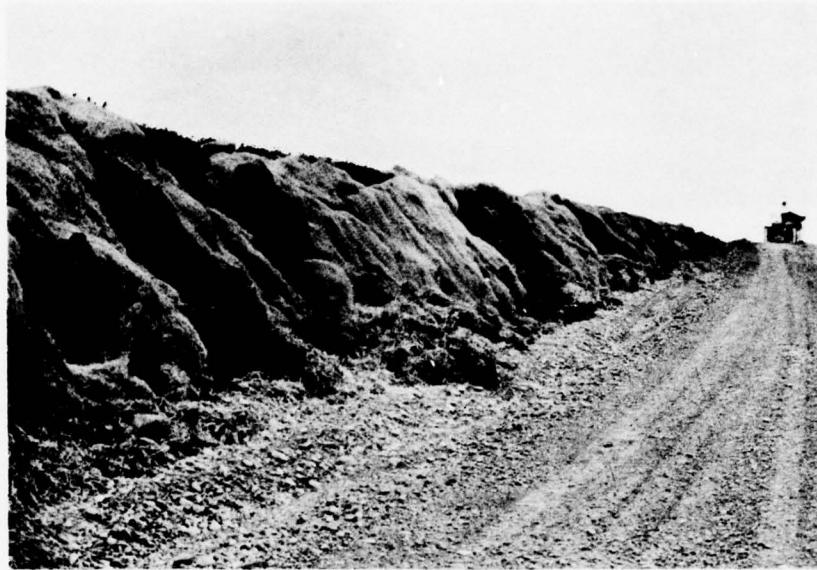
Plate 1. A.S. 131.3: Road cut near Franklin Bluffs airport slumping despite excelsior netting.

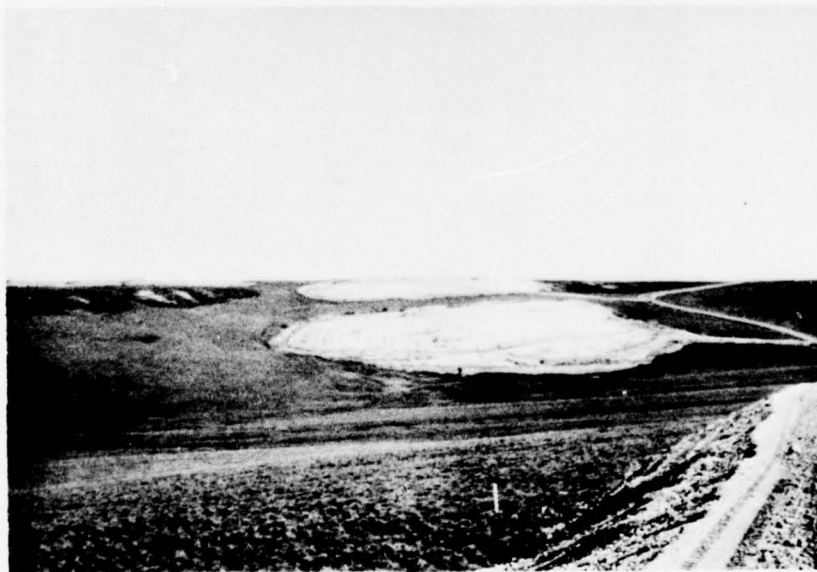
Plate 2. Material sites 127-2.1A and 2.1B: Gravels were hydroseeded but erosion, slumping, development of large cracks, and minimal plant cover persist.

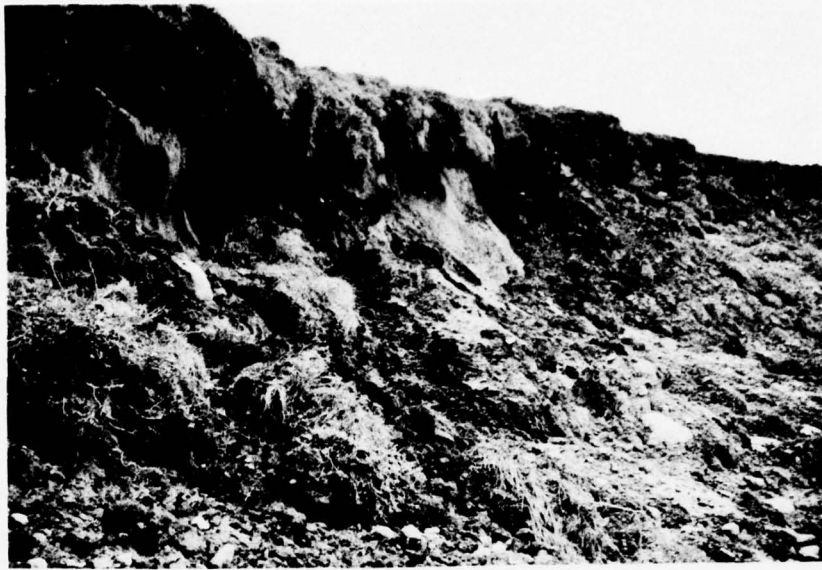
Plate 3. A.S. 122: Happy Valley road cut with ice wedge meltout and slumping.

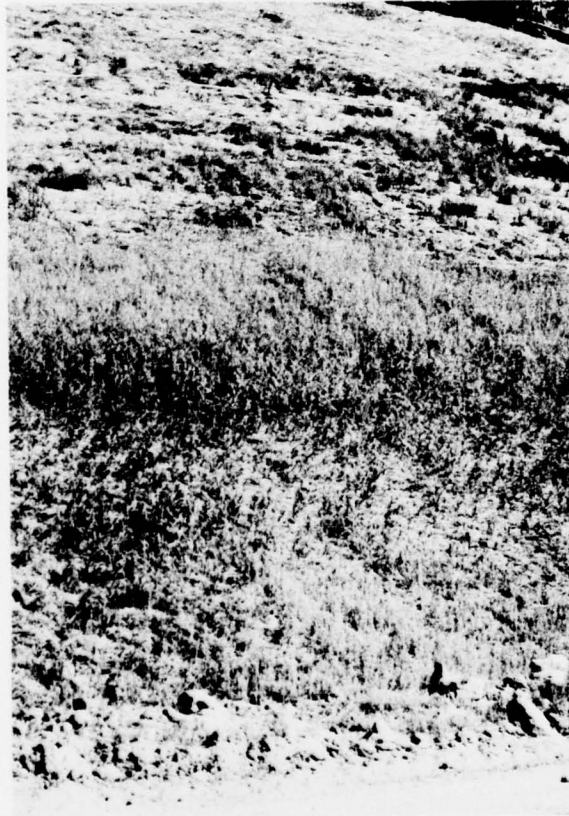
Plate 30. A.S. 48: About 1 mile north of Tanana River, road cuts in ice-rich silt, hydroseeded and hay mulched. Tractor had been run up and down the side slope to produce depressions for holding seed and moisture.

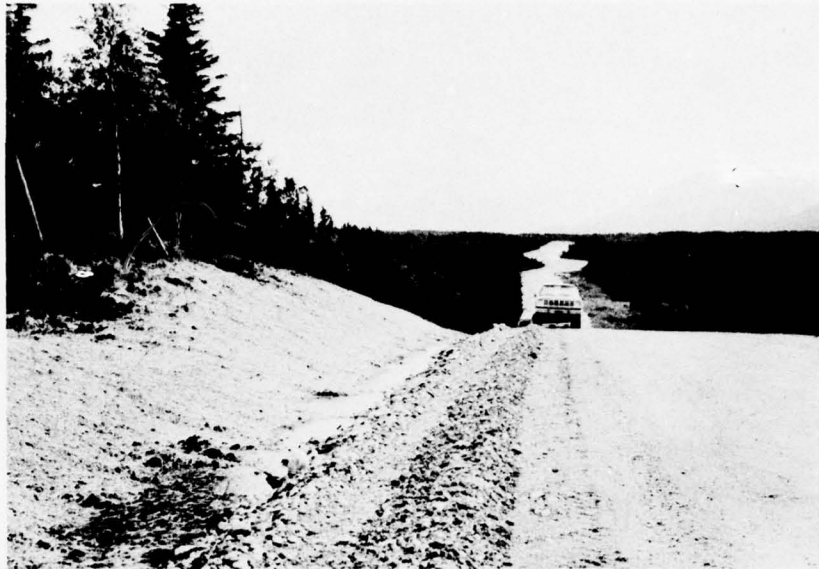
Plate 31. A.S. 42 and 41: Numerous cuts on sides of workpad hydroseeded in alpine area near Donnelly Dome.

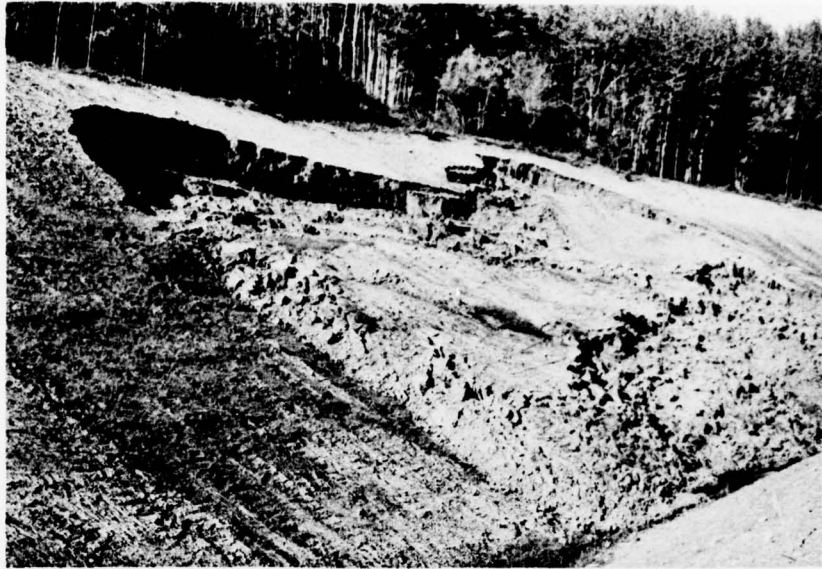
Plate 33. Pump Station 11: Massive deep seated slope failure. Failure began about mid-June after a period of heavy rainfall. Some additional sliding occurred about mid-July. Seeded latter part of June.

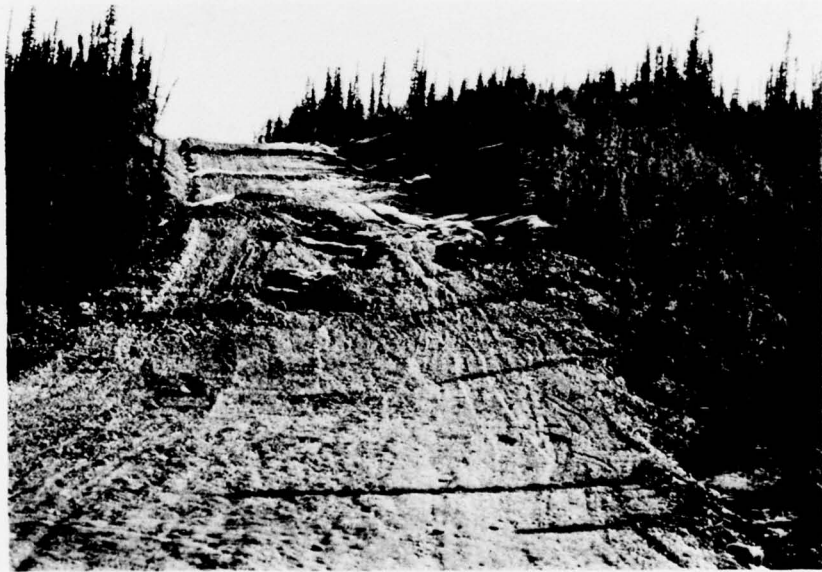
Plate 34. A.S. 18.1: Ice-rich soils exposed and eroding despite gravel overburden and thick hay mulch.
