BOEING VERTOL CO PHILADELPHIA PA

SMALL HARDWARE DESIGN FOR EASE OF MAINTENANCE AND INSPECTION.(U)

USAAMRDL-TR-76-31

March 1977

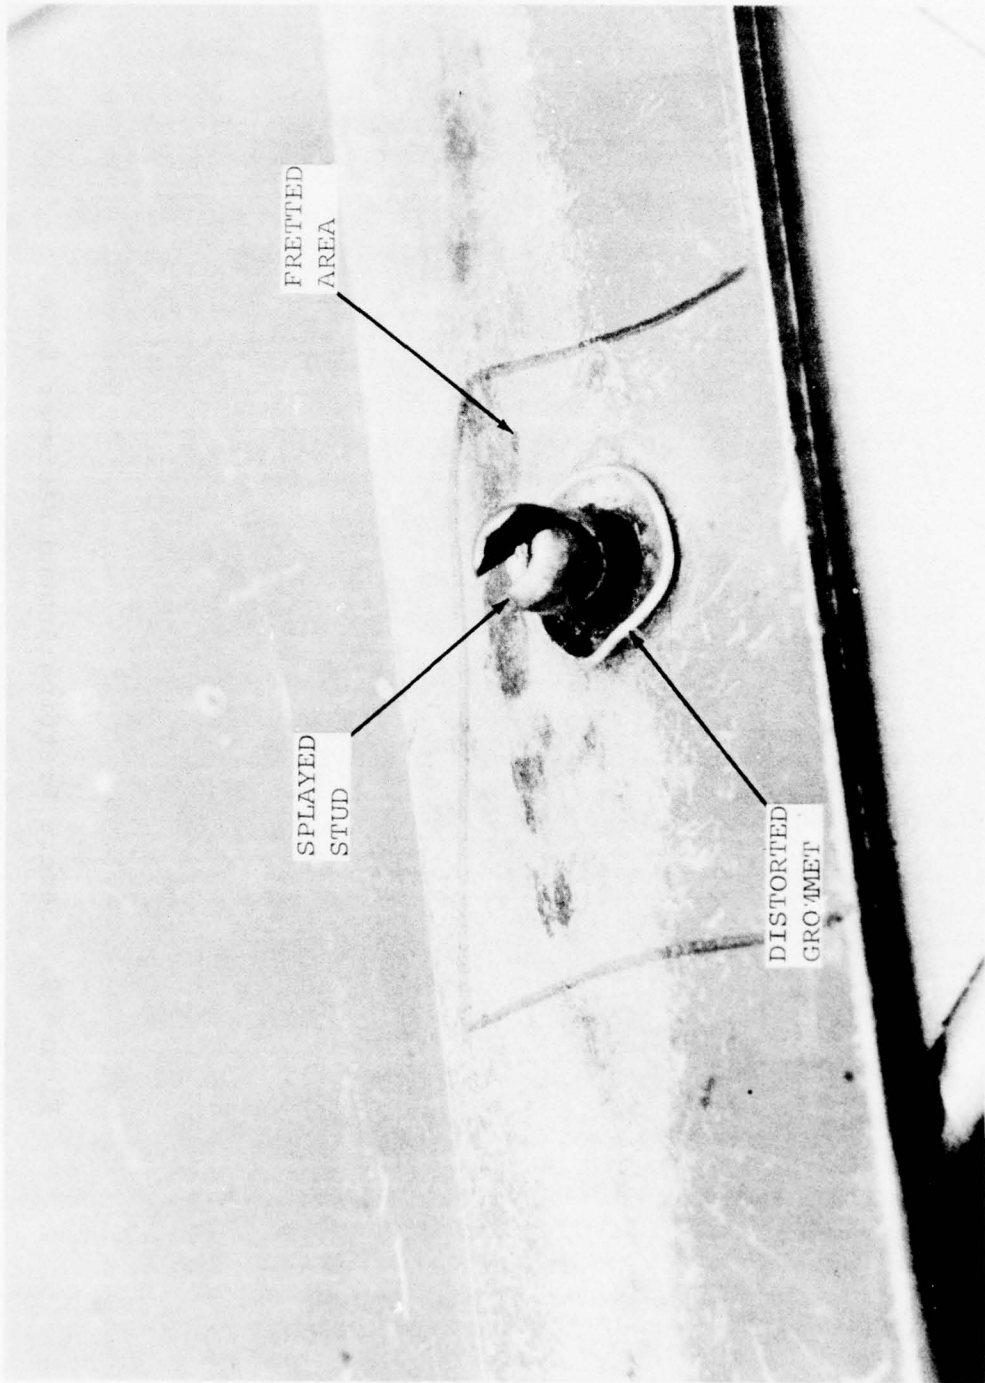
Figure 7. Distorted Stud-Retaining Grommet and Splayed Stud

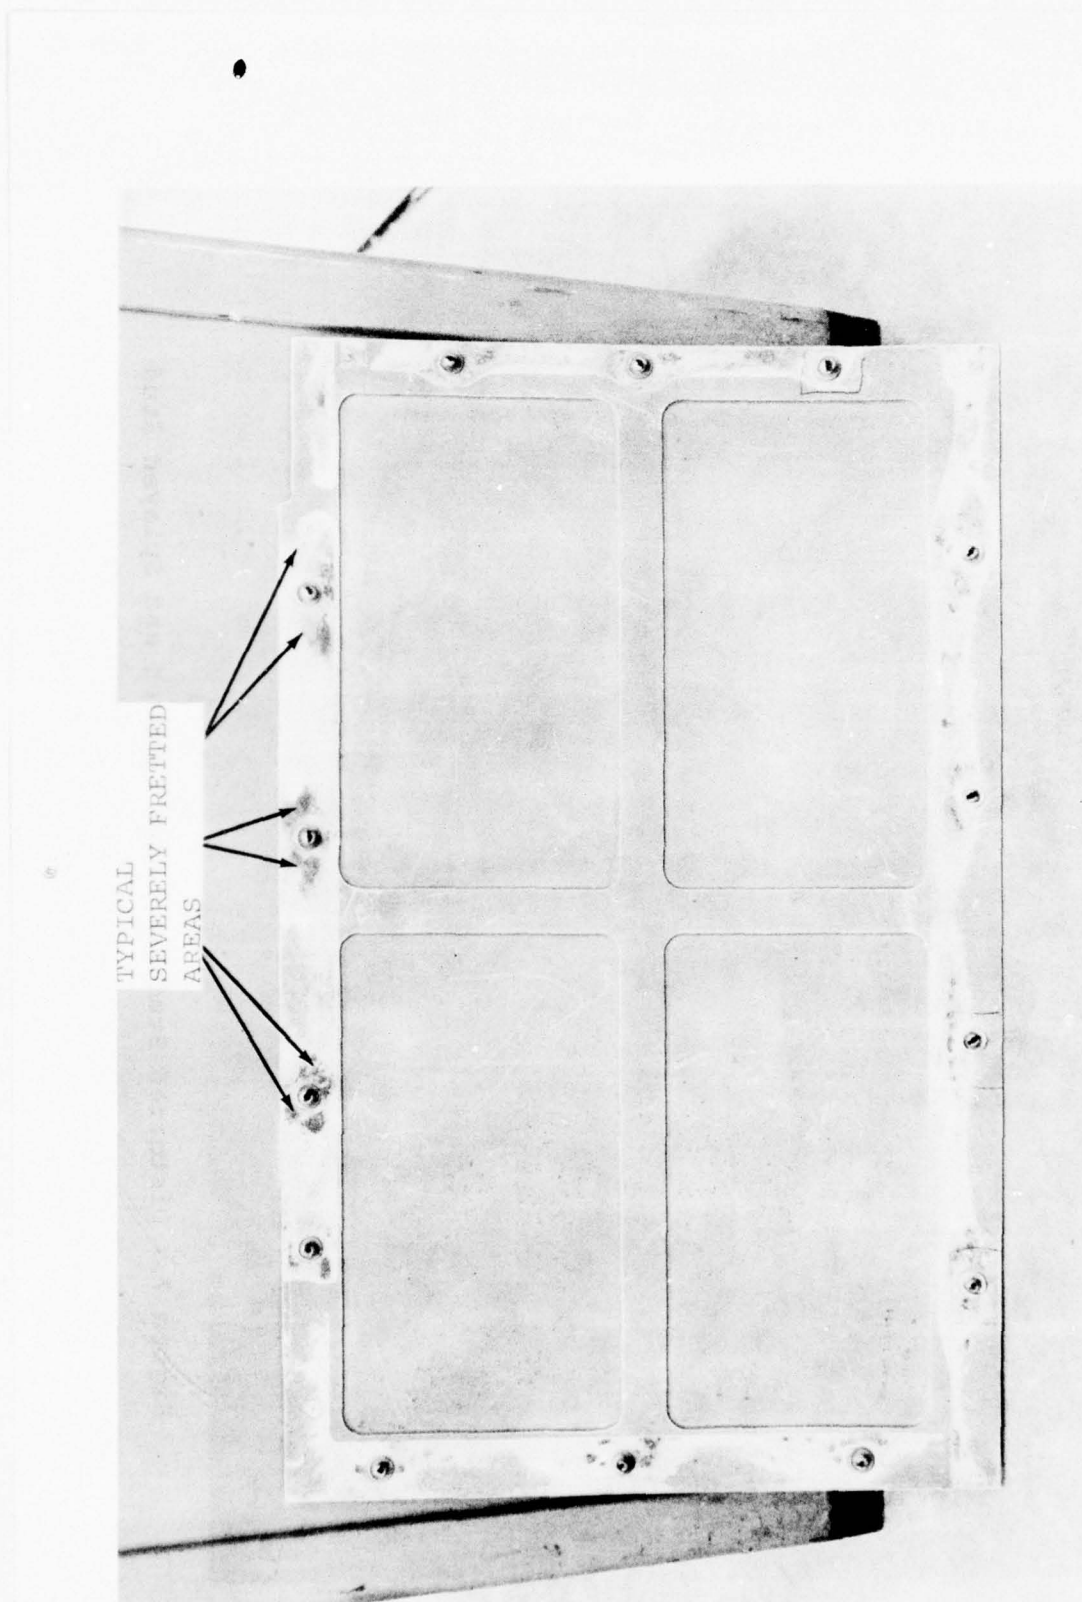
1. Frequency of utilization - daily inspection of flight controls necessitates frequent operation of the fasteners.
2. Vibration - the high vibration environment causes constant cycling of the panel in the panel's surroundings, and severe fretting around the fastener holes frequently occurs as shown in Figure 8.

Figure 8. Severe Fretting Around Fastener Holes

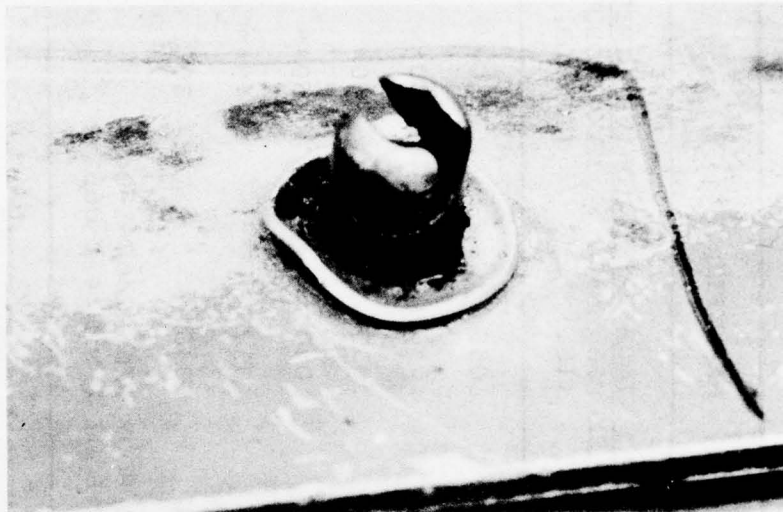
Figure 13. Deformed Dzus Retaining Washer

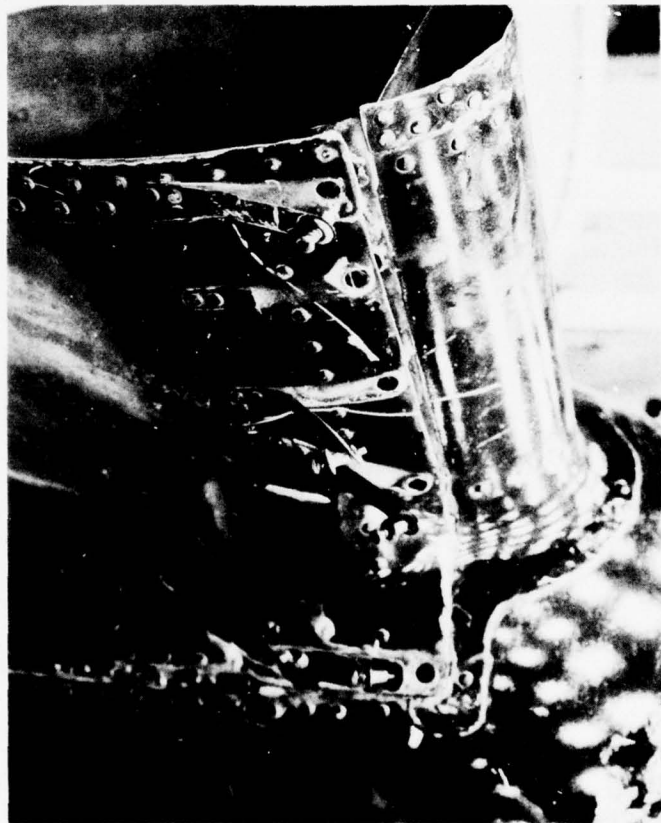
Figure 17. Chafed Fairing Edges From In-Service Vibration

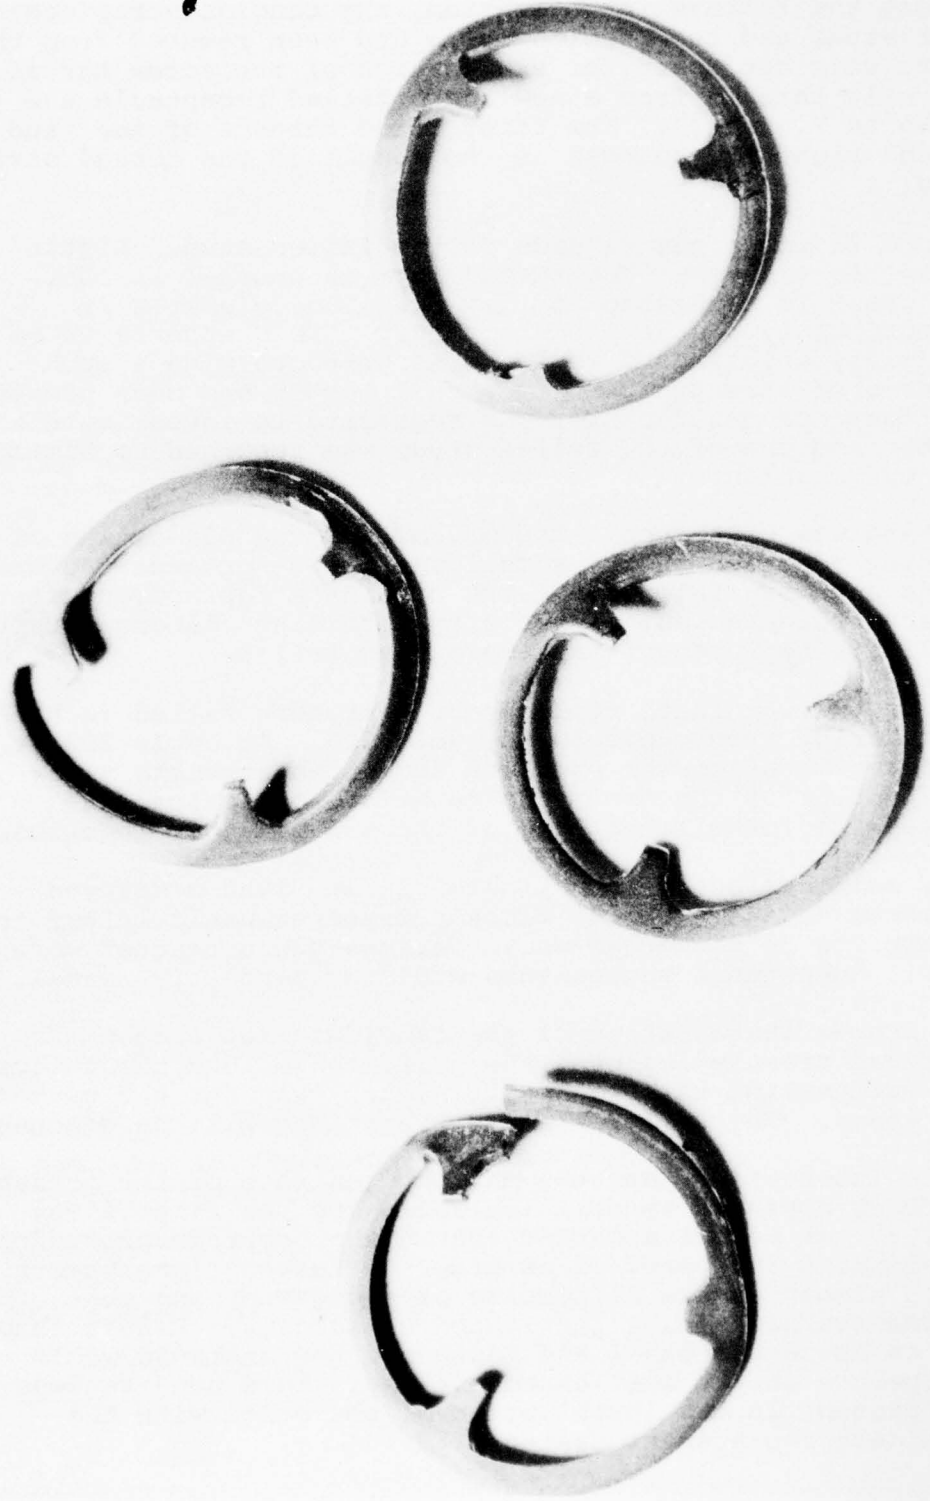
Figure 19. Candidate Replacement Stud Retaining Washer Failure

The reason for the failure of the stud retaining washer for the candidate replacement fastener could not be determined. Two factors appeared to be involved.

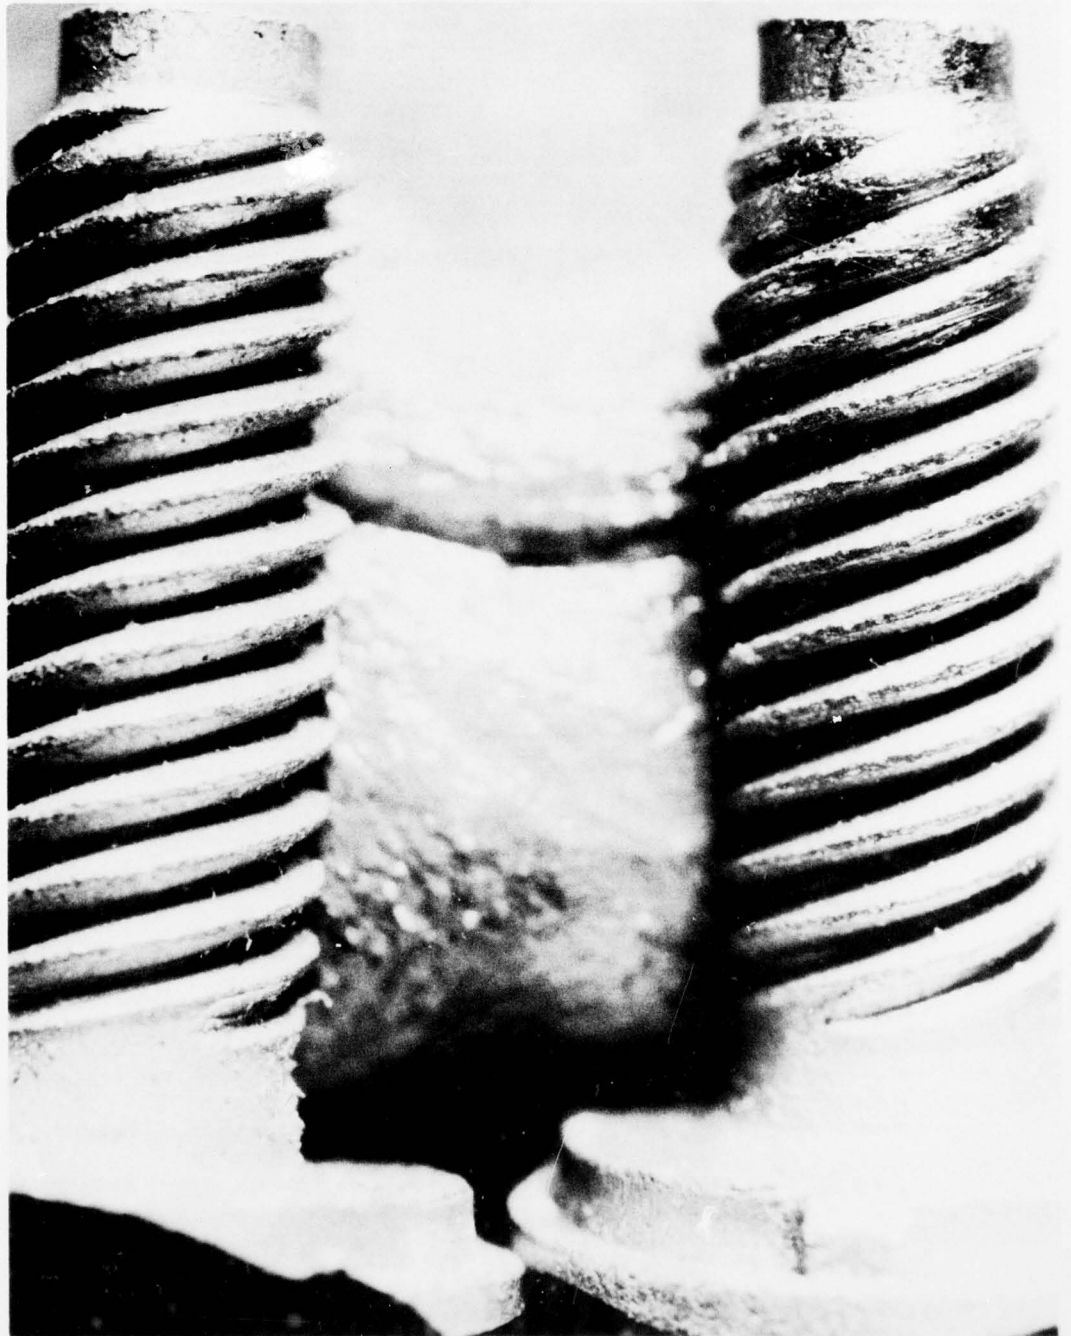
Figure 20. Failed Screw From Receptacle on Right

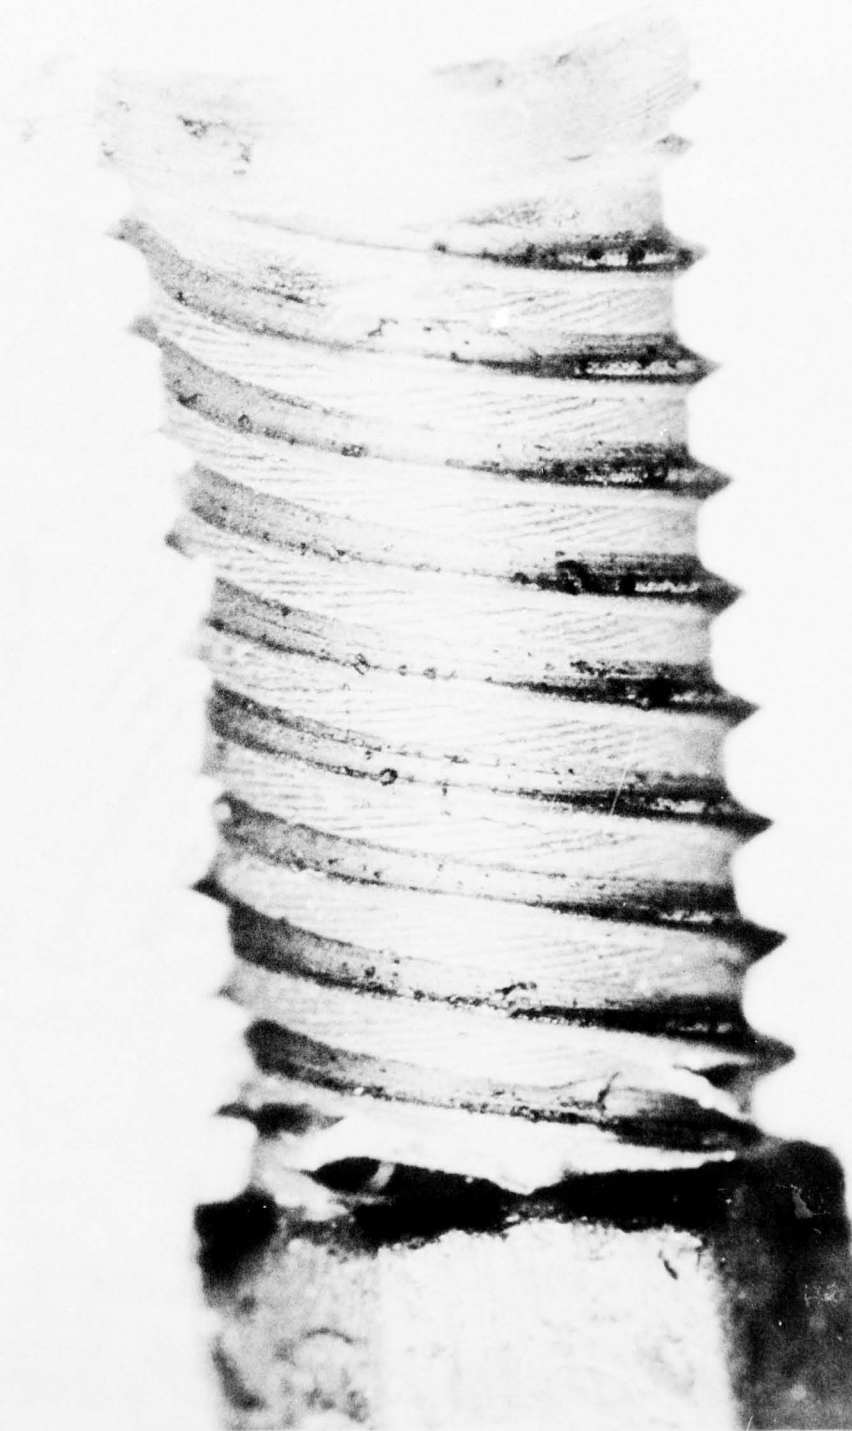
Figure 21. Truncated Thread Form From Failed Stud

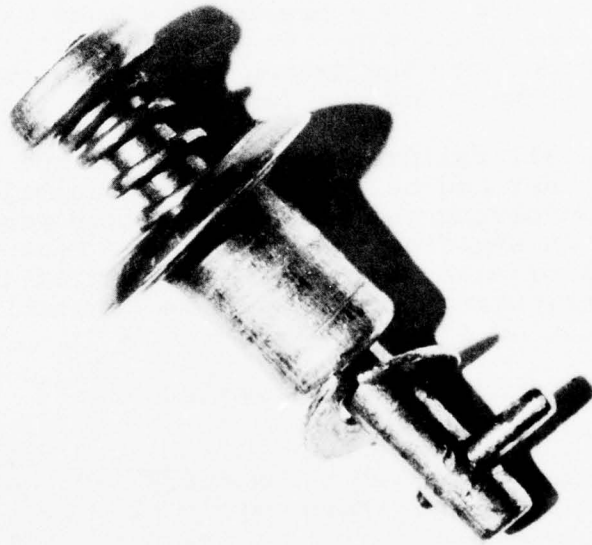
Figure 22. Present appearance of above cross pin caused by the endurance test

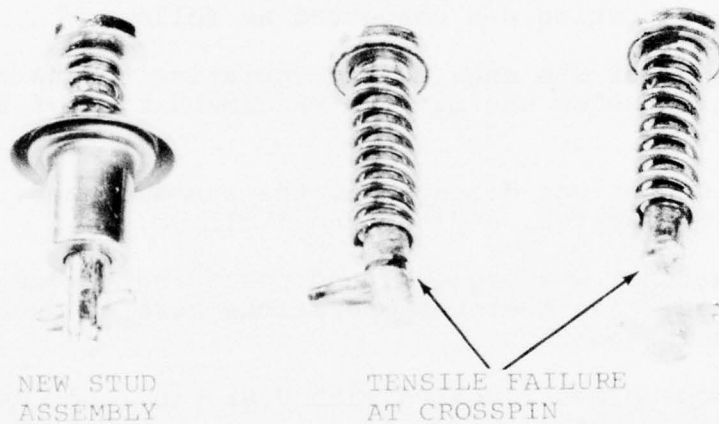
- The present fastener failed at grip lengths ranging from 0.026 to 0.039 in. above the manufacturer's recommended maximum. Maximum torques at failure ranged from 35 to 50 in.-lb. Three of the studs broke at the cross-pin attachment (Figure 25). The other three failed by the cam-out of the screwdriver slot in the head.

Figure 25. Failed Stud at Cross Pin

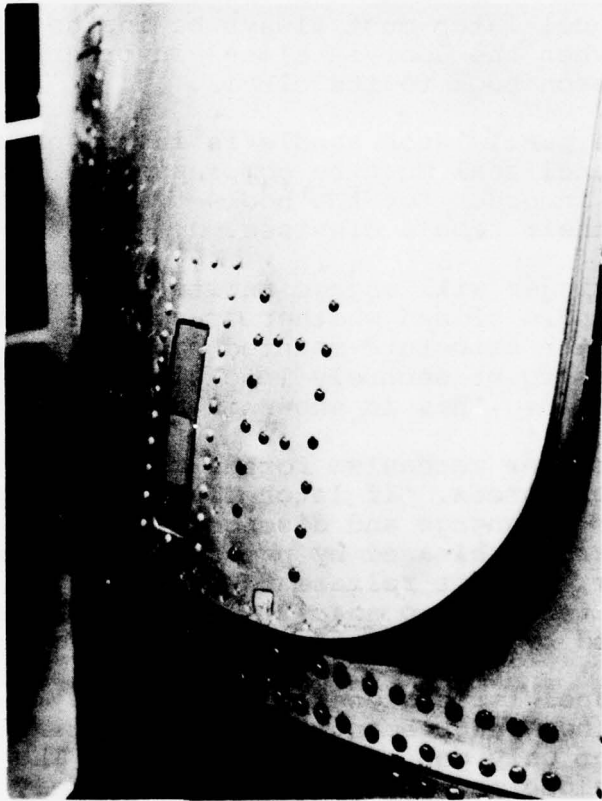
The panel hinging arrangement is very flexible laterally. This results in the situation where the panel is closed and the retention hooks entirely miss the cross pin, resulting in the situation described above.

Figure 36. Present Latch Handle is Latched but Door is Open

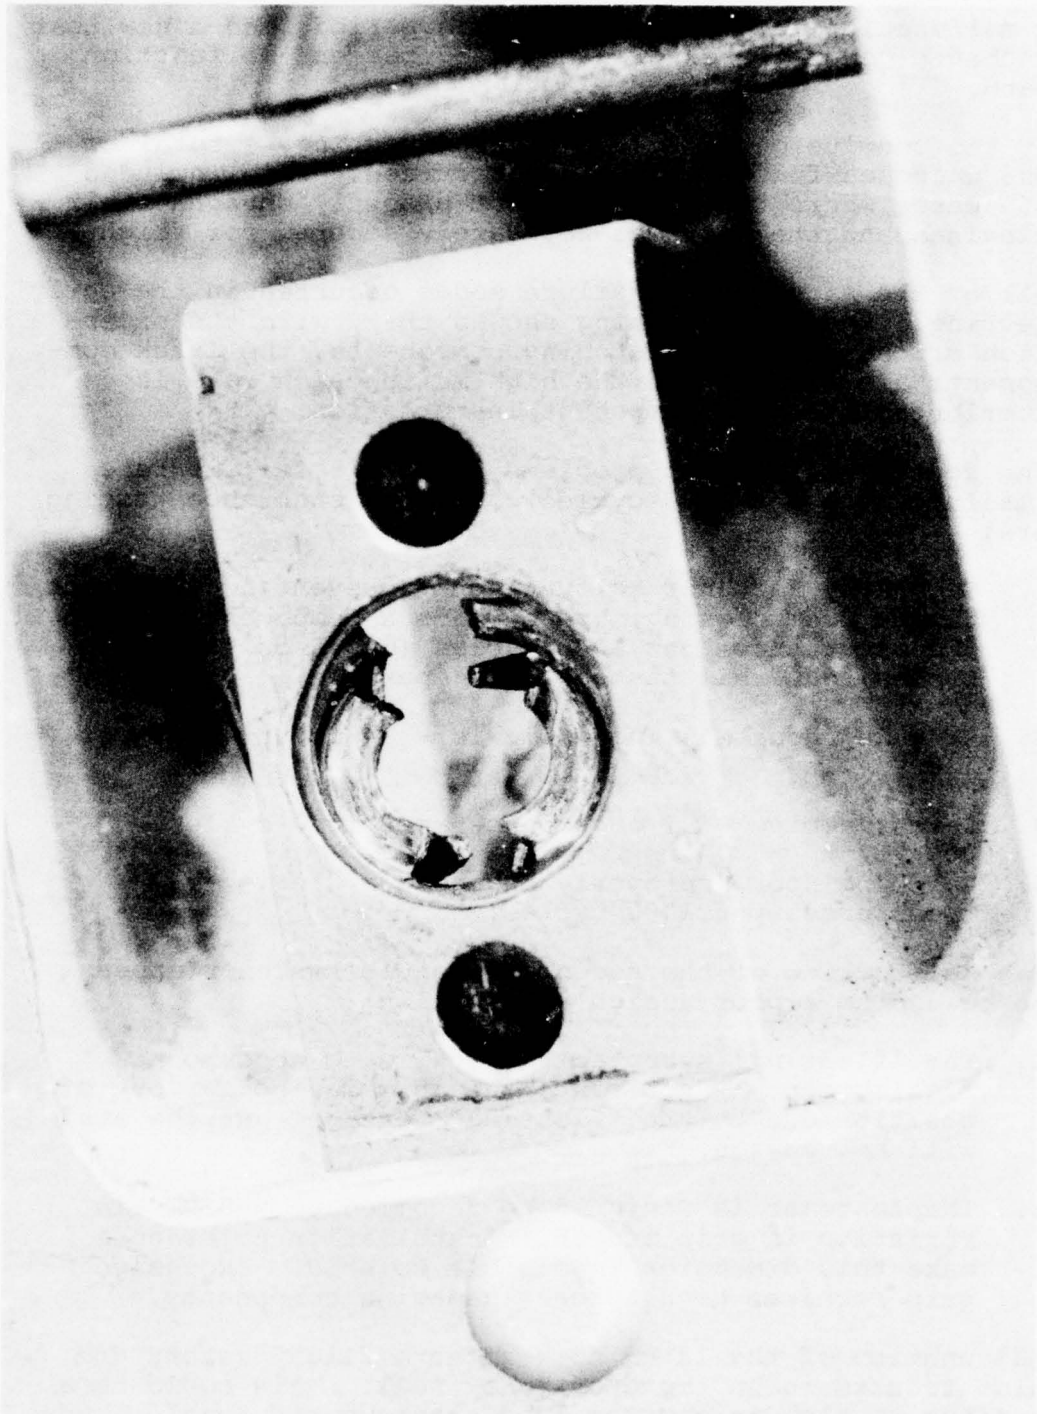
Figure 38. The Failure of the Receptacle of a Secondary Handle Lock

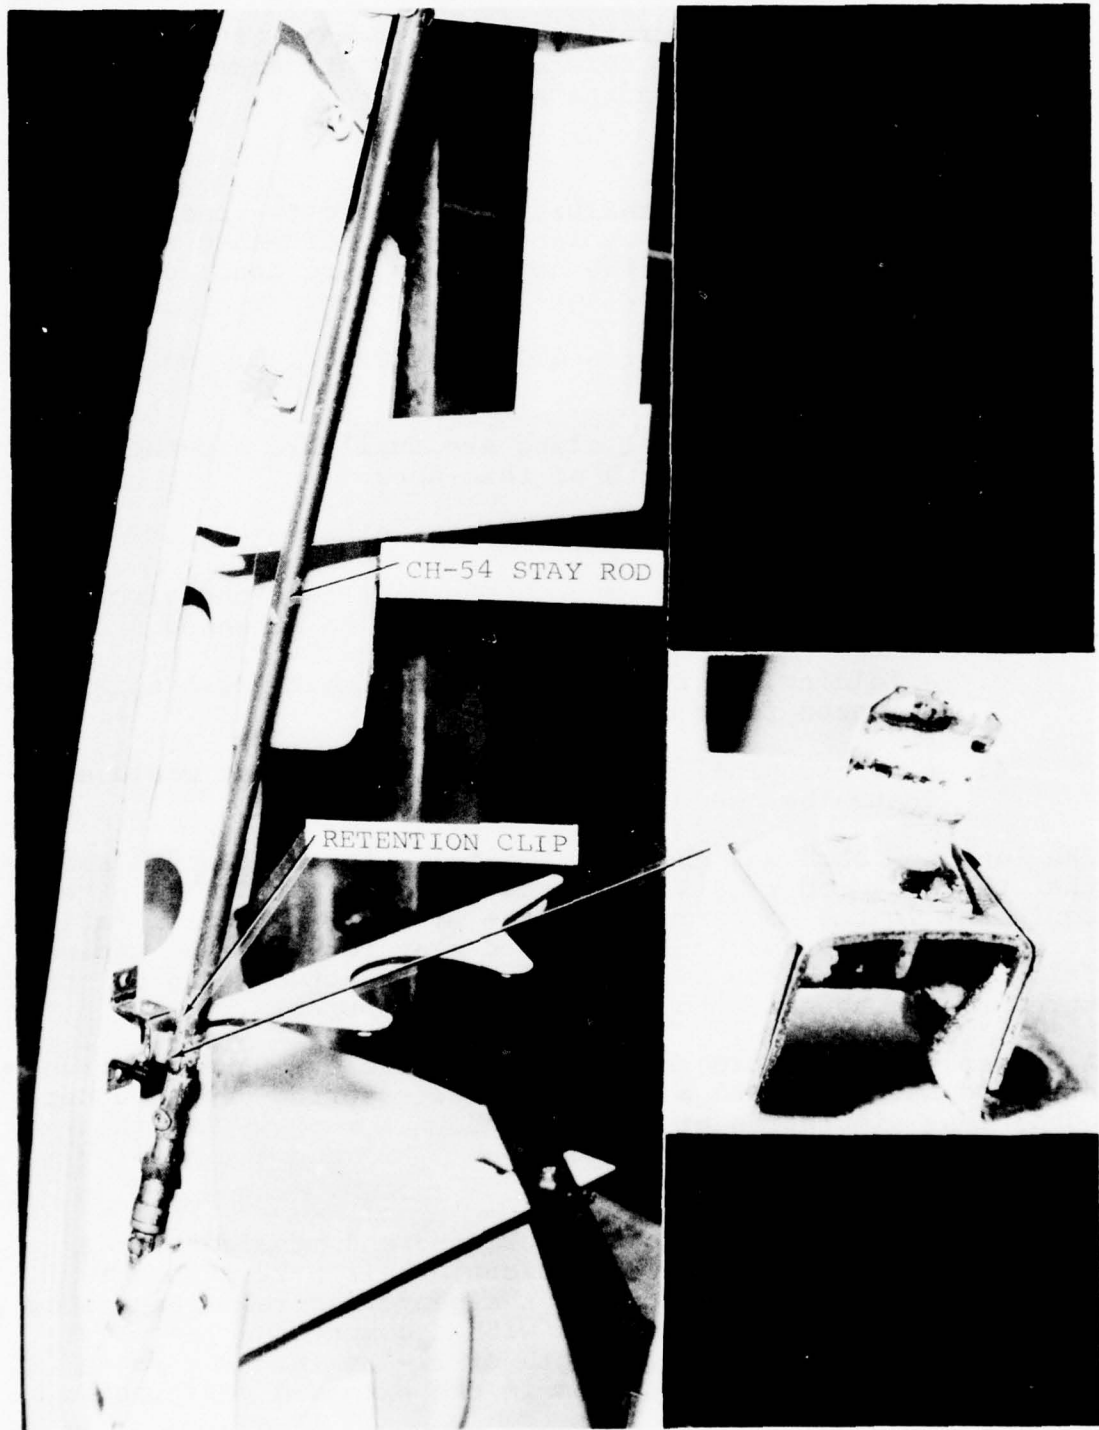
Figure 41. Test Installation--CH-54 Stay Rod, Retention Clip, and Typical Failed Clip

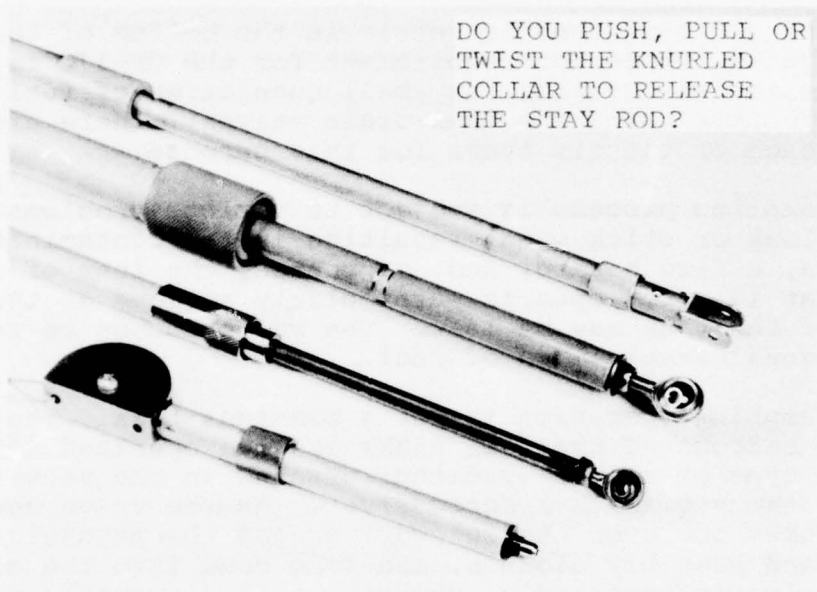
Figure 44. Stowable Stay Rods Whose Operating Procedures Are Vague

However, all factors considered, it appears that for most installations of Army helicopters the alternative design approach tested herein or a similar type of self-stowing device should be specified for new production aircraft.

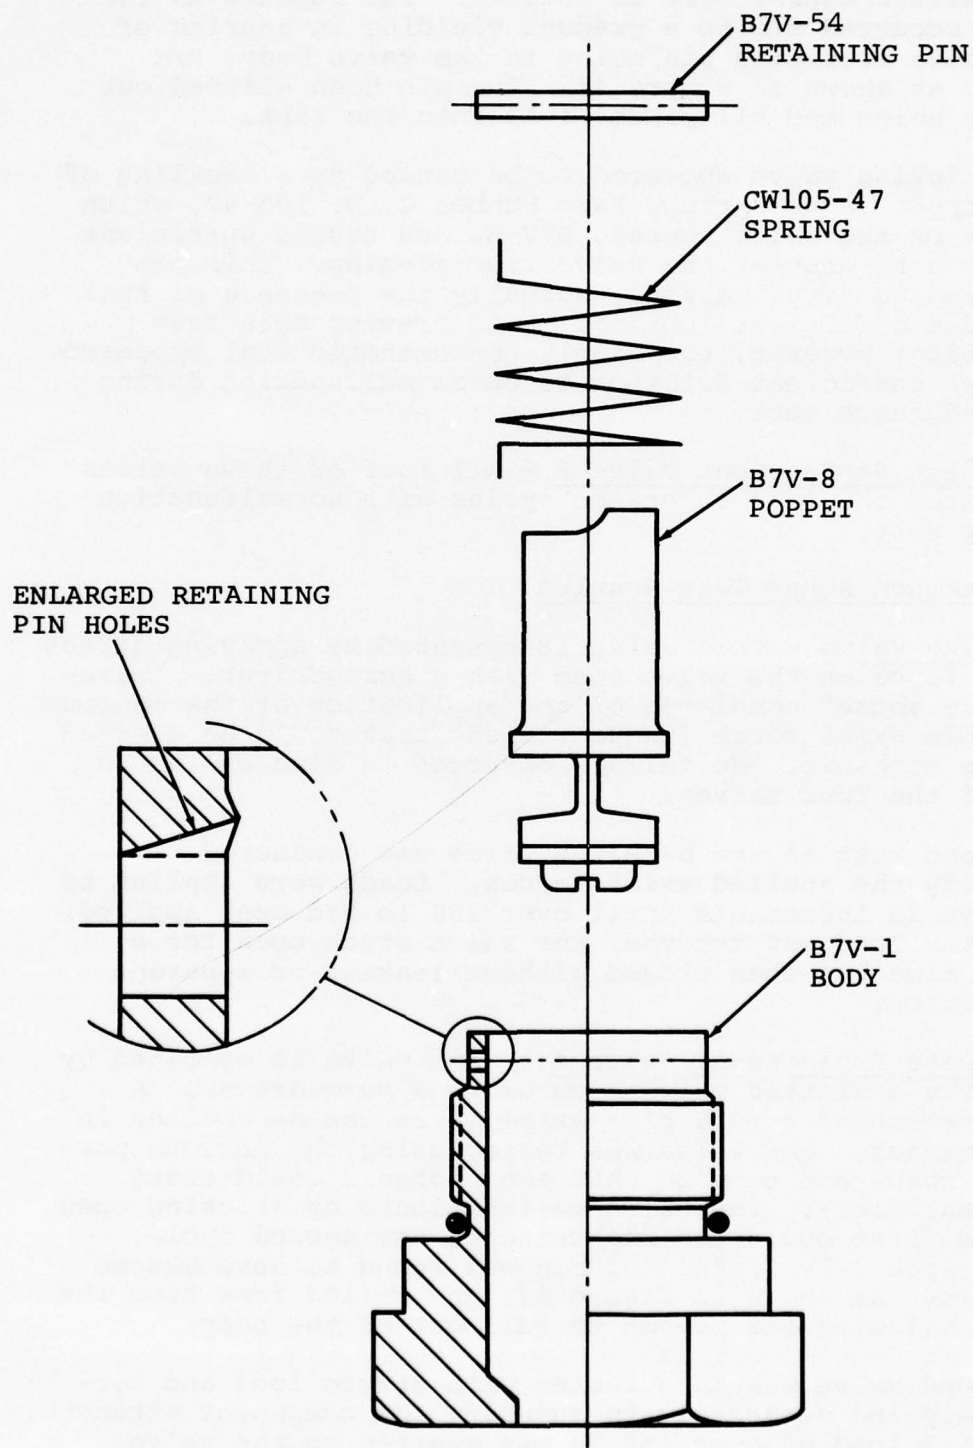
Figure 46. Endurance Test Failure of Candidate Replacement Valve 1 due to the Loss of the Retaining Pin

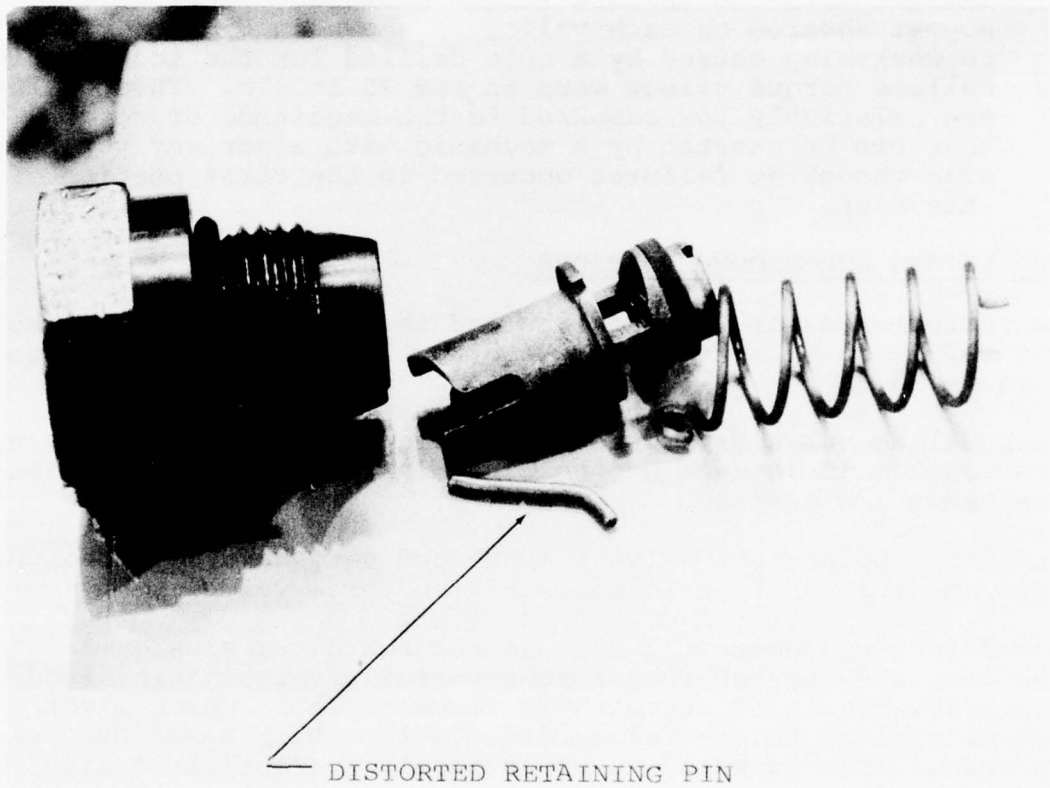
Figure 47. Candidate Replacement Valve 1--Failure in Maintenance Abuse Test

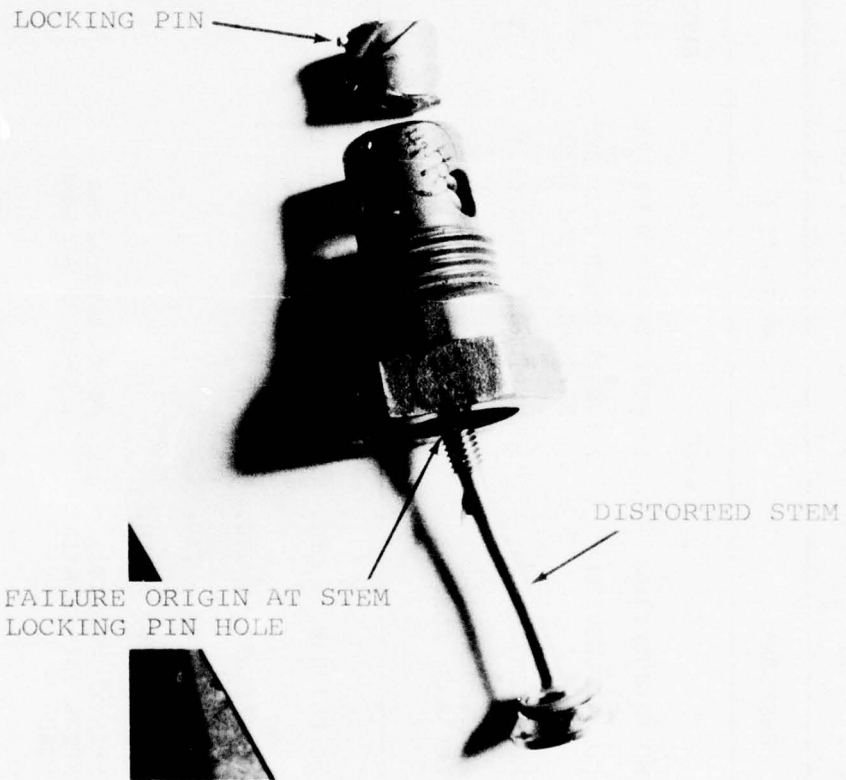
Figure 48. Candidate Replacement Valve 2--Failure During Maintenance Abuse Test

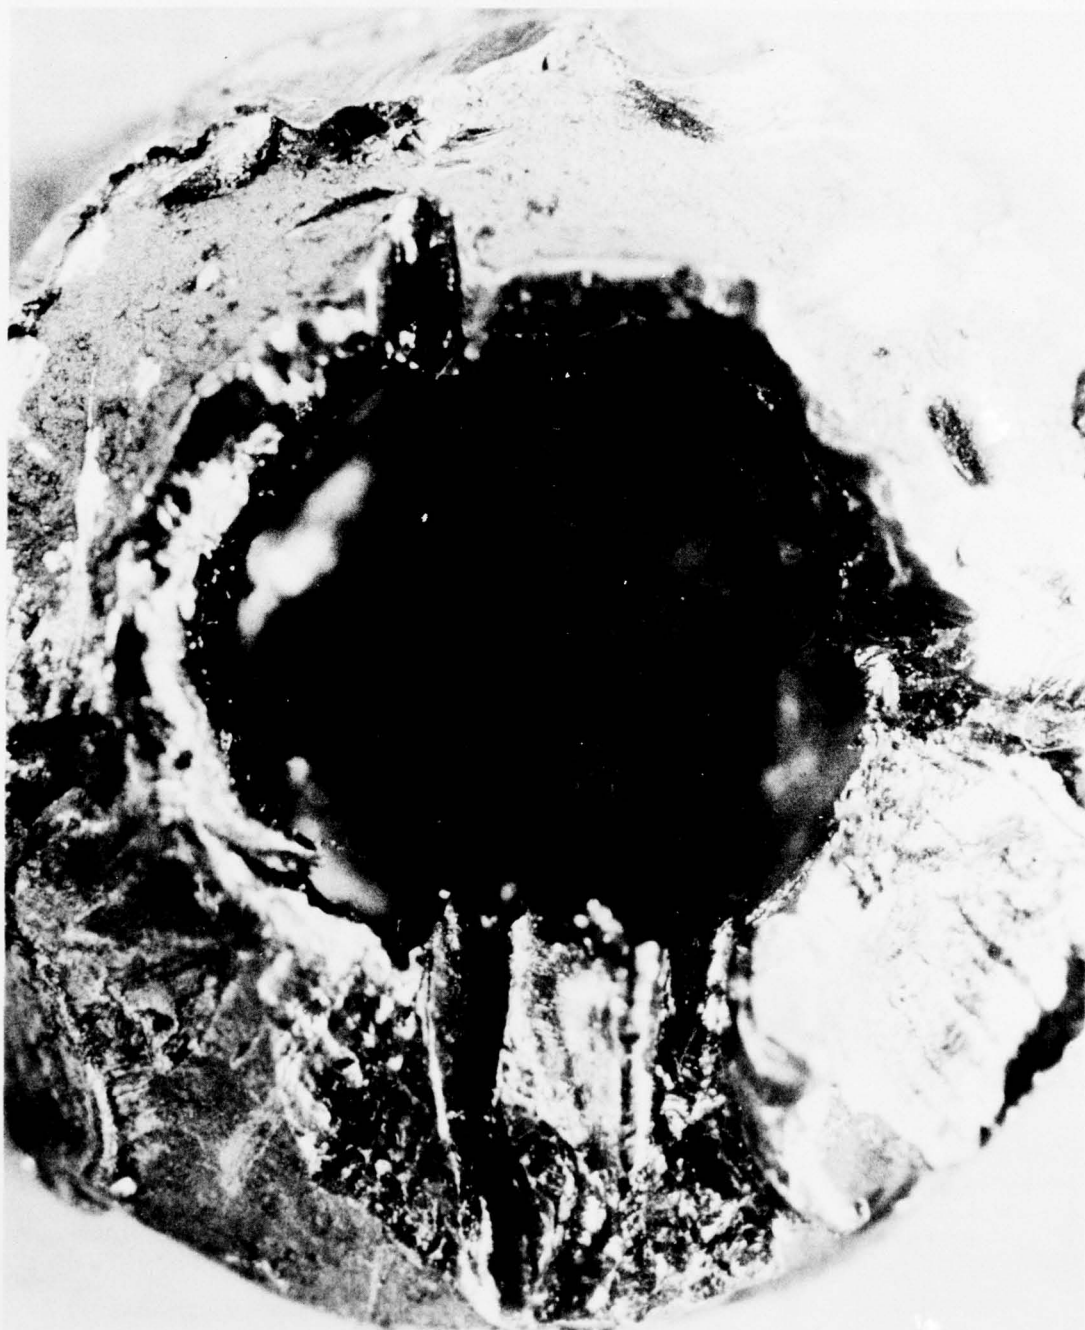
Figure B-6. Problems With Screw Removal After Recess Failure

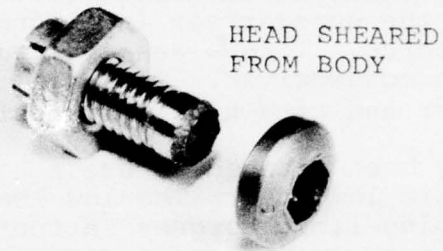
Figure B-8. Allen Head Tension Failure

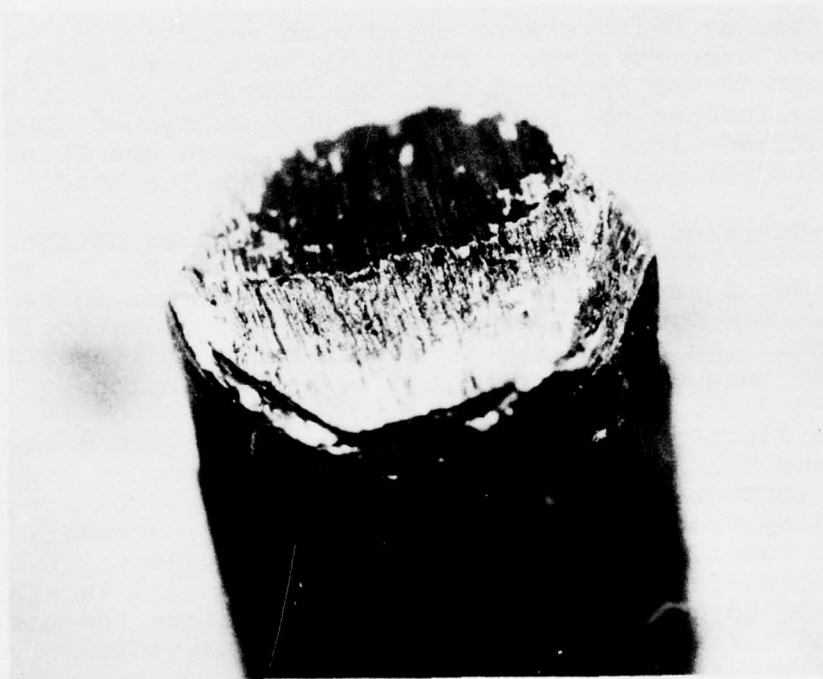
Figure B-10. Worn Allen Key
