TECHNICAL REPORT M-207  
March 1977

COATINGS AND CATHODIC PROTECTION OF PILINGS IN SEAWATER:  
RESULTS OF 5-YEAR EXPOSURE

| REPORT DOCUMENTATION PAGE | | READ INSTRUCTIONS<br>BEFORE COMPLETING FORM | |
|---|--|---|--|
| 20. ABSTRACT (Continue on reverse side if necessary and identify by block number)<br>This report presents the results of the inspection of test pilings extracted after 5 years of exposure to seawater at LaCosta Island, FL. The effectiveness of various coating systems and sacrificial anodes in preventing corrosion of H- and steel pipe pilings in seawater is assessed. Six of the coating systems were found to perform excellently, as was a coating/cathodic protection combination. Sacrificial anodes of zinc and aluminum were also found to effectively reduce corrosion in the immersed zone. → over | | | |

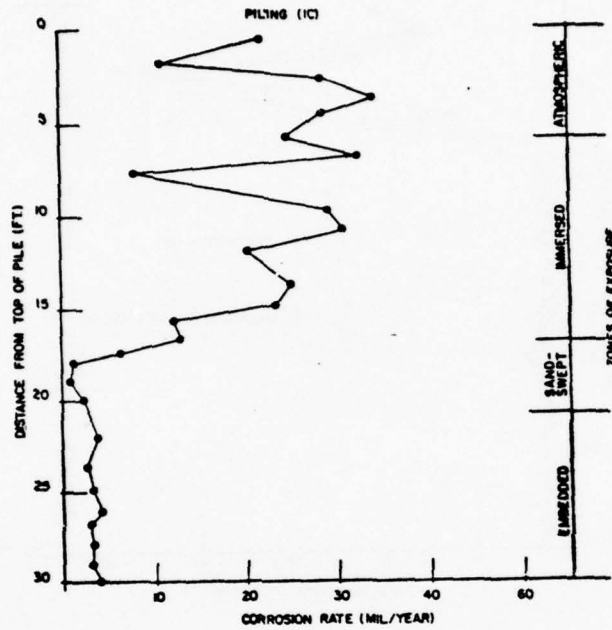
The bare piles (both unprotected and protected) were rated to obtain a surface factor to be used in the structural analysis (Table 4). As the table indicates, only the mariner steel with zinc anodes provided better than a poor surface. The other bare piles were corroded severely in the atmospheric zone, with less corrosion in the immersed zone. Corrosion was minimal and no evidence of pitting was present on the cathodically protected piles. Because the anodes protect against corrosion only in the immersed section of the piles (the salt water acts as a medium for electron exchange), the air-exposed portion (atmospheric zone) is free to corrode. This is the zone where significant corrosion occurred. The bare mariner steel provided somewhat better protection than the bare carbon steel, which was severely pitted and contained holes in the web.

Figure 15. Corrosion profile of bare carbon steel. SI conversion factors: 1 ft = 0.3048 m; 1 mil = 0.0254 mm.

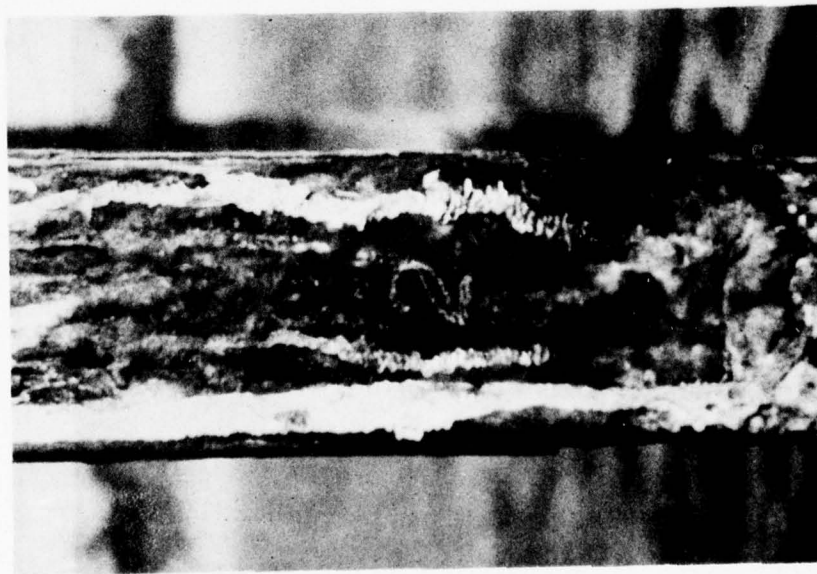
**Figure A2.** Atmospheric zone of bare carbon steel with zinc anodes. Absence of protection against corrosion in the atmospheric zone is evident.

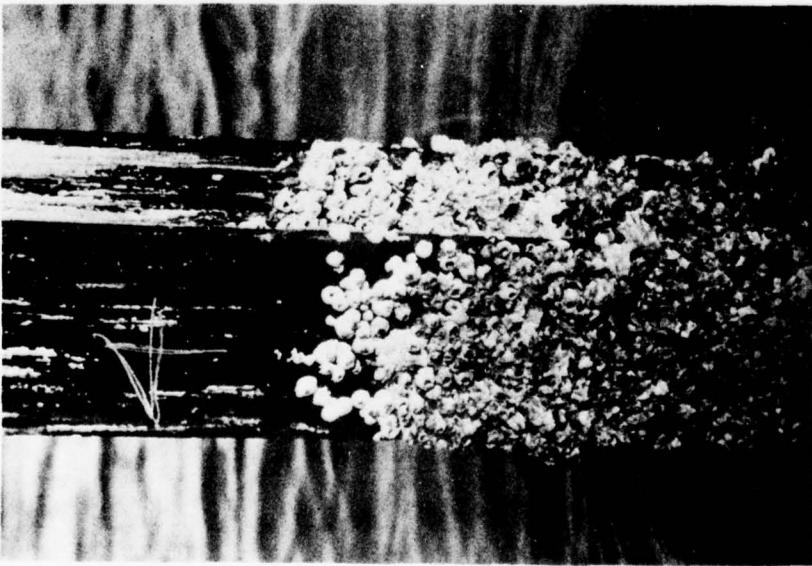
Most of the damage to the coal-tar epoxy coatings occurred in the immersed zone due to attack by marine organisms (especially barnacles). The coal-tar coatings held up very well in the sand-swept zone, where marine organisms could not attach themselves to the pile due to the abrasiveness of the sand-sea water slurry. This abrasion was not great enough to cause significant damage to the coatings, and no erosion-corrosion was noted.

**Figure A4.** Coal-tar epoxy (C-200) on carbon steel. Photograph of upper immersed and lower atmospheric zones indicates the degree of marine fouling. Some damage to the flanges is also evident.

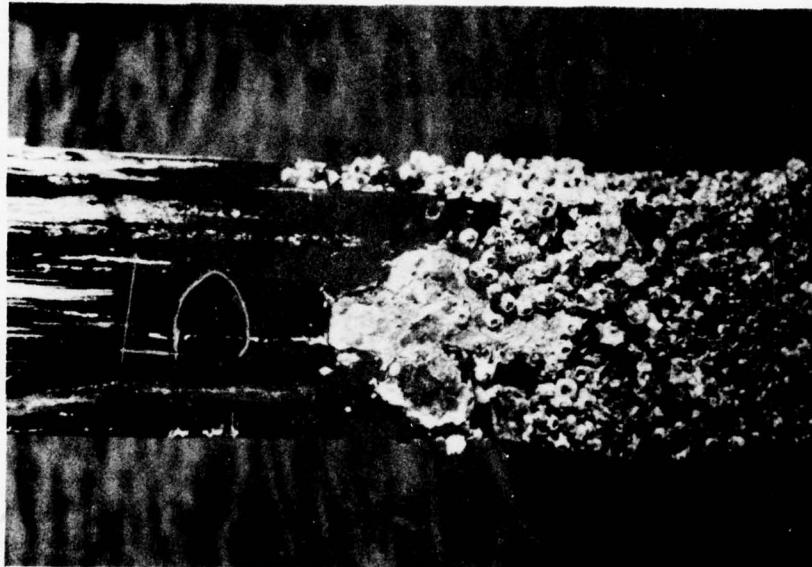
**Figure A5.** Coal-tar epoxy (C-200) with zinc anodes. Marine fouling is evident in the upper immersed zone, and some damage is present on the face of the pile in the atmospheric zone.

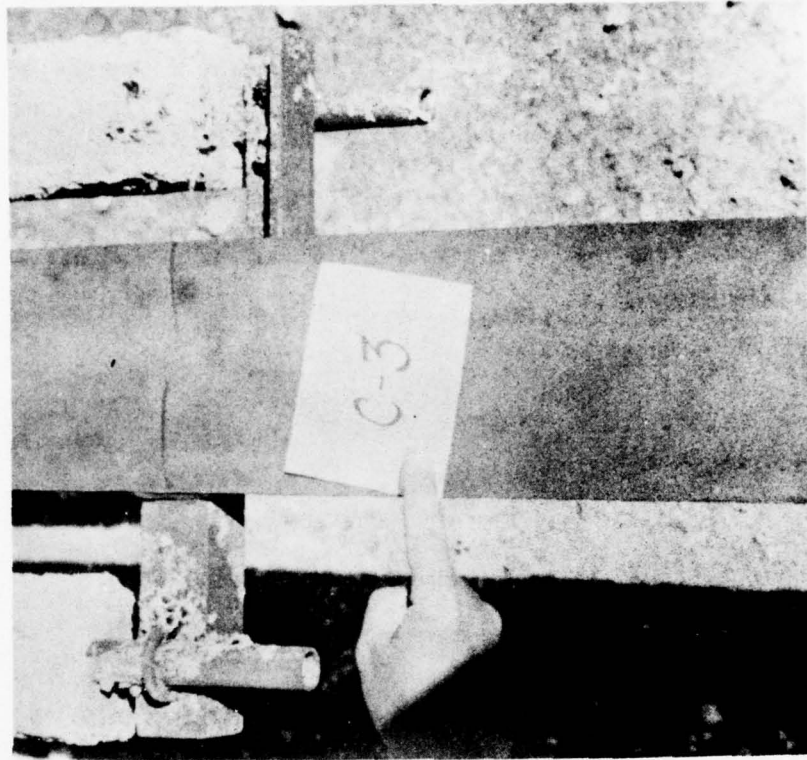
**Figure A7.** Bare carbon steel with aluminum anodes after 5-year removal. Protection afforded by sacrificial anodes is evidenced by lack of damage to immersed zone.

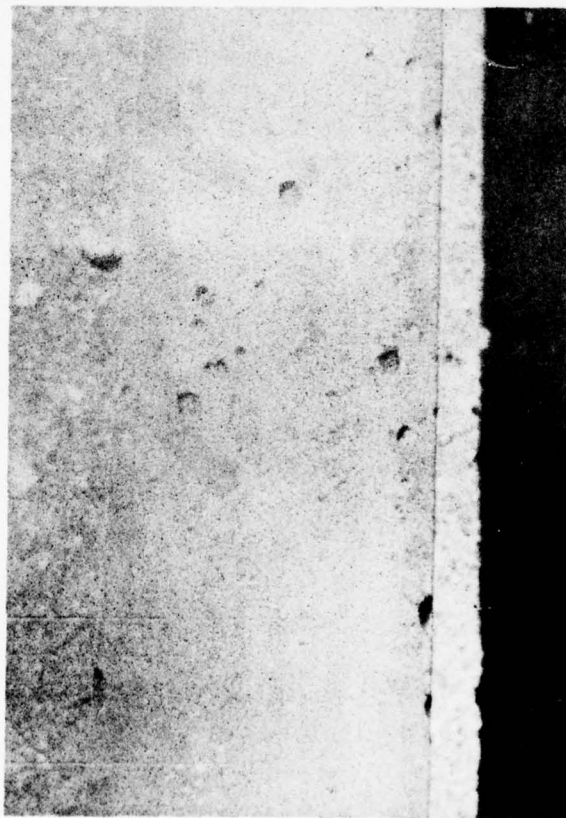
Only system 8, an aluminum-pigmented epoxy-tar, was classified as metal-filled. This coating held up excellently in the atmospheric and sand-swept zones, but suffered severe rusting, staining, and pitting in the immersed zone. Upon coating removal, the surface throughout the immersed zone was found to contain a large number of deep pits, as evidenced by the surface factor rating of 3.

Figure A9. Aluminum-pigmented epoxy tar after sandblasting. Pitting is evidence of damage in the immersed zone.

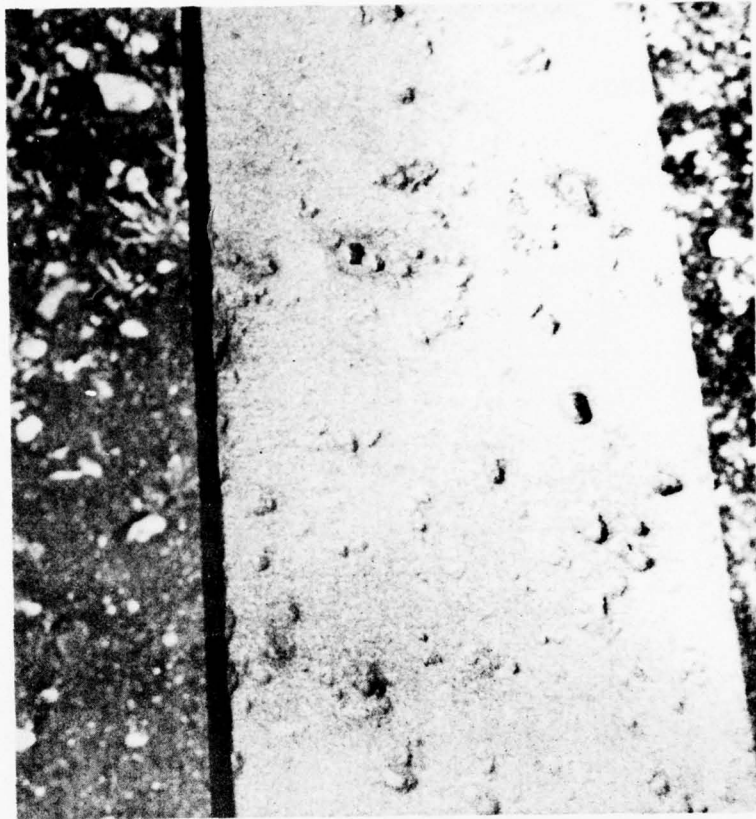
The last two systems in this classification gave poor performances in the immersed and sand-swept zones. System 21 (epoxy-tar over zinc-rich primer) performed very well in the atmospheric zone, resulting in good visual ratings during annual inspections; however, removal of the pile revealed extensive damage to the coating and pile surface. The immersed and sand-swept zones were severely pitted on all faces and flanges. The vinyl mastic over zinc-rich primer (system 22) provided only fair protection in the atmospheric zone, while the immersed and sand-swept zones received considerable damage. On coating removal, these two zones showed some surface damage in the form of a series of shallow interconnected pits on the faces and isolated pits on the edges of the flanges.

**Figure A10.** Epoxy-tar over zinc-rich primer after sandblasting. Severe pitting in the immersed zone is indication of structural degradation caused by corrosion.

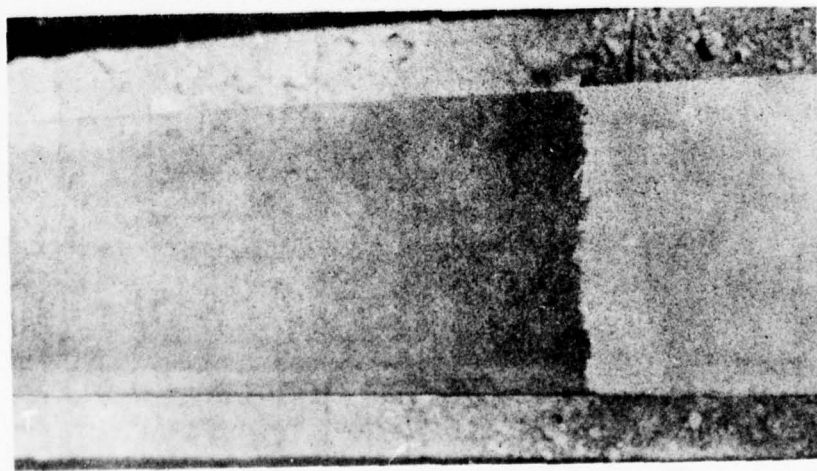
The polyester glassflake coating (system 29) gave the best results of any coating in the entire study, with an excellent visual rating in all three evaluated zones and an excellent surface factor. The marine fouling was removed very easily, and no significant damage was present.

**Figure A11.** Polyester glassflake. Coating and steel after coating removal are in excellent condition in all zones.

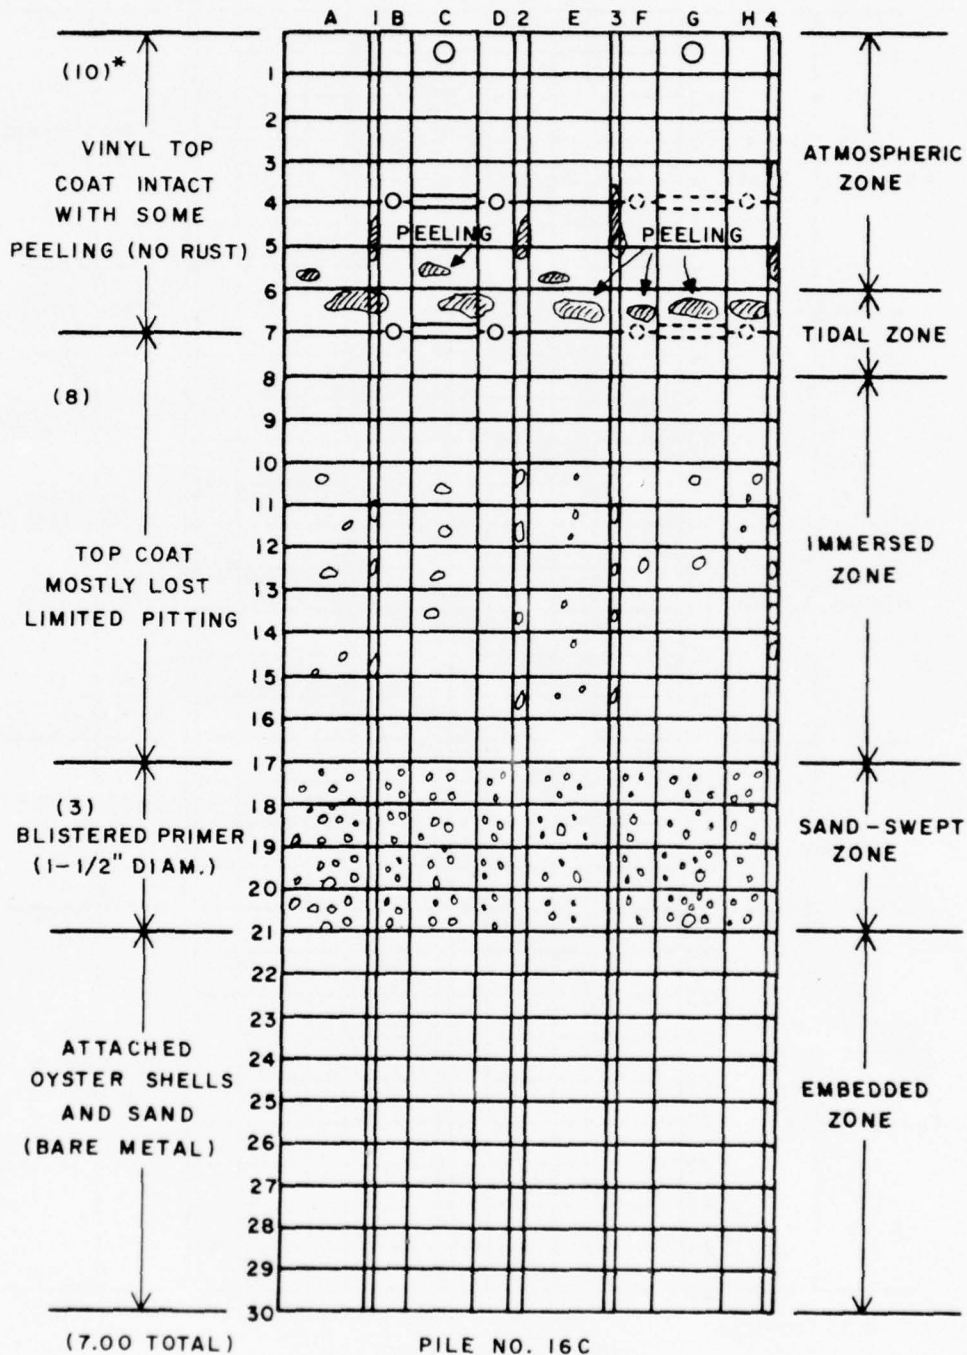
PILE NO. 16C  
 FLAME-SPRAYED ZINC WITH NAVY VINYL TOPCOAT  
 \*TOPCOAT HAD PEELED BUT NO RUST WAS PRESENT

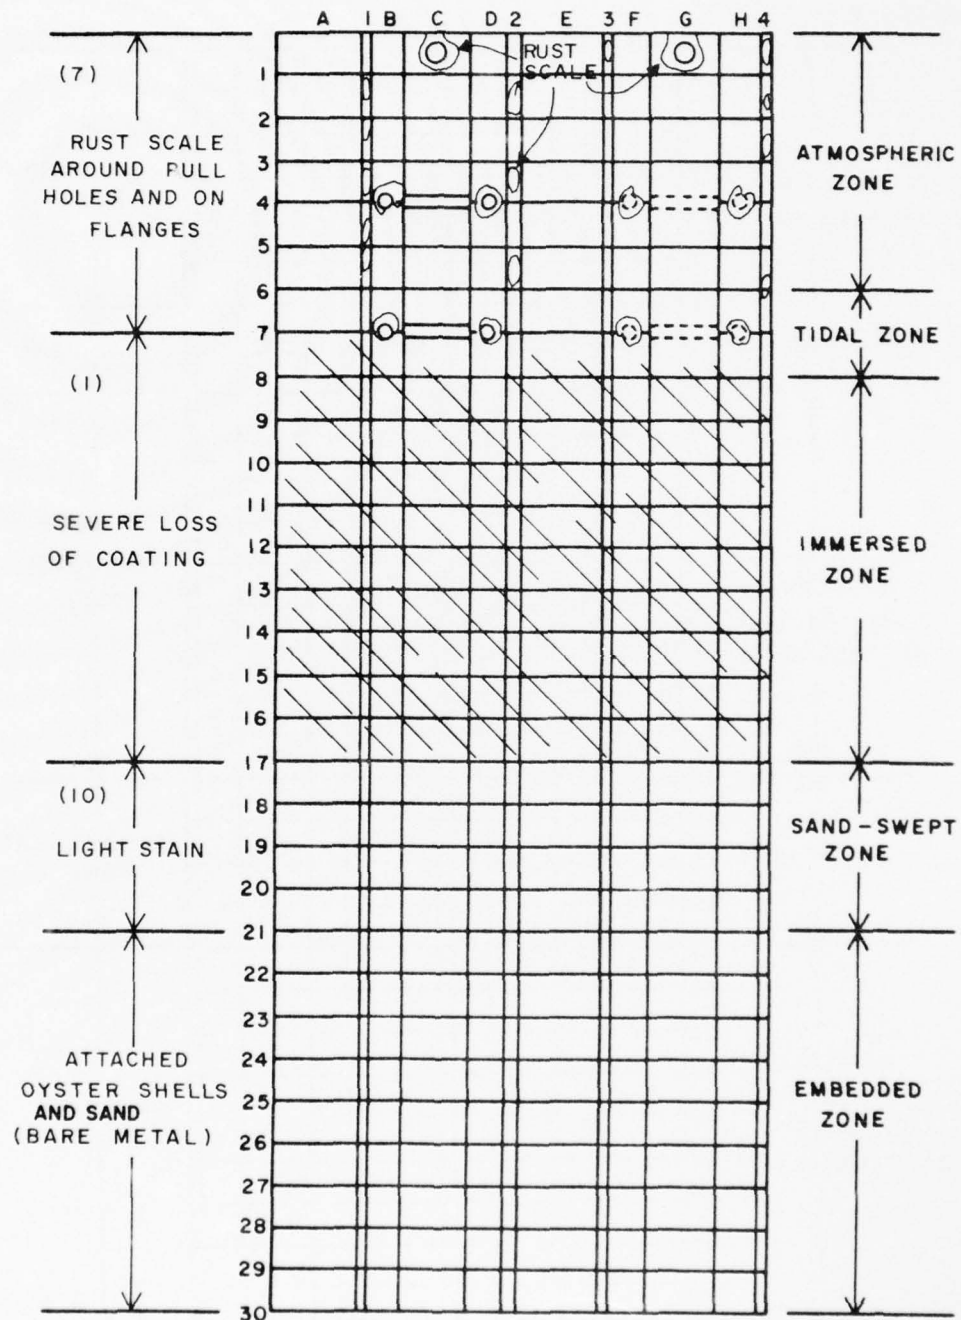
PILE NO. 19C

(7)  
 ↑  
 RUST SCALE  
 AROUND FULL  
 HOLES AND ON  
 FLANGES

(1)  
 ↓  
 SEVERE LOSS  
 OF COATING
