USAAMRDL-TR-73-98F

**3000-HP ROLLER GEAR TRANSMISSION DEVELOPMENT PROGRAM  
Volume VI - Reliability and Maintainability Report**

Sikorsky Aircraft  
Division of United Technologies  
Stratford, Conn. 06602

January 1977

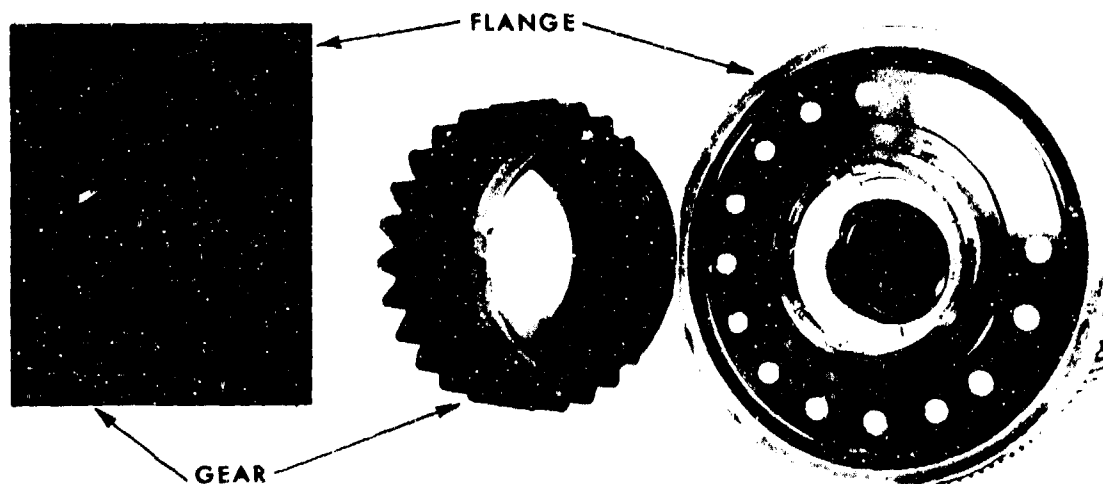
Figure B-3. Second-Row Gear/Flange Fracture.

Hereafter all welds were subjected to ultrasonic inspection.

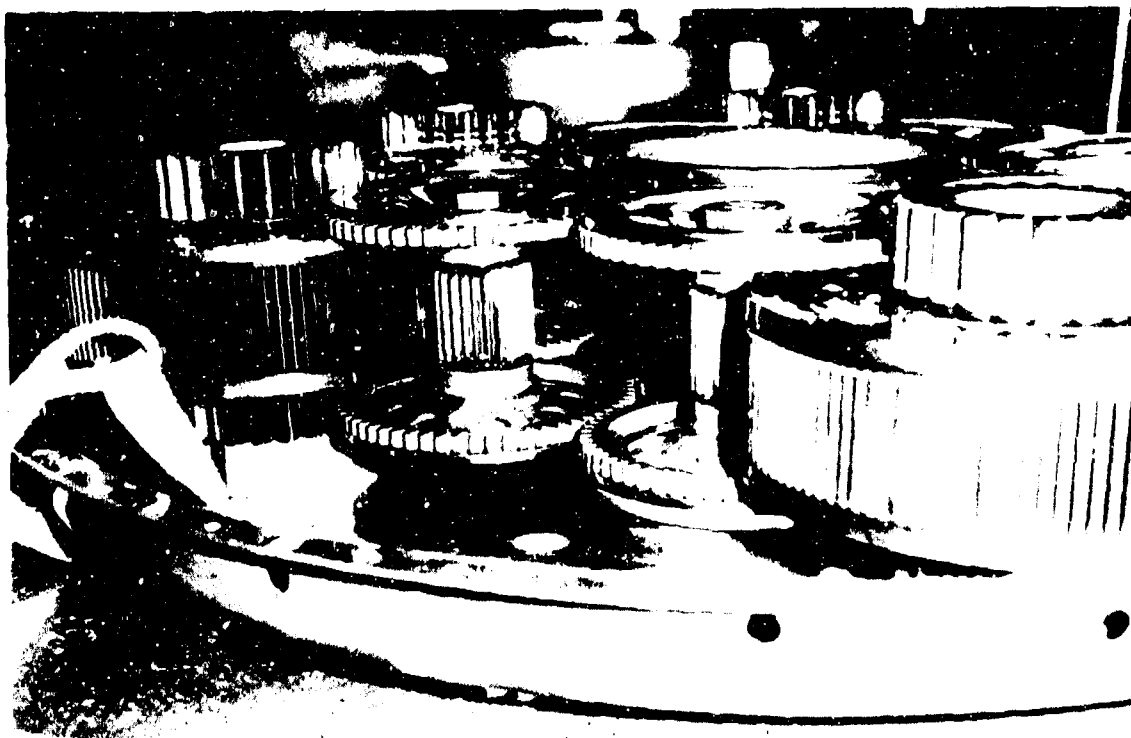
With the incorporation of the butt weld design first-row pinion and modified second-row pinions, initial testing was continued. After approximately 21 hours of regenerative bench testing of the roller gear transmissions, the teeth of the first-row pinion, 27-tooth gear fractured (Figure B-4). Examination of the fractured gears revealed that the weld heat-affected zone extended into the carburized zone at the root of the gear teeth. This caused a transition interface which acted as a stress concentration between the compressive stress zone of the carburized teeth and the residual tensile stress zone of the weld. To prevent reoccurrence of this, the groove distance between the roller and gear was increased, thereby ensuring that the heat-affected area would not encroach into the carburized layers at the gear root.

Figure B-4. First-Row Pinion Tooth Breakage.
