Technical Document 105

AN/PRC-56 HELMET RADIO SET UPGRADING

Recommended modifications require minimal resources but promise considerable improvement in reliability, operability, and logistics support

15 May 1977

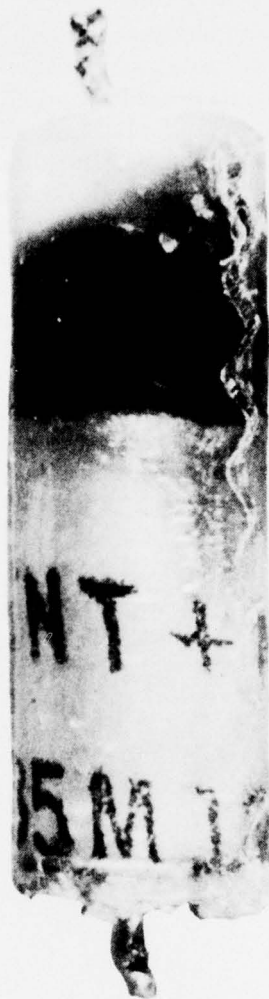
One of the parts identified as a high-failure-rate item is a 35- μ F tantalum capacitor which is designated TNT356U012P18. This miniature capacitor is used extensively in the audio circuits (audio amplifier, squelch module, noise AVC module, discriminator, low-level audio module, and clipper module). In these circuits, the capacitor accounts for a disproportionate number of module failures. Both the audio module and the squelch module appear in the list of high-failure-rate items; while they are both relatively complex and are both subject to a high false removal rate, the TNT356U012P18 failures account for approximately three-fourths of the failures of these modules. A failure in this capacitor can be predicted by the appearance of a black spot in the waxed end (see fig 1). It is now virtually impossible to get exact replacements; however, an established reliability capacitor is now available as a replacement in a style CLR65 T1 case. The replacement is a 33- μ F, 15 volt, 10- or 20-percent tolerance item. The following military parts numbers are designated for the 10-percent tolerance parts; they are listed in descending order of preference:

Figure 1. A TNT356U012P18 capacitor which will fail soon. The black in the top portion is electrolyte leaking out of the primary section.

The part numbers represent various reliability levels; only the one marked with an asterisk is in the National Stock System (NSN 5910-00-010-8015, listed at \$3.29 each). If the -6674 or -6879 becomes available, either is preferred to the -6469. This MIL-SPEC part is just able to fit into the space designated for the capacitor, and, in fact, may not fit in some modules because repeated servicing has squeezed the two module boards together; the modules can be resoldered to allow enough space. Substitution of the MIL-SPEC part will greatly improve the audio circuit reliability and the availability of replacement parts.

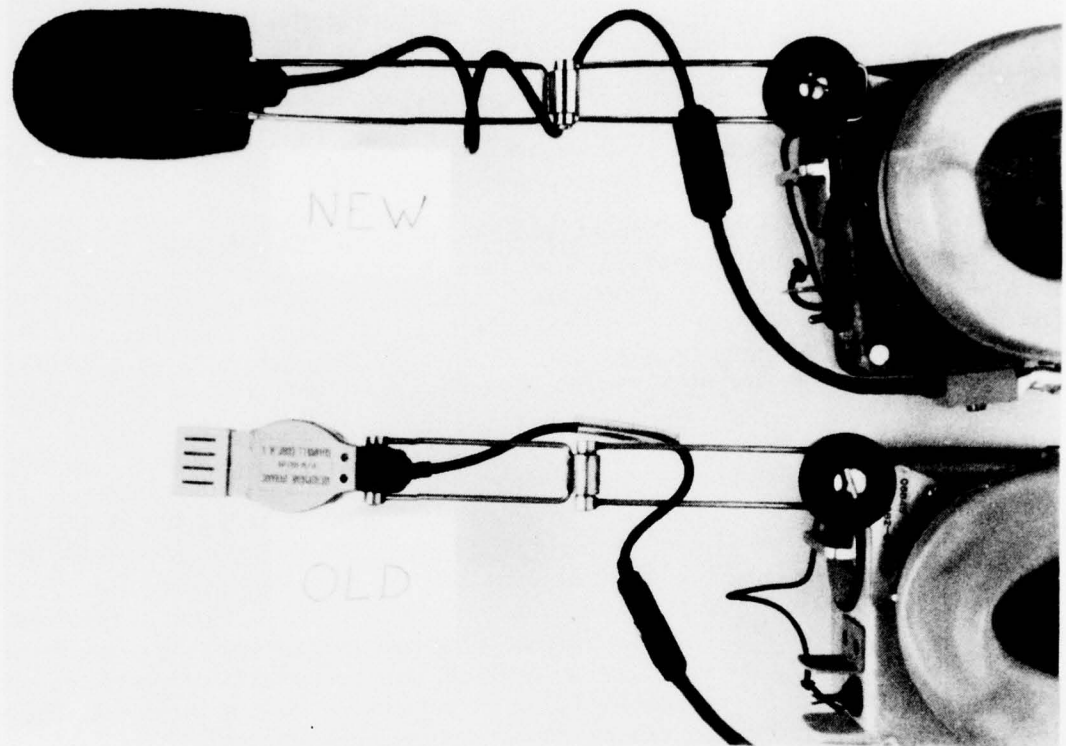
The M-87 microphone, microphone cord, and mike boom collectively suffer a very high failure rate. Failures in the microphone are both electrical and mechanical. The electrical failures appear to be caused by humidity admitted through either cracks in the case or leaks around the element seal. The cracks in the case are simply incomplete mechanical failures. A leaky element seal is most probably caused by the tearing or loosening of the seal by wind pressure. In fact, the M-87 is susceptible to saturation by wind; in the saturated condition, the output drops by at least 50 percent and the noise-canceling characteristic virtually disappears (problem 2). Another possible type of electrical failure derives from shorts or insulation breakdown, or, in conjunction with other failures, welding of the dynamic windings due to intense electromagnetic fields encountered on the flight deck (up to 200 V/m); however, there are no data confirming or refuting these failure modes. In any case, the primary electrical failure mode is humidity entering through a leaky element seal. The mechanical failures are mostly cracked cases resulting from rough abuse. The mike boom is a two-piece wire loop assembly. The most frequent failures occur at a weld on the hinge between the two pieces or at one of the wire loops. Virtually all the documented failures resulted from users' attempting to bend the mike boom to place the microphone closer to the mouth. The foreboom (the loop connecting to the microphone) is not long enough to fit all users comfortably (see fig 4). The failures to the microphone cord were breaks in the wires at the connectors (usually at the microphone end), primarily in the cloth-covered versions (as opposed to rubber or plastic coated). There are some false replacements of the microphone and cord due to input transformer failures, but these probably constitute about 12 percent of the total replacements. Research revealed a microphone assembly in the National Stock System which is made up of the M-87 with a windscreen, a mike boom with a longer foreboom, and a rubber coated cord; the stock number is 5965-00-181-0213. The windscreen will protect the M-87 from wind saturation, the element seal from wind tearing, and the case from much of the normal abuse. Additionally, the windscreen reduces annoying speech artifacts from "p" and "s" sounds and helps the user to properly position the microphone for maximum output and intelligibility.

Figure 4. The old and new microphones, boom assemblies, and connecting cords. The new boom assembly has a longer foreboom. The connecting cord is wrapped around the boom to avoid snagging and to provide strain relief.

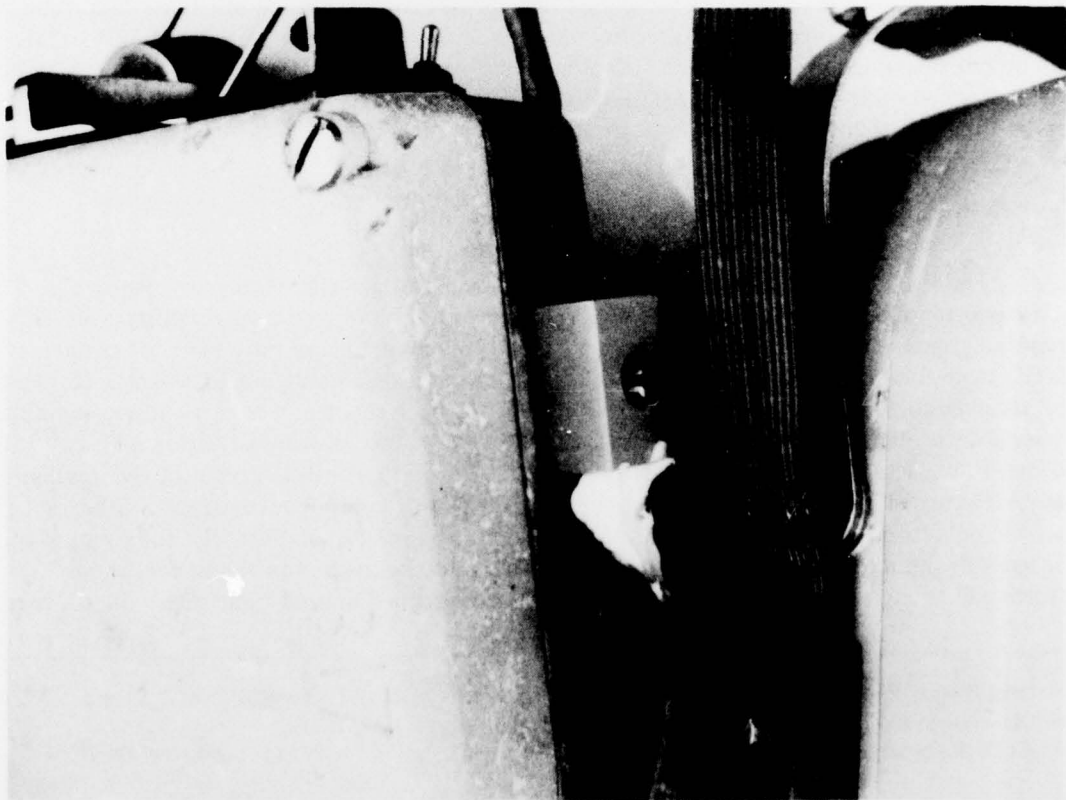
The cable assembly between the electronics pods has a moderately high failure rate. Many of the failures occur in the ribbon cable where it enters the connector blocks. At this point, the cable is flexed across its width rather than in line; this puts a severe fatiguing strain on the cable. In order to relieve the strain, it is recommended that adhesive sealant RTV-102 be applied in accordance with figure 5 or 6. Although other failures occur within the connector blocks, the design precludes doing anything to correct this problem.

Figure 6. RTV-102 applied to a connecting cable to provide strain relief. Notice how the cable is held away from the pivot on the earpod.

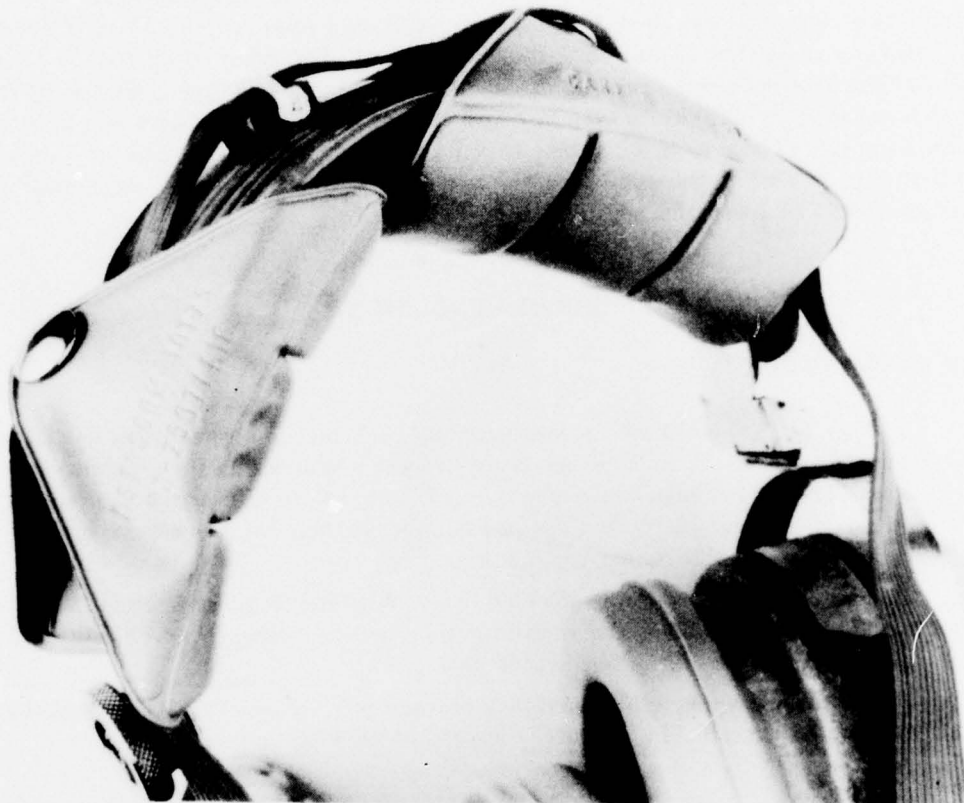
The two factors above plus a number of other minor helmet problems combine to create major problems of discomfort and irritating difficulties in the use of the helmet radio during operations. In some cases, an individual user is not aware of the irritation; however,

Figure 9. MX-2507/AIC pads installed to relieve pressure.

1. Most of the identified corrective actions can be accomplished easily as part of a field change. The proposed field change in appendix A is well within the capability of ship's forces. The field change includes new on/off and push-to-talk switches, a microphone with windscreen, a longer microphone boom, an improved squelch adjustment, improved-reliability parts, more-stable tuning, and sidetone.
2. Those users who are not subjected to the most intense noise levels (such as during catapult operations) should consider an interim replacement earseal (NSN 8475-00-940-9249) rather than the current glycerine-filled earphone cushion.
3. Those users who are bothered by a pressure point on the top of the head should install MX-2507/AIC headband pads over each end of the PRC-56 headband.
