Draft Translation 625
July 1977

CONSTRUCTION AND OPERATION OF LOW-PRESSURE DAMS ON PERMAFROST SOILS

G.F. Biyanov

CORPS OF ENGINEERS, U.S. ARMY
COLD REGIONS RESEARCH AND ENGINEERING LABORATORY
HANOVER, NEW HAMPSHIRE

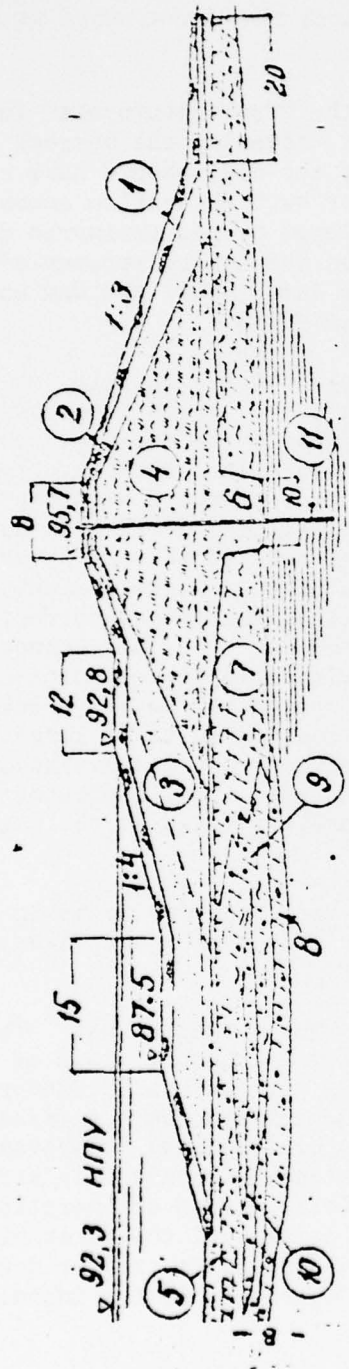
Figure 1. Dam No. 1: 1 -- sand fill; 2 -- rock rubble reinforcement of slope; 3 -- loamy clay core; 4 -- loamy clay core; 5 -- boundary of permafrost; 6 -- loamy clay tooth of dam; 7 -- swollen silted loamy clay, up to 60% ice content; 8 -- loamy clay with marl rubble; 9 -- silty loam with gravel, rubble; 10 -- sand with plant fossils; 11 -- frozen curtain wells.
 [НПУ=Normal backwater level]

According to the blueprint, drafted by the "Tsvetmetproyekt" Institute, these loose, ice-swollen Quaternary sediments, covering the bedrock in a layer up to 3 m thick under the foundation of the dam, should have been replaced by high-quality soils. The volume of such excavation amounted to more than 130,000 cm³. The blueprints, developed by the Leningrad department of the "Gidroproyekt" Institute, retained the entire stratum of Quaternary sediments in the foundation of the dam. Thus, the dam was [possibly planned] on unreliable ice-saturated soils.

Changes were later made in the construction of the facility at the suggestion of the builders. In particular, a tooth, which completely cut through the ice-saturated Quaternary, less reliable (in terms of bearing capacity), ice-saturated soils, and extended 0.5 m into the bedrock, was constructed for the purpose of fastening the body of the dam to the foundation. The width of the tooth was [one word illegible] at 12 m in accordance with construction conditions, but it was later reduced to 8 m. Such mating of the core of the dam and the bedrock, which has a low ice content, and which retains its bearing capacity after thawing, guaranteed perfect anti-filtration stability and the reliability of the dam. In this connection the builders suggested constructing the dam without a frozen curtain, since during construction of the tooth, which cut through the entire thickness of the Quaternary sediments, such a measure was considered to be largely superfluous, substantially increasing construction cost and overhead. However, the suggestion of the builders was rejected. It is important to note here that the plan of the spillway was completely revised at the suggestion of the builders.

The dam was placed in operation in 1964 and continues to be in satisfactory condition. The frozen curtain in the body of the dam makes perfect contact with the frozen foundation.

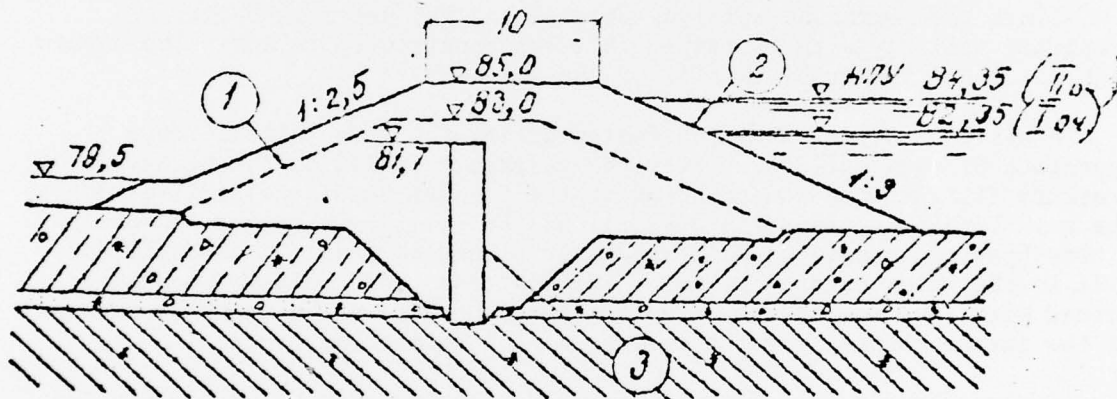
During the course of construction the plan of the dam was altered in order to increase the capacity of the reservoir; its height was increased by 2 m. The dam was widened by filling the slopes with argillaceous loamy clay with up to 35% rock rubble.

Figure 2. Dam No. 2: 1 -- contour of initial dam; 2 -- contour of dam after reconstruction; 3 -- cribwork diaphragm.

Flaws of the plan were manifested during the very initial stage of operation of the facility. After the reservoir filled to the planned level pressure filtration began to occur in the foundation of the spillway due to the weak bonding of the cribwork sill of the spillway with the foundation. A clay upstream puddle blanket was later placed in front of the spillway sill in the water intake channel. The upstream puddle blanket was reinforced with concrete slabs. A cofferdam was built in the entrance section of the intake channel for the purpose of completing this work.

6. The construction of a cribwork diaphragm in the body of an earth-fill dam cannot be considered correct. It is virtually impossible to mechanize the filling and compaction of soil along the contour of a cribwork and in its cells, and manual compaction is unproductive and, more importantly, its quality does not readily yield to control. Furthermore, because of varying degrees of settling of a relatively rigid cribwork construction with [possibly vertical] walls and of the earth-fill body of a dam at the interface of the soil and cribwork, cracks inevitably form.

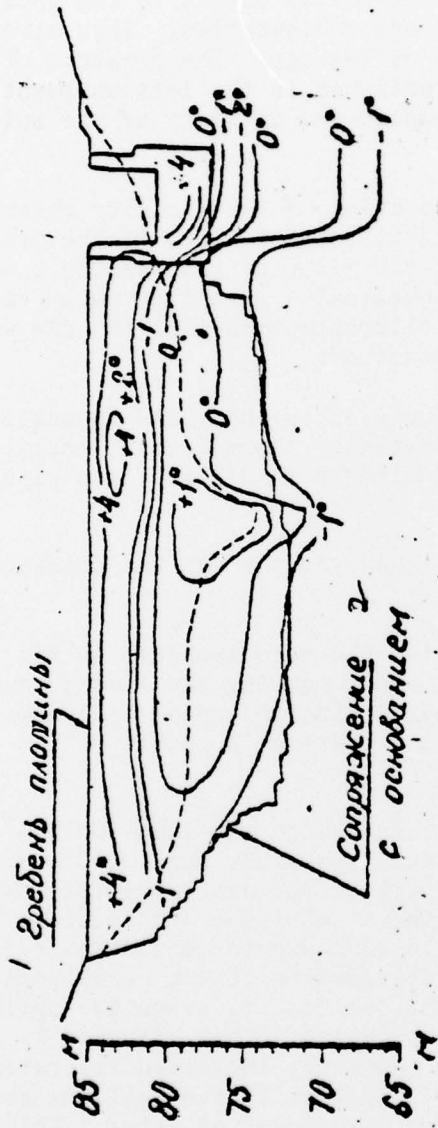
During the first year of operation the zero isotherm in the foundation of the dam fell by 1.2 m, and by 1.4 m more during the second year, under the influence of the filtration stream. Thus the upper boundary of the [one word illegible] fell by 2.8 m in 2 years as a result of the filtration stream.

Figures 3 and 4 show the isotherms through the longitudinal cross section of the dam for 1 June 1960 and 1 [possibly June] 1961. The figures show that the left bank flood plain part of the dam completely froze and the core of the thaw zone shrank in the area of the bed section. The zero isotherm under the spillway dropped to 12 m due to considerable filtration through the fissured bedrock. This degradation of the permafrost under the spillway does not pose a danger to the dam itself, since the spillway was built on soils, the bearing capacity of which is not affected by a change of the thermal [one word illegible]. However, increased filtration may result in [possibly heating] of the foundation in the spillway abutment and lead to increased filtration [one word illegible] of water. This assumption was eventually confirmed. Filtration decreased as the water level of the reservoir fell. When the water levels in the reservoir fell to the crest level of the temporary cofferdam in the intake channel filtration of water into the lower reach ceased. This showed that the source of the filtration stream was located in the intake channel between the temporary cofferdam and the spillway.

Figure 3. Isotherms in body of dam on 1 June 1960.
KEY: 1, Crest of dam; 2, Foundation abutment.

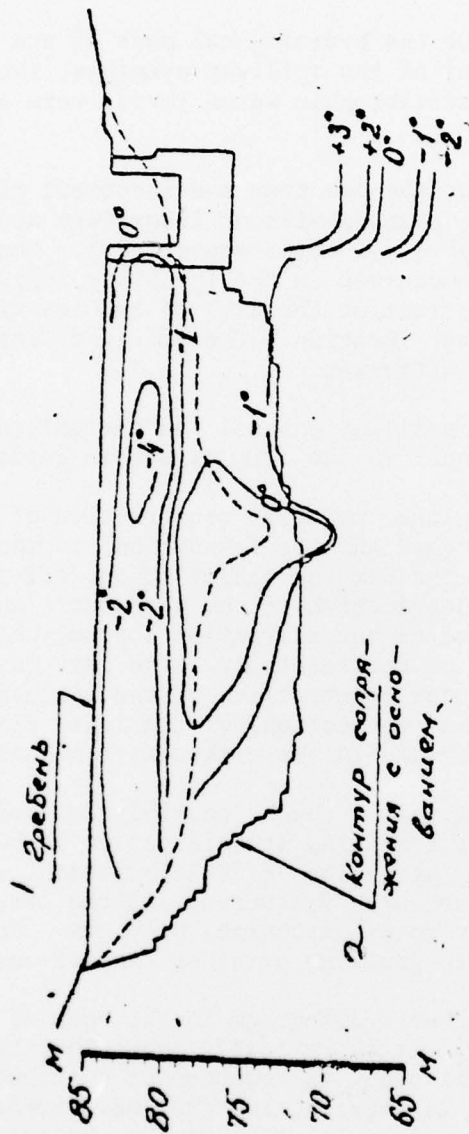
Figure 4. Isotherms in body of dam on 1 June 1961.
KEY: 1, Crest; 2, Contour of foundation abutment.

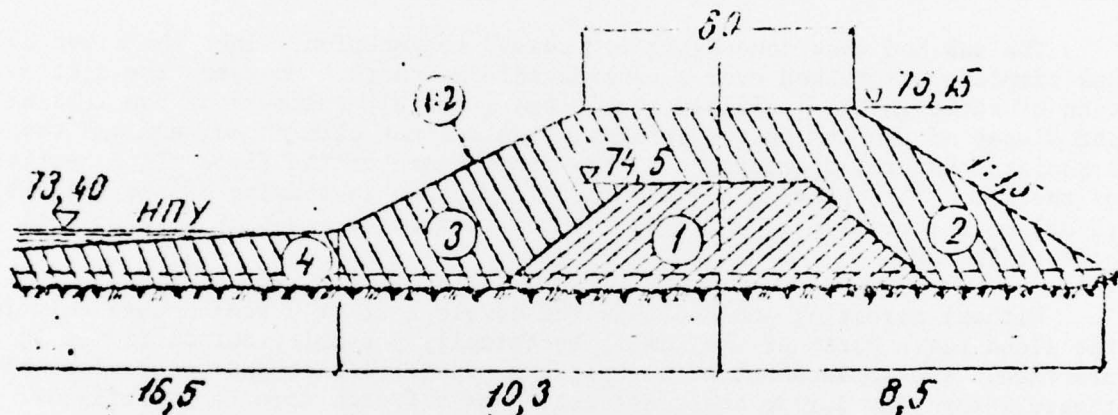
The earth-fill dam with a frozen core is [number illegible] m long, has a maximum height of 4.1 m and creates a 1.5 m pressure head (Figure 5). The frozen core of the dam, which acts as an antifiltration curtain, was built by layer-by-layer packing of frozen soil, flooded with water and allowed to freeze. The volumetric ratio of ice to soil was 1:1 and the density of the ice-soil [possibly curtain] is 1.2-1.5 t/m³ [2]. The top of the frozen core of the dam, [possibly built] during the winter (February-March), is covered with a buffer heat-insulating layer of earth to a depth exceeding the depth of seasonal thawing of the soil in the vicinity of the construction site.

Figure 5. Dam No. 3: 1 -- frozen core; 2 -- lower wedge of dam filled with frozen soils; 3 -- frozen soil fill; 4 -- shield and upstream puddle blanket of thawed soils.

The sub-bed thaw zone basically ceased to function, since the river bed was completely scrubbed over a considerable distance. However, the filtration of water in the [possibly receiving] [possibly contour] of the threshold and slopes of the dam on the spillway side was not eliminated, nor was the associated natural degradation of the frozen core of the flood plain sections of the dam. This process began to accelerate due to thawing of the [possibly floor] of the reservoir, and a frozen core ceased to exist as a structural part of the dam.

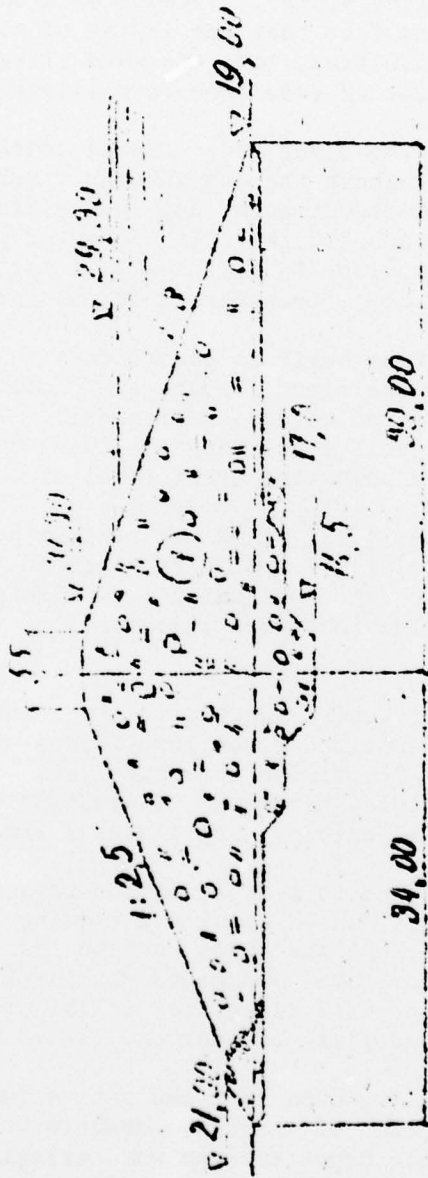
Figure 6. Dam No. 5: 1 -- [three words illegible].

During operation of the dam a head-[one word illegible] of water was observed under the foundation of the dam. The reservoir filled with spring flood waters in 1965. [One or two words illegible] on the left bank, 10 m below the dam, formed a [one word illegible] with an up to 0.5 m head and a discharge of up to [illegible], without erosion. Later on the discharge increased to [illegible] second. The source of the stream is located in the slope of the dam at a height of [one or two words illegible] of the stream bed. Filtration developed under the dam due to thawing of [one word illegible]. The foundation of the dam, after removal of the topsoil and before being covered with clay, was left exposed for two summers. During that time the fractured [one or two words illegible] of the foundation thawed, the ice thawed and the cracks [one word illegible].

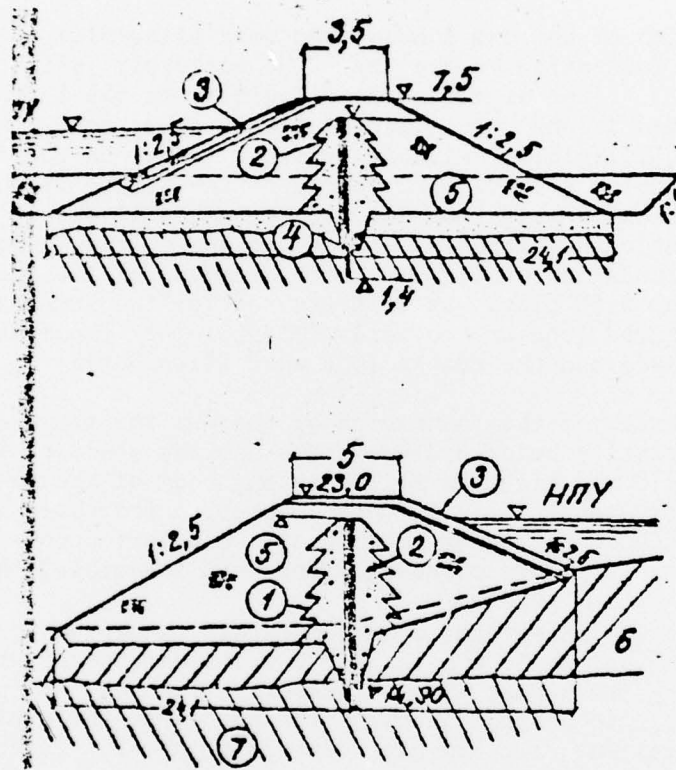
Both dams are structurally identical and are built of marlaceous soil with an antifiltration curtain made of wood panels. The body of the dam is mated with the foundation by an up to 2.2 m deep tooth with a trench in the less ice-saturated bedrock.

Figure 7. Dams No. 6 and 7: 1 -- wood panel diaphragm on [one word illegible] pilings; 2 -- sand-gravel core; 3 -- [one word illegible] with small rocks; 4 -- clay lock; 5 -- body of dam; 6 -- ice-saturated clay with rubble; 7 -- marlaceous rock.

During the spring-summer period of the first year of operation thawing of the frozen marlaceous loamy clays by [possibly self-compaction] resulted in up to 50 cm of subsidence. However, the dams were filled with a margin against the projected height by [illegible] cm. During the first year of operation, one day after [one word illegible] of the planned pressure head, filtration of water was observed in the left bank part of the upper slope, with a discharge rate of up to [illegible]. The presumed cause of filtration was misalignment of the diaphragm panel joints as a result of inadequate [one word illegible] filling and packing of the frozen chunk clay. Filling of the lower slope of the dam at the point of discharge of the filtration stream with local thawed soil stopped [one word illegible], and then filtration completely ceased. This dam has exhibited no filtration phenomena since then. During the first weeks of operation the pumping station operated with interruptions, the reservoir filled and the water level in it rose above the [one word illegible] of the top of the antifiltration diaphragm, but no undesirable consequences were observed. Both dams have been operating satisfactorily for [one or two words illegible].
