Special Report 77-18

INSTALLATION OF LOOSE-LAID INVERTED ROOF SYSTEM AT FORT WAINWRIGHT, ALASKA

David Schaefer

June 1977

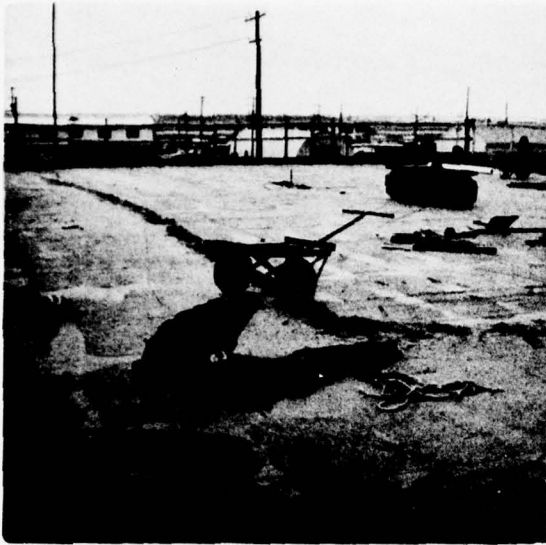
3. Contractor began removal of existing BUR on 6 July 1971.

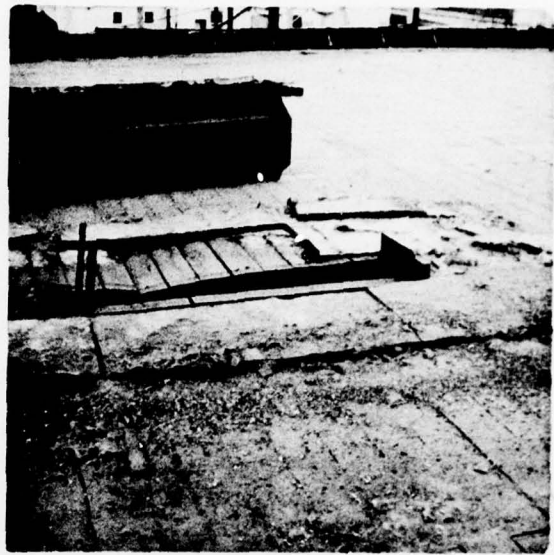
4. Metal deck, insulation and metal deck at ridge vent.

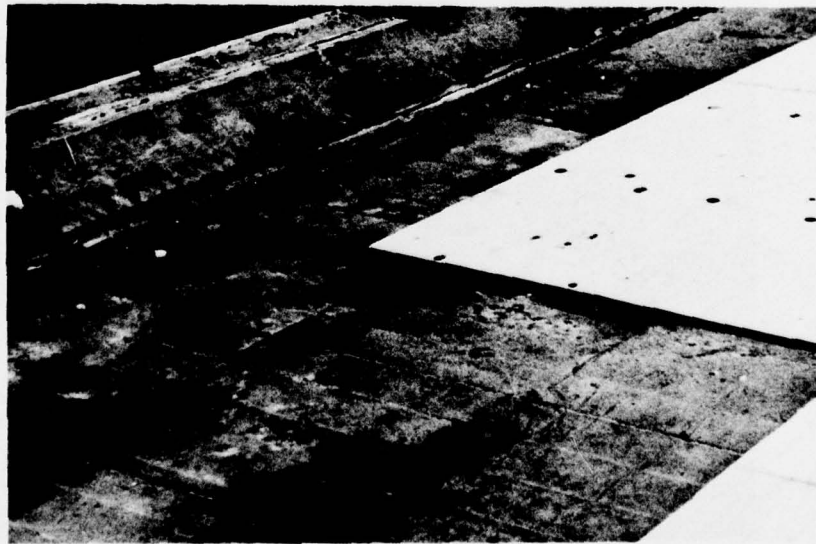
Upon removal of the existing roof, it was found that the steel deck had rusted in numerous places. This was especially evident in areas of high humidity where portions of the deck had rusted through. The insulating board was completely water soaked even though the built-up roofing (BUR) membrane appeared to be in fair shape.

5. Condition of metal deck after stripping existing BUR. Note that the corrosion has penetrated the steel deck.

Basically the contract work called for the removal and replacement of the existing roof with a loose-laid inverted system. In order to replace the roof, a 1/2 in. (12 mm) exterior plywood sheathing was required over the steel decking since the membrane must be placed on a smooth surface. The roof drains had to be lowered to provide positive drainage at the membrane level. The principal components specified were:

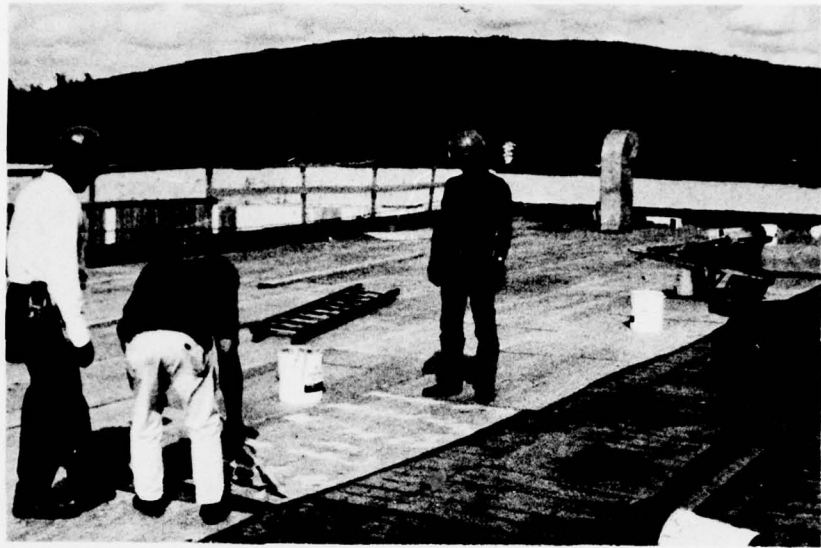
6. Application of 1/2 in. plywood sheathing to prepared metal deck. Plywood was glued to deck.

2. The application of the plywood decking to the prepared structural steel deck (Fig. 6).

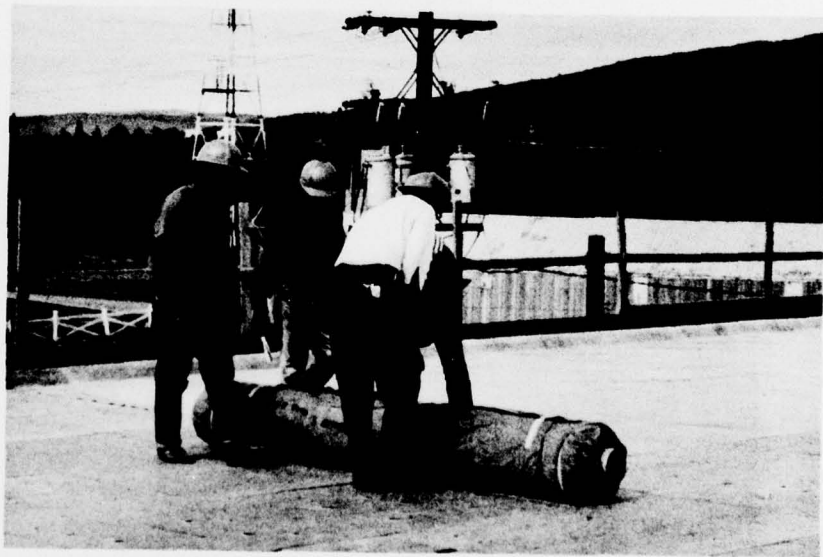
7. Rolling butyl rubber membrane on plywood deck.

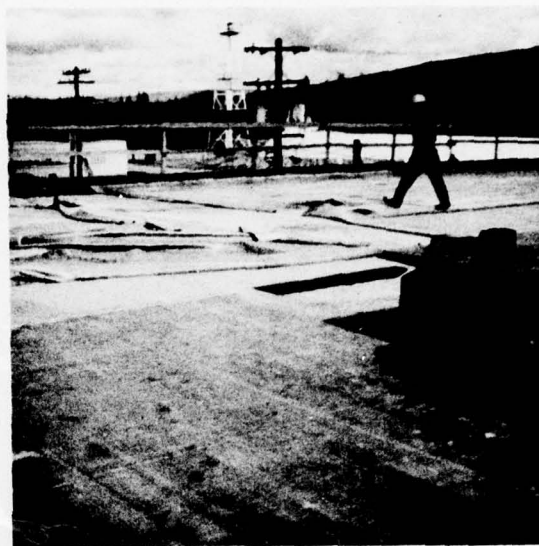
9. Placement of the butyl rubber membrane on the plywood deck. The placement took 3 hours.

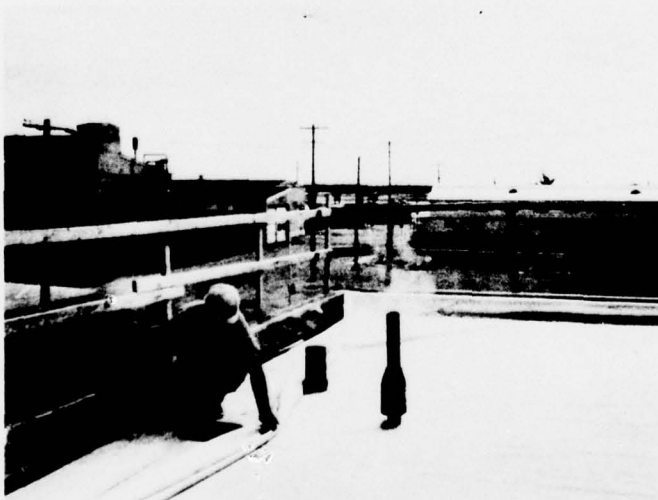
14. Exhaust stack and waste vent penetrations.

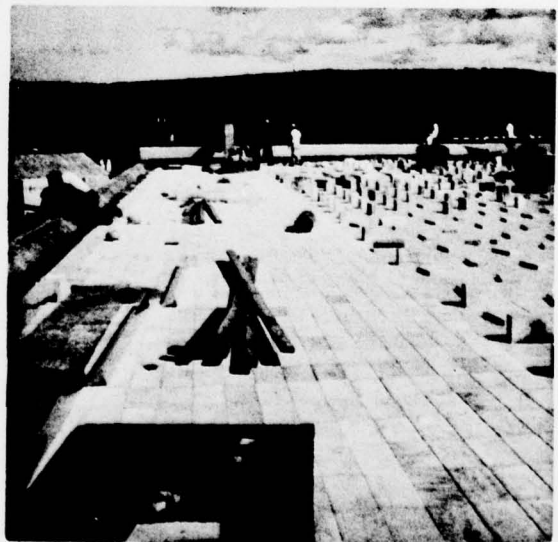
18. Drain after lowering to membrane level and bonded in place.

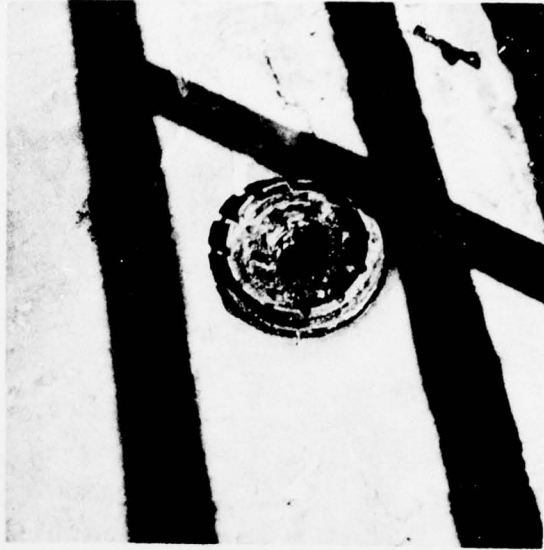
19. Placement of polystyrene insulation at drain.

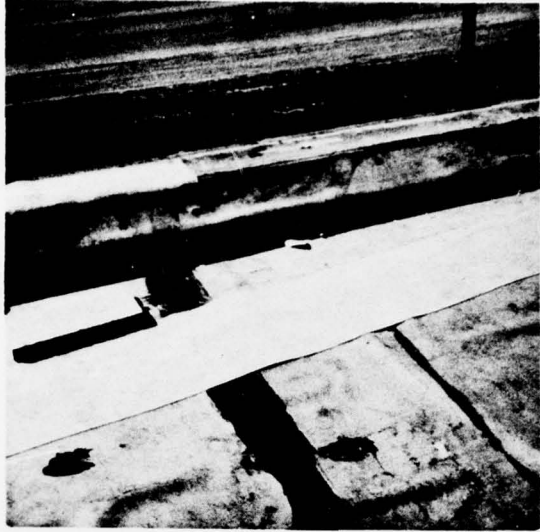
22. Typical patch.

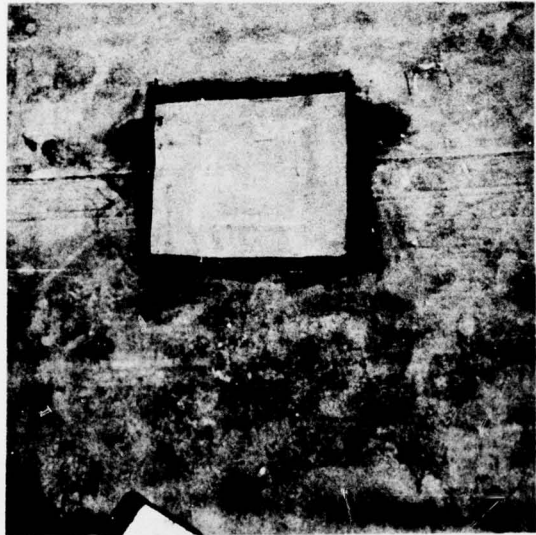
23. Completed flashing at a
building corner. Insula-
tion in place ready for
pavers.
