title: REFLECTIVE FLOOR FINISHES FOR AIRCRAFT MAINTENANCE HANGARS

author: Robert L. Alumbaugh, Ph D, and David Gurganus

date: May 1977

CIVIL ENGINEERING LABORATORY

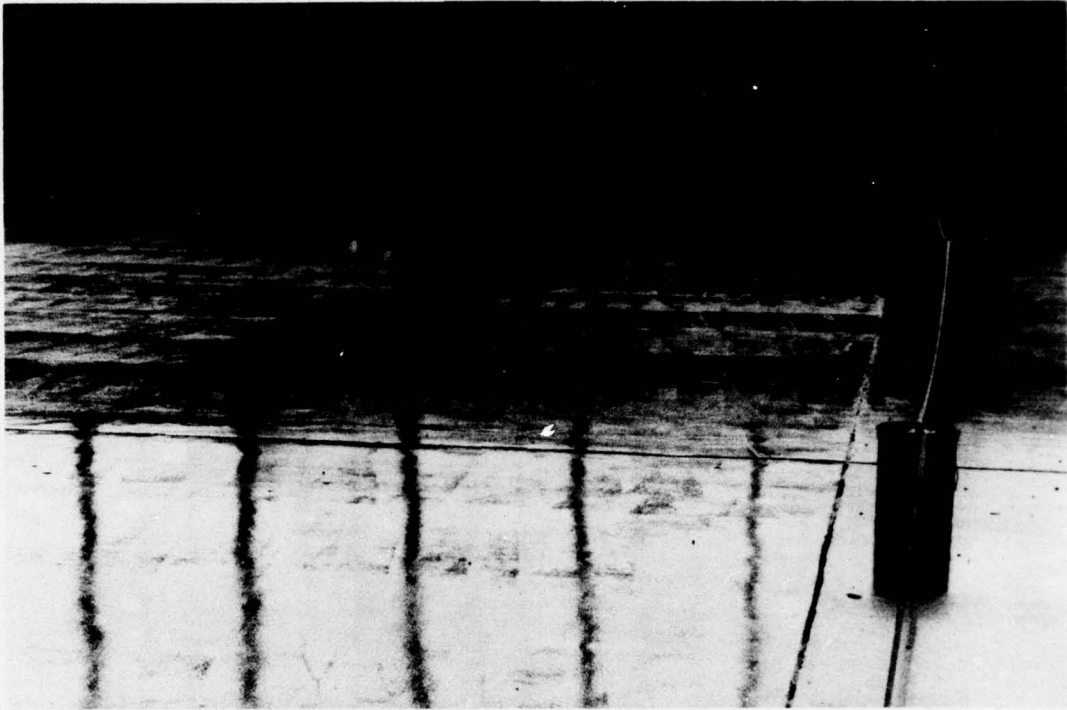
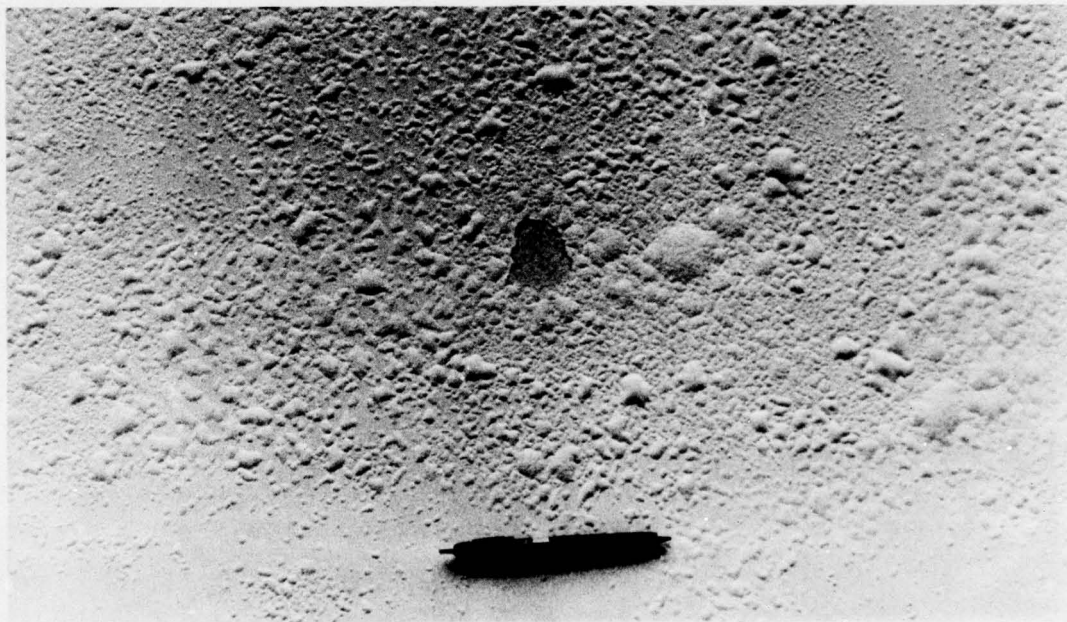
By late afternoon, the first finish coat had dried tack-free. At that time, there was no further blistering observed other than the normal pinpoint size. However, the following morning, much of the System C area exhibited severe blistering, from pinpoint up to about 2 inches in size. Figure 9(a) gives an overview of the system while Figure 9(b) shows a closer view giving an indication of blister sizes and frequency in one of the areas (note cleaned and spot-primed areas on hangar door in Figure 9(a)).

and the humidity was generally above 70%. These conditions were largely responsible for the blistering problems, and the manufacturer currently does not recommend application of this material above 80°F. The high humidity caused a certain amount of moisture to be retained by the concrete deck, even though it appeared dry. The combination of high temperature and humidity caused both the CRU primer and first finish coat to skin over and retain a larger amount of solvent than normal. It is believed that the blistering resulted from reaction of the urethane with moisture, producing carbon dioxide and vaporization of entrapped solvents. The vapor pressures of these gases were greater than the adhesion of the system to the deck. The volatiles could not escape because of the premature skinning on the surface of the coating systems and hence caused the blisters to form.

(a) Overview of CRU finish showing blistering.

(b) Closeup of CRU finish showing size and frequency of blistering.

Figure 9. CRU primer and first finish coat blistered badly due to high temperature and humidity.

The CRU primer was applied to the cleaned deck and allowed to cure sufficiently. This was followed by application of the two finish coats with a sufficient drying period between coats to prevent the blistering problem from recurring. Grit for nonskidding was again sprinkled into the first wet topcoat of one-half of this area (see Figure 6). No serious problems developed during the reapplication. However, because of the high temperature/humidity conditions, pinpoint blistering was still observed.

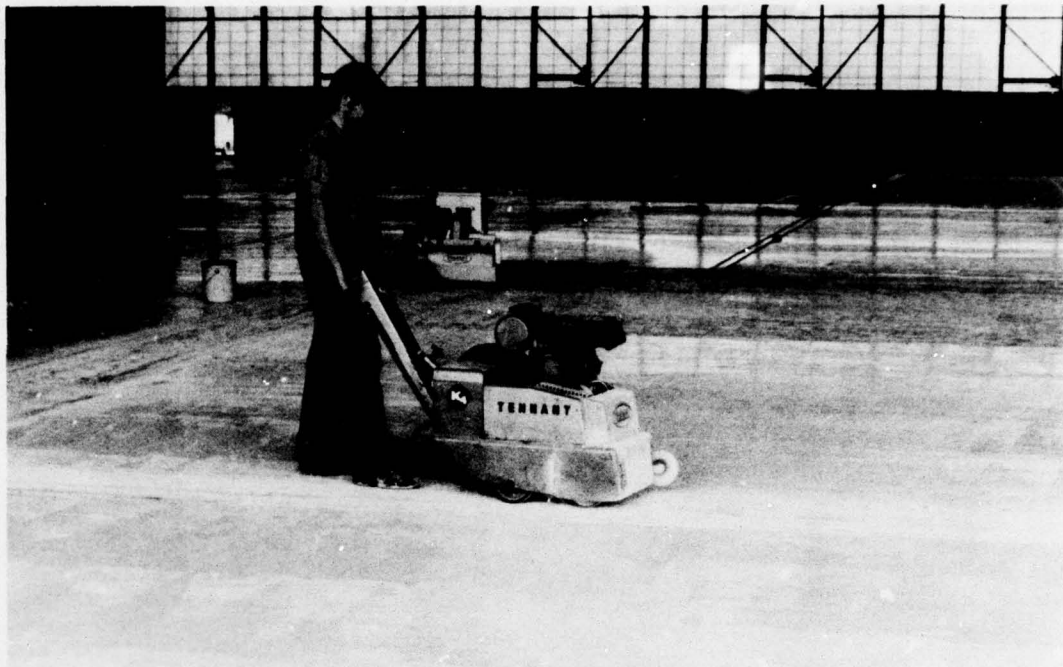
Figure 10. Removal of the CRU using a K-4 scarifying machine.

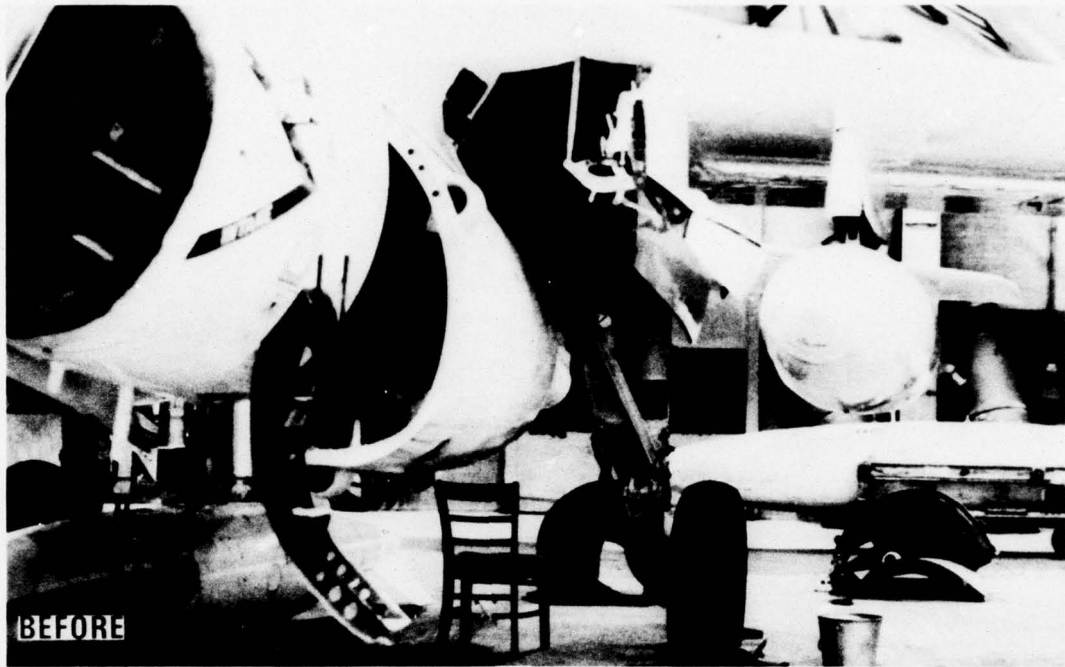
Results indicate that the reflective floor finishes do provide improved illumination underneath aircraft compared to the illumination reflected from an uncoated concrete hangar deck. The increase in average reflected illumination as shown in Table 3 was from 1 to 2 FC/lamp before painting to 10 to 12 FC/lamp within a couple of weeks after painting (as much as a tenfold to twelvefold increase). After 3 years of use, the average illumination per lamp was 3 to 4 FC (a twofold to fourfold increase over the uncoated hangar deck). It should be noted that this increase in the average intensity of the reflected light from the coated hangar deck resulted from an average incident illumination at the time that was only 43% as intense (7.5 FC/lamp) as the direct illumination in the uncoated hangar (17.2 FC/lamp). This reduction in direct illumination was due primarily to the fact that 57% of the lamps were either out or missing in the coated hangar while only 18% of the lamps were not burning in the uncoated hangar. If all lamps were functioning properly, the amount of reflected illumination in the coated deck hangar should be considerably higher.

(a) Uncoated

(b) Coated

Figure 13. Comparison of underaircraft illumination on uncoated and coated hangar decks.

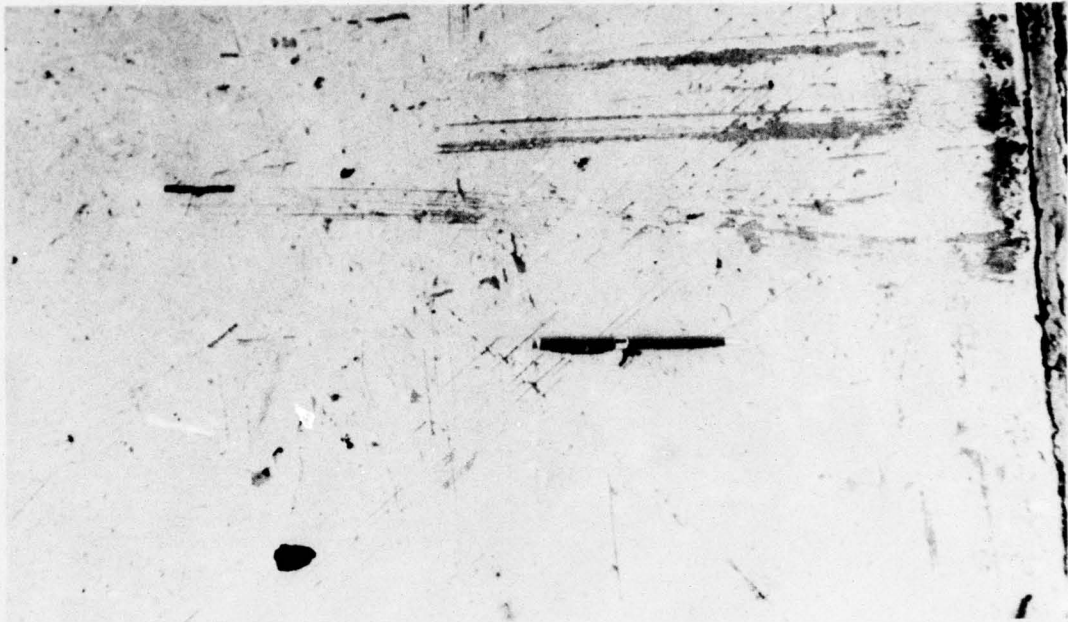
In spite of the performance of these reflective systems, all of them exhibit one common problem. That is, loss of nonskid grit that is crushed and removed from the floor system when heavy equipment is dragged or rolled across the deck. This loss of grit seemed to occur at approximately the same rate in all three systems. A typical condition is shown by a photomicrograph (Figure 16) of a reflective finish 2 years old, where the larger dark spots are in effect holes in the coating where the grit has been removed. This certainly reduces the nonskid character of the deck.

(a) Scratching and scraping by heavy equipment.

Figure 14. Damage to reflective floor finishes.

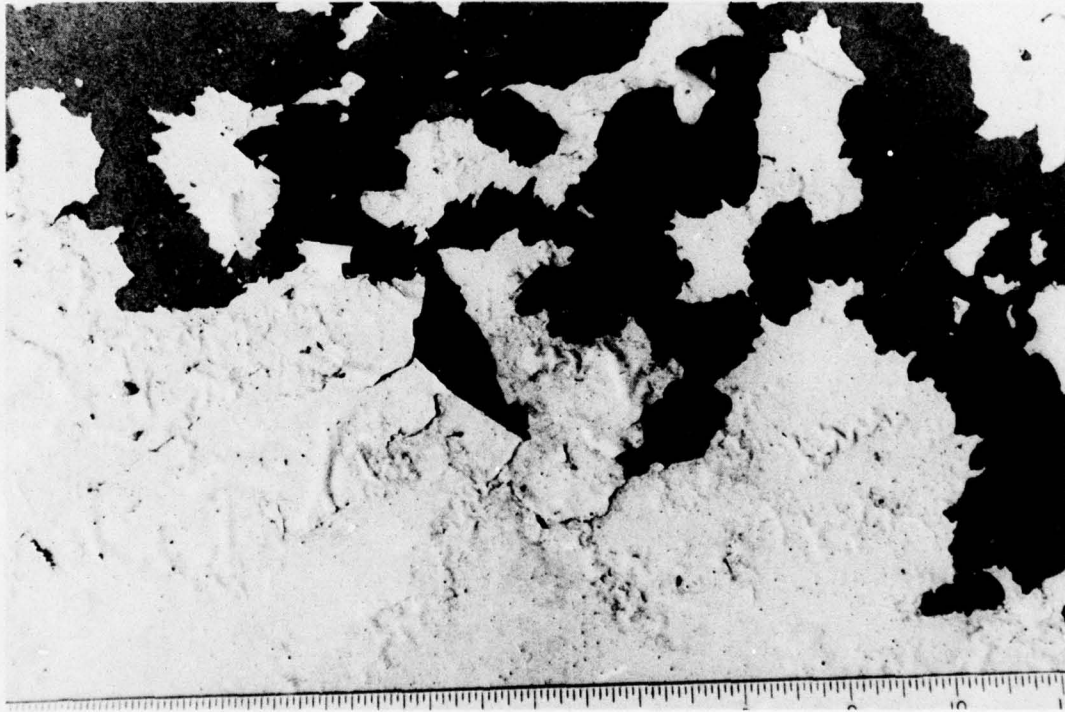
Where the coating had lost bond in this large area of System B, the problem appeared to be lack of adhesion between the first finish coat and the epoxy primer. The lack of adhesion did not appear to be caused by oil or other spilled fluids that had saturated the deck over the past years but rather was attributed to the high temperatures during the application which caused the epoxy primer to cure too rapidly. The

(b) Loss of bonding from chemical spills.

primer was beyond the tacky stage when the first finish coat was applied and this affected the bonding of the first reflective finish coat. The contractor removed the coating system in this area either down to the concrete or at least to the primer and completely reapplied the total system; i.e., one coat of primer and two coats of moisture-curing urethane with grit applied to the first wet finish coat. The second application performed considerably better than the first, although this area of System B has exhibited poorer adhesion characteristics than most of the reflective finishes in other parts of the hangar.

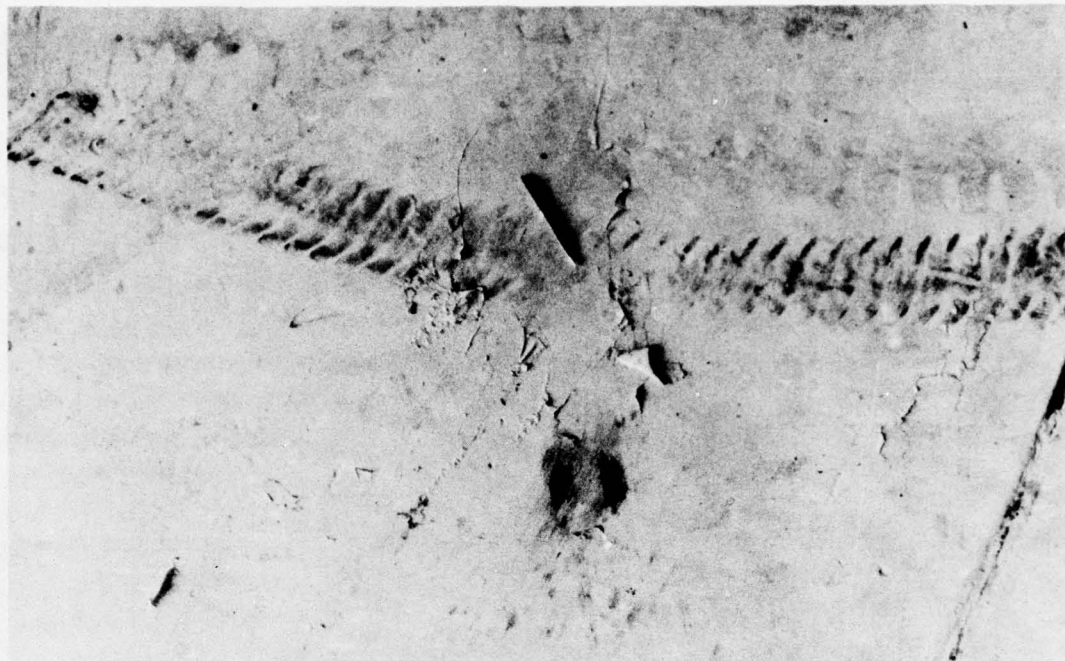
Figure 15. In a few small spots, new coating in System A area delaminated from original system.

Because of the potential problem, the nongritted area of System A was recoated 12 months after the original application. This process consisted of chemically cleaning the surface to remove all contamination, mechanically abrading (sanding) the existing finish coat to provide a better bonding surface, and applying two coats of the same moisture-curing urethane as that used in System B. Although grit was broadcast into the first wet topcoat during this repair, it was applied very unevenly. As a result, there are still some small patches that do not have nonskid grit. Because of this repair, this area of System A is currently in somewhat better condition than much of the System B area. While there have been some problems in this new coating bonding to the old in the System A area (see Figure 15), this is considered very minor at this time. In addition to the above, one other very noticeable difference in the systems is the yellowing and staining of the moisture-curing materials (Systems A and B). The chemically resistant urethane (CRU) retained its whiteness very well which is due not only to its nonyellowing characteristics when exposed to sunlight, but also to its excellent chemical resistance which inhibits staining. Also, because of this chemical resistance, the CRU has been virtually unaffected by chemical spills, and no loss of bonding has resulted.

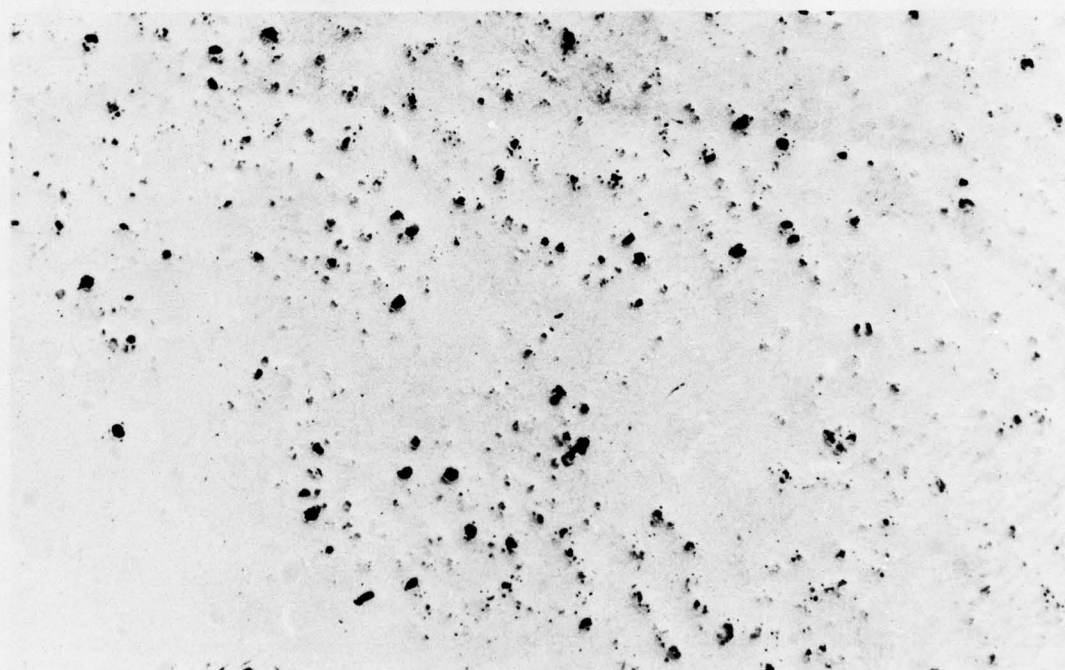
Figure 16. Photomicrograph of urethane reflective coatings after two years. Black holes in coating are where grit has been removed.
