USAAMRDL-TR -77-9

INVESTIGATION OF FACTORS CONTROLLING ENGINE SCHEDULED OVERHAUL - T53/T55

Avco Lycoming Engine Group
Stratford Division
Stratford, Conn. 06497

May 1977

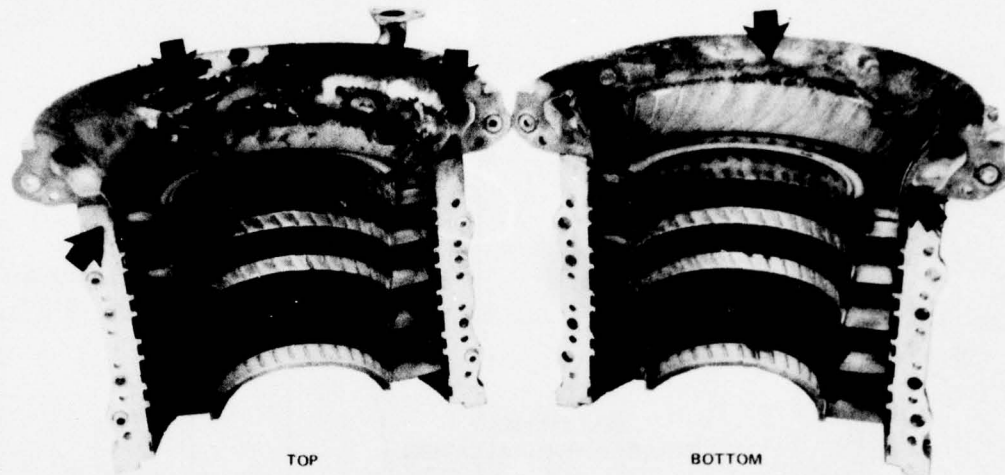
Figure 16. Centrifugal Compressor Housing Flame-Spray Repair

During the Vietnam War, the unprecedented demand on the supply system caused shortages of some long lead-time items. One such item, a cast magnesium centrifugal compressor housing used in the T53 series engines, was seriously affected by erosion. Because of the short supply, a flame-spray repair procedure was developed in an effort to return some of the eroded housings to service (see Figure 16).

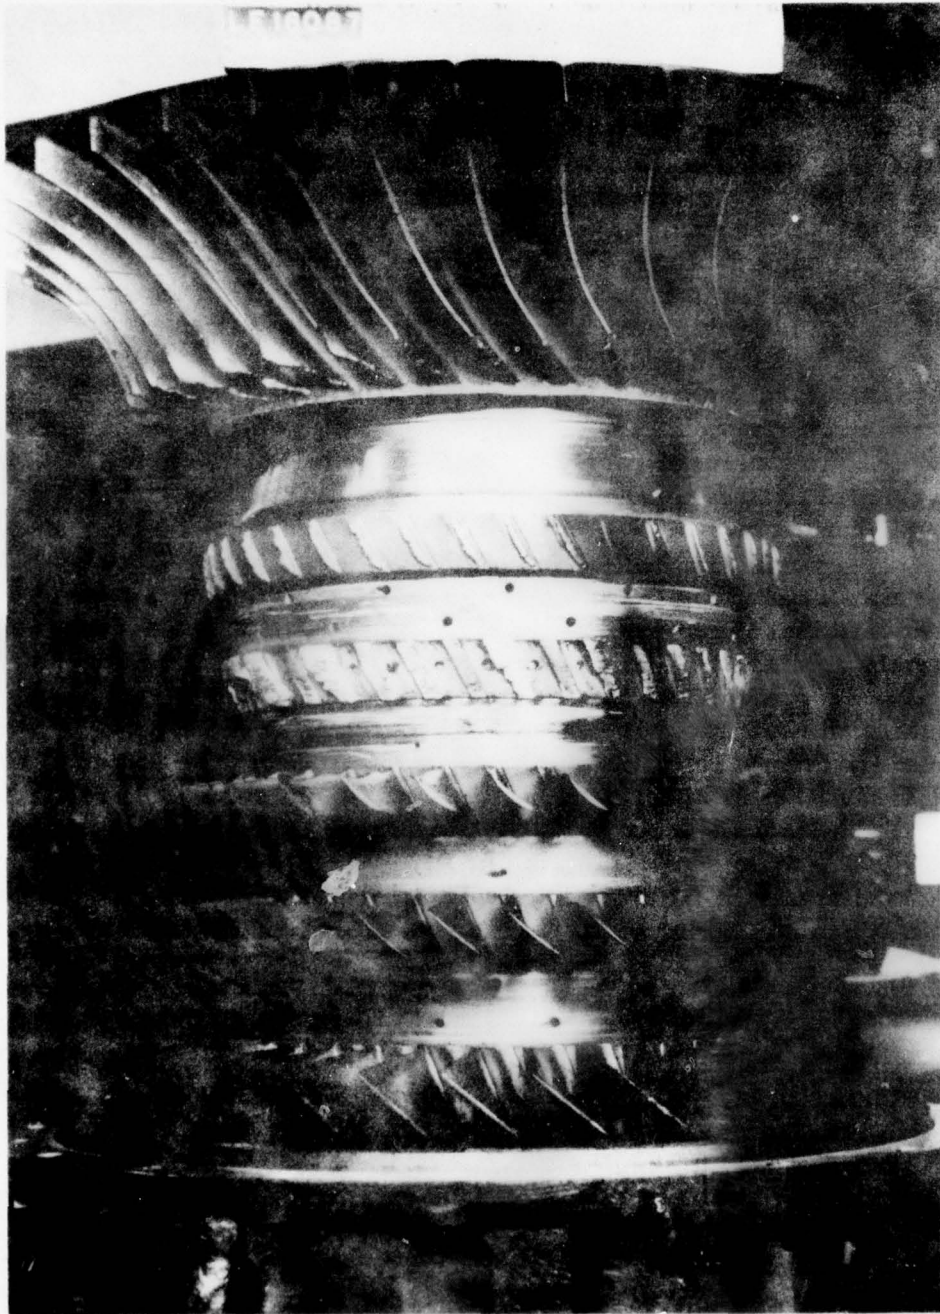
Figure 30. Typical T53-L-13 Compressor Rotor After Failure of the Fourth-Stage Disc

A Product Improvement Program was initiated in 1963 to provide compressor components with increased strength, durability, and corrosion resistance by utilizing the superior characteristics of titanium. During 1963, a titanium compressor rotor was designed and fabricated to demonstrate the potential improvements to existing assembly techniques, maintainability criteria, and environmental influences experienced by the rotor during its operation. This rotor design demonstrated, via 400 hours

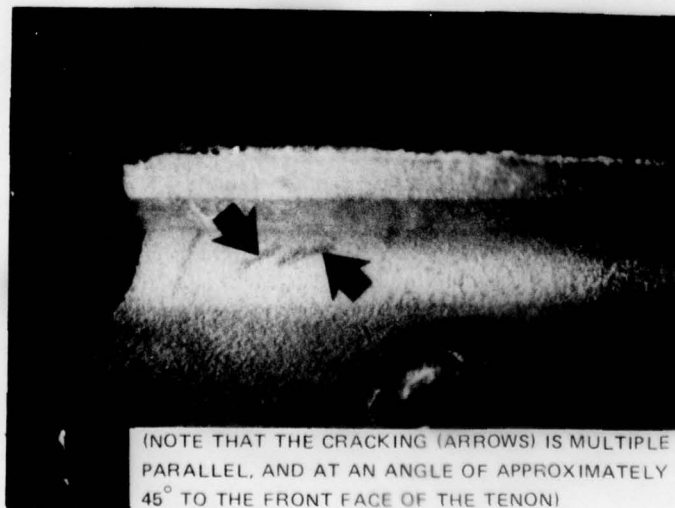
(NOTE THAT THE CRACKING (ARROWS) IS MULTIPLE PARALLEL, AND AT AN ANGLE OF APPROXIMATELY 45° TO THE FRONT FACE OF THE TENON)

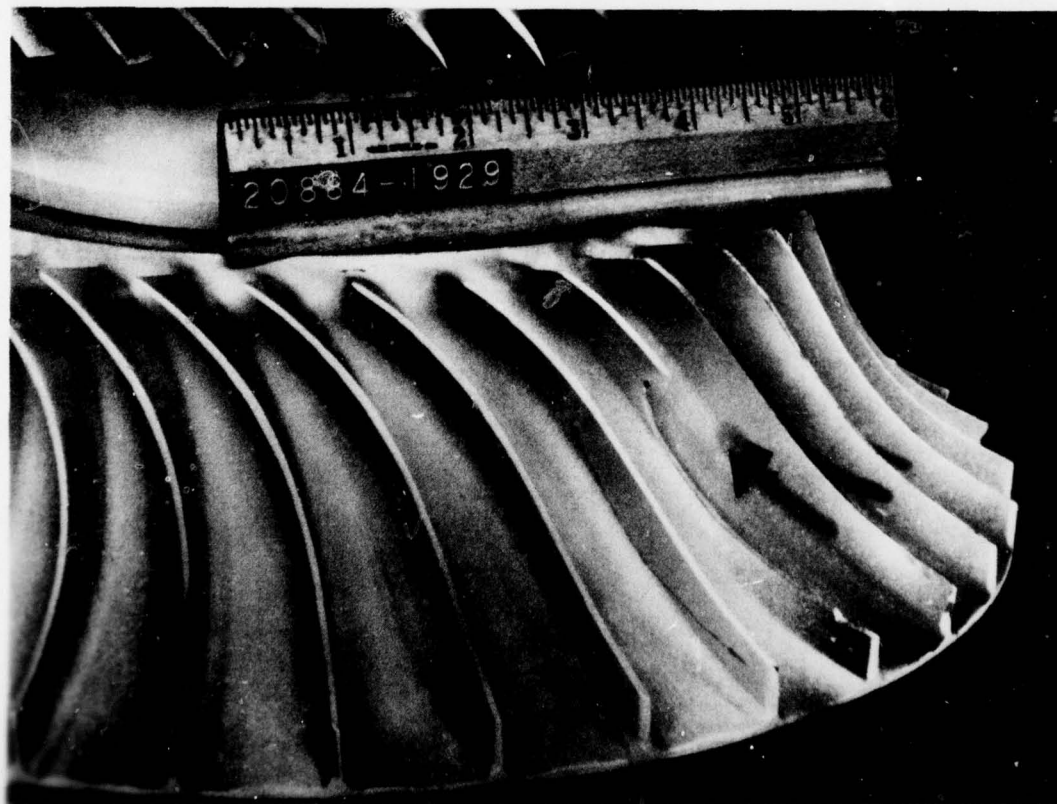
Figure 36. Centrifugal Impeller Showing Vane Damage

Centrifugal Impeller - During 1971, vane fracture of the T53-L-13B centrifugal impeller became a problem. The failure mode constituted cracking and/or complete breakout of a vane section by fatigue. Fracture origin was observed at approximately vane midspan, just above the fillet radius, at the concave surface of the vane (see Figure 36). Crack propagation took place along the vane length in both fore and aft directions. When complete section breakout was experienced, cracking terminated at the vane outer edge.
