ANALYSIS OF ARRAY COMPONENTS RECOVERED AT ST. CROIX, VI

Research & Engineering Department

May 1977

NAVAL TORPEDO STATION ✓
Keyport, Washington 98345

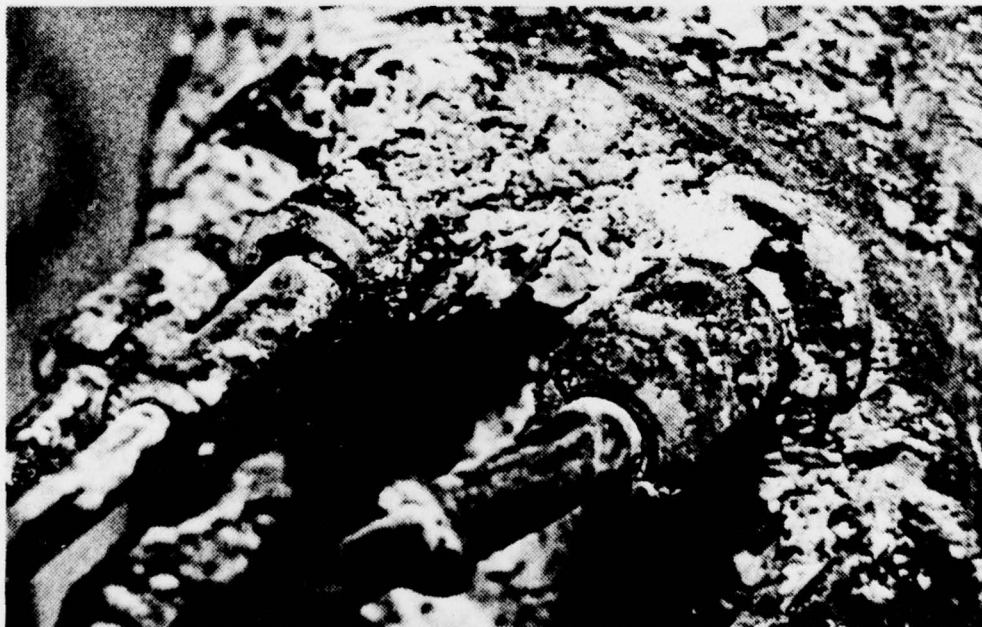
Junction Box. The junction box was heavily corroded on the exterior, with yellow powdery corrosion products accumulated around the Morrison seals of the hydrophone breakout end. See Figure 3. The end plate of the hydrophone side was removed

Figure 3. Exterior Corrosion, Junction Box, Array 7
(Approx. life size)

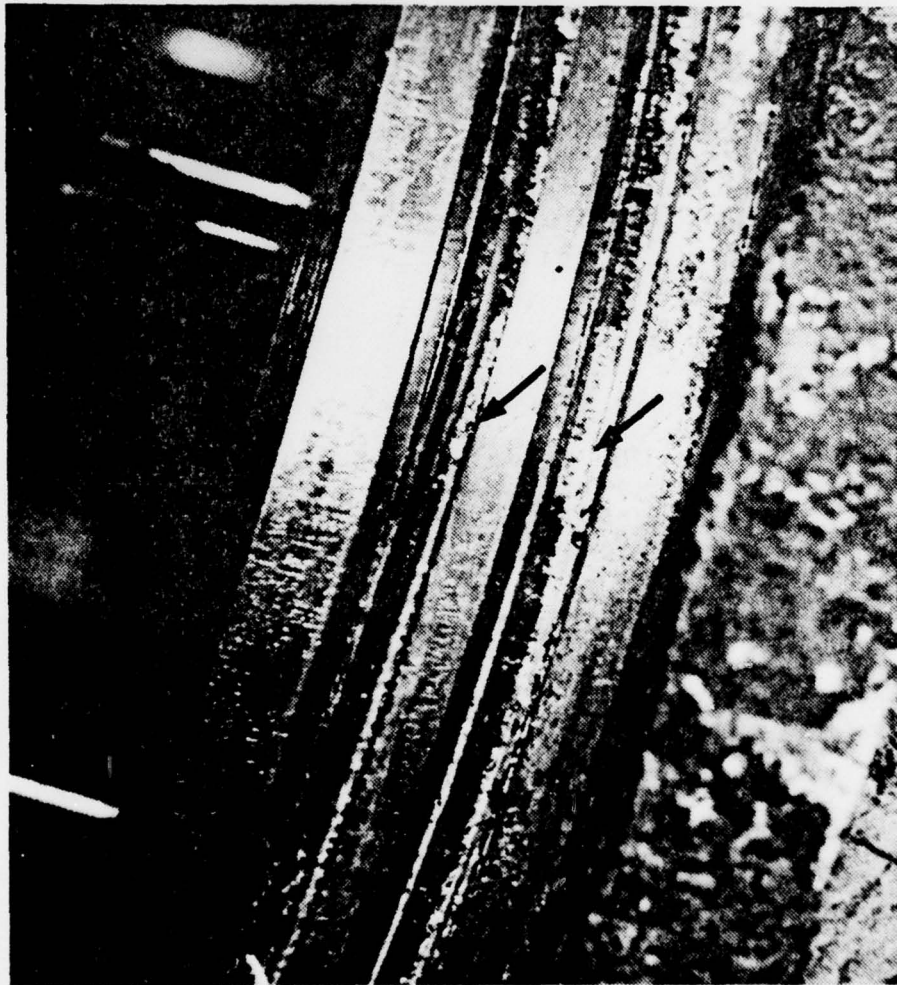
first. Very little corrosion was evident at the sealing surface to the first O-ring. The O-rings had a moderate amount of grease on them, as can be seen in Figure 4. The inside surface of the end plate had a dull green coating which, a discussion with APL personnel indicated, was a proprietary dichromate sealing finish used on zinc-plated surfaces.

Figure 4. End Plate O-rings, Junction Box, Array 7
(Enlarged)

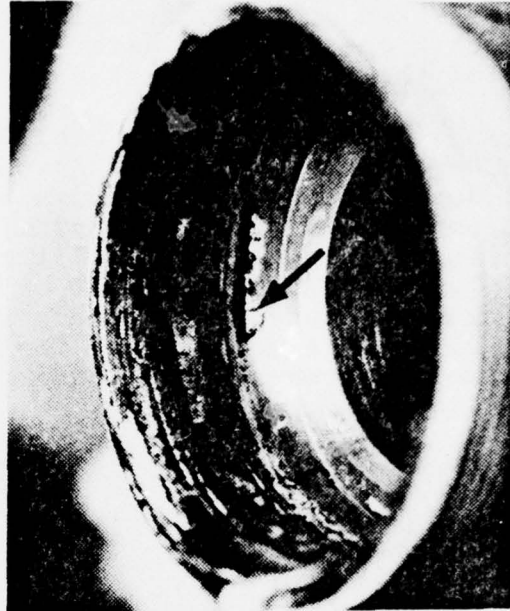
Morrison Seals. The Morrison seal of the main cable was inspected. The O-ring seal of the Morrison seal body was corroded to a maximum depth of 1.241 inches at one point, which is beyond the second O-ring; however, no water was found in the seal area (see Figure 5). The O-rings were fairly heavily greased. The grease on the outer O-ring had become a chalky white due to exposure to seawater. This condition has also been observed on components recovered at NAVTORPSTA ranges. The O-ring squeeze was found to be about 12 to 13 per cent, which was about one-half that of the squeeze at the preamplifier seals. The observed dimensions were found to be in accordance with a detailed drawing of the part.

Figure 5. O-ring Surface,
Main Cable Seal
(Approx. life size)

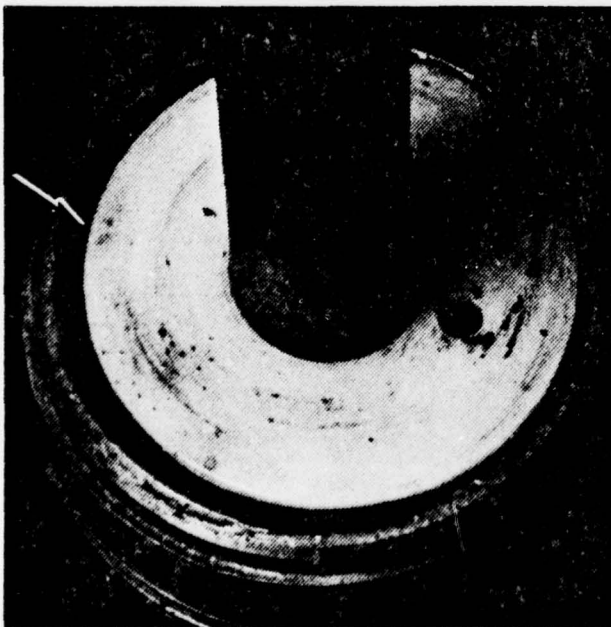
The back-up washer at the face of the first Morrison seal was slightly off center, causing the seal to extrude slightly at one side. (See Figure 6). Water which apparently entered along the gland wall, was found under the third main seal. Corrosion depth in the Morrison seal gland was 1.724 inches from the top of the gland. The corrosion line reached to the middle of the third seal. Water was also found at the solder cup, where the cable shield is attached to a feed-through pin.

Figure 6. Extruded Seal, Main Cable Seal
(Approx. life size)

The water found in the solder cup evidently entered the severed end of the cable during re-submergence. Supporting this observation, water was found along the complete length of the cable stub attached to the seal.

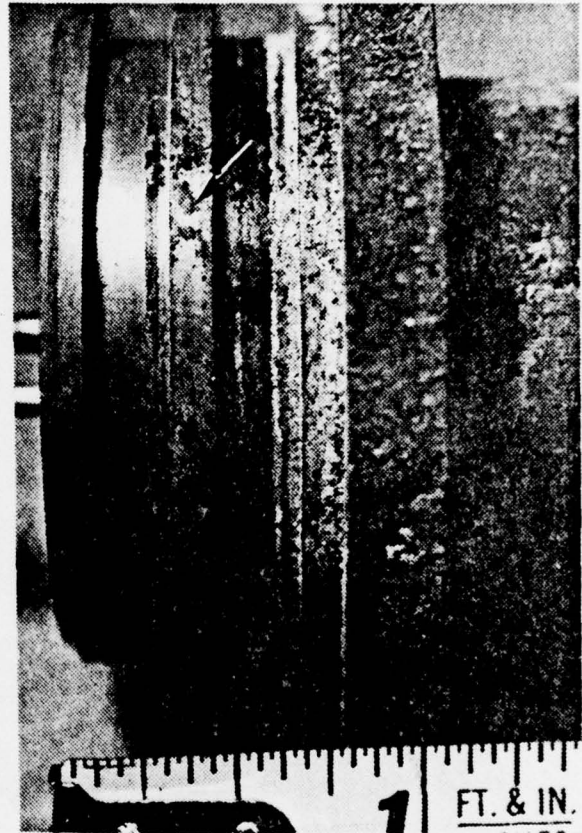
Preamplifiers. No water leaked beyond the second O-ring of any of the preamplifiers. However, some moisture had leaked past the first O-ring of the cable seal end caps. This was evidenced by slight corrosion of the surface between the two O-rings of the cable seal end caps of the c, x, xy, and UQC preamplifiers. Figure 8, a photograph of the x preamplifier cable seal end cap shows this condition. The hydrophone end of the preamp is capped by a similar double O-ring seal. These showed no leakage past the first O-ring in any of the preamplifiers. Figure 9 is a photograph of the x preamplifier hydrophone end cap seal. The scratches on the lands were made during disassembly. It was noted that the O-ring surfaces of the end caps had two types of finishes: some the dull green type mentioned earlier, and the others a bright gold type. The bright gold-colored surface is a sodium dichromate seal finish used on zinc plate. There appeared to be no difference in corrosion protection between the two types of finish.

Figure 8. Corrosion Between O-rings,
X Preamplifier Cable Seal End Cap
(Enlarged 2X approx.)

1. The only leak past a double O-ring occurred where the O-ring squeeze was 12 per cent versus 23 per cent at other O-ring seals. It is recommended that the higher squeeze be used to achieve a longer service life.

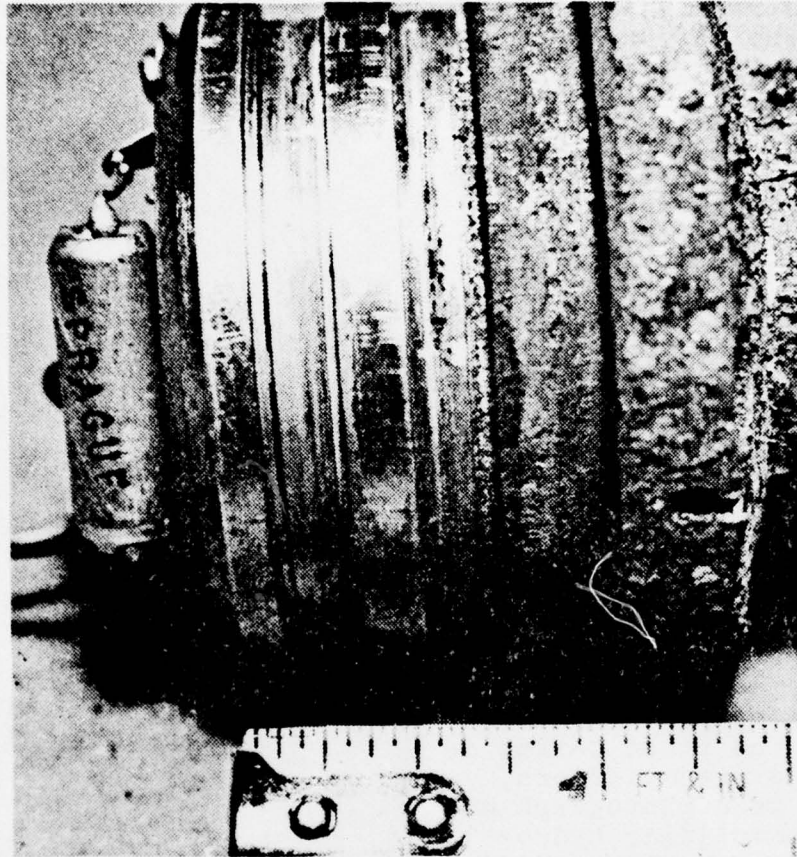
The O-ring squeeze of the preamplifier seals was determined by measuring the outboard groove/gland dimensions and the corresponding O-ring dimensions. The average squeeze was about 23 per cent on the cable seal end and 24 per cent on the hydrophone end. The lubrication, or amount of grease, on the O-rings on both ends appeared to be about equal. All O-rings had back-up rings.

Figure 9. O-ring Seal Surface, X Preamplifier Hydrophone End Cap
(Enlarged 2X approx.)

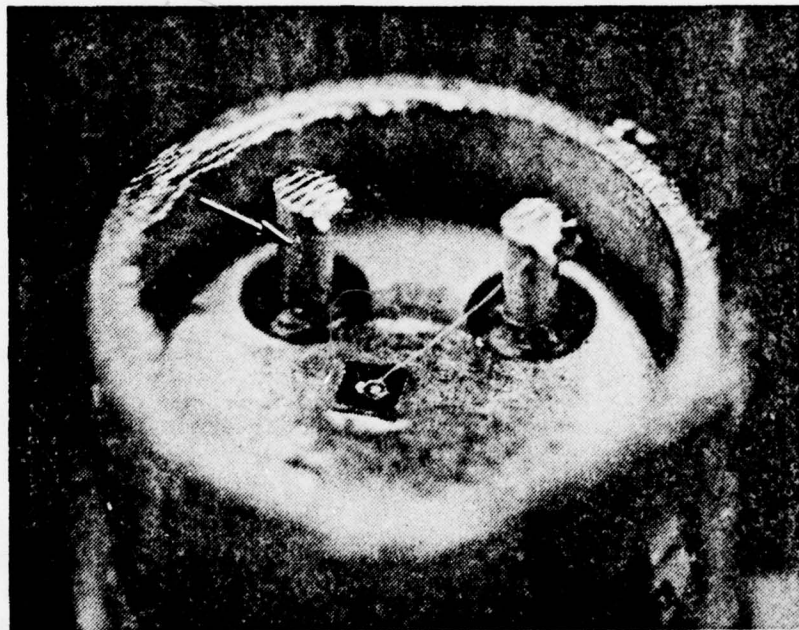
The array was recovered because of malfunctioning of the c and x preamplifiers. Bench tests of the c preamplifier indicated its failure was due to an open in the base of the first input transistor, Q1, a 2N2484. The transistor can was cut open and it was found that the lead to the base junction of the transistor had melted, thus creating an open to the base. See Figure 11. The failure of the x hydrophone was not

Figure 11. Open Contact in Q1 Transistor
(Enlarged 19X approx.)

The malfunction of the c preamplifier was due to an open in the base junction contact of the Q1 input transistor. The x preamplifier failure most probably was due to a low-resistance path between the shield and center conductor. Crevice corrosion at the seal gland progressed past three rubber seals into an area where seawater created a conductive path between the conductors.

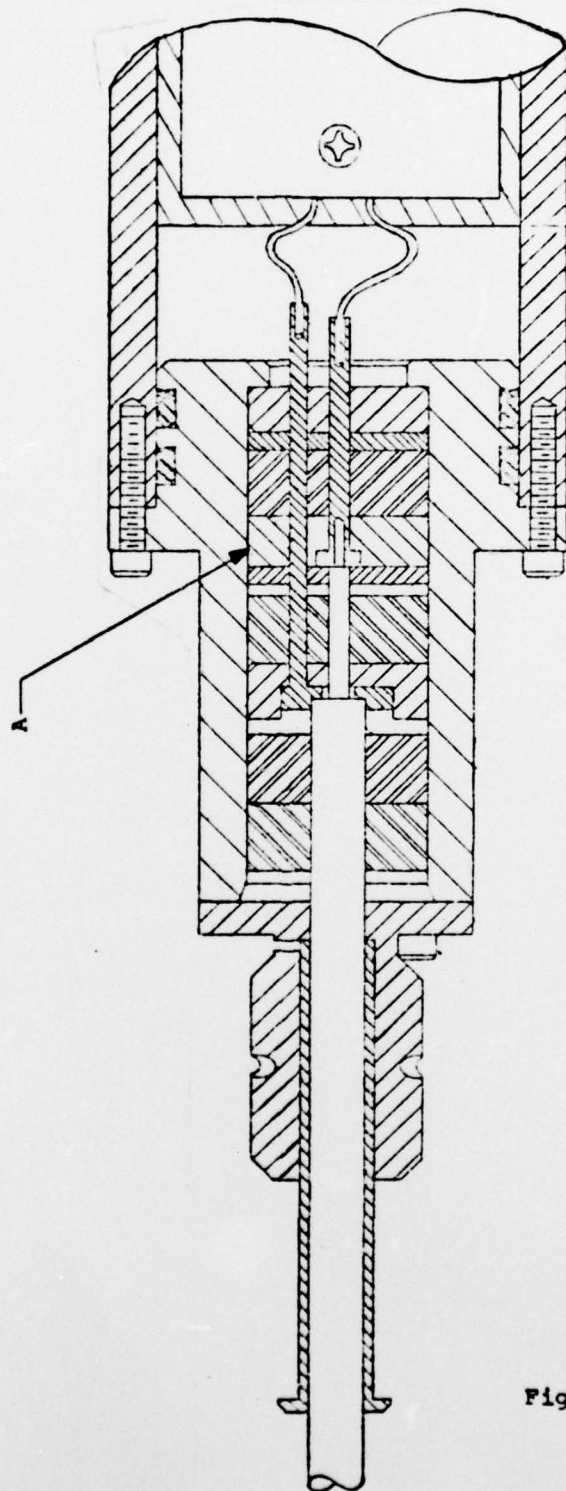
so clear cut. The preamplifier was tested on a bench but no malfunction was apparent. However, the interconnect cable had a resistance of 29k ohms between shield and center conductor prior to disassembly of the housing. With the ohmmeter polarity reversed, the resistance was 52k ohms. This difference indicates a small battery action which occurs with seawater leakage. This resistance was taken after the cable and seals had been out of the water for 3 months; the resistance when the array was in the sea is not known. Corrosion in the seal gland at the preamplifier indicated that moisture had reached the point where the center conductor and shield are separated just ahead of the last seal. This is shown as A in Figure 12. Moisture at that point resulted in a conductive path between the two conductors. The effect could range from no signal to a very noisy signal from the preamplifier depending upon the resistance of the path.

Figure 12. Corrosion Area,
Morrison Seal

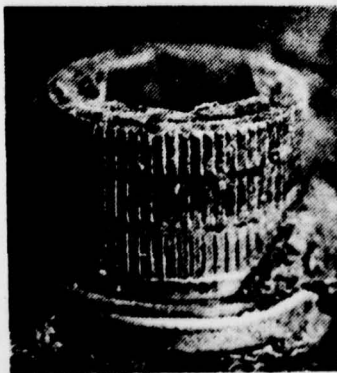
Figure 14. Hold-Down Screw on Tilt Housing (Enlarged 2½X approx.)

Tilt Housing. The exterior of the housing was heavily corroded with red-brown to yellow-brown layers. See Figure 13. However, the 3/8-16" stainless-steel hold-down screws were uncorroded; see Figure 14. On removal of the housing cover, about

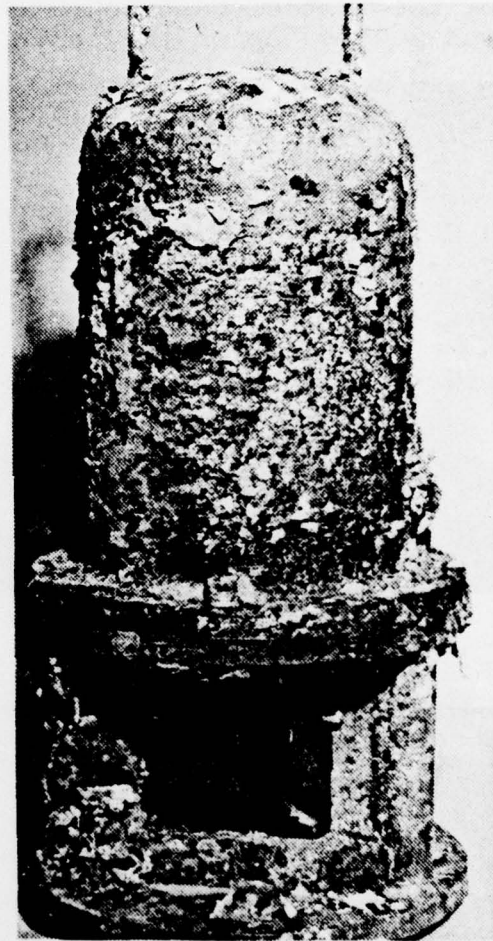
Figure 13. Tilt Housing, Array 10 (0.23X approx.)

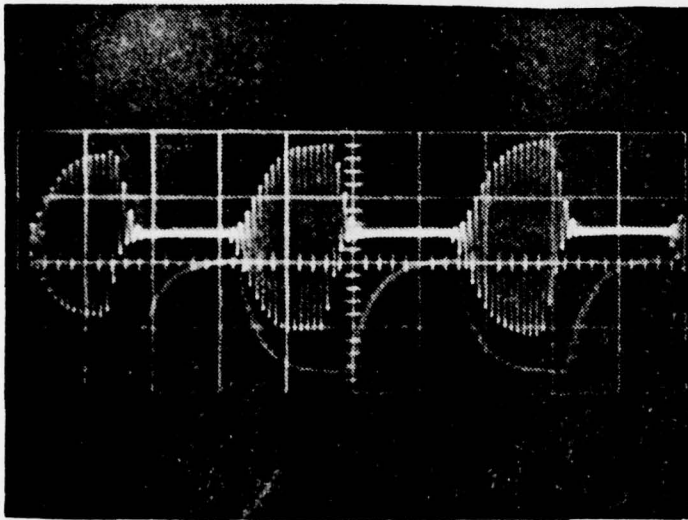
Figure 15. Tilt Output Waveform Observed in Bench Test

on a Tektronix 545 oscilloscope. The output at the cable terminals with the pendulums in a level attitude was a 20-kHz sine wave on a pulsed frequency of 588 Hz. The peak-to-peak output level was about 3 volts with 28 volts dc power. See Figure 15. The lower sawtooth wave is the output of the unmodulated synchro transmitter. Operation of the tilt circuit appeared normal. As a comparison Figure 16 shows the output as was seen at the computer site at St. Croix when the array was still on the range.

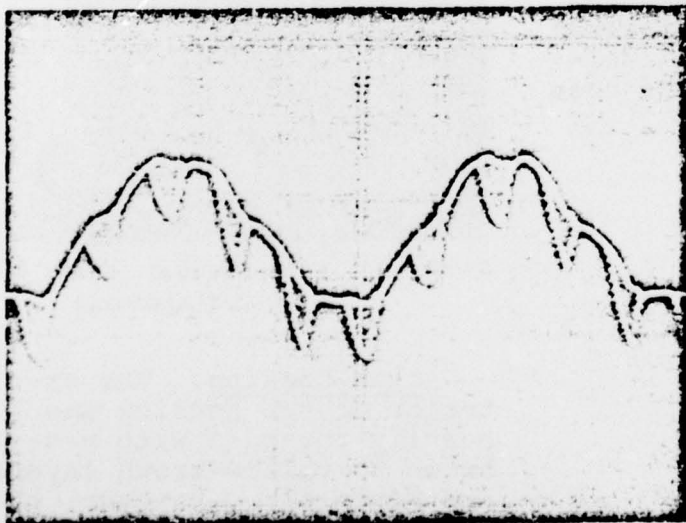
Figure 16. Tilt Output Observed at St. Croix

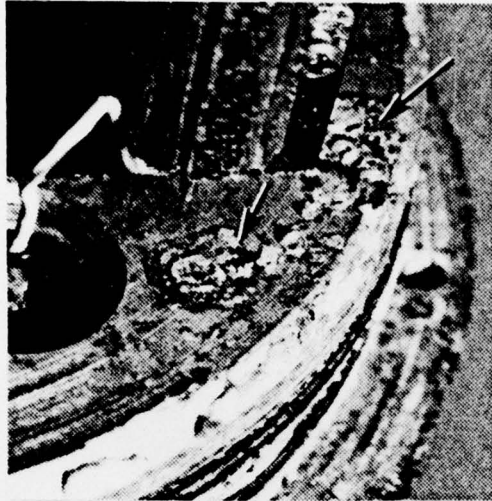
The main junction box exterior was heavily corroded with red rust and a yellow powdery residue around the interconnect cable seals. The j-box housing was oil filled, which is unusual. Some corrosion was noted in the interior at the interconnect cable end plate and on the housing wall, which had two dime-size spots. These corrosion areas appeared to be isolated and not a result of a seawater leak.

Figure 17. Corrosion on End Plate, Main Junction Box (Enlarged)

(See Figures 17 and 18.) A corrosion spot was also seen on the printed circuit board which was mounted on standoffs on the end plate. (See Figure 19.) This indicates that some moisture may have been in the oil at the time of installation. The double O-ring seals of the end plates were heavily greased. Some corrosion was evident in the O-ring grooves but was irregular; see Figure 20. Seawater corrosion of O-ring surfaces ordinarily advances along a line roughly parallel to the grooves, as in Figure 21.

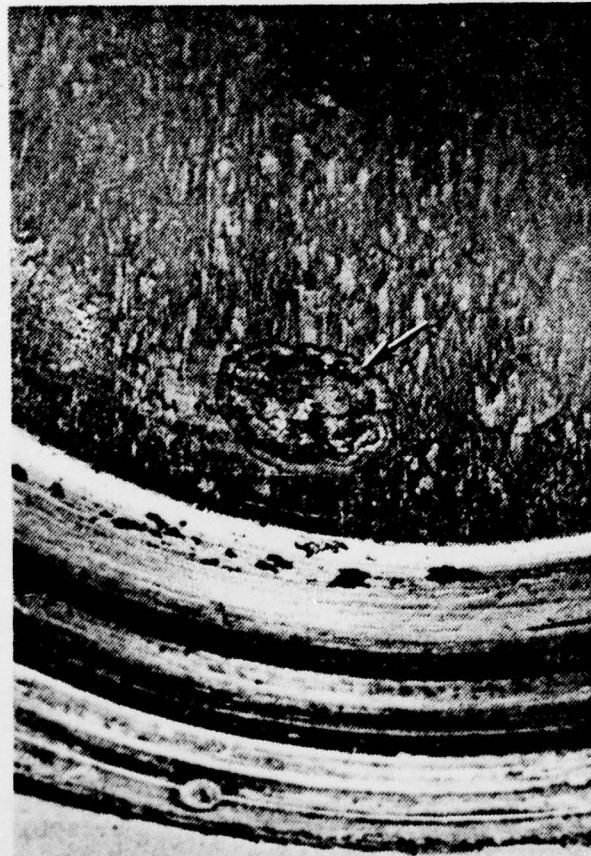
Figure 18. Corrosion in Housing, Main Junction Box (Enlarged)

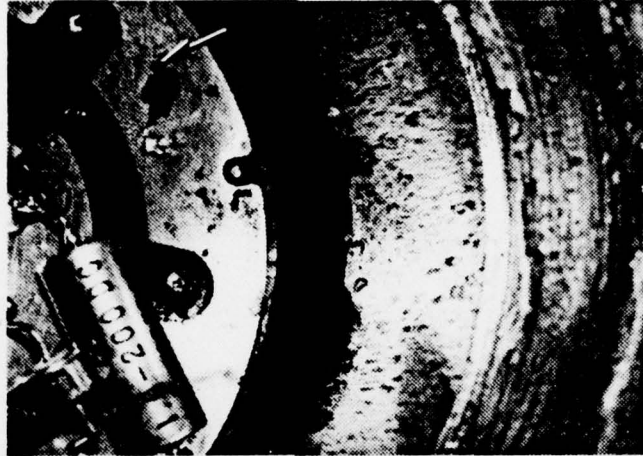
Figure 19. Corrosion on Circuit Board,
Main Junction Box (Enlarged)

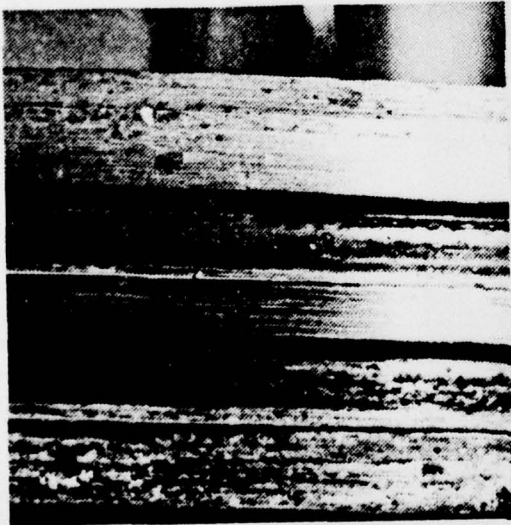
Figure 20. Corrosion of O-ring Surfaces,
Main Cable End Plate (Enlarged)

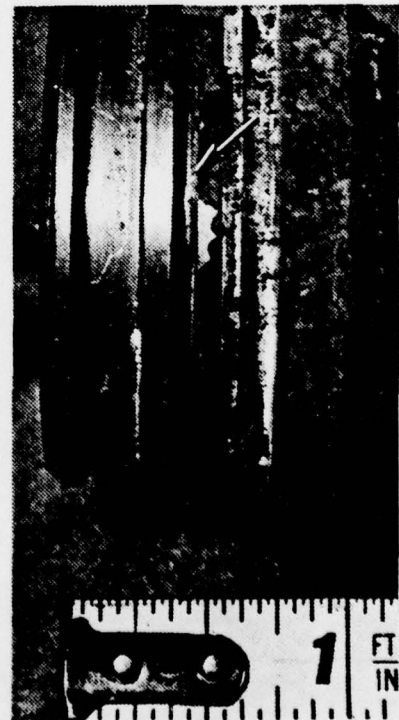
Figure 21. Corrosion of
O-ring Surface,
C Pre-amplifier Cable Seal
(Enlarged 1.5X)

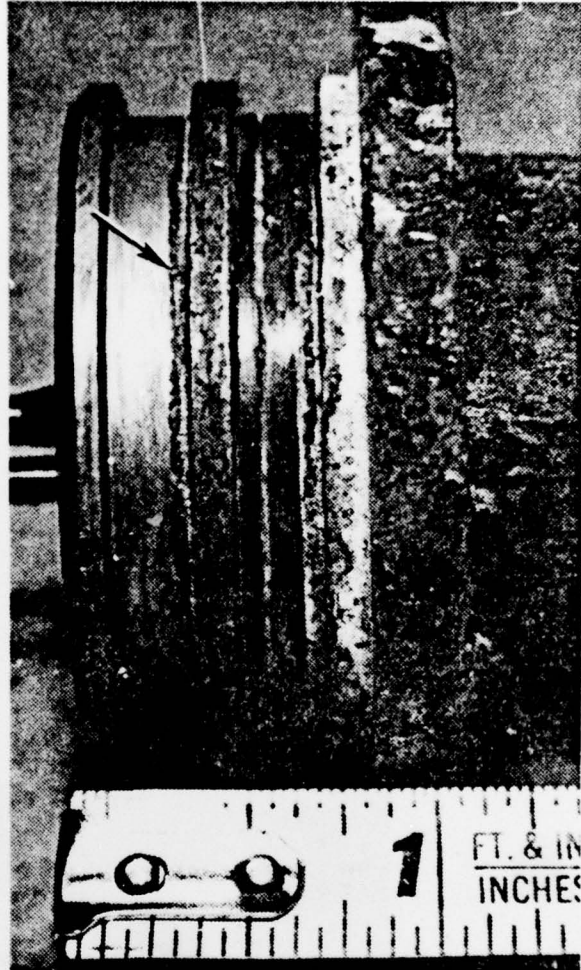
In the case of the x pre-amplifier cable seal end cap, corrosion reached the second O-ring (see Figure 22). The O-ring glands of the housings were corroded to the depths corresponding to the corrosion on the plugs, as shown in Figure 23 for the c pre-amplifier. The c pre-amplifier had a ruptured capacitor (Figure 24) in the tuning circuit. This was a 0.1-microfarad capacitor rated at 200 Vdc. It provided ac ground to seawater on the secondary side of the hydrophone tuning circuit to prevent oscillation in the preamplifier circuit. The failure is believed to have been caused by the high voltage surge of a lightning strike. Strikes had occurred in 1968 and 1973. The resistance across the damaged capacitor was 1 megohm. This would not have materially affected functioning of the preamplifier.

Figure 22. Corrosion of O-ring Surface, X Preamplifier Cable Seal (Enlarged 2X)

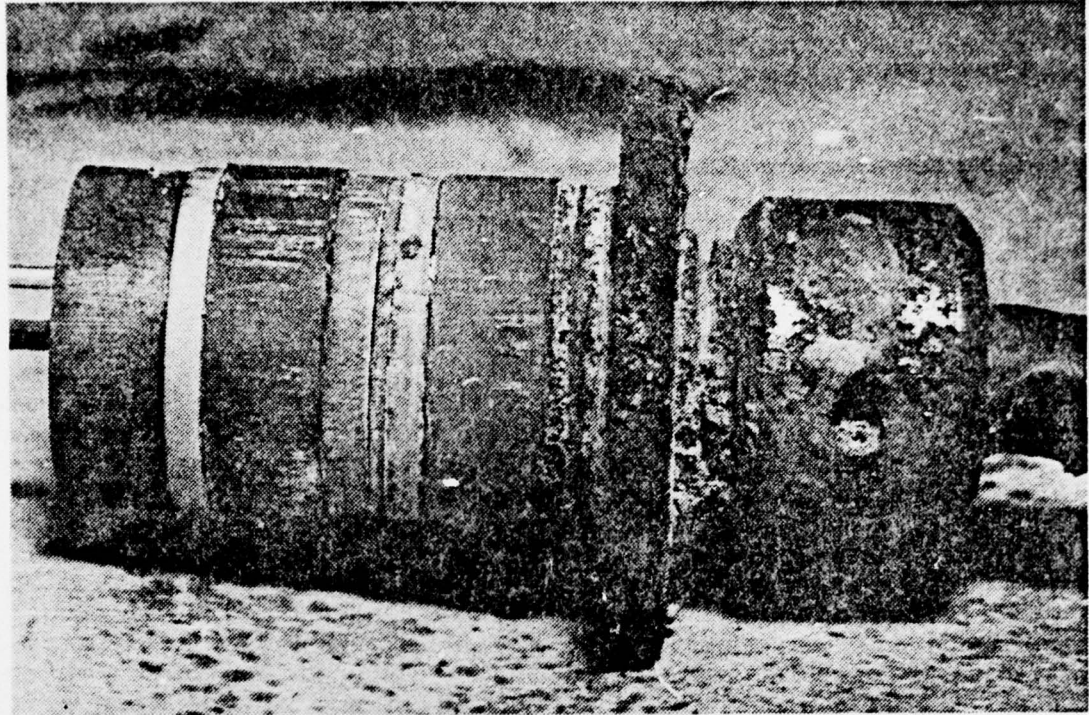
The corrosion in the gland of the main cable seal had progressed 1.238 inches into the seal to the point at which the shield is soldered to a feed-through pin. Figure 25 is a photograph of the seal, whose overall length was 2.4 inches. Water was found at the shield termination but little corrosion had occurred there. Since the main cable had been cut and the array subsequently re-submerged for towing to shore, the water probably entered along the shield from the cut. However, the corrosion path along the gland wall indicates that some water entered at the wall.

Figure 25. Main Cable Seal, Array 10 (Approx. life size)

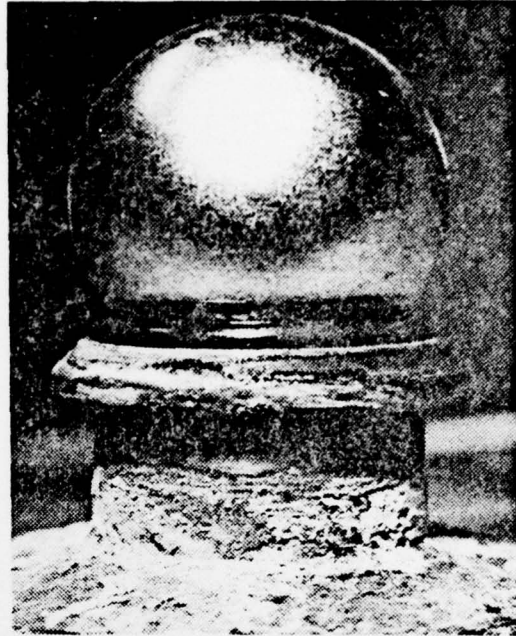
Hydrophone Seals and Transducer. The rubber boots sealing the transducer mounted atop the preamplifiers were inspected. All five hydrophones evidenced water leakage to the O-ring from the wire-wrapped seal at the base of the boot. Figure 27 is a photograph of the xy hydrophone without the boot, which fits over the O-ring and the rounded flange at the base of the

Figure 27. XY Hydrophone, Boot Removed (Enlarged 1.4X approx.)

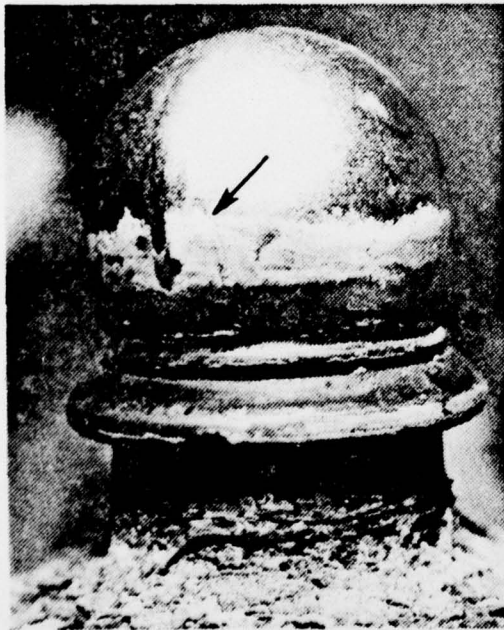
Figure 28. Watermark on Lower Side of Sphere, C Hydrophone (Enlarged 1.4X approx.)

Three of the five hydrophones showed evidence of water leakage at the boot. Watermarks were visible on the transducer elements above the mounting pedestal.
