BALLISTIC DAMAGE OF GRAPHITE-EPOXY PLATES

George Arthur Eaton

June 1977

MASTER OF SCIENCE IN AERONAUTICAL ENGINEERING

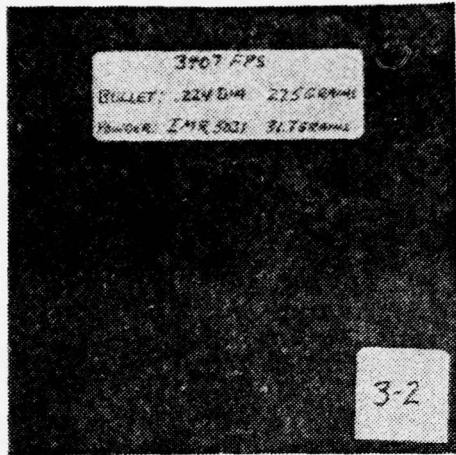
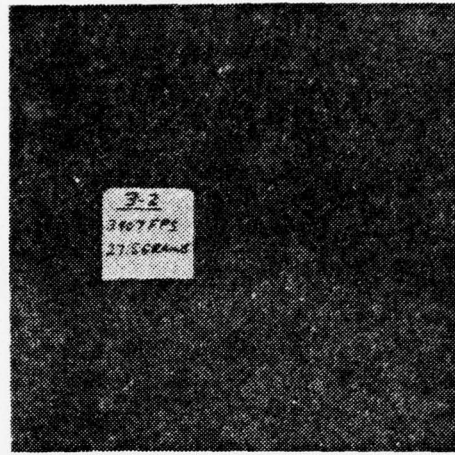
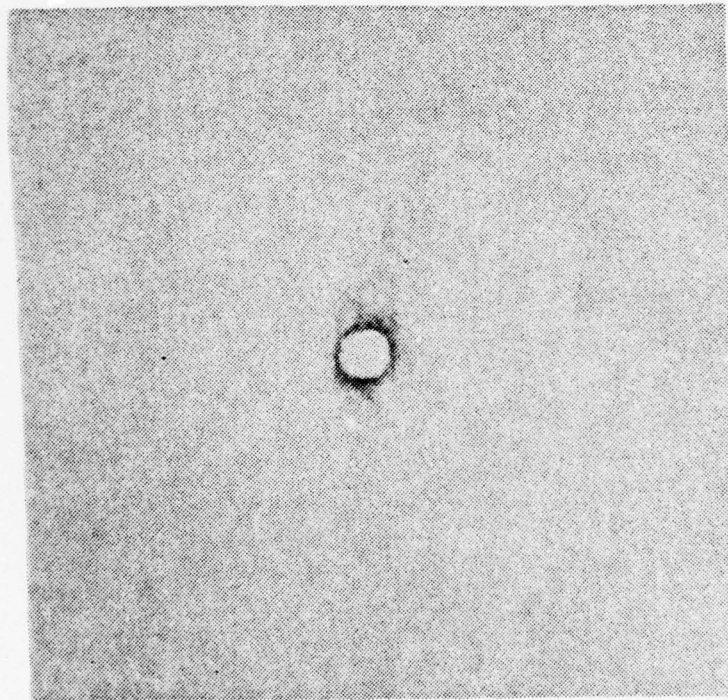
Figure 12 - COMPARISON OF X-RAY AND PHOTOGRAPH OF SPECIMEN DAMAGED AT 3407 FPS

The effect of mass variation did not appear to be a major factor in damage area or extent of fiber separation due to ballistic impact. The damage done to the specimens was nearly uniform for the three masses investigated. Figures 12, 13, and 14 depict the variable-mass specimens and the damage experienced.

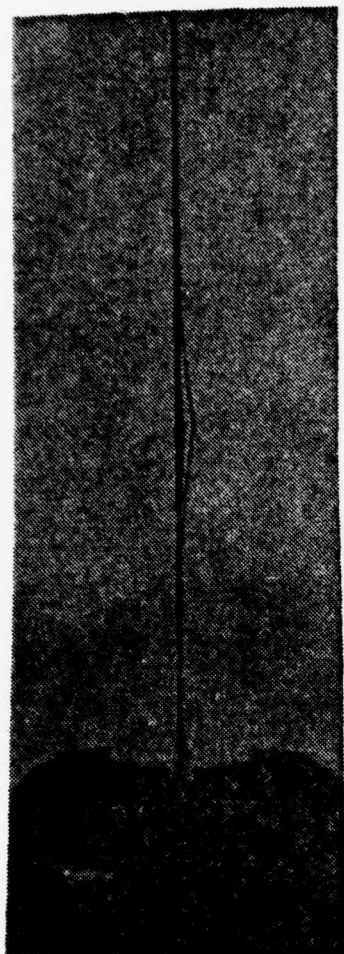
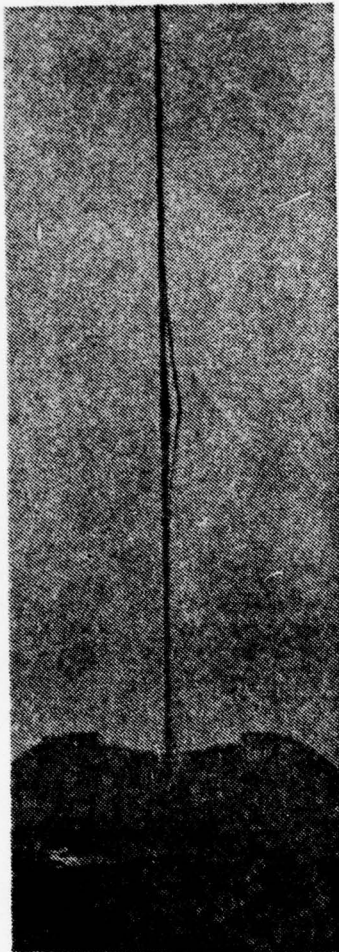
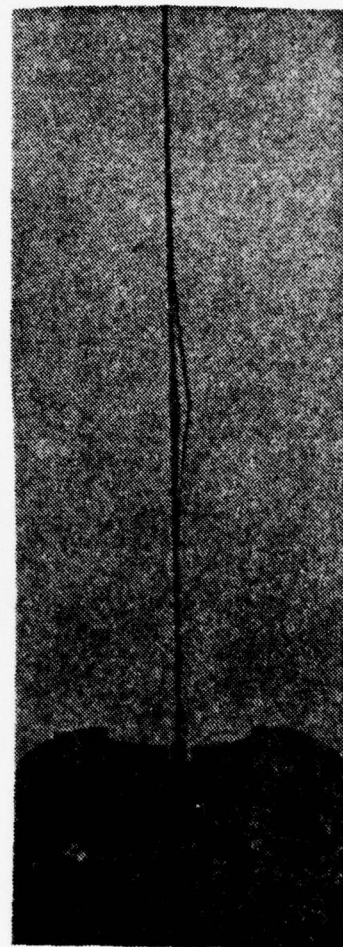
Figure 20 - TENSILE TEST LOADING-TO-FAILURE SEQUENCE

The maximum loading at failure was recorded. Figures 20, 21, and 22 illustrate the sequence of events leading to and including failure of a specimen. The outer laminae of the composite specimens (0° direction) were the only laminae that experienced this separation and protruding. The second ply (45° direction) appeared to remain intact until final failure. The three mechanically drilled control specimens also experienced this separating and protruding above and below the hole, even though they did not have any prior delamination caused by ballistic damage. As loading was applied to these specimens they reacted the same way as the ballistically damaged specimens behaved up to and including failure. The undamaged control specimens showed no sign of physical change while being loaded until they broke.
