INVESTIGATION OF SLUMPING FAILURE IN AN EARTH DAM ABUTMENT AT KOTZEBUE, ALASKA

Charles M. Collins and Terry T. McFadden

July 1977

Prepared for
U.S. PUBLIC HEALTH SERVICE
By
CORPS OF ENGINEERS, U.S. ARMY
COLD REGIONS RESEARCH AND ENGINEERING LABORATORY
HANOVER, NEW HAMPSHIRE

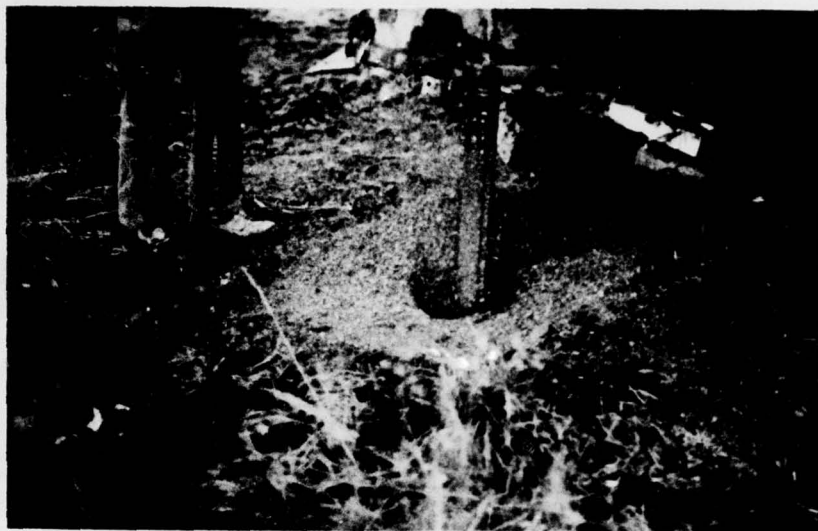
Figure 6. Thermocouple hole being drilled in the crest of the dam. Note the extensive amount of clear ice being extracted from the hole.

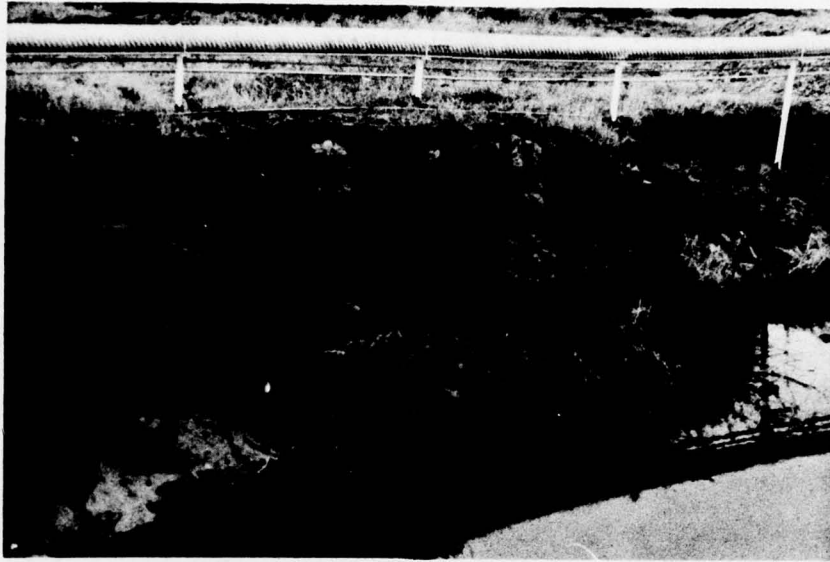
The drill logs (Fig. A5-A11, App. A) and the thermocouple readings (Table I) show that the dam construction has not disturbed the natural permafrost. Except in the reservoir, all of the material below 2 to 3 ft (0.6 to 1 m) from the surface was frozen. In many of the holes a large amount of massive ice was present [over 20 ft (6-m)]; some of it was very near the surface. This ice was present before the dam was built. However, melting is taking place along the steep, unprotected vertical face of the south dam abutment on the upstream side. Melting of these massive ice

structures is causing the silty soil to slump and collapse. Wave action then contributes further by eroding away the collapsed material.

The observations of this study suggest that, although not immediate, the possibility of failure in the south abutment does exist. It would be caused by the gradual, progressive advancement of the melt line and the subsequent slumping failure of the nearly vertical slopes of the original soils. The problem is confined to the south abutment, where the earthfill dike adjoins the natural terrain, and is due to the high ice content of the natural ground in this area. As is seen in drill logs (Fig. A5-All, App. A), several tens of feet of clear ice are present in this portion of the structure. The progressive melting is caused by heat flux from the water into the frozen soil. As the ice structures melt, the silty soil sloughs off and collapses (Fig. 7). This exposes a new surface to the melting action of the water and the 0°C isotherm progresses farther into the abutment. It is conceivable that this process could continue until the dam has been breached in this area.

Figure 7. View of slumping abutment.

1. The upstream side of the embankment at the south abutment of the dam should be refilled to bring the slope to a much shallower configuration, something approximating that of the man-made embankment (Fig 10 and Fig. B5, App. B) a few yards to the north. This will involve hauling in several hundred cubic yards of embankment fill, such as clean gravel, which is not frost-susceptible. This should be done with the water at the lowest possible level so that the resloping can be as effective as possible. Particular care should be taken to protect the pole foundation under the west end of the bridge carrying the water conduit between the south abutment and the intake structure.

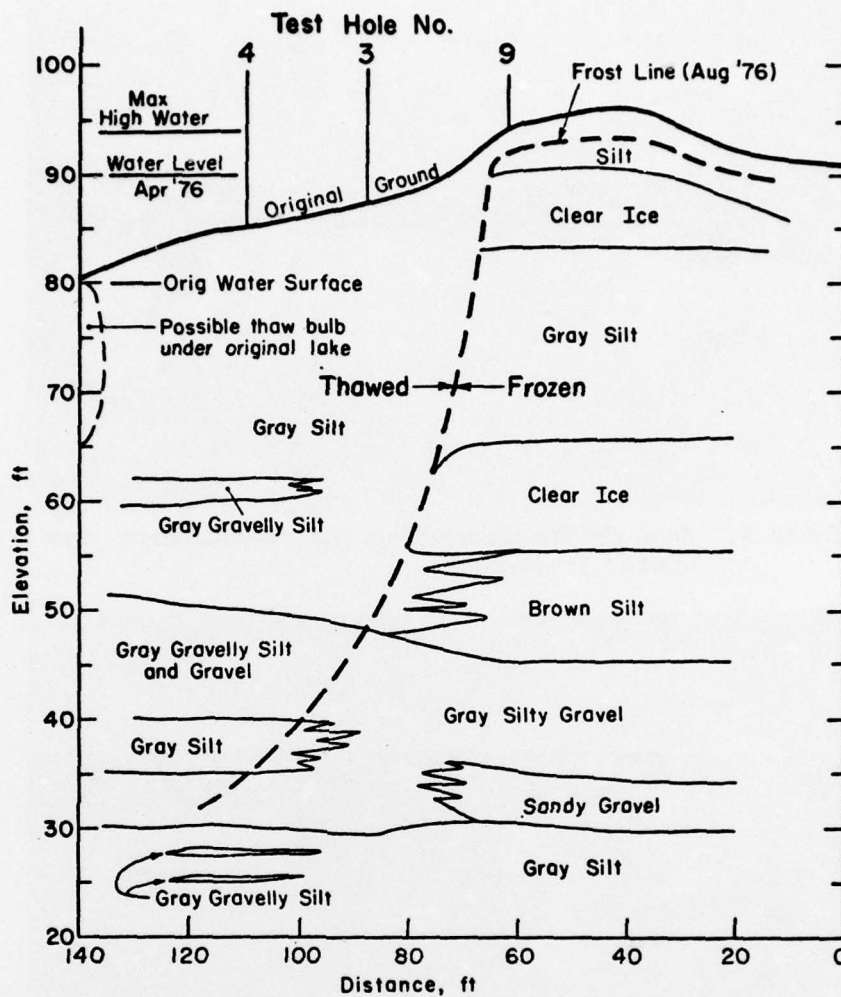
The depth of the thaw bulb beneath the reservoir was not measured at this time; however, it must be less than 47 ft, since all of the thermocouples installed behind the dam show that the portions of the dam which are being measured are below freezing. The thermocouple readings along with the probing and drill logs show that the dam is frozen and is in no immediate danger of failure. All presently observable problems are confined to the south abutment where the embankment adjoins at the south end. No signs of failure or stress of any kind could be found in the embankment of the dam or the north abutment. A composite cross section of the south abutment shows the probable extent of the thaw bulb underneath the reservoir (Fig. 8).

Figure 8. Thaw bulb in Vortac Dam south abutment.

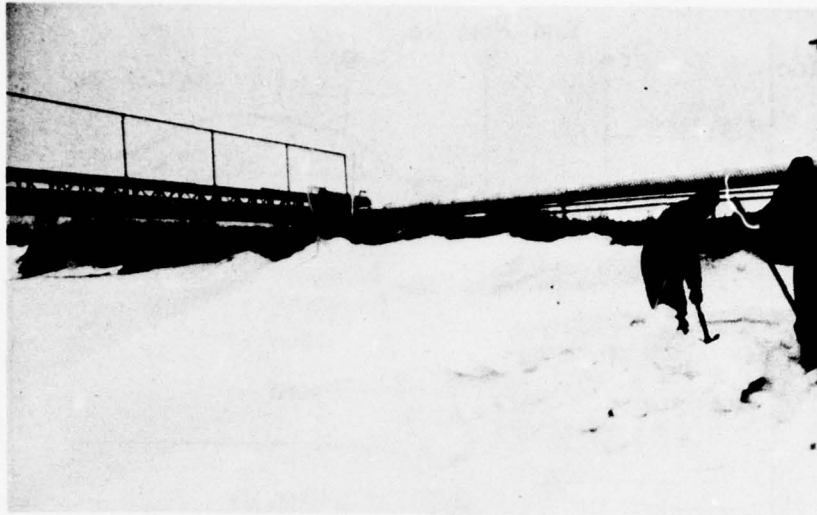
The continual raising and lowering of the water level is detrimental to the performance and lifetime of the embankment. Each time the water level is raised, heat flows into this newly inundated portion causing melting and slumping. When the water level subsides, this area is left to come to equilibrium with the atmospheric conditions which in summer are more conducive to continued melting rather than any refreezing. It would, therefore, be desirable to maintain as stable a water level as is practical (without hindering use of the dam as a water supply). It would also be desirable to maintain a low water level during the winter months so that areas in the embankment could be allowed to refreeze. However, refreezing may be thwarted by the large snow drifts that accumulate on the upstream side of the dam. These drifts effectively insulate the embankment from the winter temperature extremes, and much of the desired freezing (Fig. 9).

Figure 9. Snow drifts insulating the slumped area from winter freezeback.

2. The area around the dam should be cleaned up. Piles of gravel are sitting on the dam crest where they serve no useful purpose and cause snow drifting, which insulates the embankment from the winter cold. In addition, a good deal of debris from construction is scattered around the area and serves only to insulate portions of the embankment that should

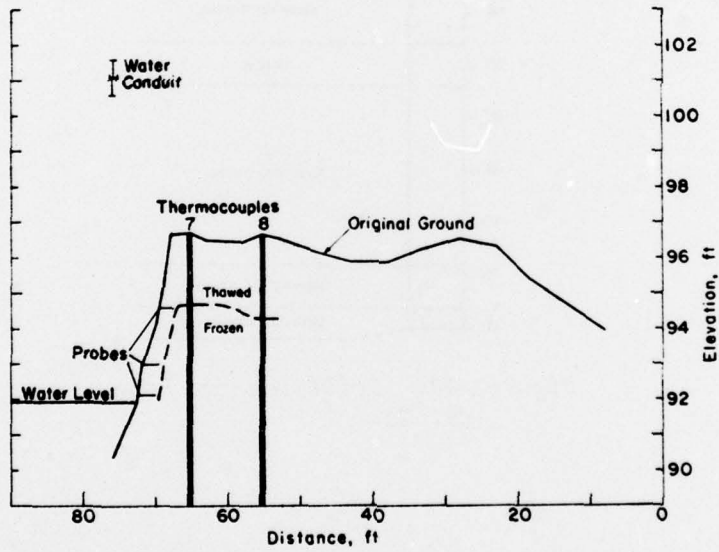
Figure B2. Cross section no. 2.

Five cross sections were made across the dam (see Fig. 2 for locations). Figures B1-B5 (App. B) show these cross sections. The cross section shown in Figure B2 gives the location of permafrost probings which were made in the near vertical upstream bank of the dam abutment and shows the zone of thawed material.
