ADHESIVE BONDED AEROSPACE STRUCTURES STANDARDIZED REPAIR HANDBOOK

BOEING COMMERCIAL AIRPLANE COMPANY
P.O. BOX 3707
SEATTLE, WASHINGTON 98124

December 1976

PHASE IV FINAL REPORT FOR PERIOD 1 OCTOBER 1975 THROUGH 31 MARCH 1976

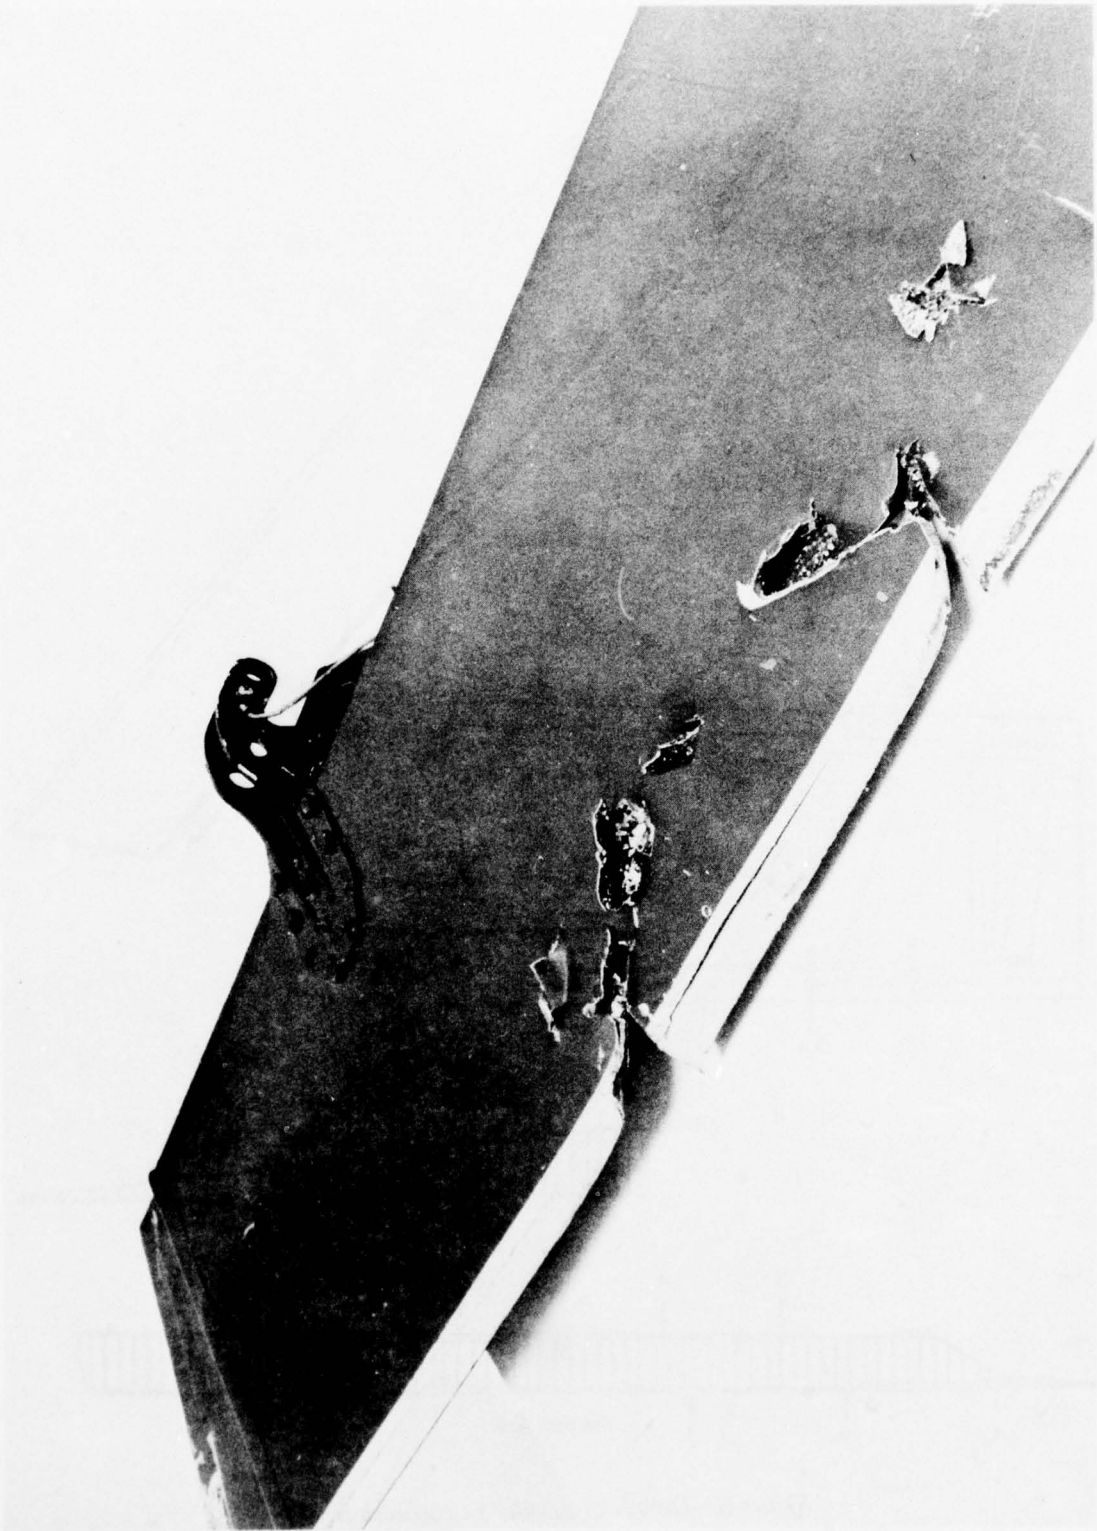
Figure 7. — Damaged F-111 Spoiler

The spoiler was obtained from the Sacramento ALC. The part had been surplused as part of a remodification program. As such, it was undamaged. Since typical damage to this type of part is in the trailing-edge, damage was inflicted in that area, as shown in figure 7. The damage was toward the outboard end of the spoiler. It included part of the skin that was padded up to distribute load from the hinge fitting (see fig. 6, table 1). The damage extended inboard approximately 24 in. and about 5 in. into the spoiler chordwise.

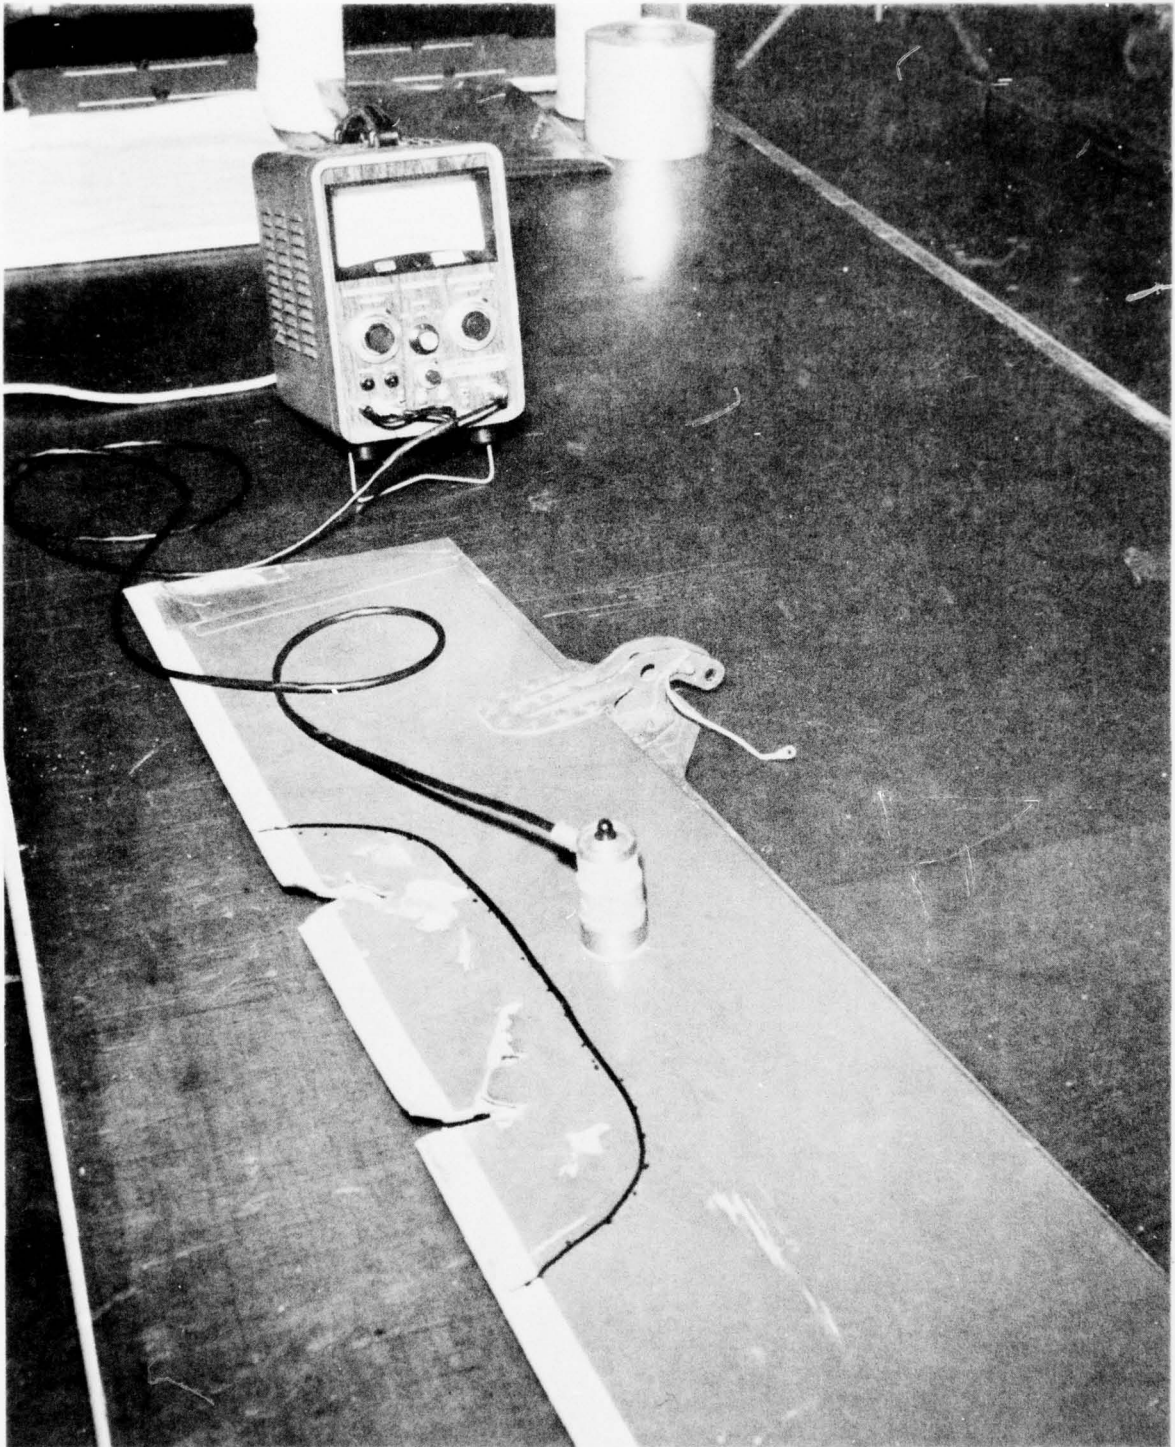
Figure 10.—Ultrasonic Inspection of the Damaged Spoiler

The boundary of the damage was outlined using a Harmonic Bond Tester as shown in figure 10. This gave an indication of the extent of any delamination that had progressed beyond the usual damage.

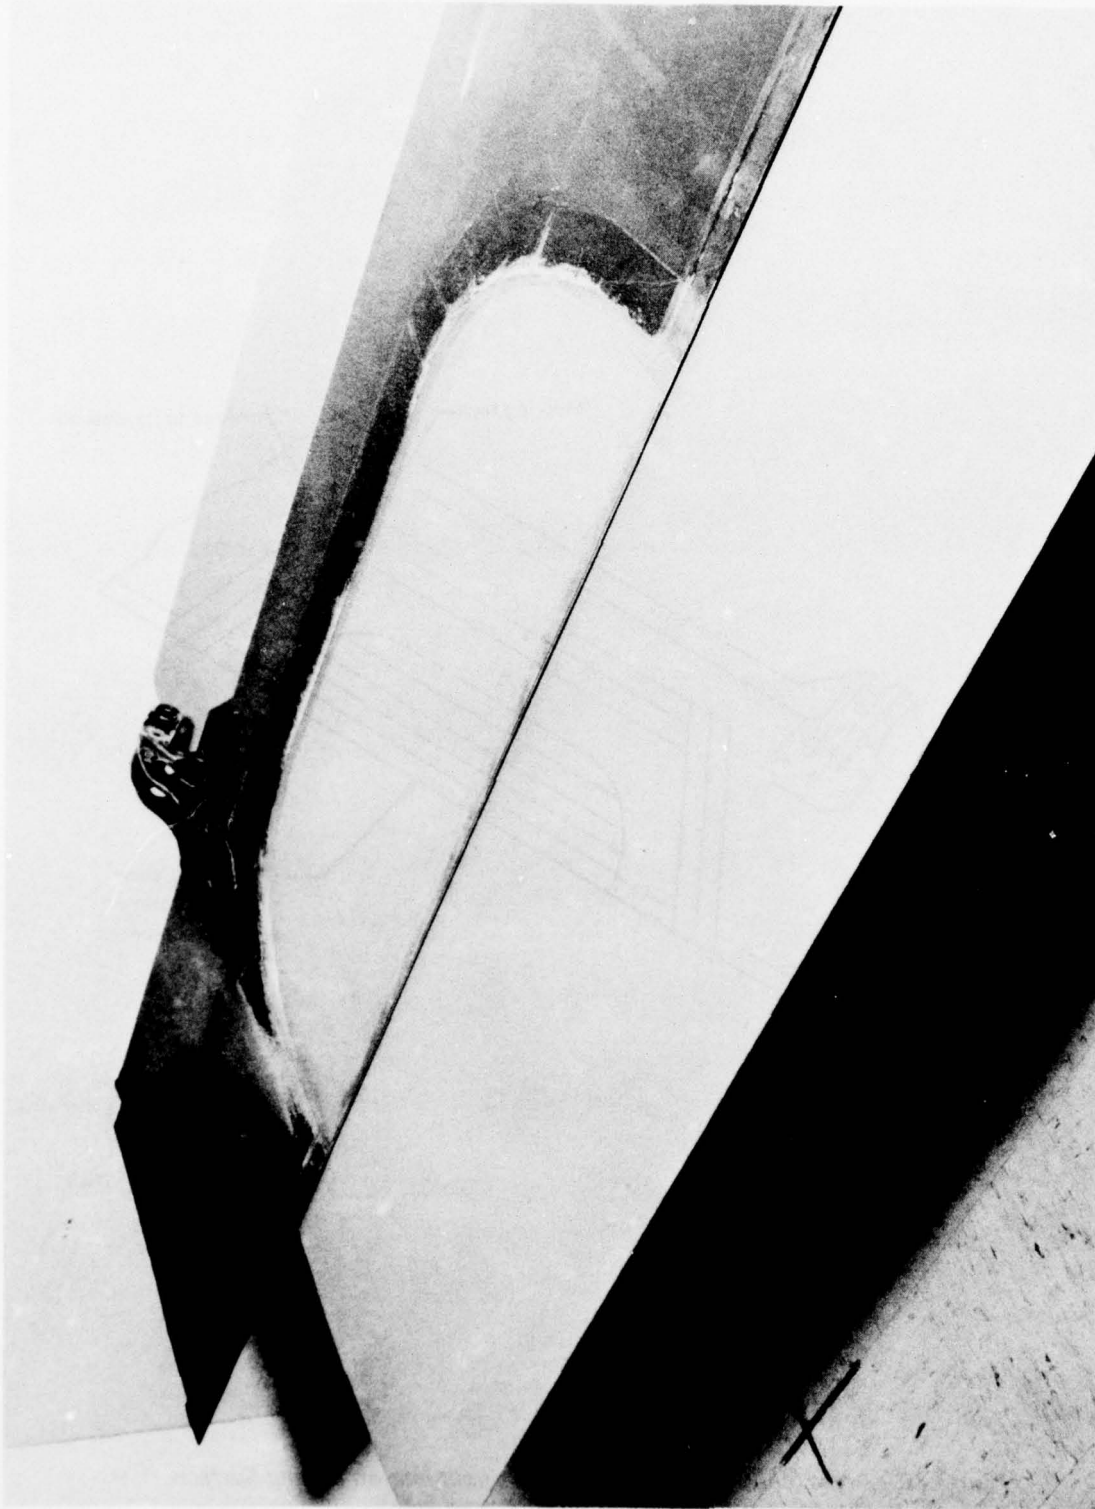
Figure 20.—Nonflush Patch on the Lower Surface

The completed repair was inspected using through-transmission ultrasonics and a portable Harmonic Bond Tester. The results were satisfactory; no voids or delaminations were found.

The next step was to prepare the metal surfaces for bonding the nonflush lower skin patch plate and the doubler shown in figure 10. The areas surrounding the area to be cleaned were masked with aluminum foil tape as shown in figure 19. The bond surface on the spoiler, the doubler, and the patch plate were then phosphoric acid anodized by the procedure noted previously in table 2. Following the surface preparation, the masking materials were removed and the doubler and patch plate taped in position. The assembly was then bagged and cured at 350°F for 60 min under 35-psi pressure. The repair is shown after cure and debagging in figure 20.

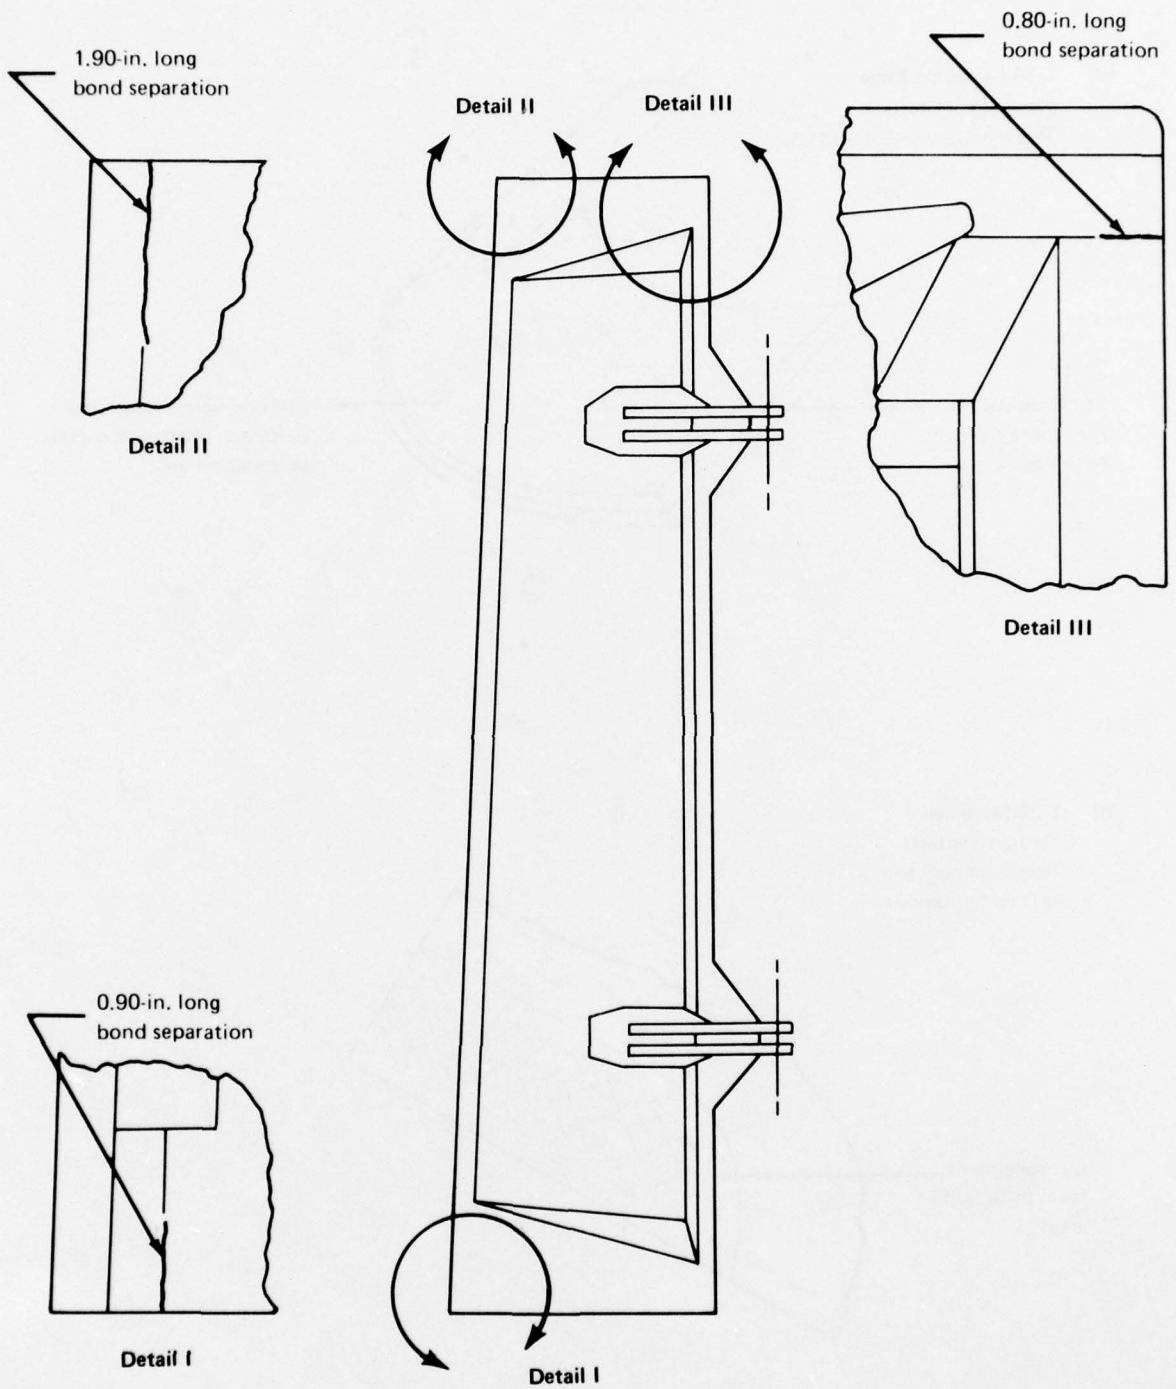
Figure 27.—Areas of Bond Delamination

There was no indication during the test of any failure. A posttest visual inspection, however, revealed bond separations in three areas. These were at the specimen's corners outside the repaired area as shown in figure 27. Subsequently, inspections were made using water-coupled through-transmission ultrasonics and a Harmonic Bond Tester. These verified the three delaminated areas. There was no indication of any failure in the repaired area.

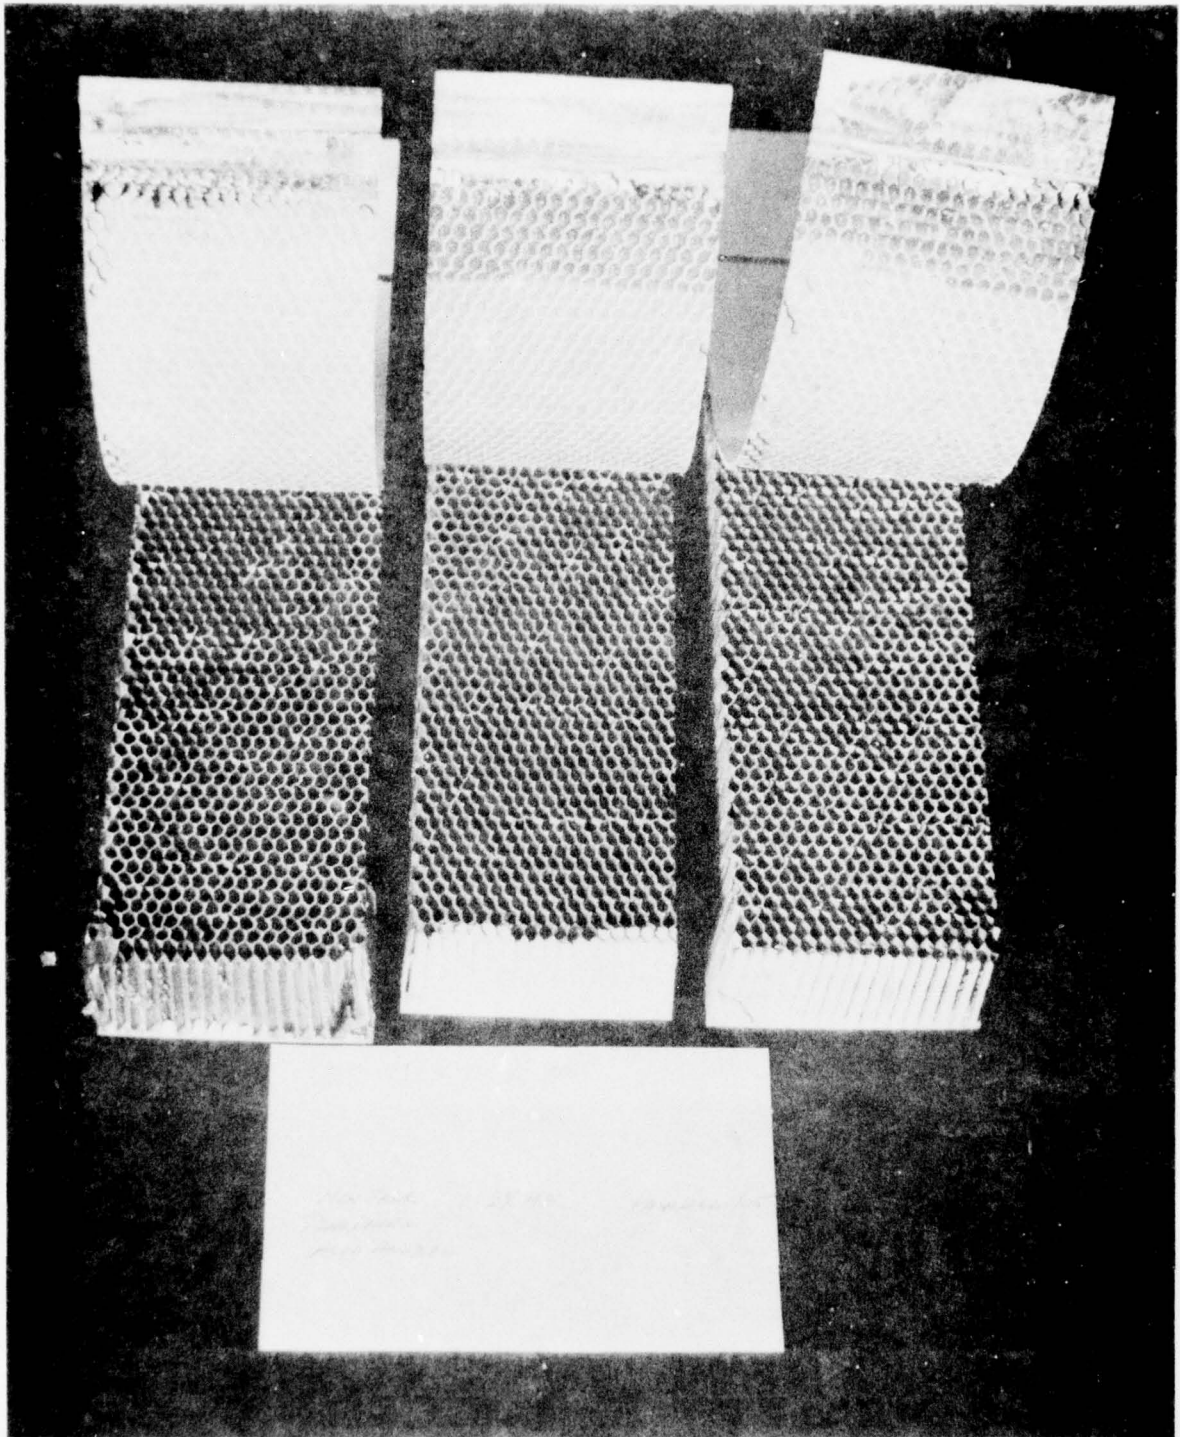
Figure 30. Honeycomb Peel Tests From the C-141 Wing L.E. Repair Showing Core Failure

The results of the tests are given in tables 3 and 4. The test results on the C-141 leading-edge repair were quite good. Core failure was obtained with the peel specimens as shown in figure 30. The test values were consistently high. The wedge tests for this component were invalidated because the crack growth jumped to the surface where an additional metal strip had been bonded to increase the metal thickness. Subsequent opening of the repair interface, however, did indicate satisfactory cohesive failure, figure 31.

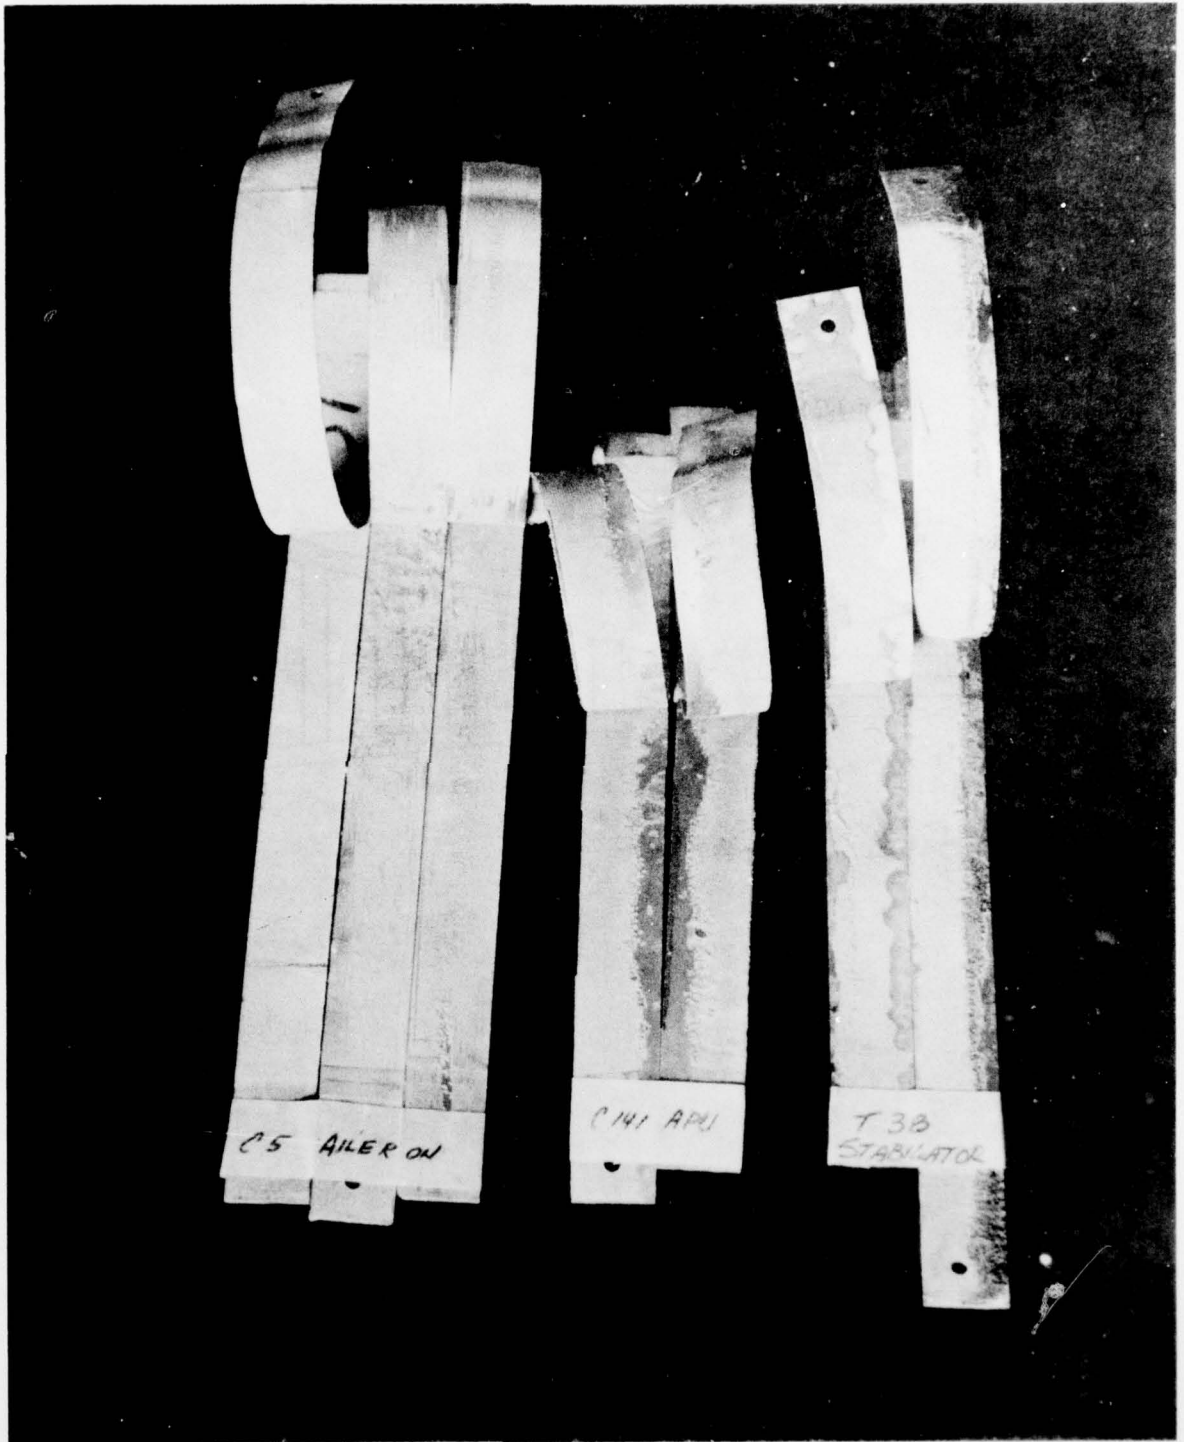
Figure 32.—Salt Spray Exposed Peel Specimens After Test

The metal-to-metal salt spray exposed peel specimens are shown in figure 32. Those from the repaired area of the C-5A aileron component looked very good, and the test values were high. Lower values were obtained on the specimens from the auxiliary power unit (APU) panel and the stabilator. The stabilator specimens were taken from along the laminated

The lower failure values for the APU access panel appear to be primarily a problem with inadequate curing pressure on the repair details. The cure was made using a vacuum bag. The patches were preformed by roto-peening. The core plug was not preformed. It was expected that the plug would form into place with the bonding pressure. This did happen, but the result was apparently some reduction in pressure in the metal-to-metal bondlines next to the core. This was indicated by the lowered peel and wedge values and was additionally apparent by examination of the failure surfaces. They did show that the use of vacuum bag curing should be limited to simple repairs. Double contoured details especially present a problem because of their inherent configuration stiffness and the increased pressure required to pull the details into intimate contact. The use of extra adhesive in these areas offers one possible solution.

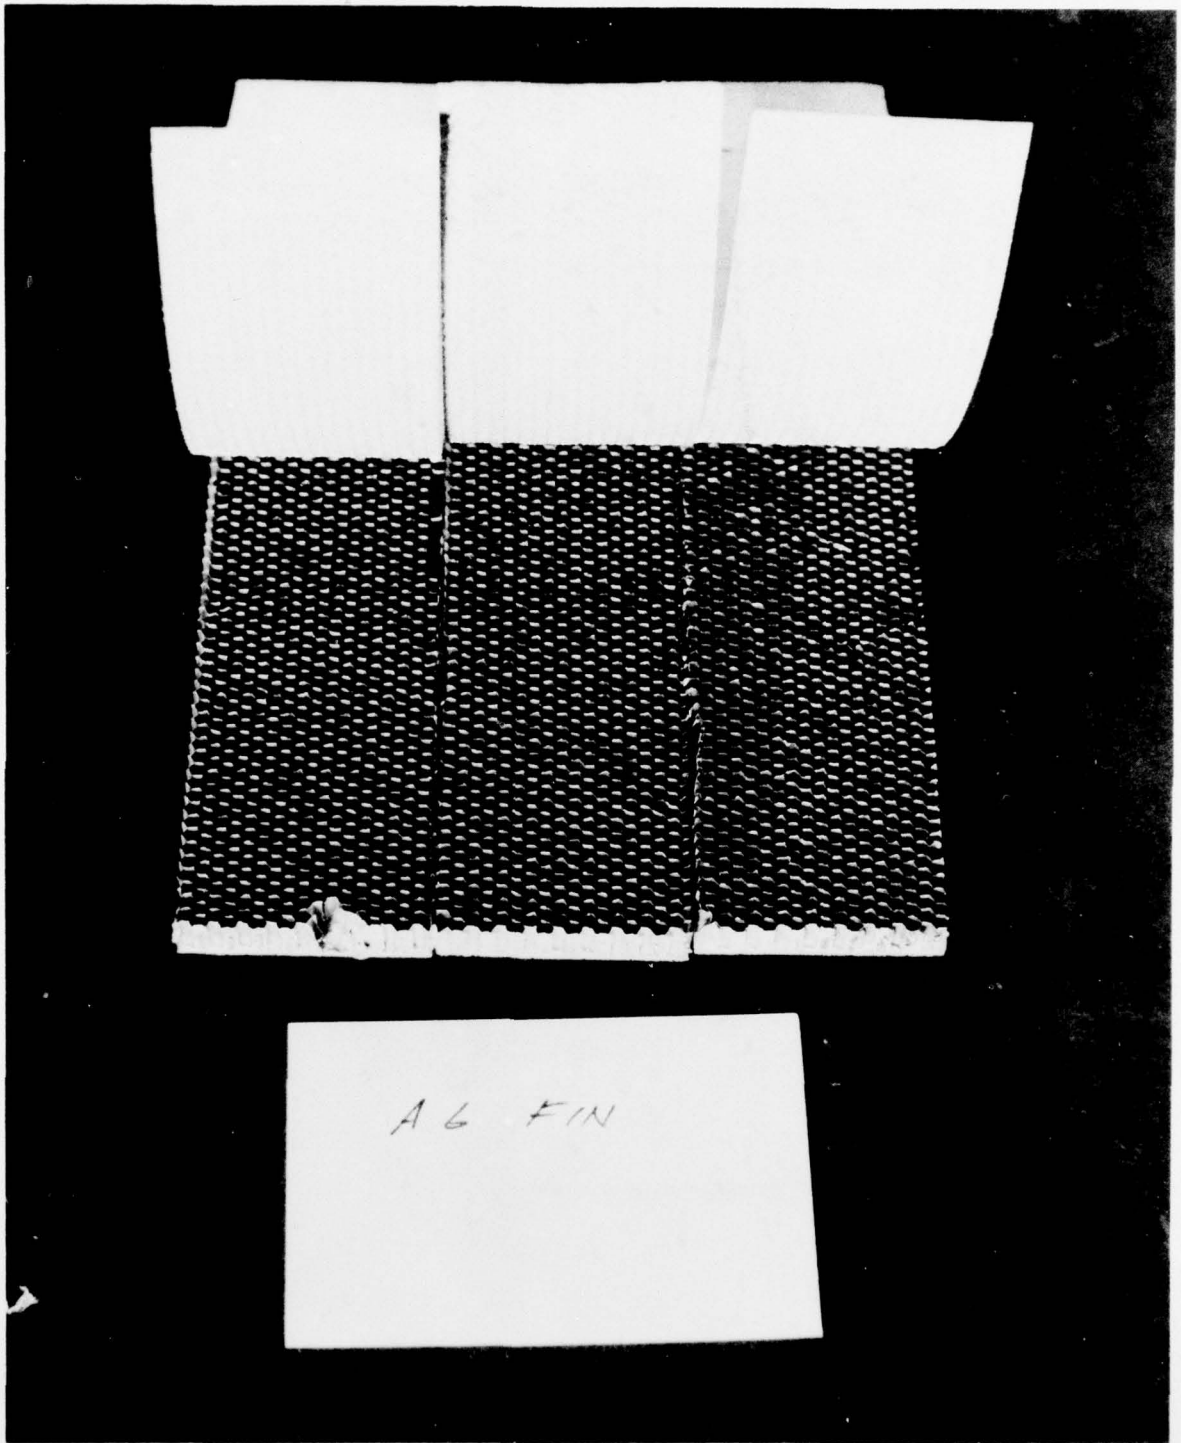
Figure 34.—Honeycomb Peel Specimens From the A-6 Fin Panel Repair Showing Core Failure

Values from the A-6 fin panel repair were very good. Core failure was obtained with the honeycomb peel specimens, shown in figure 34. The failed lap shear specimens are shown in figure 35. The values obtained were comparable to those obtained for that adhesive (AF127-3) during Phase II of this program.

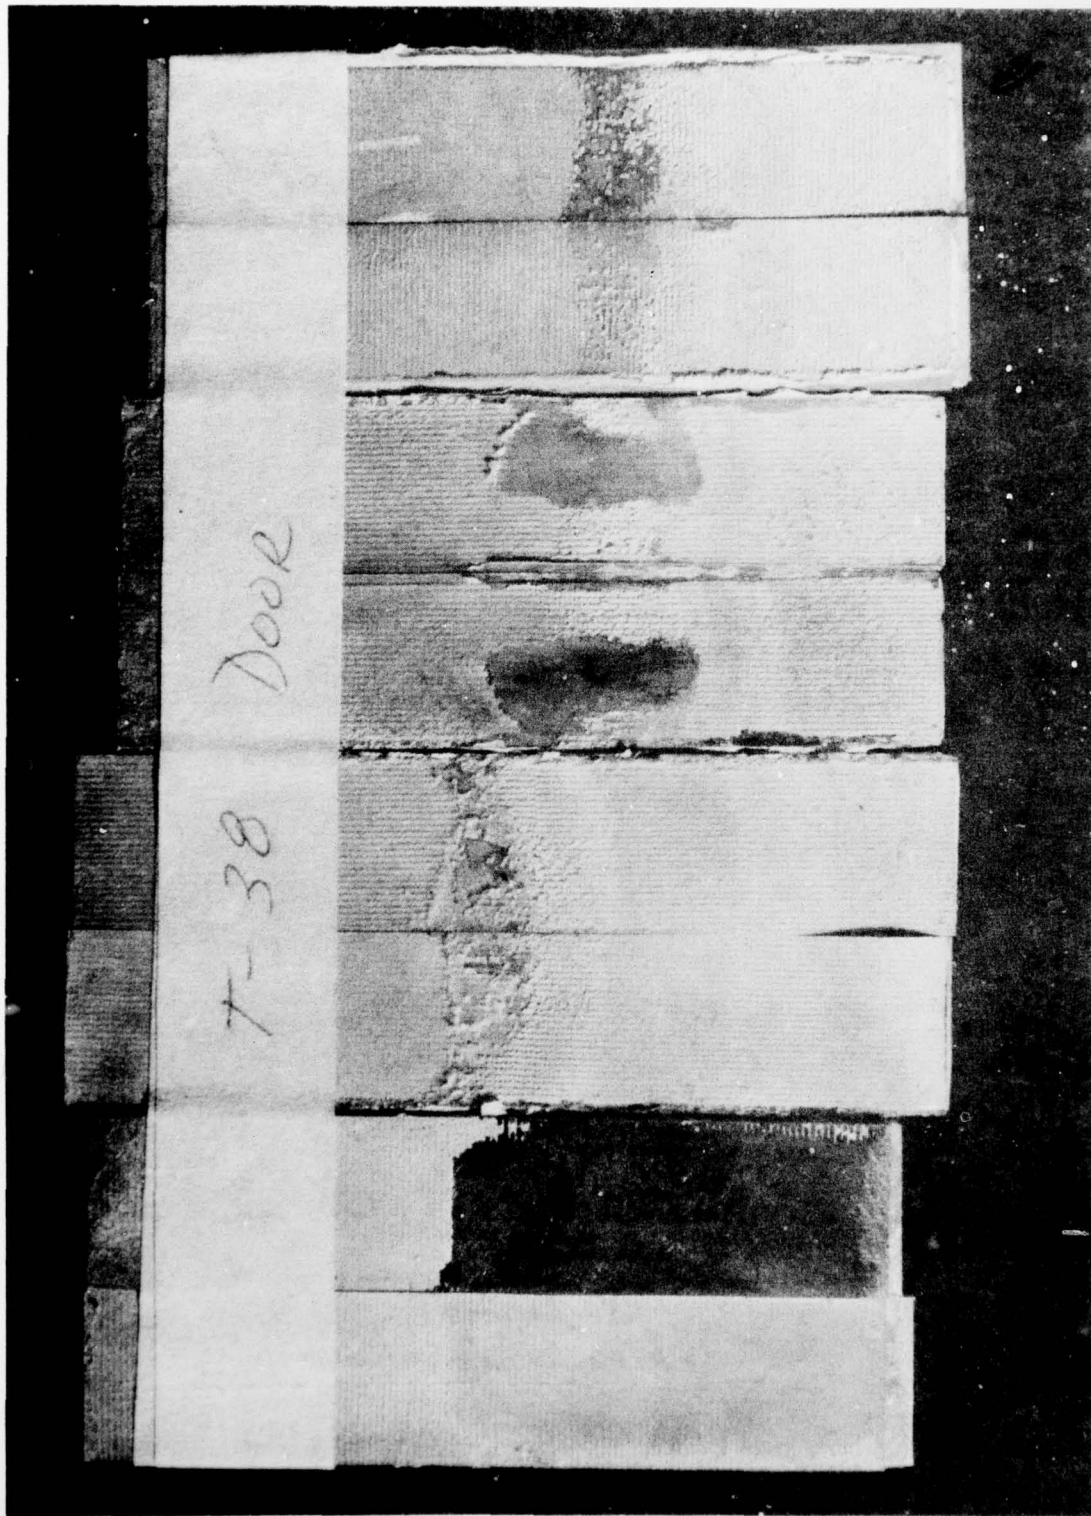
Figure 36. — Failure Surface of Wedge Specimens From the T-38 Door Repair

The failure surfaces of wedge specimens from the T-38 main landing-gear door are shown in figure 36. High crack growth is noted on one specimen. (See the following note and listing.) This is the specimen to the right in the photo that shows a high percentage of adhesive failure. *This may be attributed to inadequate surface preparation.* Apparently the surface did not anodize properly. However, results from the other three specimens were satisfactory with crack growth within the range of expected values.

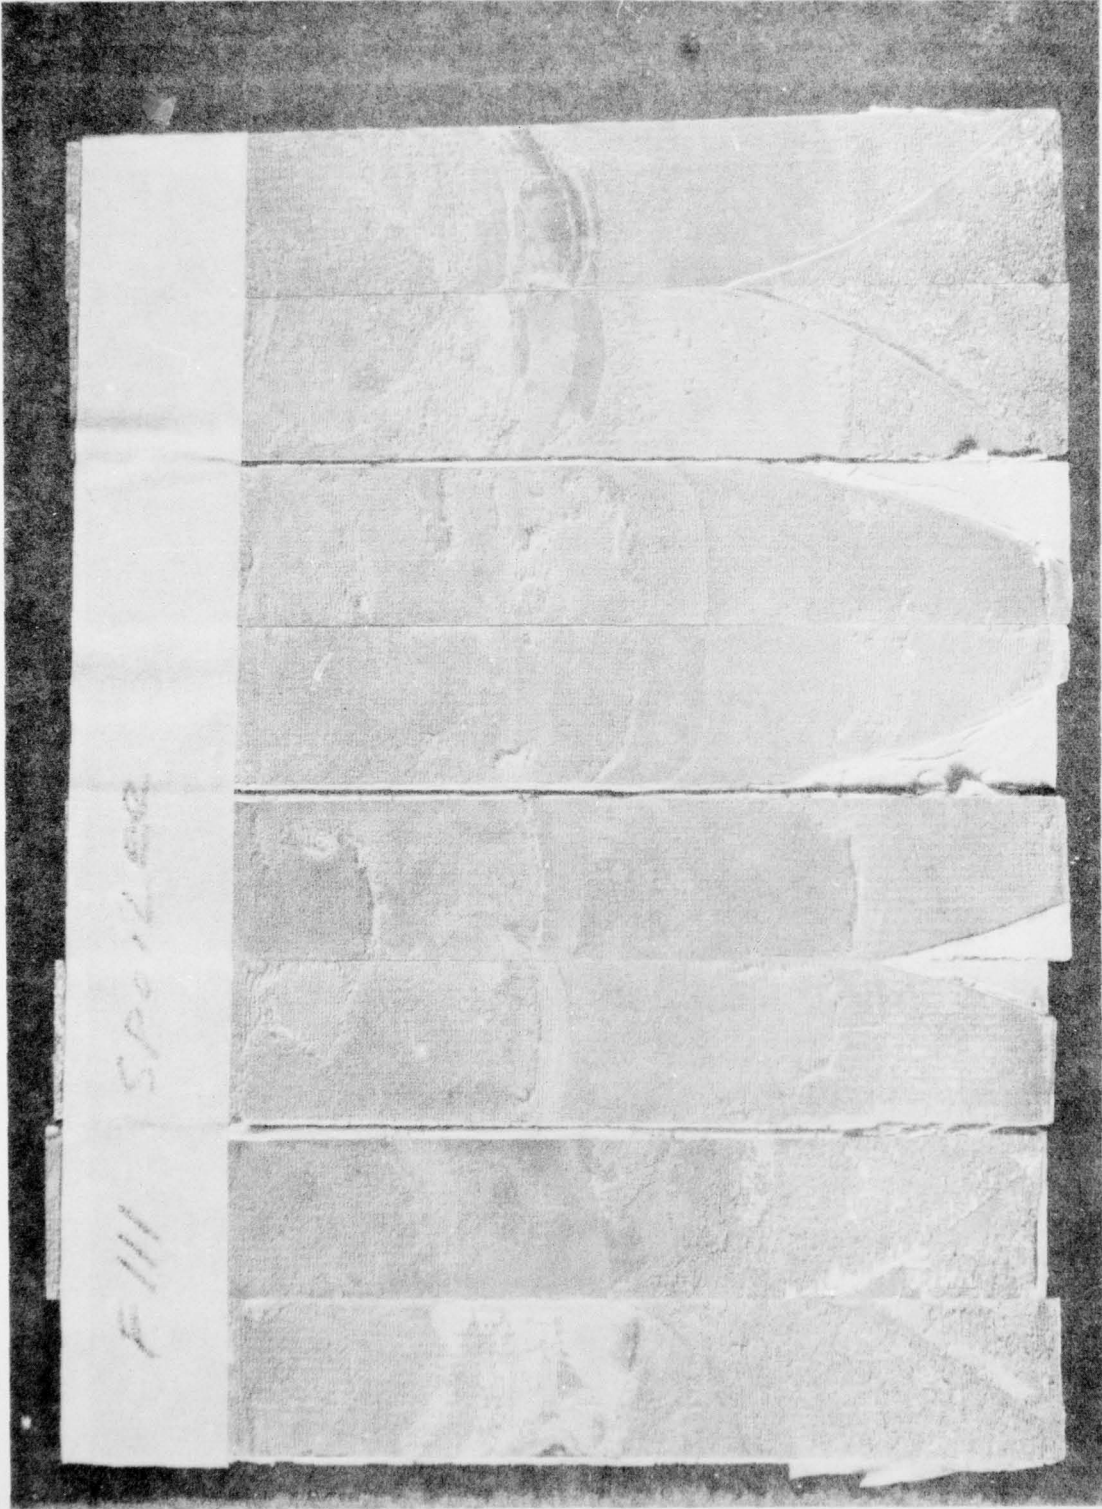
Figure 37.—Failure Surfaces of Wedge Specimens From the F-111 Spoiler

Failure surfaces of the wedge tests for the F-111 spoiler are shown in figure 37. The values were consistently good. The failed lap shear specimens are shown in figure 38. Some porosity is apparent in the two outside specimens. This was undoubtedly due to some reduced bonding pressure in these areas. The values were still quite adequately above the design requirement of 1300 lb/in. (see sec. 2).

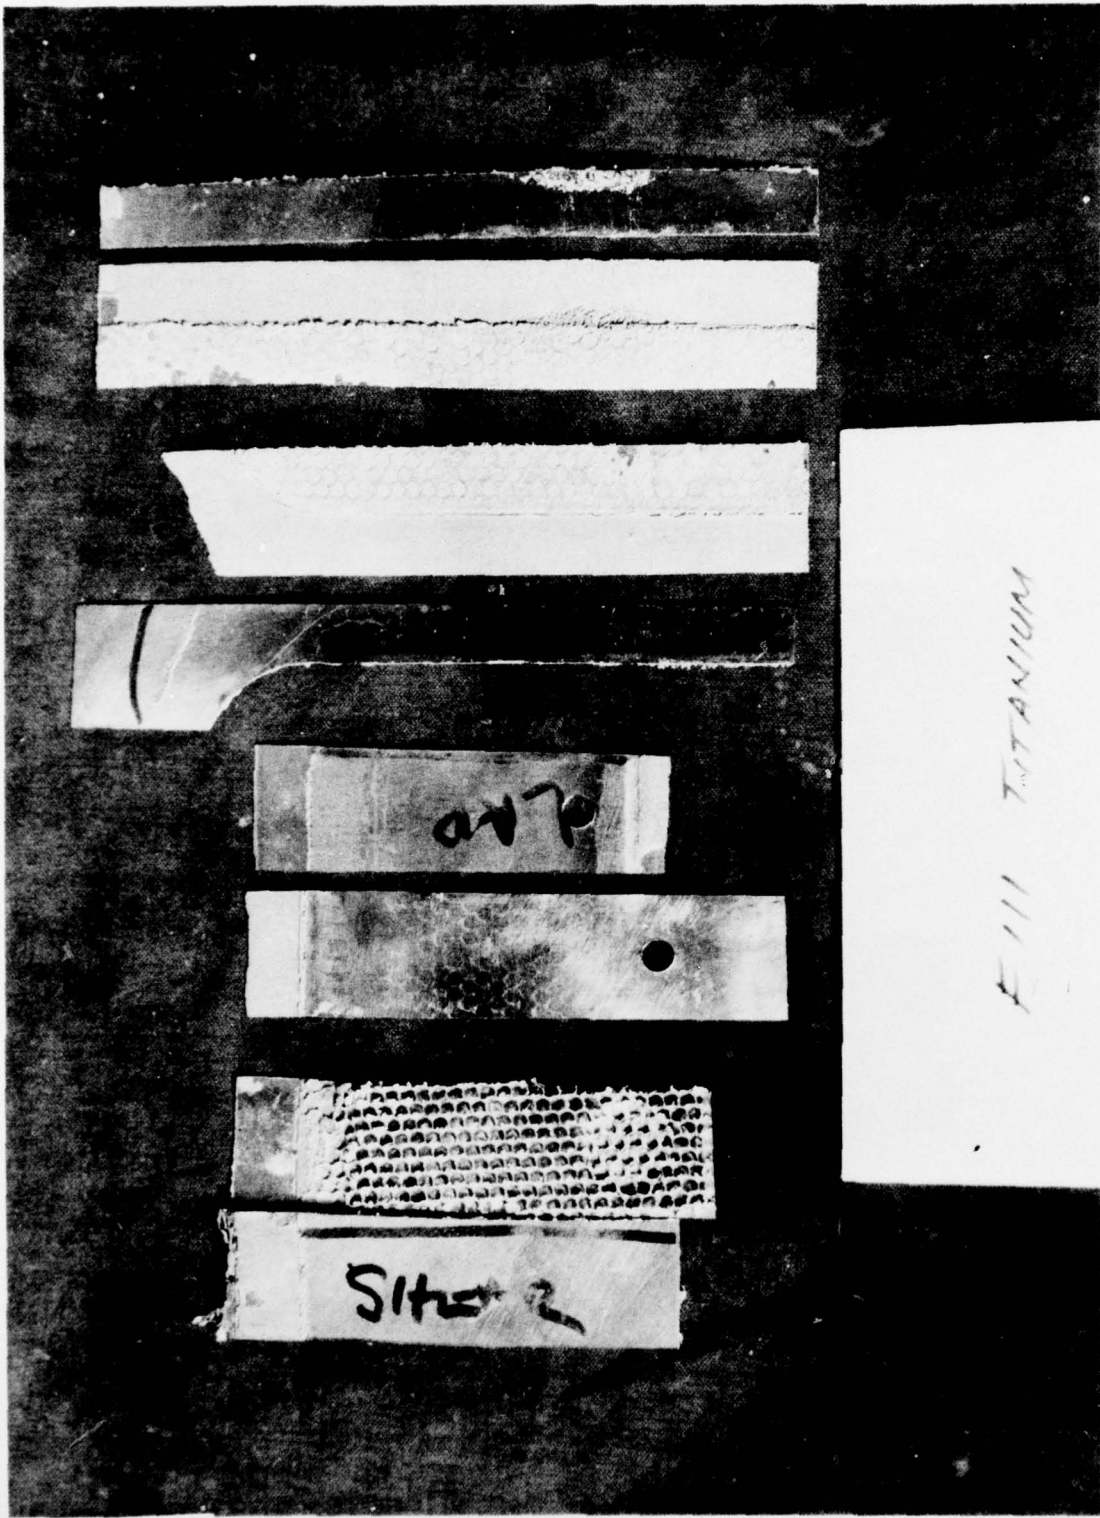
Figure 39. - Failed Lap Shear and Wedge Specimens Cut From the F-111
Titanium Fuselage Panel Repair

A major problem was encountered with the repair on the F-111 titanium fuselage panel. Two wedge and two lap shear specimens were tested, as shown in figure 39. The adhesive is FM400. The values were poor, and the adhesive failed clean from the metal surface. *It was concluded that further work needs to be done to develop a satisfactory nontank surface preparation method for titanium.*

Attention to proper surface cleaning is exceedingly important. In many repair applications, the use of a nontank procedure is necessary. Proper procedures must be used if a high quality bonding surface is to be obtained. Masking should be used to prevent contamination of surrounding areas. All bond surfaces should be carefully inspected to ensure that they have been prepared properly prior to bonding. Additional work on a repair compatible surface preparation method for titanium is necessary.
