TECHNICAL MEMORANDUM ARPAD-MR-77002

ULTRASONIC NONDESTRUCTIVE INSPECTION
OF XM650 ROCKET ASSISTED PROJECTILE
FOR BONDING QUALITY OF THE ROTATING BAND

JAY S. PASMAN

JULY 1977

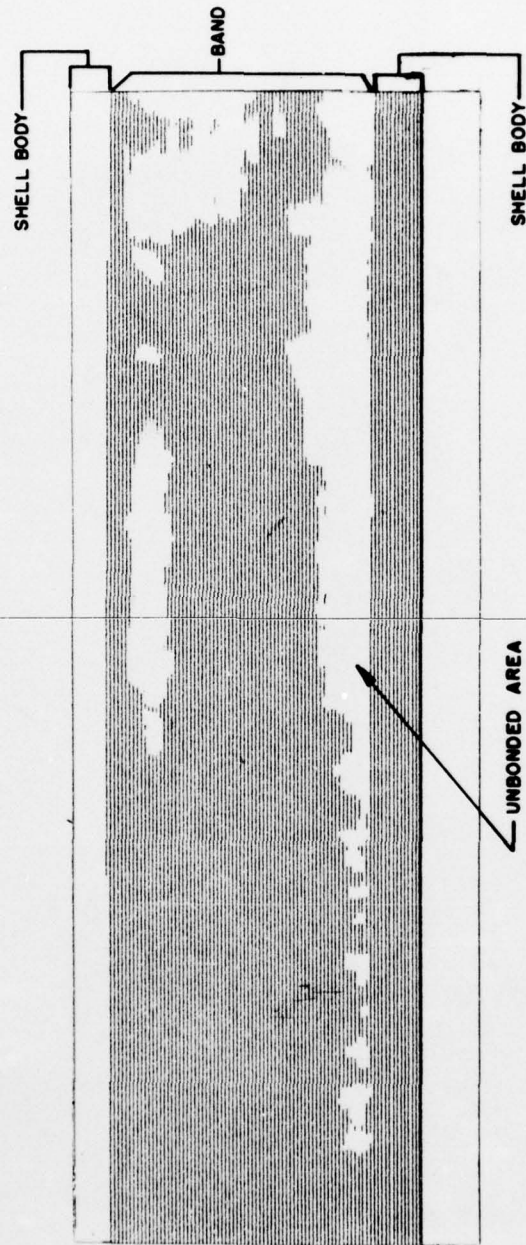
The complete system is shown in Figure 2. The lower section, a cabinet and stand, supports the apparatus. Centered on the cabinet is a glass-walled water tank with a 12-inch (300 mm) motor-driven turntable on which an XM650 motor body is positioned. The recording drum (on the right) is synchronized to rotate with the turntable. The stylus steps vertically, synchronized with the transducer-holding search tube located just above the shell in the water tank. In this program, a rotary speed of 30 rpm and a vertical indexing increment of .045 inch (1.1 mm) per revolution scanned the rotating band in less than 1.5 minutes. The recording illustrates a generally good bond condition with only one rather large unbonded area. Another C-scan of a band with flawed bonding is shown in Figure 3. The chart paper is wide enough to permit recording the scans of three motor bodies on each sheet.

Fig 3 C-scan of a poorly bonded rotating band

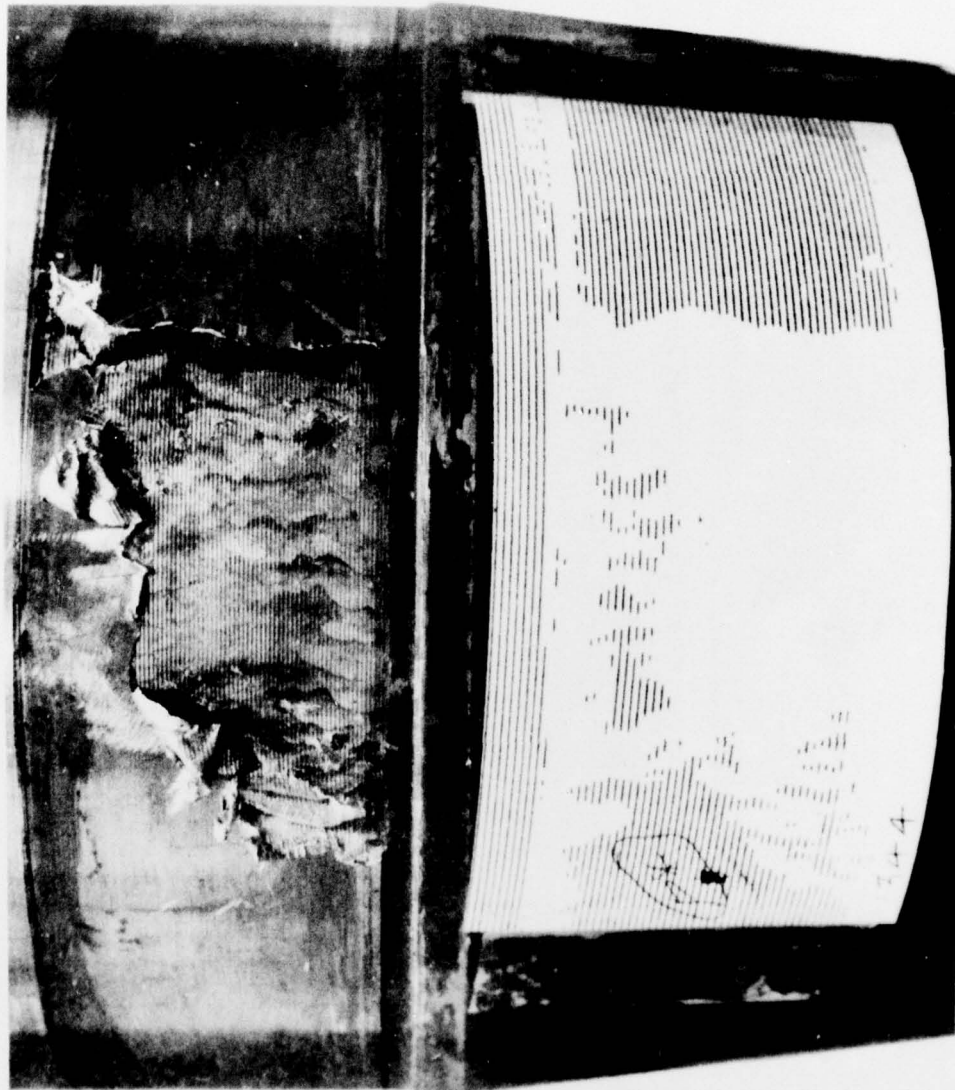
b. As the program progressed, the copper bands were removed from selected samples. The contours generally followed the pattern seen on the C-scan, although in many cases the flaw area appeared to be slightly smaller than on the C-scan chart. This is believed to be caused by a transitional zone where the bond is of marginal quality.

Fig 4 Unbonded area - comparison of C-scan and machined rotating band
