NWEF REPORT 1079

EVALUATION OF A-7E AIRCRAFT THERMAL RADIATION CLOSURE FOR LIGHT LEAKAGE

NAVAL WEAPONS EVALUATION FACILITY
ALBUQUERQUE, NEW MEXICO 87117

20 April 1971

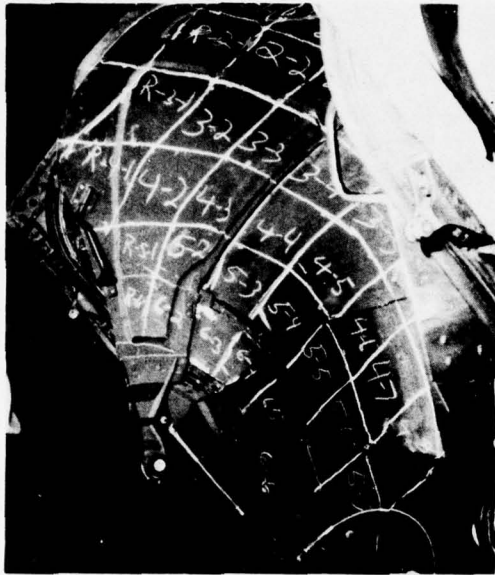
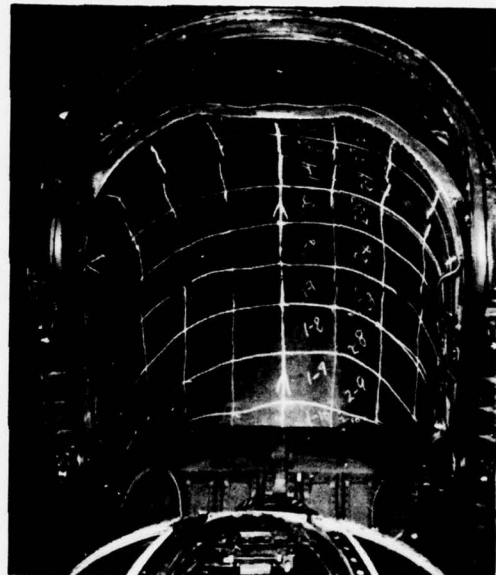
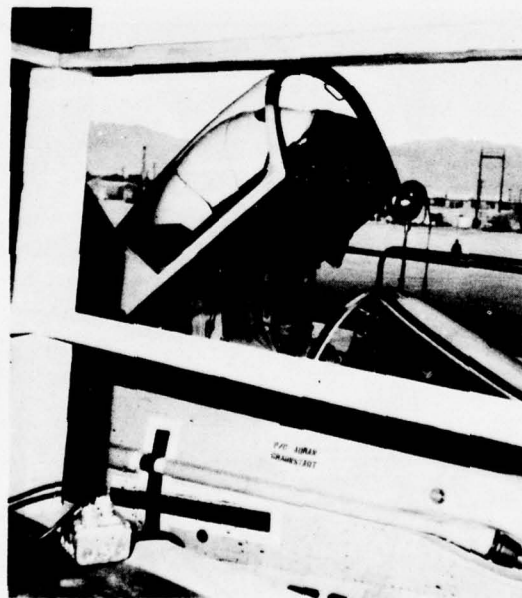
FIGURE 2. SEGMENT MARKINGS FOR POSITION IDENTIFICATION

1. Major transmission areas on both left and right sides at positions 5-6 and 6-6 (Fig. 2) along the interface between the fixed segment and the movable segment, with particular emphasis on the area around the metal-slider hinge.

2. Major transmission area directly aft of the pilot's seat along the rear edge of the aft movable segment at positions L-1-10 and R-1-10.
3. Major light leaks, apparently direct, at left and right corners of the cowling with the right-hand leak directly above the standby compass. The left-hand leak appeared slightly worse than the right. Another cowling leak on the left-hand side was attributable to a hole in the cowling.

4. Major transmission area at positions L-5-2 and L-6-2 (Fig. 2) along the interface between the forward and center movable segments.
5. Numerous scratches visible in the closure material. The forward movable segment appeared slightly more translucent than the center and aft movable segments.

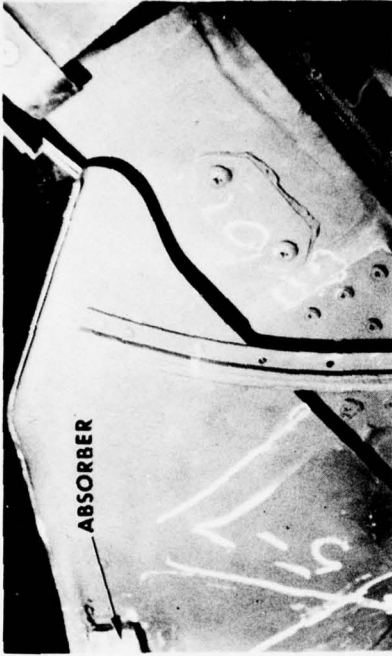
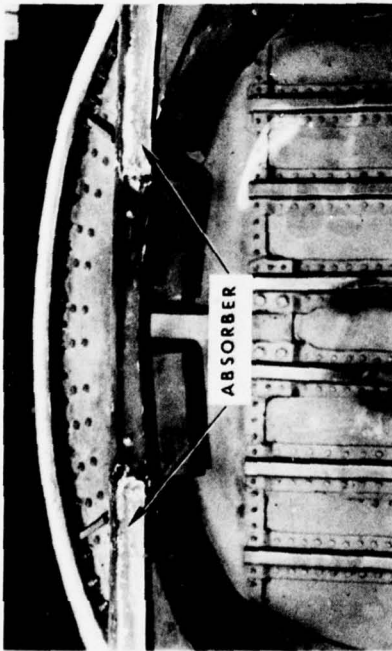
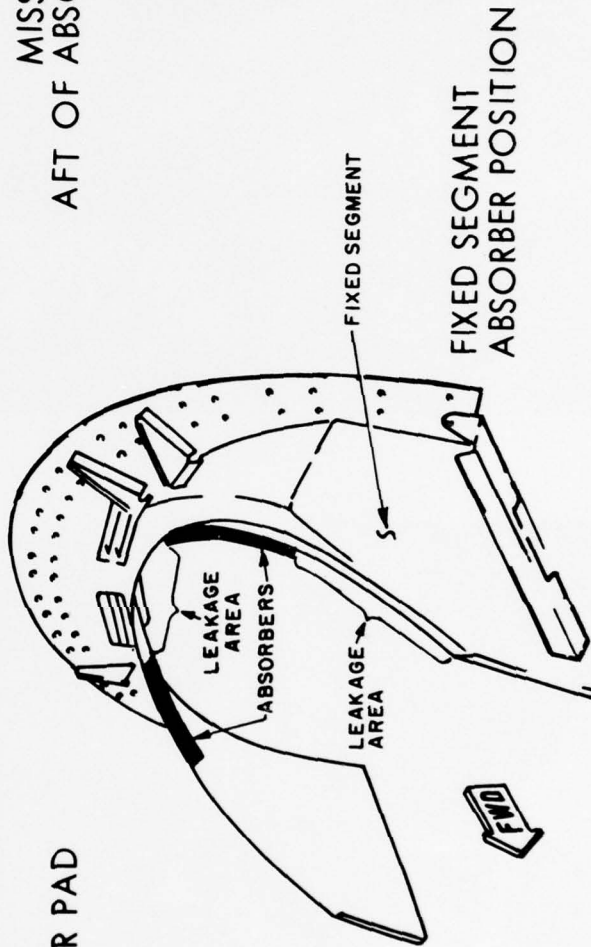
FIGURE 4. CAUSE OF LIGHT LEAKS ALONG AFT-MOVABLE SEGMENT AND FIXED SEGMENT

The gross leak area aft of the seat along the rear edge of the aft movable segment was traced to lack of a seal for a length of approximately 12 inches along the top periphery of the fixed segment (Fig. 4). LTV was contacted to determine if for some reason lack of a seal at this point was limited to aircraft BuNo 156739. It was established that the only seal along the interface between the aft movable segment and the fixed segment is provided by the absorber (LTV part No. 215-21136-9), and that this condition is common to all A-7E aircraft.

Lack of a seal along the forward edge of the fixed segment (Fig. 4) was also determined to be the cause of light transmission noted at positions 5-6 and 6-6 along the interface between the aft movable segment and the fixed segment in the area of the metal-slider hinge on both left- and right-hand sides.

MISSING SEAL
AFT OF ABSORBER PAD

MISSING SEAL
FWD OF ABSORBER PAD

5. Severe light leaks exist at the interface between the fixed segment (LTV part No. 215-21136-86) of the segment assembly (LTV part No. 215-21136-90) and the external face of the aft movable segment. Although the absorber (LTV part No. 215-21136-91) acts as an effective seal along part of this interface, the observed leaks are directly attributable to lack of a seal forward and aft of the absorber along the interface length.

Prior to Phase III testing, an attempt was made to eliminate leakage areas at the interface between the aft movable segment and the fixed segment (Fig. 4). Seal material available at NWEF was bonded to the fixed segment both forward and aft of the absorber (LTV part No. 215-21139-91) to complete the seal pattern around the fixed segment edge. Severe interference problems were encountered with the materials used. Particular problems involved the seal aft of the absorber along the periphery of the fixed segment. Because of clearance variations during closure operation, severe interference necessitated removal of the aft seal installation. These problems could be minimized if the seal were positioned on the outside edge of the aft movable segment rather than the fixed segment. There would then be no interference during closure, and a seal would result as the aft segment completed its motion. Installation of seals along this interface was intended to demonstrate that a complete seal along the fixed segment could eliminate all remaining leakage paths yielding out-of-specification values, and not as a proposed fix in lieu of an engineering evaluation by LTV.

1. Install a seal along the entire interface between the fixed segment of the segment assembly and the aft movable segment to ensure a reduction to specification levels of all light transmitted to the cockpit, either directly or indirectly.

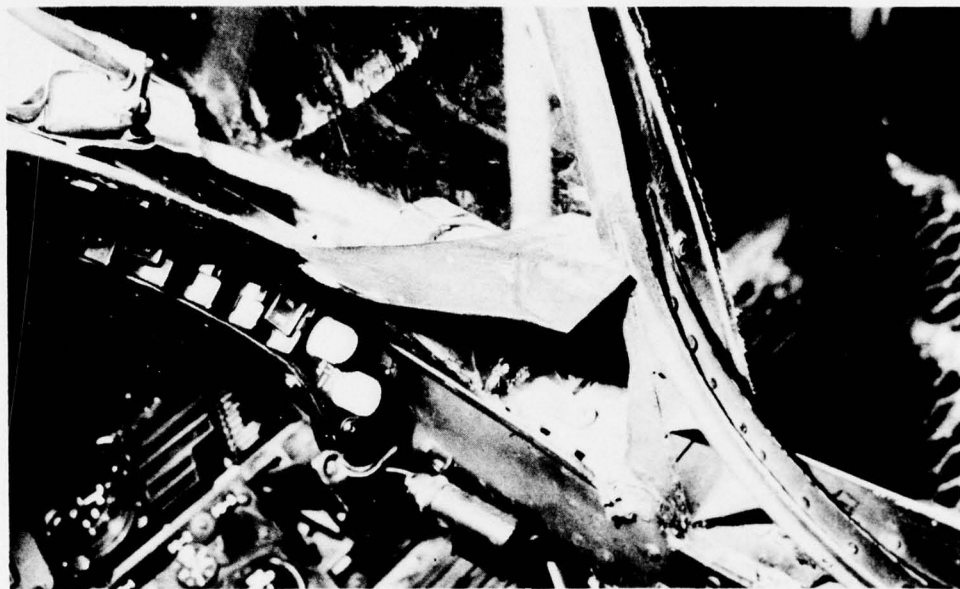
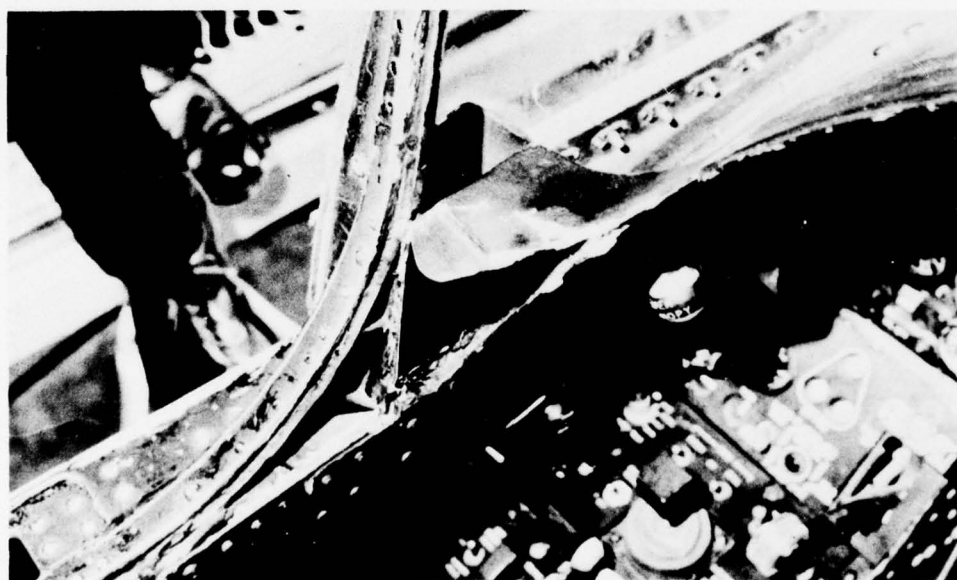
**FIGURE 5. COWLING SEAL LOCATIONS-
BEFORE SEAL INSTALLATION**

It was noted that seals (LTV part Nos. 218-21136-7 and -8) at left and right corners of the cowling had not been installed during incorporation of AFC 111 (Fig. 5). These seals were installed as part of the retrofit operation (Fig. 6). Figure 5, sheet 5 of 6, of AFC 111 shows the 218-21136-7 and -8 seals as rectangular, while the marked drawing (218-21136, sheet 3) furnished NWEF indicates that these seals should be cut to fit. Difficulties encountered during seal installation revealed that a hand-fit operation

is necessary to eliminate all leakage paths. AFC 111 does not specify the requirement for a hand fit operation.

3. Modify Fig. 5, sheet 5 of 6, of AFC 111 to show that cowling seals (218-21136-7 and -8) must be cut to fit as required to eliminate leaks.

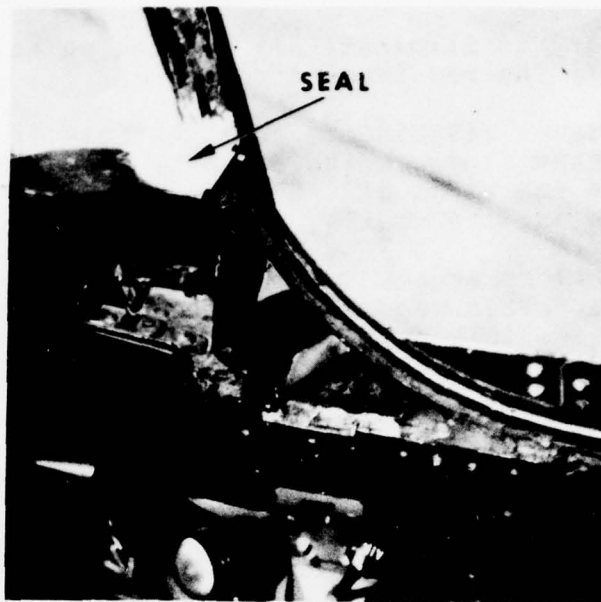
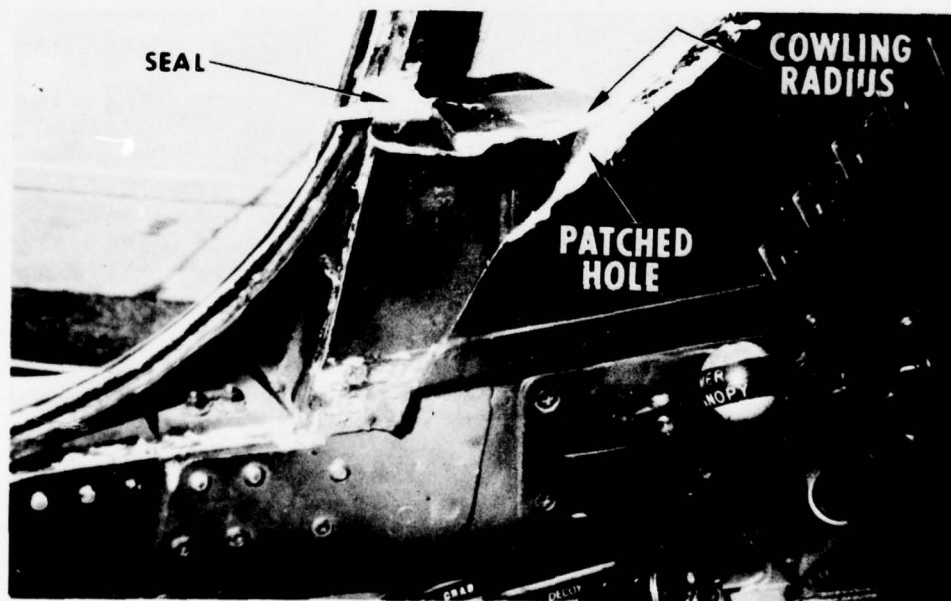
FIGURE 6. COWLING SEAL LOCATIONS- SEALS INSTALLED

An attempt was made to seal the hole in the cowling on the left-hand side, as indicated by the seal material visible to the right of LTV part 218-21136-7 up approximately 4 inches along the cowling (Fig. 6).

Although the seals added at the corners of the cowling reduced intensities at those points to acceptable levels, a high transmission area was present along the cowling on

both left and right sides at the curved section immediately above the patched hole as shown in Fig. 6. There was an apparent mismatch between radius of the cowling and radius of the fwd movable segment of the TRC. Measurements of this area indicated a transmission level of 36 footcandles on the right radius during the third set of readings taken. It was not as severe earlier and seems to be reduced significantly when the TRC is closed pneumatically.

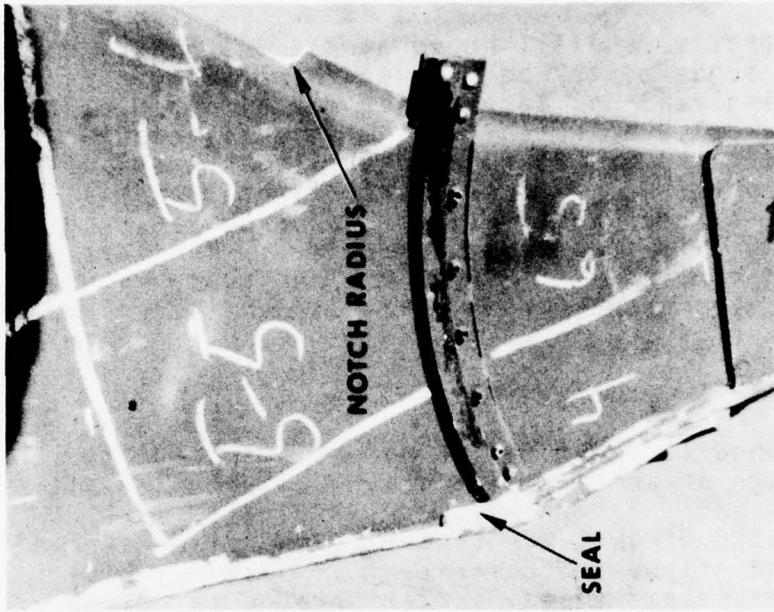
FIGURE 7. MOVABLE SEGMENT REWORK TYPICAL

SEGMENT AFTER REWORK

SEGMENT BEFORE REWORK

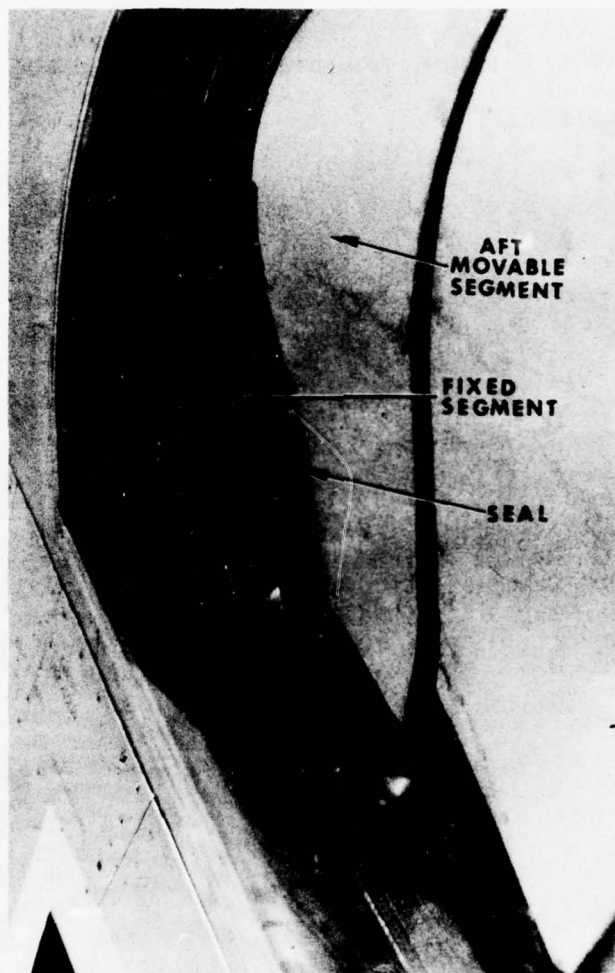
FIGURE 8. FIXED-SEGMENT SEAL INSTALLATION RIGHT SIDE

Because of considerable binding from the seals installed on the fixed segment, the TRC was initially closed manually to prevent damage to the closure mechanism. It was noted that the right seal (Fig. 8) was pushing against the closure to such an extent that an excessive leak measuring 180 footcandles appeared along the interface between the aft movable segment and the fixed segment at positions R-6-5, R-5-6, and R-4-8. Conversely, the seal on the left side worked properly, and reduced all light transmission to a level of 0.7 footcandle which is within specification limits. The second set of measurements repeated after removal of these seals (Table 2) revealed that the reduction in light-transmission levels was directly attributable to presence of the seal material. Further, after seal removal, a direct light leak approximately 0.25 inch in diameter and measuring 260 footcandles was noted on the right side near the hinge.

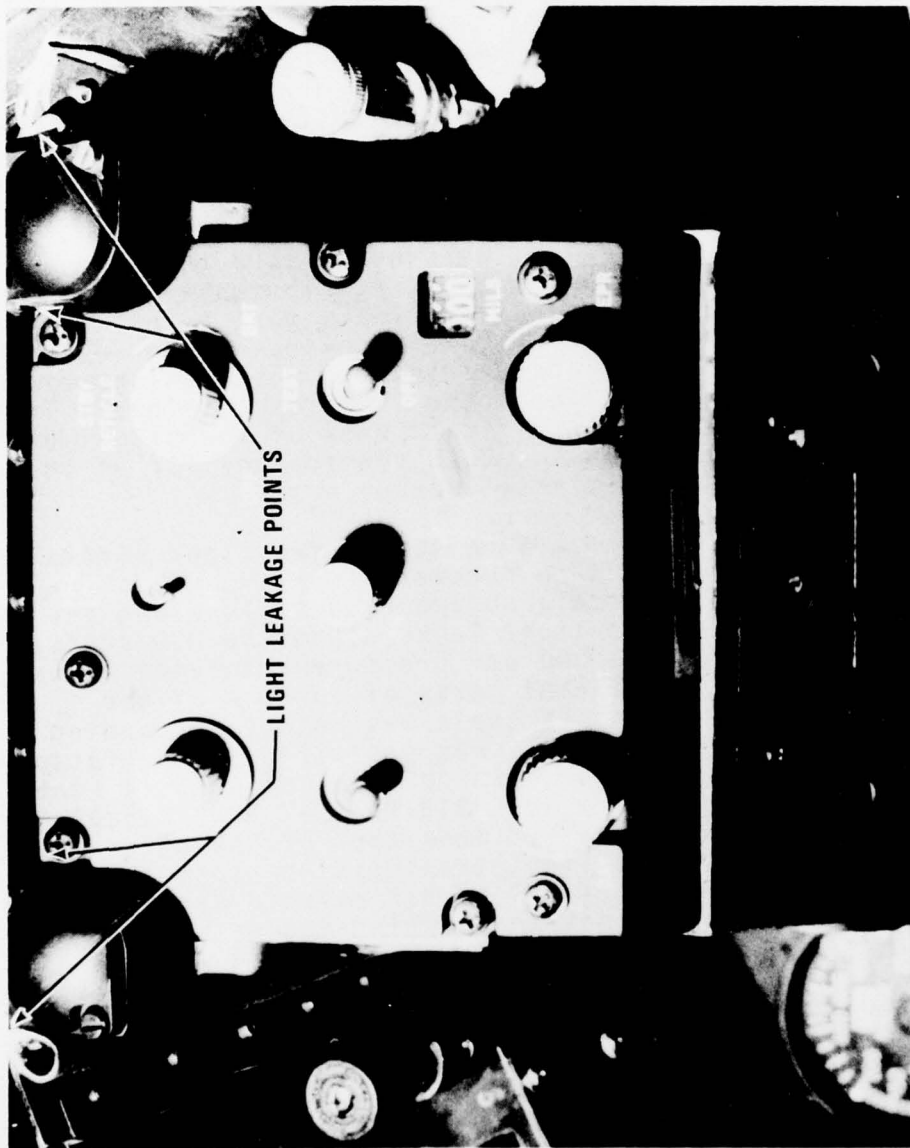
FIGURE 9. DIRECT LIGHT LEAKAGE POINTS ALONG HUD SEALS

Four direct light leaks, which allow light to shine directly in the pilot's eyes, were noted throughout this test series. Although they are not attributable to any fault of the closure, these direct leaks must be eliminated because of their position. Figure 9 defines these leak locations. A shield attached to the fwd movable segment could be positioned so that as the TRC closed, pinhole leaks would be eliminated from the direct view of the pilot; or a permanent seal could be added to the top portion of the HUD control panel to eliminate leakage paths

6. Direct light leaks, which are supposed to be eliminated by seal assemblies (LTV part Nos. 215-20078-187, -188, and -240), exist along the edges of the HUD. However, adjustments of these seals failed to remove four pinpoints of direct light which shine into the pilot's eyes. These leaks are not attributable to a fault of the TRC per se, but are definitely serious because of their position.

2. Eliminate direct light leaks to the pilot's eyes from positions along the HUD.
