TN no. N-1495

**title:** INVESTIGATION OF MATERIALS FOR SHIP-TO-SHORE LOW PRESSURE STEAM HOSES

**date:** July 1977

## CIVIL ENGINEERING LABORATORY

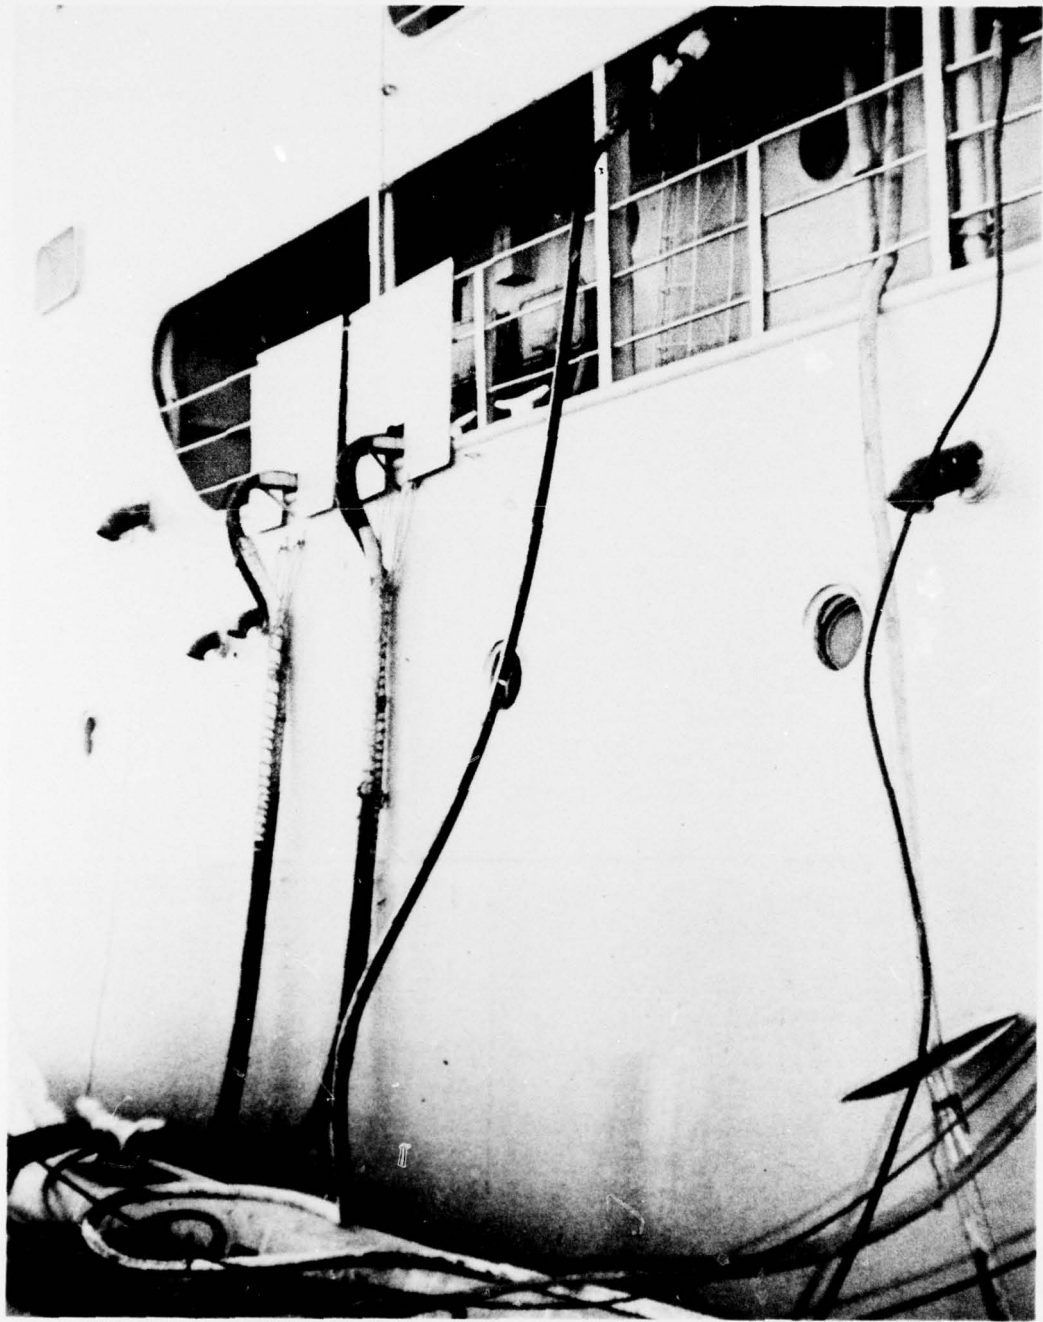
Abuse. Use plus abuse can greatly shorten the service life of a steam hose. Kinking, twisting, or hanging hose on a peg for storage can cause mechanical damage to it, and the amount of damage caused will increase as the hose components are affected by heat aging. Connecting a hose to a horizontal steam line at the ship causes a sharp (90 degree) bend in the hose and subsequent early failure.

Figure 1. Sharp 90-degree bends in steam hoses at ship's intake.

4. Use fittings where sharp bends are required. The minimum bending radius (inside) should be not less than ten times the outside diameter of the hose. Where the intake fitting is flush with the side of the ship, a fitting should be available so that the steam hose can be connected in a downward direction. Figure 1 shows a 90-degree hose bend at a horizontal intake where early failure occurred (see Appendix B).

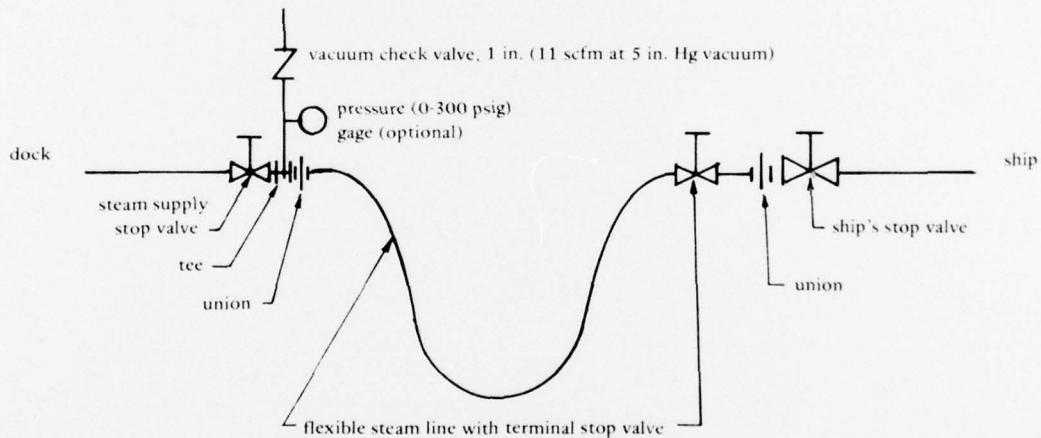
Figure A-1. Steam hose and valve system.

A procedure to prevent rapid pressure release in steam hose consists of: (1) closing both the ship's stop valve and the flexible hose terminating stop valve, (2) disconnecting union at ship's line between valves, (3) closing dockside stop valve, and (4) allowing hose to cool slowly, with the vacuum check valve preventing pressure inside the hose from dropping below atmospheric. The hose and valve system is shown schematically in Figure A-1.

The rate of decrease in internal pressure will depend upon the heat loss from the hose section, but it should take less than 5 minutes to reach one atmosphere. If pressure decrease appears to be too rapid one could crack the dockside steam valve and bleed the steam into the hose to slow the rate of pressure decrease.

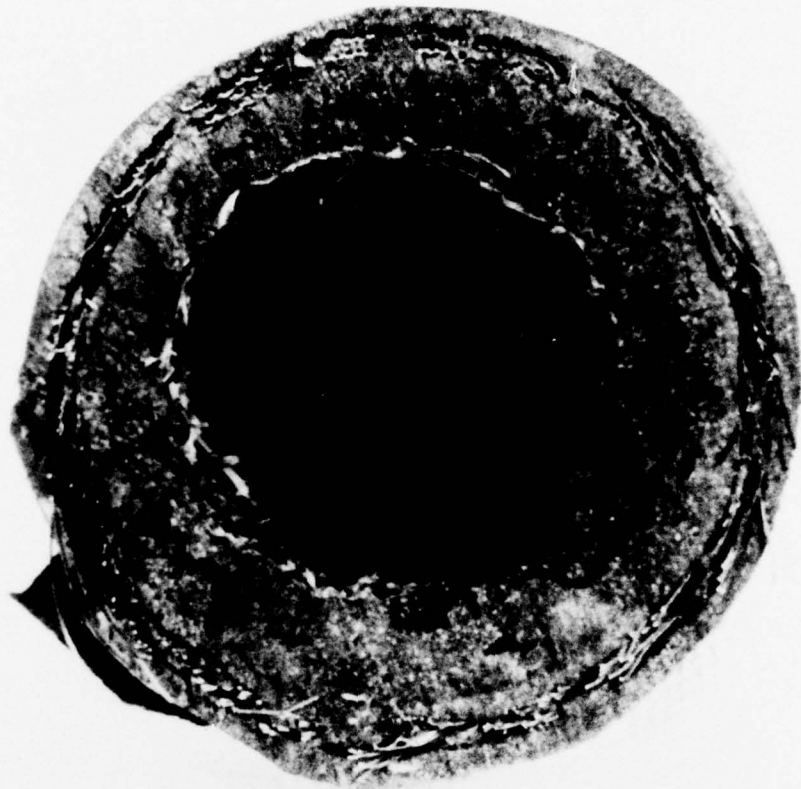
These hoses were removed from service temporarily in January 1977 when the USS Norton Sound was undergoing refitting at Long Beach. One of the glass braid-lined rubber hoses had sustained abrasion damage on one end after 112 days of intermittent service. When the damaged section was cut off so that the fitting could be reinstalled, it was found that the glass braid liner had deteriorated; thus, the hose had to be discarded (Figure B-1). One 2-inch stainless steel-lined rubber hose had sustained cover damage after 140 days of intermittent service. This occurred where the hose made a sharp 90-degree bend adjacent to the ship's inlet line (Figure B-2). Because this hose cannot be field-repaired, it was removed from service.

Figure B-1. Deteriorated glass braid-lined steam hose.

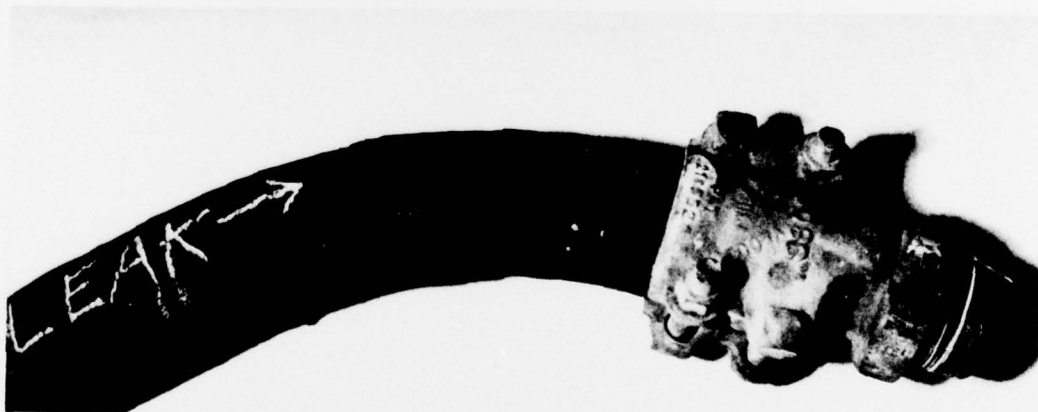
Figure B-2. Cover damage on 2-inch stainless steel-lined rubber hose caused by sharp 90-degree bend at ship's intake.
