TSARCOM
REPORT TR 77-2

**OH-6A TAIL ROTOR TRANSMISSION
GREASE EVALUATION AND
FAIL DETECTION SYSTEM TEST**

**B.R. Smith & G. Grigorian
Hughes Helicopter Company
Centinela Ave. at Teale St.
Culver City, CA 90230**

~~██████████~~ JUN 1977
Final Report

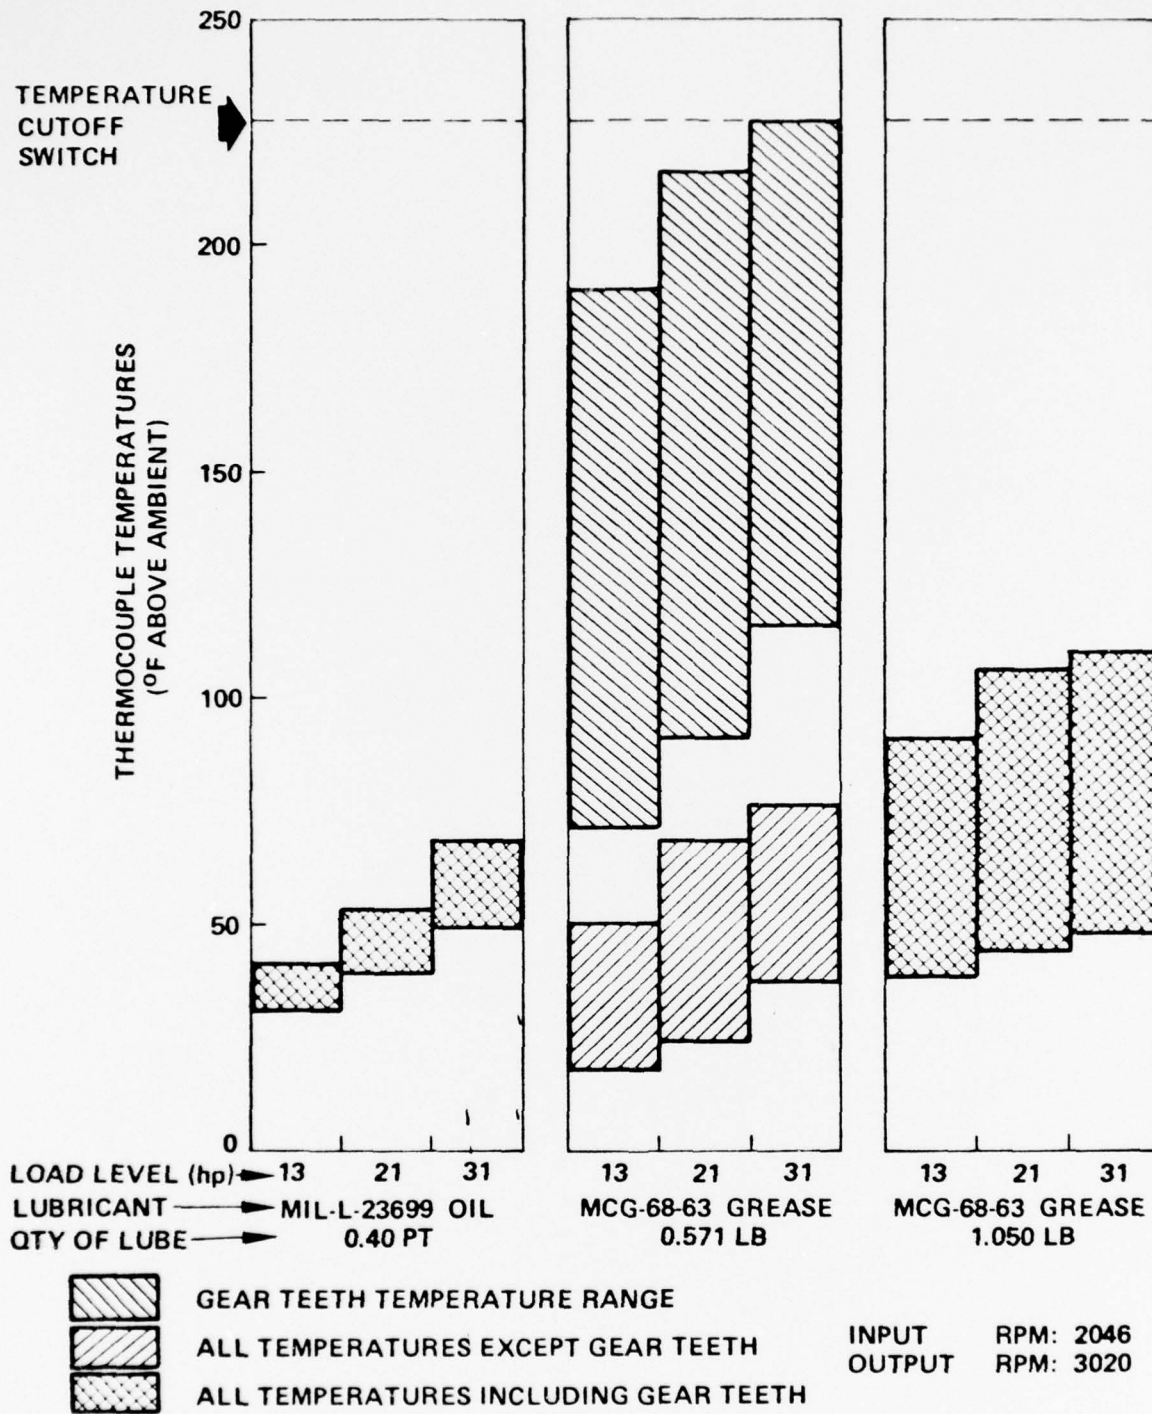
Figure 1. OH-6A Transmission Temperature Comparisons - Grease versus Oil

Temperature comparisons of the OH-6A and OH-58 are shown in Figures 1 and 2, respectively. Test results are described in more detail in Appendix A.

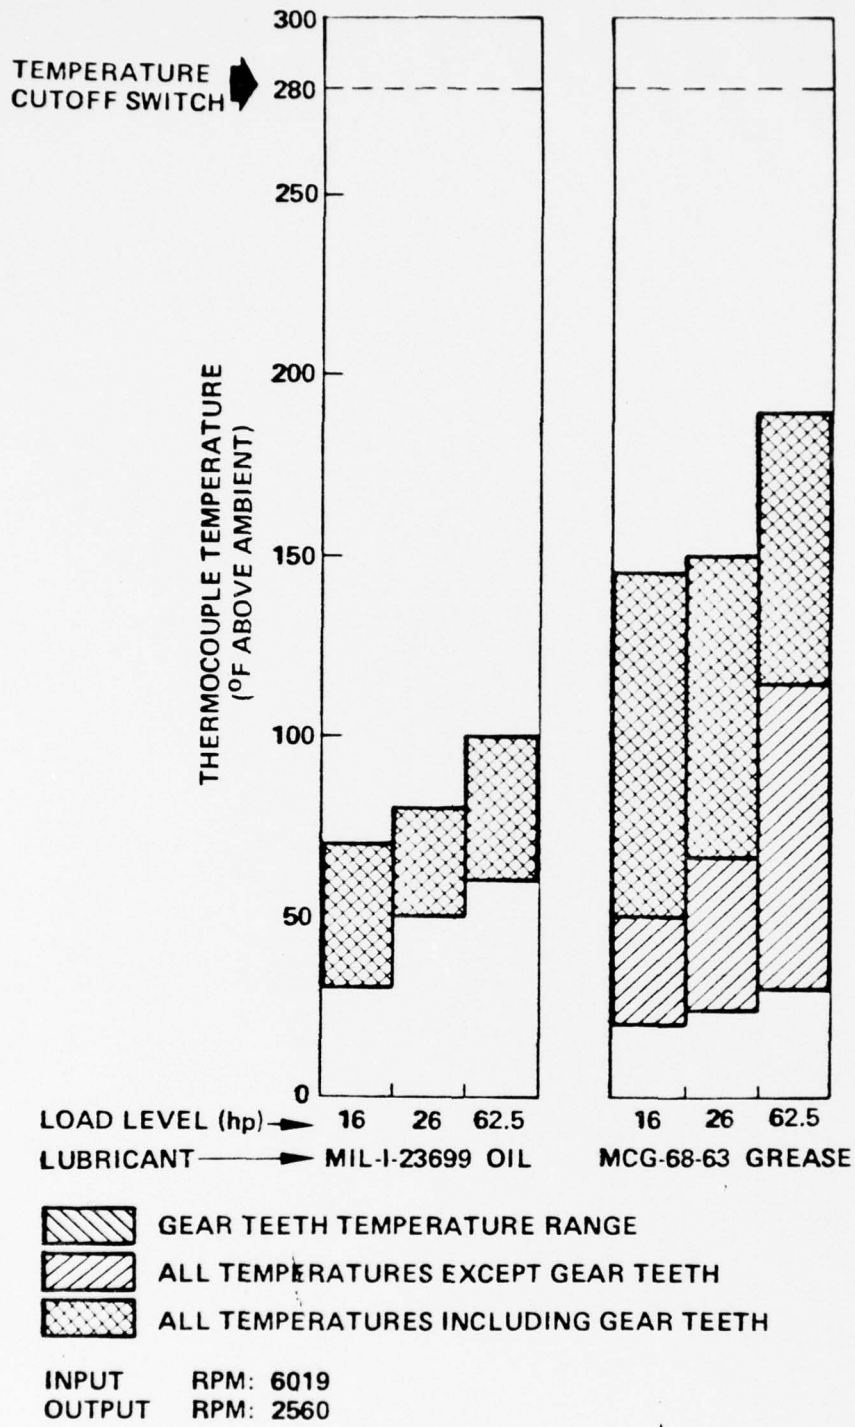
Figure 2. OH-58 Transmission Temperature Comparisons - Grease versus Oil

The OH-58 spectrum load test results were similar to those obtained with the OH-6A transmission, except that the temperature changes were less than those experienced in the OH-6A spectrum load tests. Excessive wear and scoring of the OH-58 transmission gear teeth was noted as a result of the test.

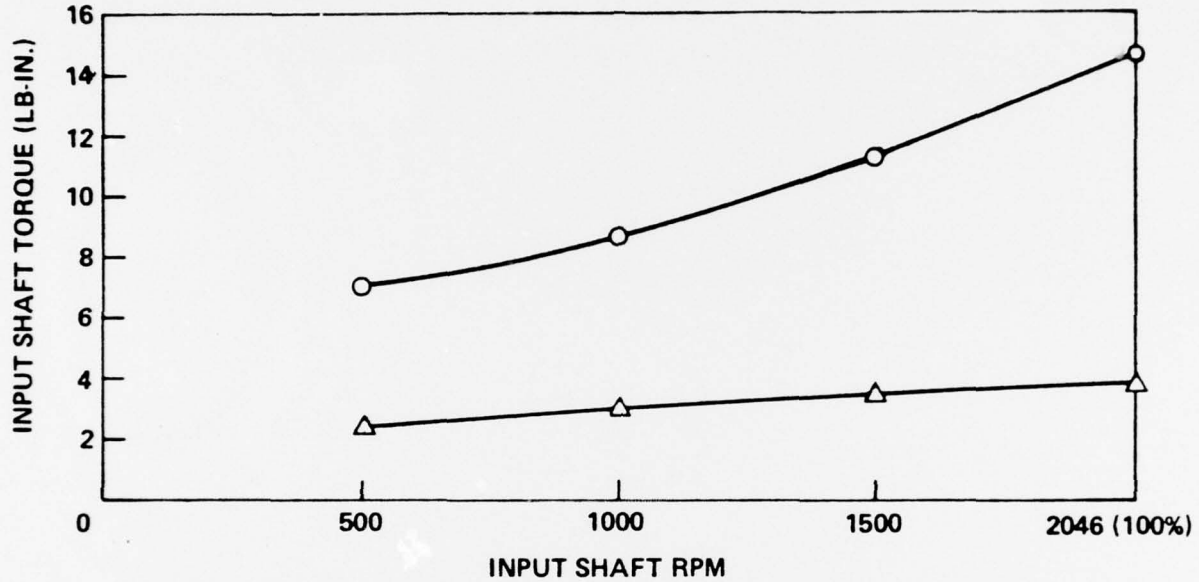
Figure 3. OH-6A Transmission No-Load Dynamic Torque - Grease versus Oil

A no-load dynamic torque test for the OH-6A transmission, filled with grease to 98 percent of capacity, revealed the torque to be approximately four times the value demonstrated when the transmission was filled with oil (Figure 3). Test results are described in detail in Appendix A.

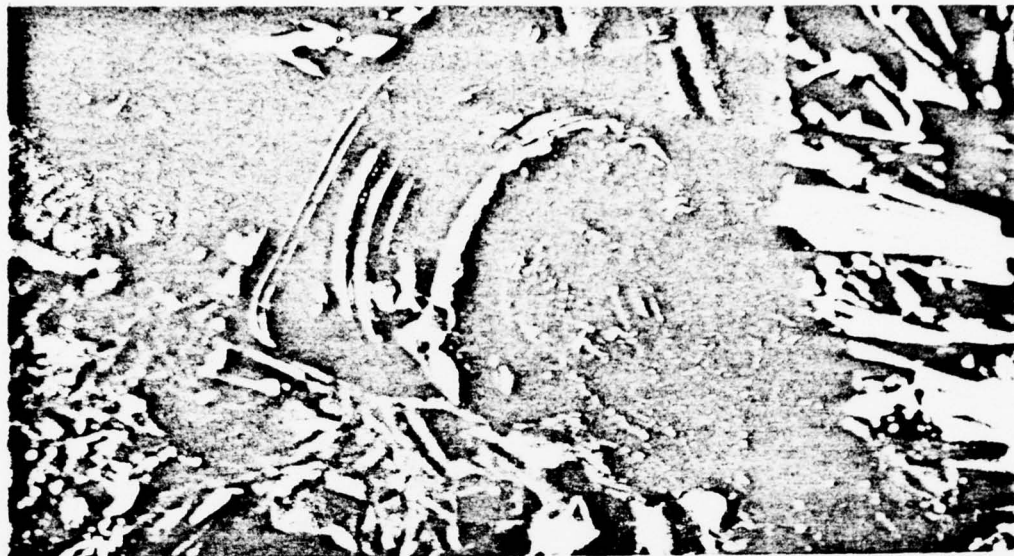
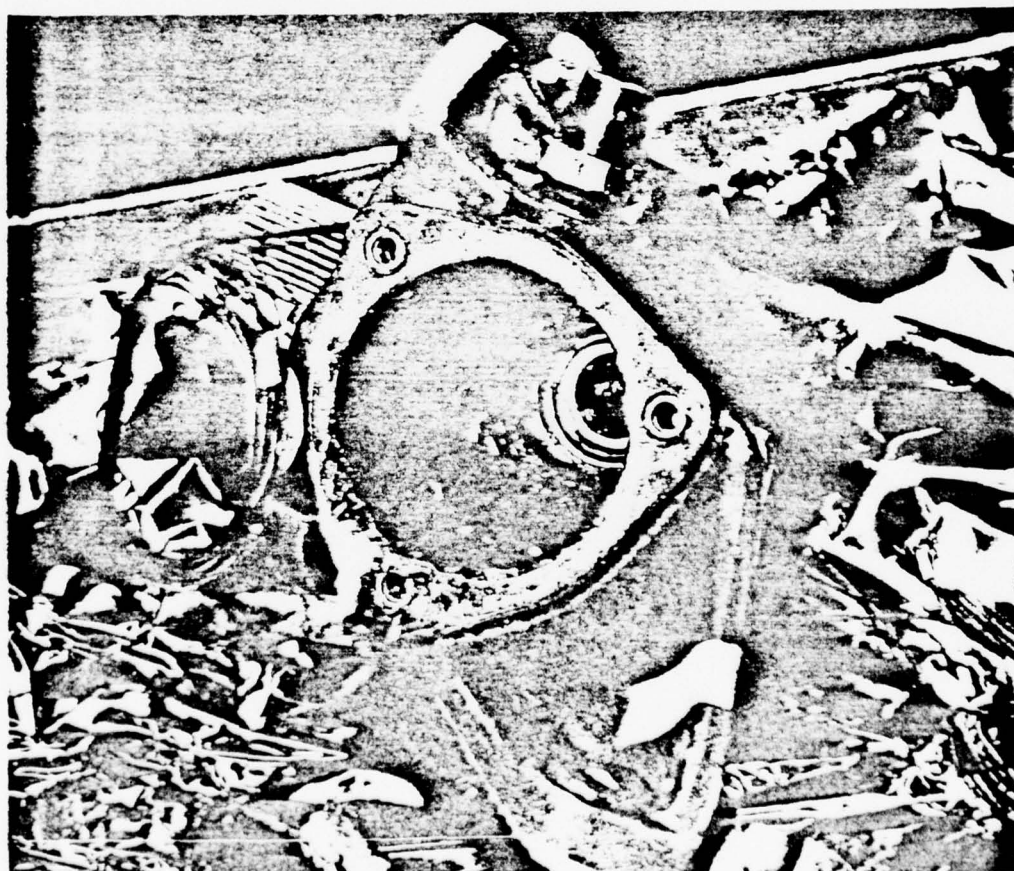
Figure 8. First Transmission Output Gearshaft and Housing
(OH-6A)

1. The gear teeth appeared to be well coated with grease (see Figures 8, 10 and 12)
2. The roller bearing on the inboard end of the output gearshaft appeared to be adequately coated with grease (see Figures 8 and 10).
3. The seals on both shafts appeared to have significant wear.

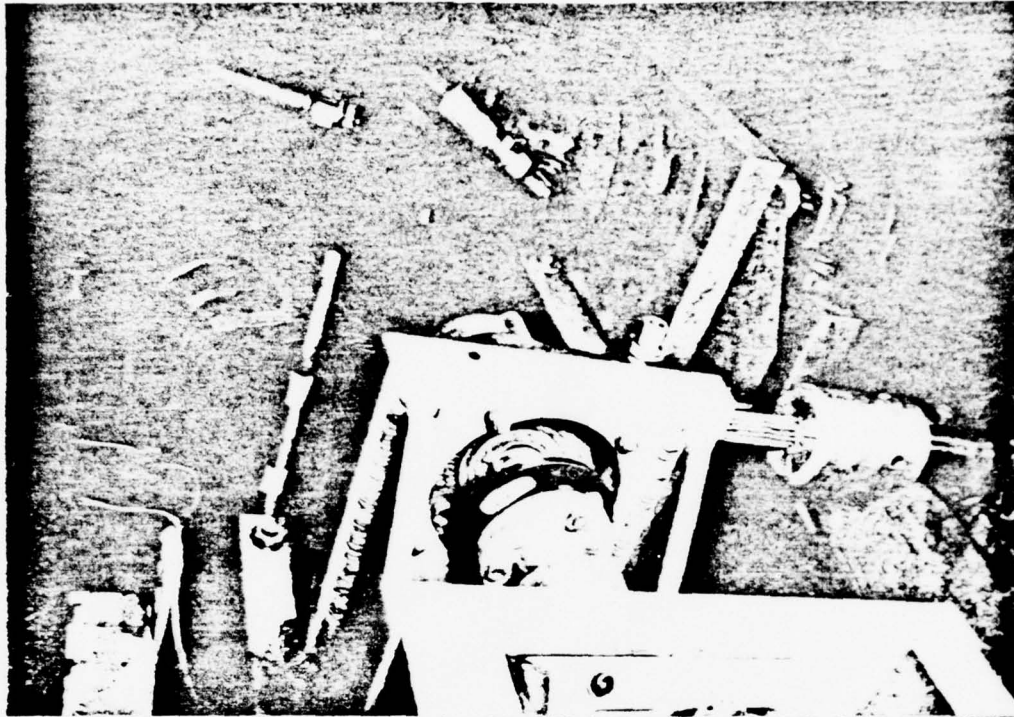
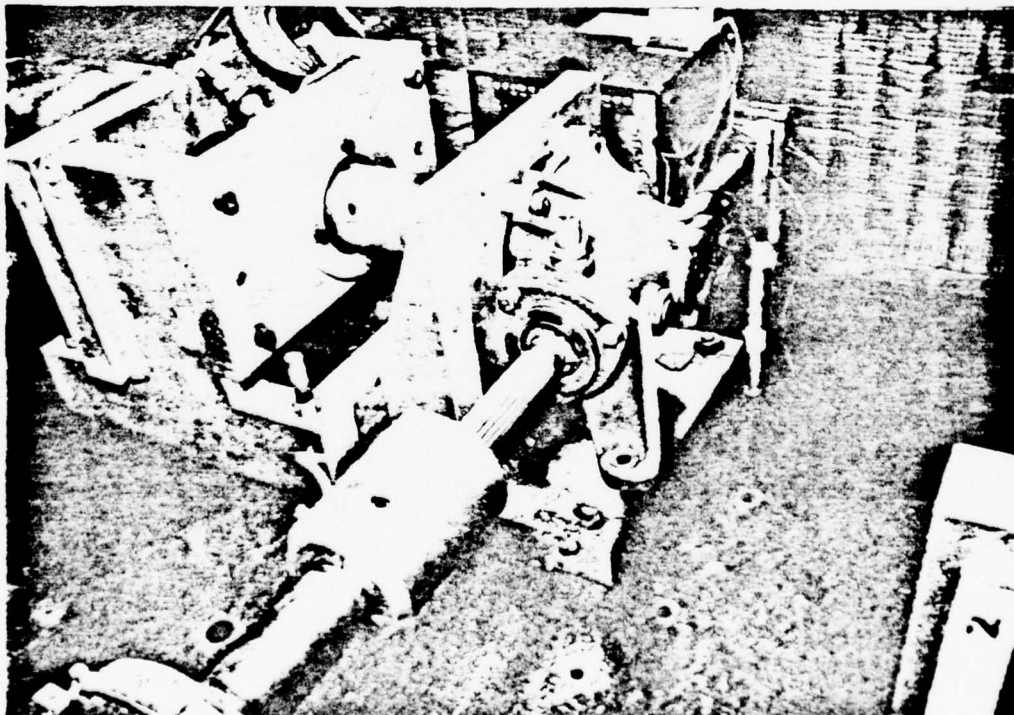
The shaft seals on both the OH-6A and the OH-58 leaked throughout the test at a rate of about 0.037 pound per 20 hours. The grease loss is not significant but deposits of grease around the shaft seals, drive couplings, and swashplates would be undesirable in that there would be an additional attraction of abrasive particles, thus accelerating the wear of drive components adjacent to the transmissions. Also, the breather on the OH-6A transmission would have to be redesigned as there is a constant undesirable internal pressure of 3 to 5 psig.

Figure 9. Grease Leakage at Seals of Second Transmission

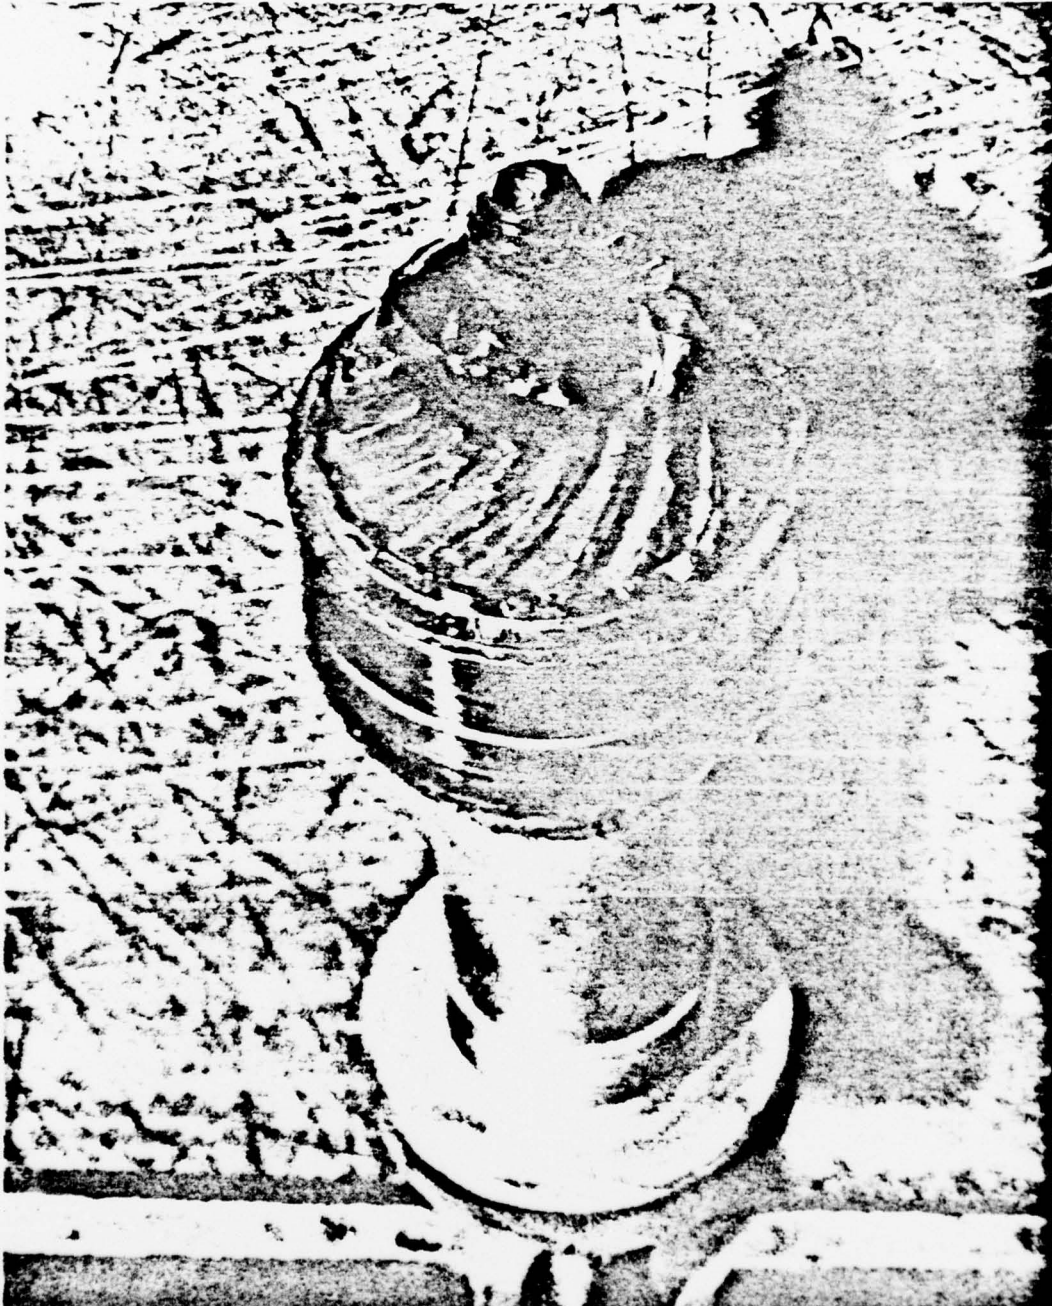
Figure 15. Input Gear Shaft, OH-58 Transmission

1. The gear teeth and bearing surfaces and housing cavities appeared to be adequately coated with grease (see Figures 15 and 16).
2. Grease discoloration from ivory to gray and black is shown in Figure 16.
3. Considerable amount of wear and scoring was noted on the gear teeth surfaces indicating that the grease was pushed out at the contact points due to excessively high test loads.

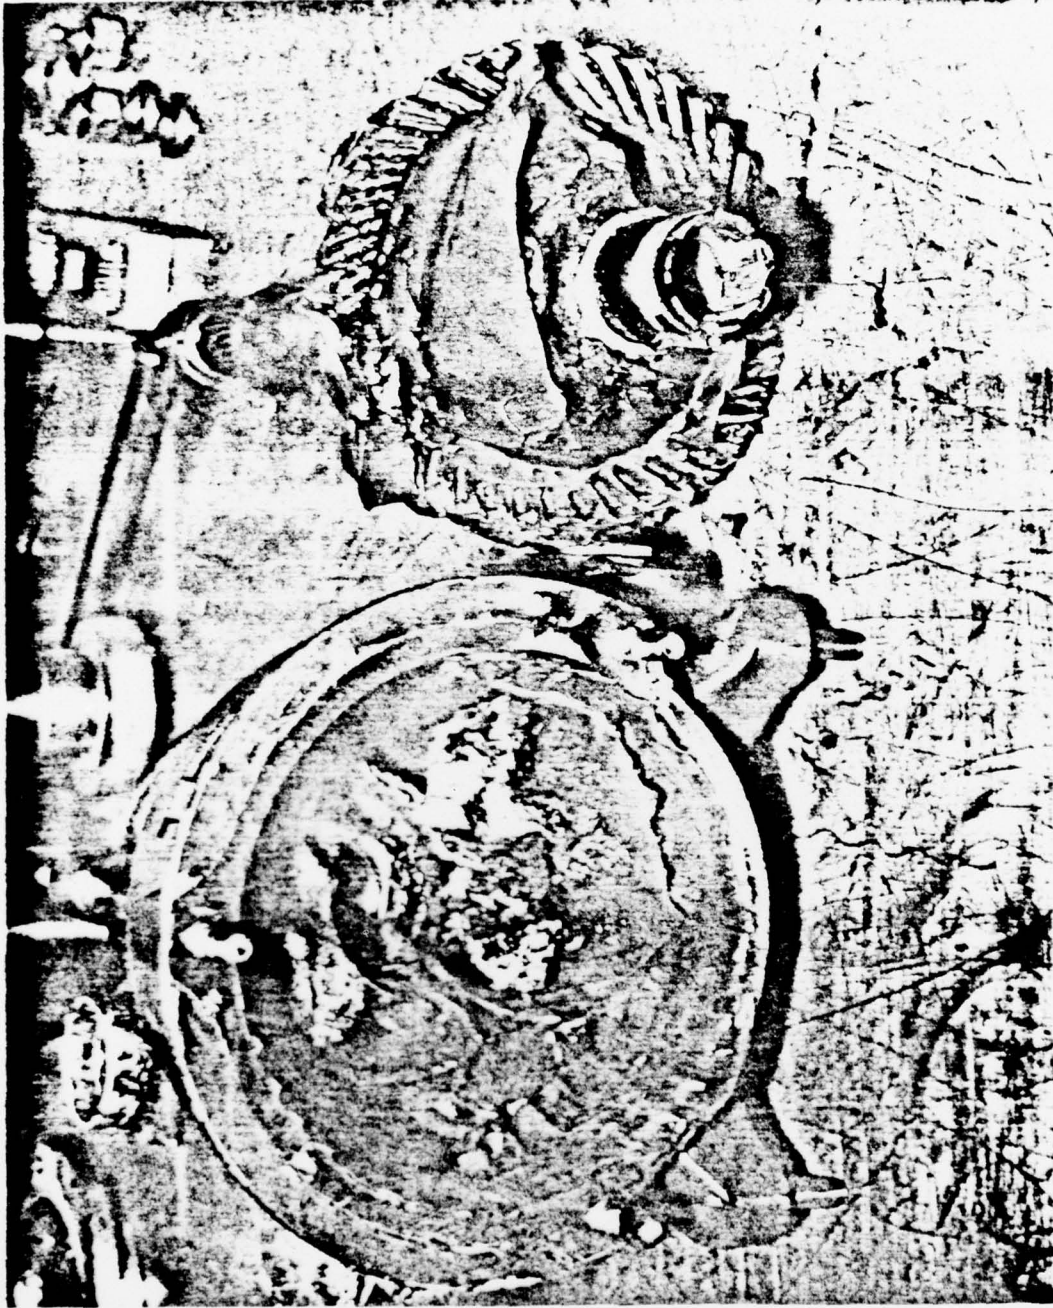
Figure 16. Grease Discoloration, Output Gear Shaft and Cavity,
OH-58 Transmission
