**ACID ATTACK OF CONCRETE CAUSED BY
SULFUR BACTERIA ACTION, PIEDMONT AND
CLENDENING LAKES OUTLET TUNNELS
MUSKINGUM WATERSHED, OHIO**

Henry T. Thornton, Jr.

Concrete Laboratory

Final Report

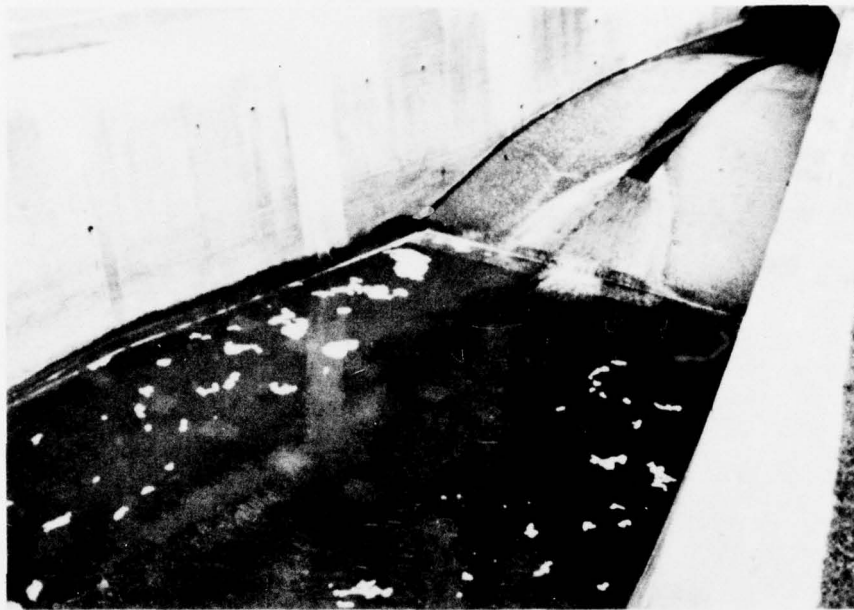
11. The water in the stilling basins and in the streams at both projects was of a pale blue color with a white foam floating on it (Photographs 3 and 4). The lines of normal flow were clearly discernible by the water marks on the sides of the tunnels. About one-third of the way into the tunnels the deterioration became evident above the normal flow lines (Photograph 5). In the vicinity of the gate-transition areas the deterioration was more pronounced (Photograph 6). The conditions inside the tunnels were very similar to those described by Parker⁶ when relating to acid attack in concrete sewers.

Photograph 3. Clendening Lake, view showing rising invert with slot

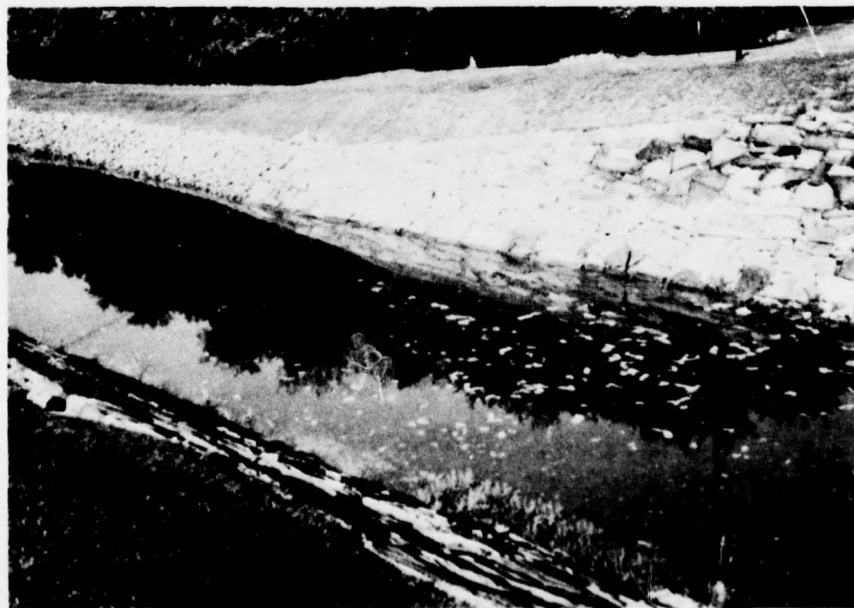
Photograph 4. Clendening Lake, view downstream of stilling basin

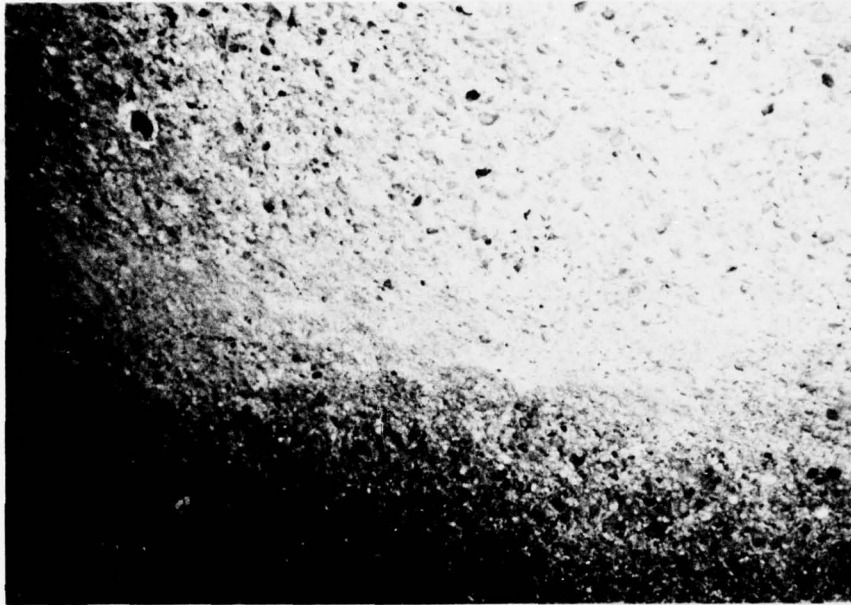
32. After an evaluation of the summation of test results and other accumulated data and information pertaining to this investigation, it is concluded that the deterioration of the concrete in the outlet tunnels of Piedmont and Clendening Lakes is most likely due to acid attack and is the final stage of a corrosive process caused by sulfur bacteria action. The process starts with the production, by bacteria, of hydrogen sulfide from the sulfate-rich water in the lake, and by organic decomposition in the sediment. The hydrogen sulfide passes through the siphons and gates and is released into the atmosphere in the gate-transition area due to the turbulence of the water. The hydrogen sulfide collects in the crown of the tunnel in concentrated amounts for some distance down the tunnel, is oxidized into sulfuric acid by concretivorus bacteria, and the constituents of the cement paste are decomposed by the acid. Physical mechanisms such as freezing and thawing and hydraulic washing probably aid the corrosive process.

Photograph 5. Clendening Lake, deterioration
above normal flow line

33. It is recommended that remedial measures such as ventilation, flushing, or raising siphon intakes be implemented as soon as determinations have been made concerning the applicability of each measure to the problem. Considering the emphasis placed on energy conservation and increased productivity within most energy sources, it seems unlikely that strip-mining operations will cease or diminish in the near future. Therefore, if strip-mining operations are the major contributors of sulfates to Piedmont and Clendening Lakes, the corrosion process caused by the action of sulfur bacteria will have to be interrupted at some point after the sulfates have entered the lake water.

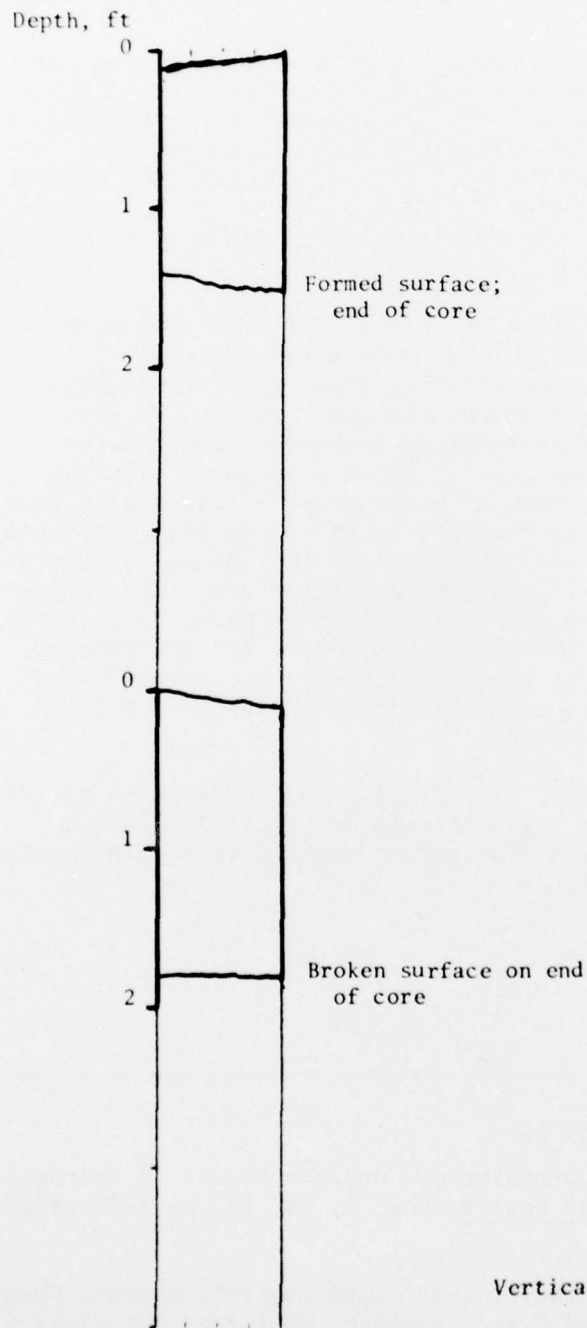
Figure A1.

Core C-1 (HUN-8 CON-1(A))
Near upstream end of tunnel.
Outer surface has aggregate
particles in relief. This
suggests removal of about
1/4 in. of original surface.

Core C-2 (HUN-8 CON-1(B))
Near midpoint of tunnel.
Aggregate in relief on
outer surface suggests
removal of about 1/8 in.
of original surface.

Both cores are intact concrete.
They contain a natural sand and
gravel of mixed composition.
Maximum aggregate size is about
1 in. The core ends show that
tunnel surfaces are iron stained.

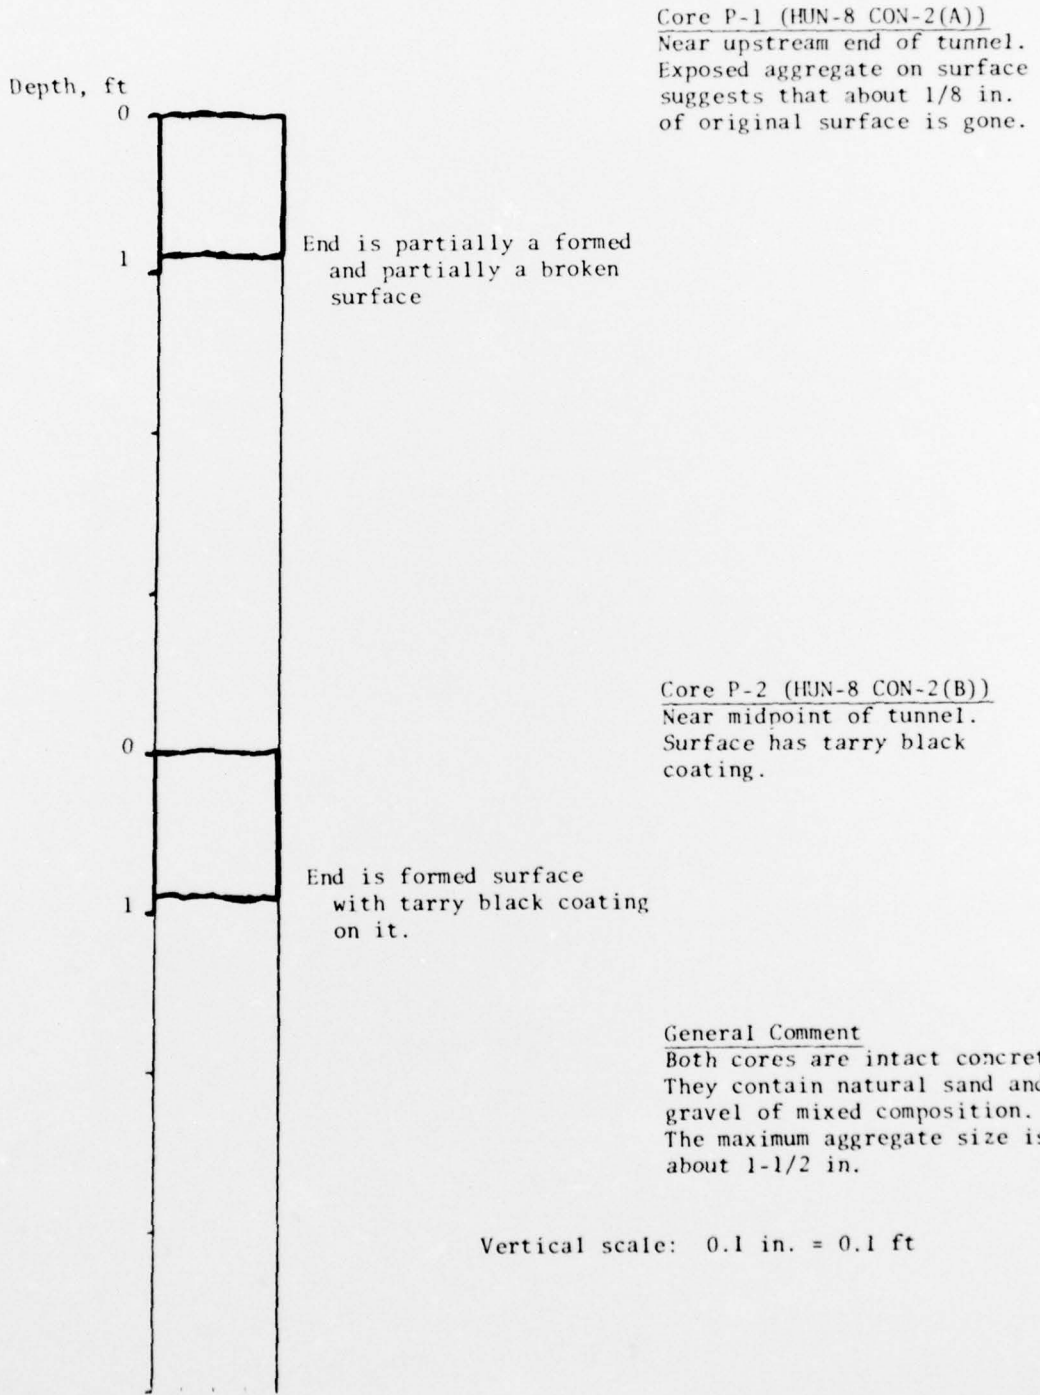
Figure A2 .

Log of Two Horizontal 4-Inch-Diameter Concrete Cores from Outlet Tunnel,
Piedmont Lake, Huntington District
