Special Report 77-29

# INFRARED THERMOGRAPHY OF BUILDINGS

## Qualitative Analysis of Window Infiltration Loss

Federal Office Building, Burlington, Vt.

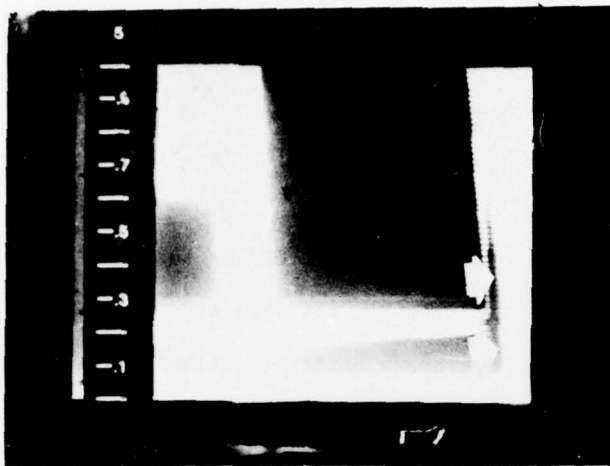
Figures 1 and 2 show thermograms of two north-facing windows in Room 621 taken from inside the building. The infiltration (arrows) seen around these windows is typical of the condition observed at all of the randomly selected windows during the thermographic inspection of this building. Note that in Figure 2 the infiltration is more extensive than in Figure 1. The horizontal black line between the two arrows in Figure 2 shows cold

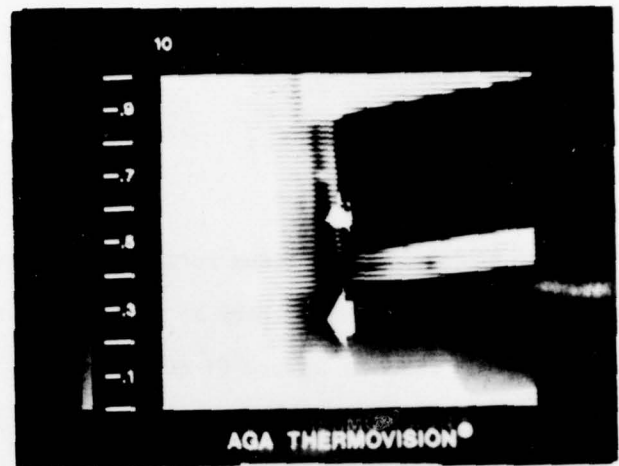
Figure 2.

air leaking through the seal at the top of the opening window. Generally speaking, the air leakage at this location was not as severe as it was around the framing space of these windows. Figure 3 is a photograph of three windows in Room 621.

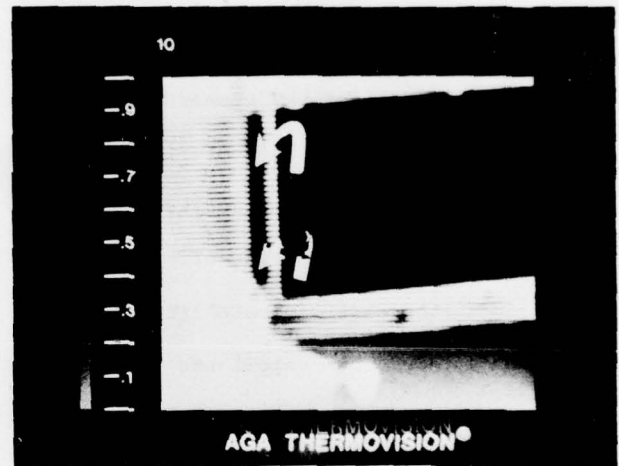
Figure 4.

Figure 4 is a thermogram of the top left part of another projected window in Room 621. Note that air leakage at the window opening is minimal compared with leakage through the window framing space. Also, note in the three thermograms shown in Figures 1, 2 and 4, and in all subsequent ones, that the aluminum frames do not constitute a source of heat loss quite as severe as the infiltration losses.

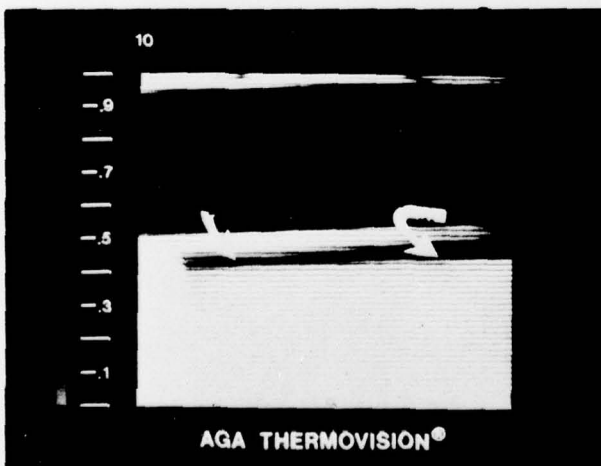
Figure 5.

Figure 5 is a thermogram of cold air leakage under the frame of the opening sash of a window in Room 621. This leakage is probably due to a deficiency of caulking, whereas in the previous three thermograms (Figs. 1, 2 and 4) lack of insulation in the framing space results in excess heat loss.

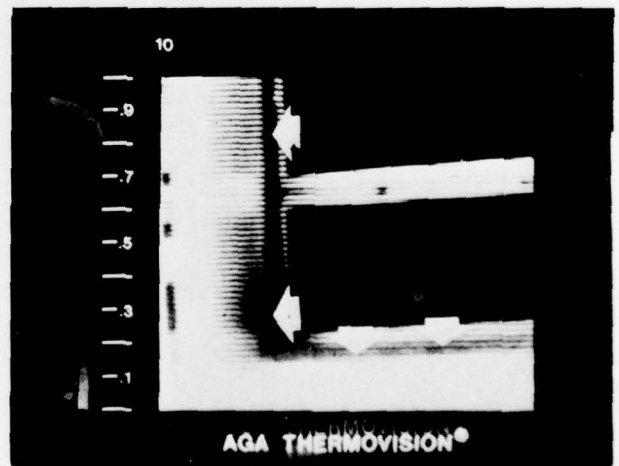
Figure 6.

Figure 6 is a thermogram showing the comparative difference between the heat loss through the framing space (horizontal arrows) and the heat loss under the frame of the opening window (vertical arrows). In this situation, there is more heat loss through the framing space than under the window frame.

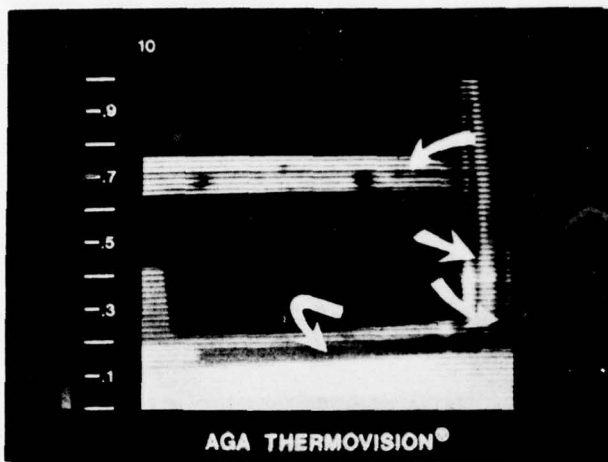
Figure 7.

All of the previous thermograms were taken of windows adjacent to opaque wall sections. Figure 7 is a thermogram of a window which is bounded on each side by another window. The top arrow points to cold air

leaking around the seal at the top of the opening window. The lower right two arrows identify cold air leaking around the mullion between this window and an adjacent one. The arrow at the lower middle identifies a location of greater leakage under the frame of this window than at the other two locations mentioned above.

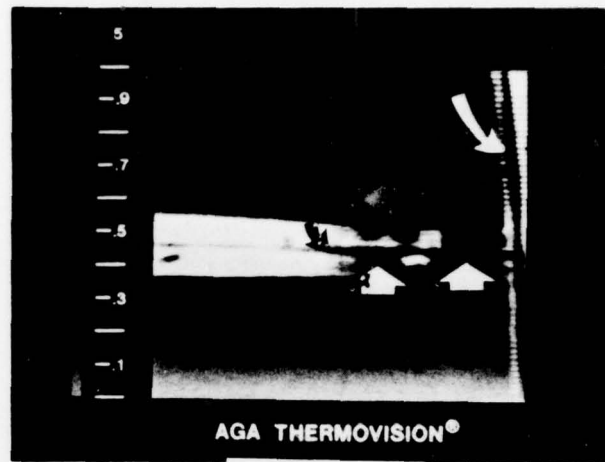
Figure 8.

Figure 8 is a thermogram of a window showing heat loss due to infiltration around the mullion (top arrow) and around the glass-aluminum frame interface (bottom arrows). The heat loss at the latter location could be due to a poor glazing seal. However, it is difficult to determine from the thermogram which pane of glass is not glazed properly. The black arrow identifies excess air leakage around the top seal of the opening window.

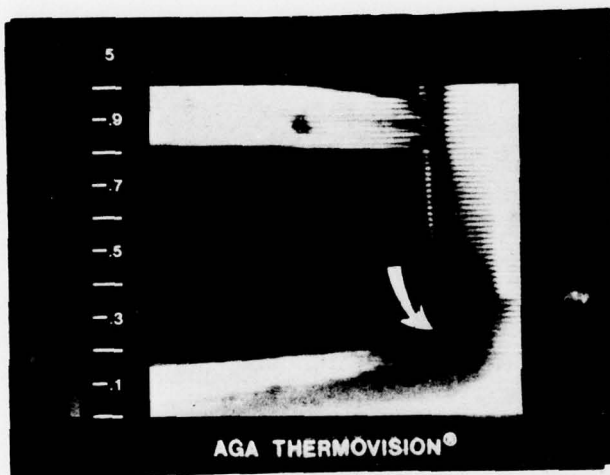
Figure 9.

Figures 9 and 10 are thermograms of two north-facing opening windows in Room 629. The arrows identify excess air leakage entering the room through the interface of the glass and aluminum frame. As in the case of Figure 8, the heat loss around these windows could be due to an inadequate glazing seal. Figure 11 is a thermogram of the lower left corner of another window in Room 629 having a situation similar to those in Figures 9 and 10.

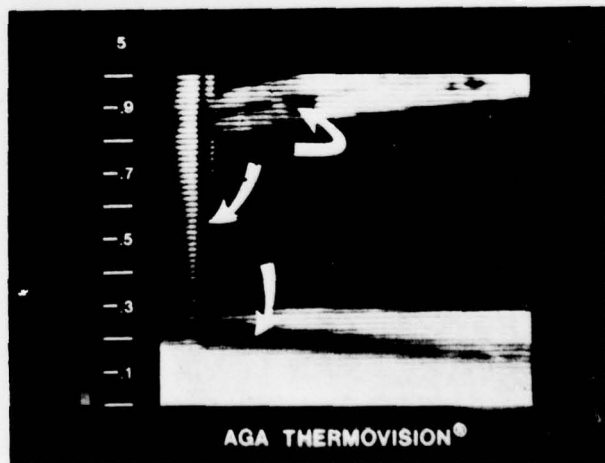
Figure 12.

Figure 12 is a thermogram of an opening window on the northeast corner of Room 631. The top arrow identifies heat loss at the top opening crack, the middle arrow locates air leakage around the mullion, and the lower arrow shows air leakage under the aluminum frame.

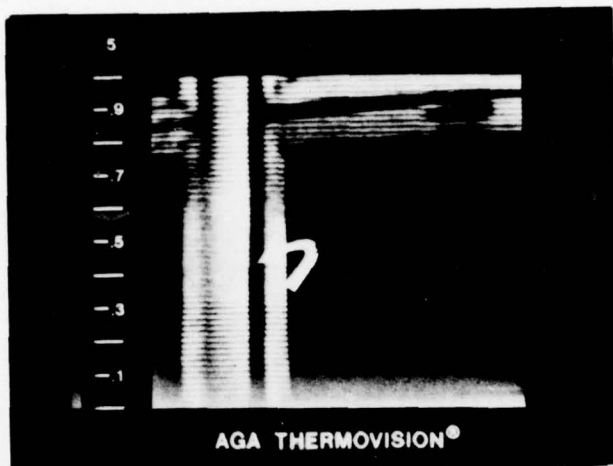
Figure 13.

Figure 13 is a thermogram of the top left section of an east-facing opening window in Room 631. The cold air leakage is fairly uniform around the mullion and the top opening crack. Figure 14 is a thermogram of the

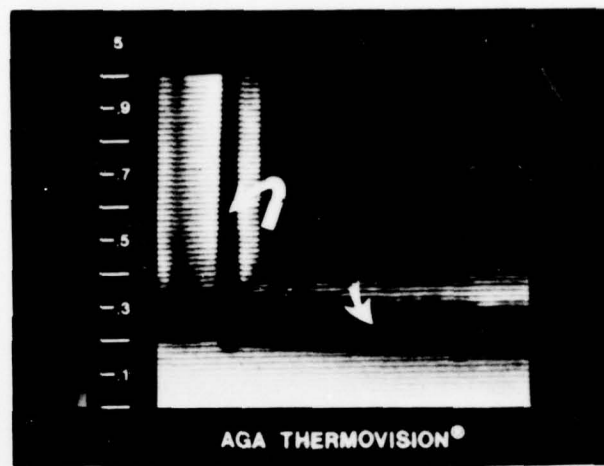
Figure 14.

same window but taken below the frame at the sill level. Notice that while the infiltration remains constant up the left side of this window the air leakage under the frame is more severe due to a poorly caulked joint.

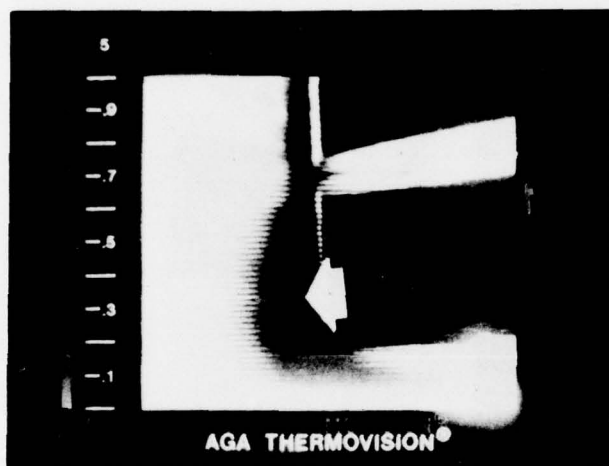
Figure 15.

Figure 15 is a thermogram of a section of a north-facing opening window in Room 234. This particular window abuts an opaque wall section. The thermal pattern seems to indicate that the infiltration is taking place through the framing space of the window. Obviously, it is much worse at the lower part of the window than at the upper part. However, at the top opening crack no air leakage is visible.

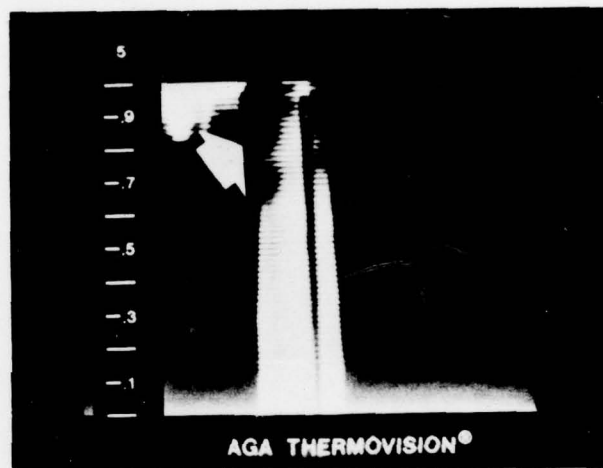
Figure 16.

Figures 16 and 17 are thermograms of mullions of north-facing stationary windows in Room 234. The excess heat is probably being lost at the glass/aluminum frame interface in a manner similar to the situation in Figures 8-10.

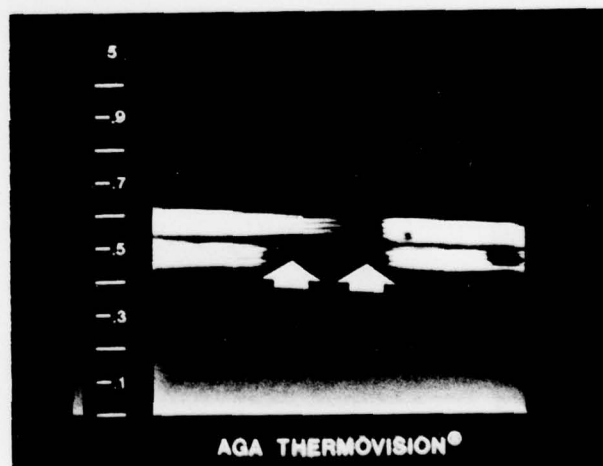
Figure 18.

Figure 18 is a thermogram of the top opening crack of a north-facing window in Room 234. The uniform, thin, black horizontal line indicates air leakage at the top opening crack, while the arrow points to excess heat loss at the glass/frame interface. The glass pane in the opening window shows leakage at two locations (arrows). Figure 19 is a thermogram of the lower right corner of the same window. While there is some cold air present at the sill/frame interface, the greatest heat loss (arrow) seems to be at the bottom right corner of the glass/frame interface.

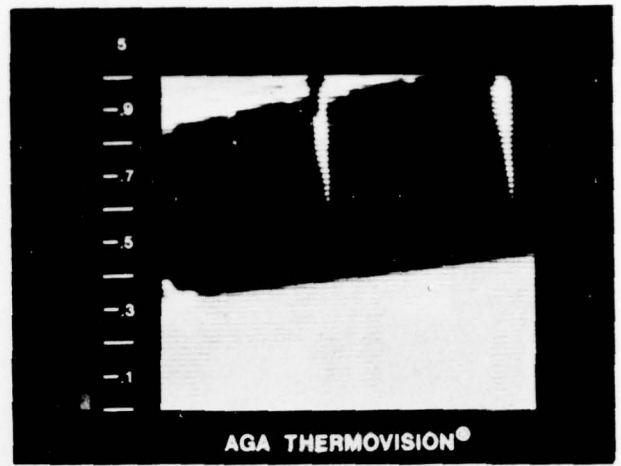
Figure 20.

Figure 20 is a thermogram of two south-facing basement windows in the Post Office workroom. Figure 21 is a photograph of these windows.

Personnel stated that they were very cold when working near these windows. In fact, this section of the workroom was not used during the winter months for this reason. The thermogram shows the convection of cold air from each of these single-pane windows.

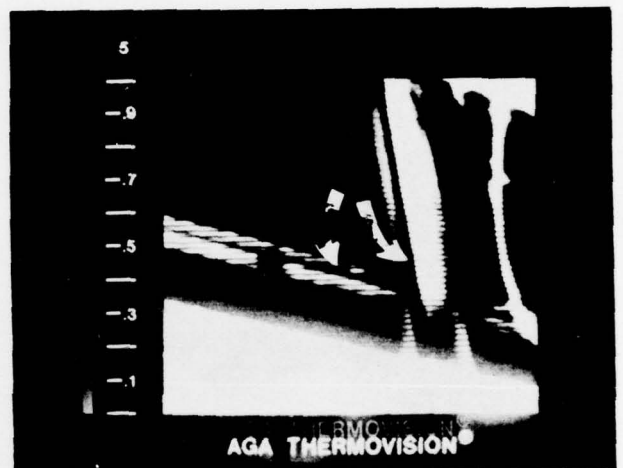
Figure 22.

Figure 22 is a thermogram of two other south-facing windows in the Post Office workroom. The arrows identify the usual sources of heat loss found in all the other windows inspected during this survey. However, the general appearance of the thermal pattern of the window on the right indicates why it is so cold working near these windows.

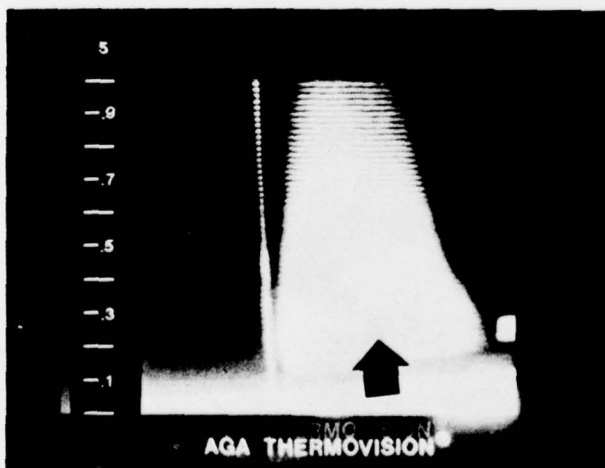
Figure 23.

Figures 23 and 24 are thermograms of the lower sections of the east-facing stationary single-pane windows in the Post Office lobby. Arrows identify a plume of heat rising from the convectors directly under these windows. Figure 25 is a thermogram of the top section of one of these windows. The arrows locate the warm spots on the glass due to the heat rising from the convectors. Figure 26 is a photograph of these windows.

The discussion relating to the windows considered the retrofit options for all of the projected windows which opened. However, referring to Figures 23, 24, 25 and 27, we see that significant heat losses are occurring through the stationary windows in the Post Office lobby. To effect a significant reduction in heat loss, two possible corrective actions can be taken: 1) reduce glass area according to our previous recommendations or 2) retain the same glass area but install double- or triple-glazed windows. In either case, we also recommend that 1) aluminum reflectors be placed behind the convectors to deflect the heat back into the lobby, 2) heavy lined drapes be used during all non-occupancy hours, and 3) the temperature in the lobby (and in the whole building) be maintained at 68°F during occupancy hours, and reduced to 65°F at night.

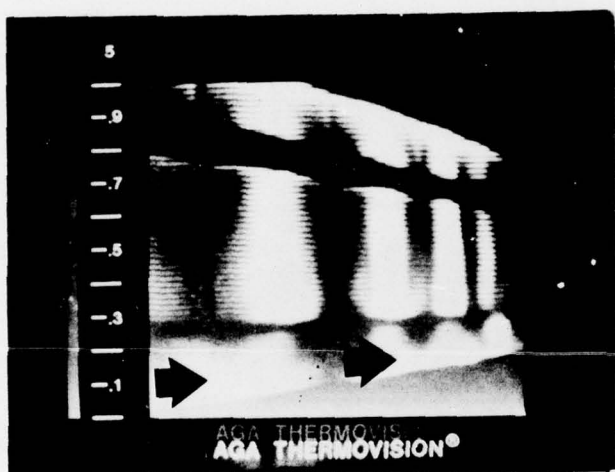
Figure 27.

Figure 27 is a thermogram taken directly outside the Post Office lobby; thus it can be compared with Figures 23-25. This thermogram proves beyond a doubt that the plume of heat is being readily conducted through the single-pane glass. Also note that the convectors themselves are transmitting heat (arrows) directly through the masonry wall. Figure 28

Figures 27 and 28 show evidence of excessive wall heat losses through the lower part of the east-facing wall (Post Office lobby) and the lower part of the south-facing wall (Post Office workroom). While the area involved is not extensive, these losses could be up to 5% of the total BTU loss of this building.

If aluminum reflectors can be inserted behind the convectors in the Post Office lobby so that they extend to the floor level, the situation shown in Figure 27 can be greatly remedied. However, a better solution can be achieved to reduce the wall heat losses shown in Figure 28. The wall can be insulated using various methods. If an approved finishing material is used for covering and fire codes permit, urethane could be sprayed on the wall. Urethane has the highest thermal resistance (R) factor of any commercially available insulation. Other possibilities include the use of rigid urethane or Styrofoam, fiberglass insulation, and urea formaldehyde insulation. GSA management personnel will have to assess the trade-off between relocating pipes on or near this wall, and the cost of installing insulation with the savings that could be realized.

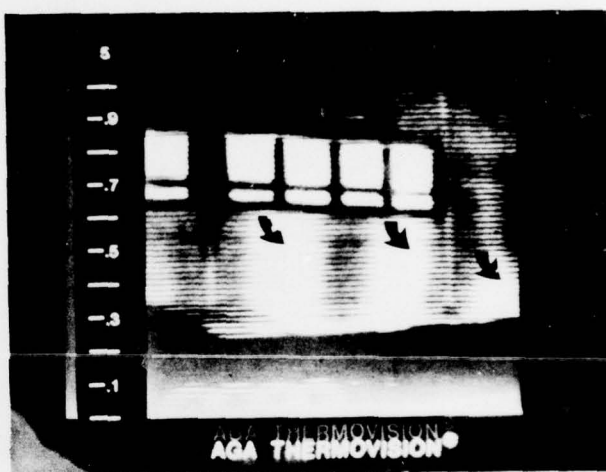
Figure 28.

is another thermogram showing heat being conducted through the masonry wall. This is the south-facing wall of the Post Office workroom where radiators and hot water pipes are mounted directly to the wall.

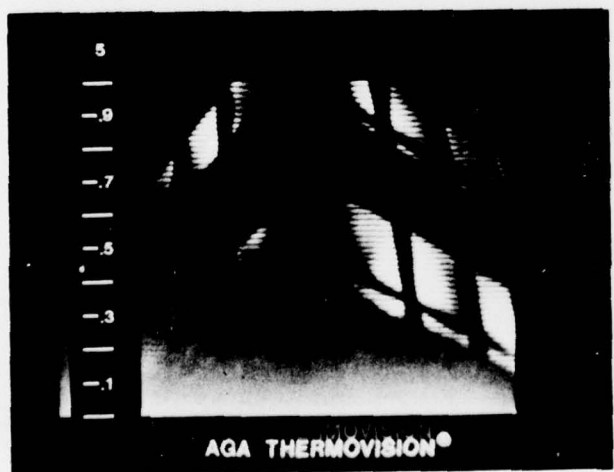
Figure 29.

The remaining three thermograms (Figures 29-31) show the heat loss from east-facing windows. The windows having "bright" thermal patterns either have warmer interior temperatures than the ones that do not, or in some cases, the "dark" windows have a higher thermal efficiency due to the presence of drapes.
