Report No. CG-D-40-77

RECREATIONAL BOAT SAFETY
COLLISION RESEARCH:
COLLISION ACCIDENT INVESTIGATIONS
JULY 1976 - DEC 1976

JANUARY 1977

FINAL REPORT

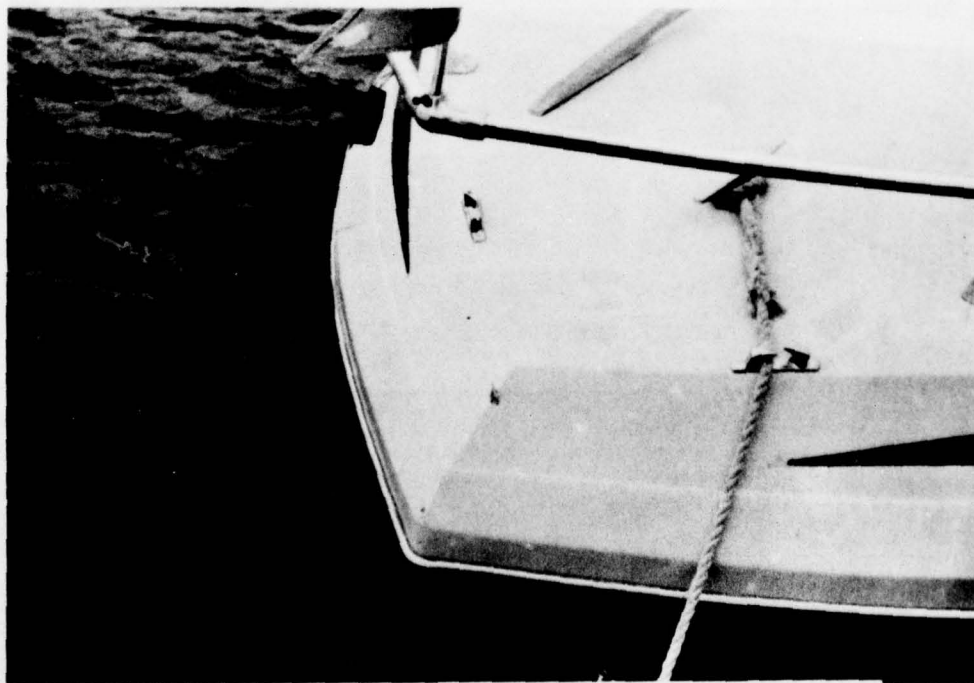
FIGURE 6. 21' (6.5 M) CRUISER. DETAIL OF BOW DAMAGE

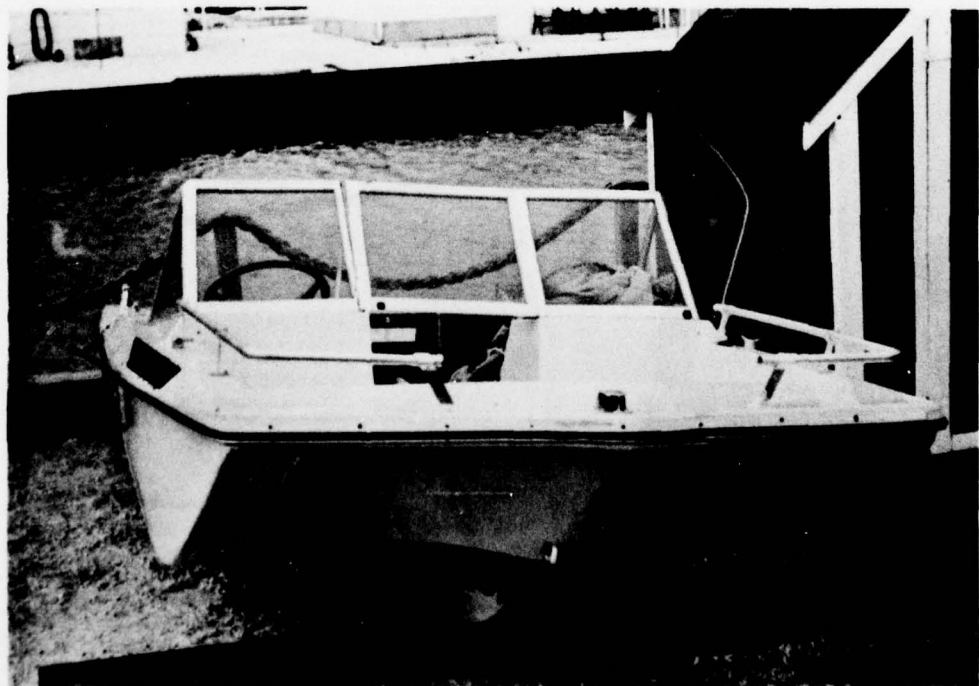
FIGURE 8. 14' (4.3 M) RUNABOUT. NOTE OPEN RIVET HOLES ABOVE RUB RAIL WHERE DECK POPPED LOOSE

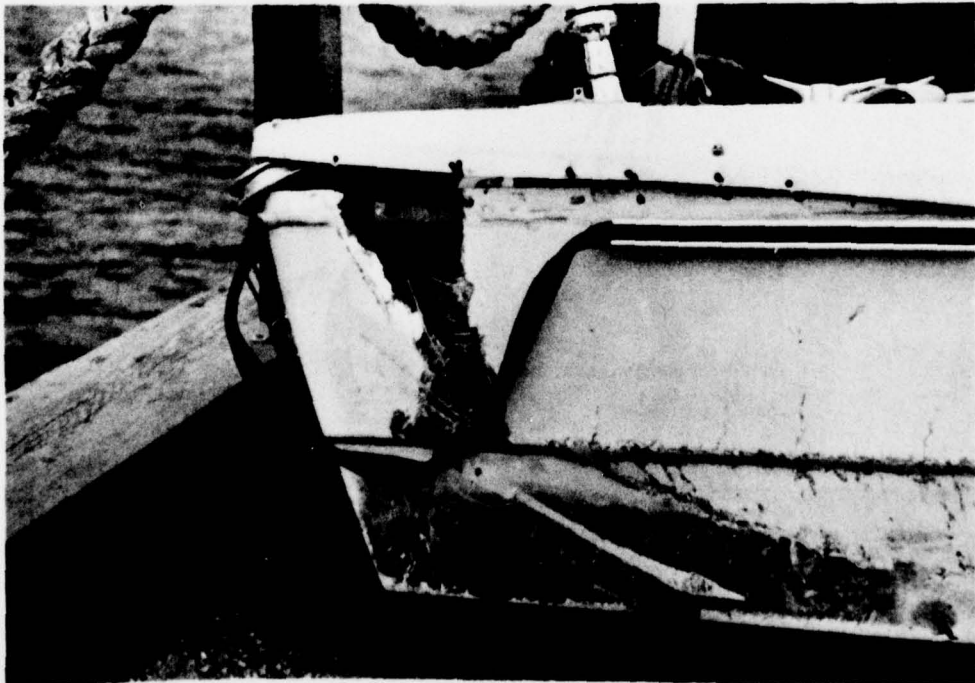
FIGURE 10. 14' (4.3 M) RUNABOUT. DETAIL OF STARBOARD QUARTER DAMAGE

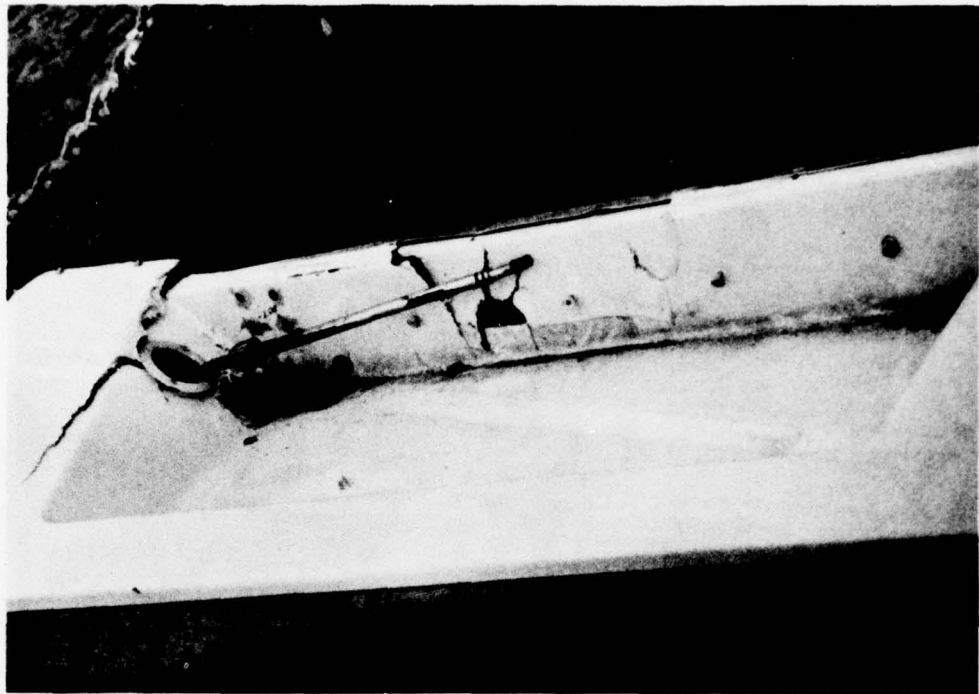
The runabout's steering was affected as the sleeve and control cable were displaced to port by the impact. It would probably have been necessary to disconnect the steering gear and turn the motor by hand if the runabout needed to travel any distance to reach safety.

FIGURE 11. 14' (4.3 M) RUNABOUT. DETAIL OF MOTOR WELL, TRANSOM AND STEERING CONTROL DAMAGE

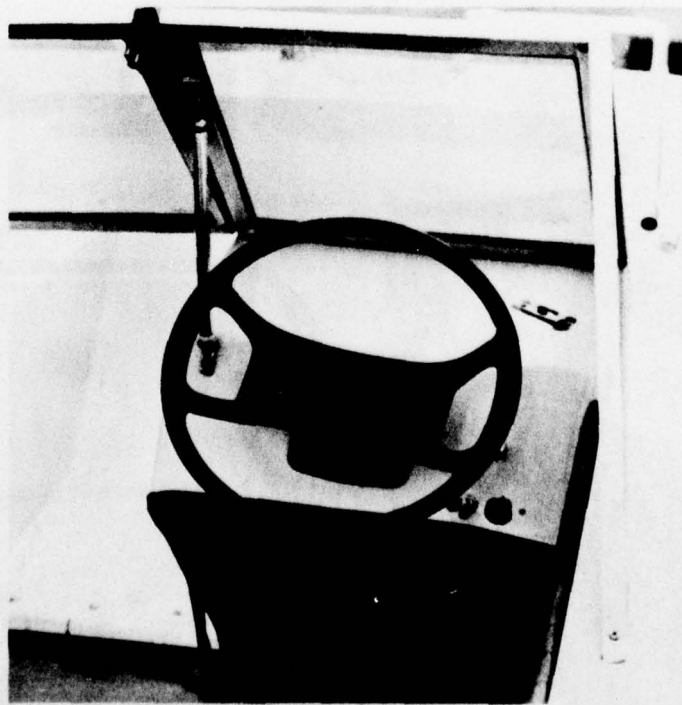
FIGURE 12. 14' (4.3 M) RUNABOUT CONTROL STATION. NOTE SHARP WINDSHIELD EDGES AND CORNERS

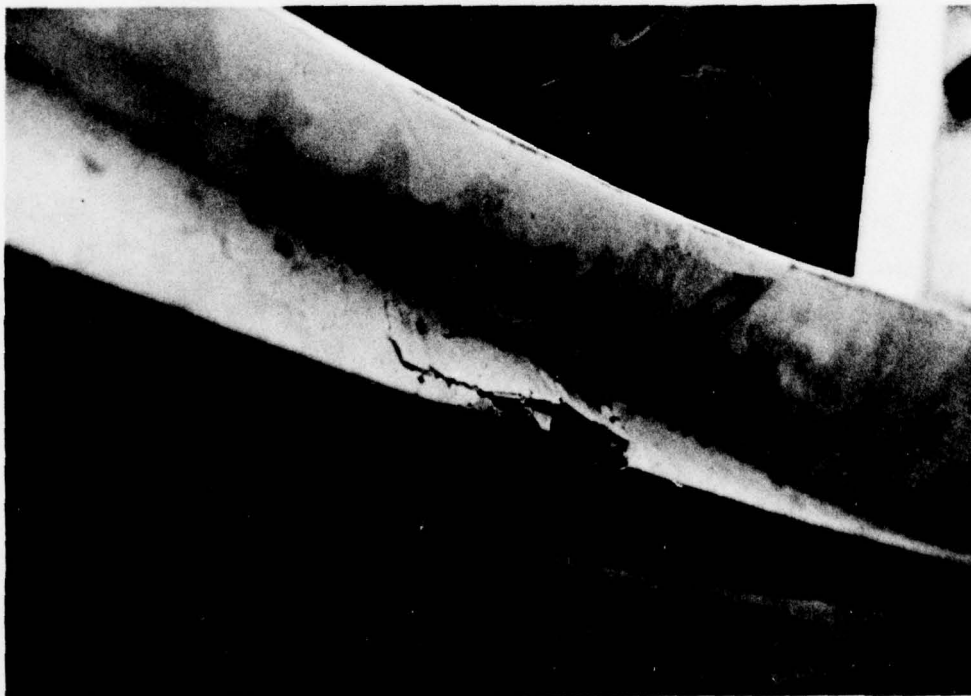
The port coaming was crushed in a six inch (15.2 cm) area where the stem of the cabin boat impacted it. Scratches and bottom paint from the cabin boat were evident where the three separate hulls contacted the coaming and the engine. The port seat had been knocked loose and the engine mount was twisted slightly. The gel coat was cracked for about four feet (1.2 m)

under and outboard of the coaming where the fiberglass structure had bent. No structural damage could be found in that area. In fact, the only apparent structural damage was a bent aluminum gunwale guard rail and the six inch (15.2 cm) portion of crushed coaming mentioned above.

FIGURE 8. GUNWALE DAMAGE

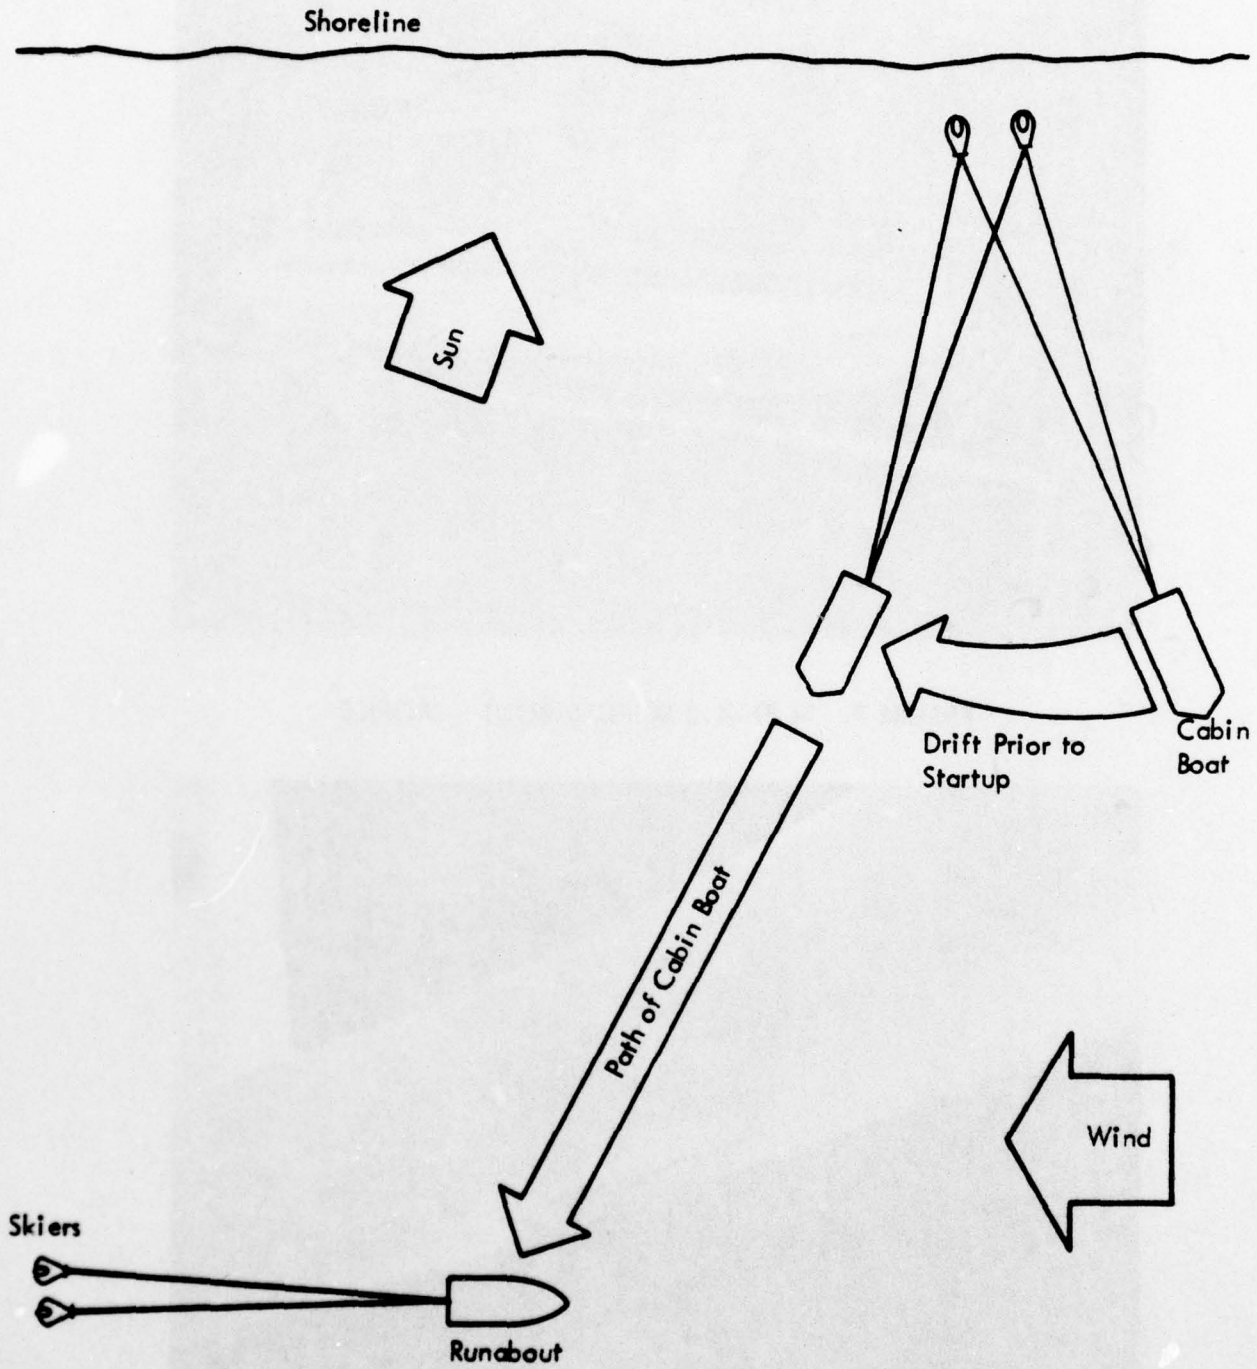
The runabout was struck broadside, (see Figure 9) by the lower portion of the stem of the cabin boat. As the cabin boat slid up and over the runabout, it pushed the port corner of the runabout underwater causing it to swing. First, as cited with the fact that the runabout had a double wall construction in the lower portion of the hull sides, was the reason that the runabout sustained relatively little damage.

FIGURE 9. COLLISION AREA

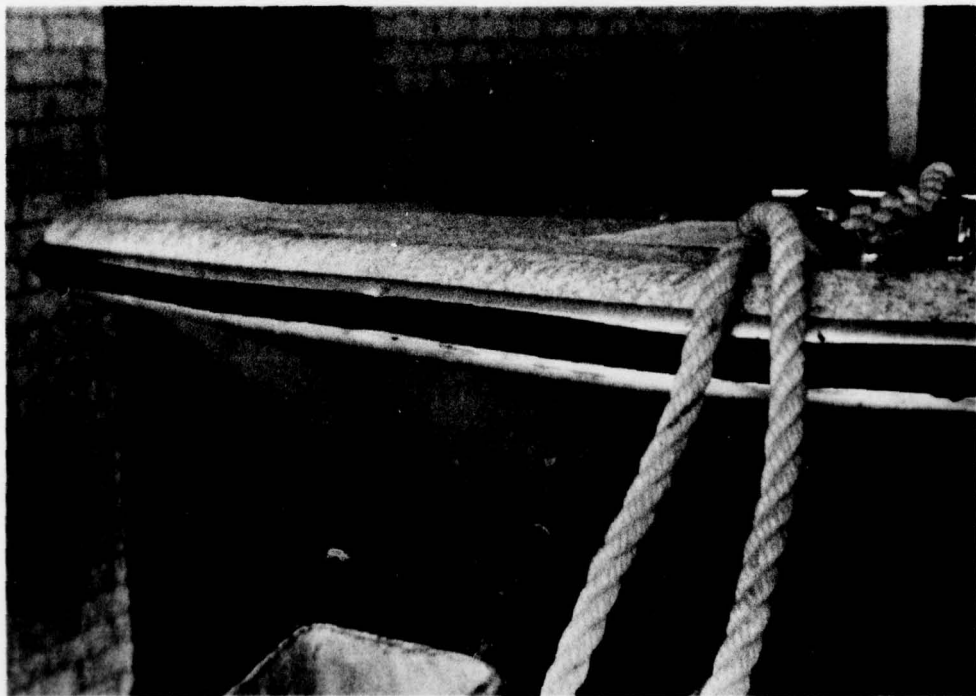
The hull design and load distribution in Boat #1 would have made it run in a near level attitude at any speed over 20-25 mph (32.2-40.3 kph). Damage to the bow bump rail shows that the boat was in a near level attitude on impact, which indicates that the boat was traveling at a high speed. No marks could be found on the port side of Boat #2; therefore, Boat #1 went airborne high enough to clear the port side. It is believed that the boat speed had to be near maximum (approximately 40 mph (64.4 kph)) to have sufficient momentum to clear the port side of Boat #2 after impact with the starboard side.

FIGURE 3. DAMAGE TO BOAT #1

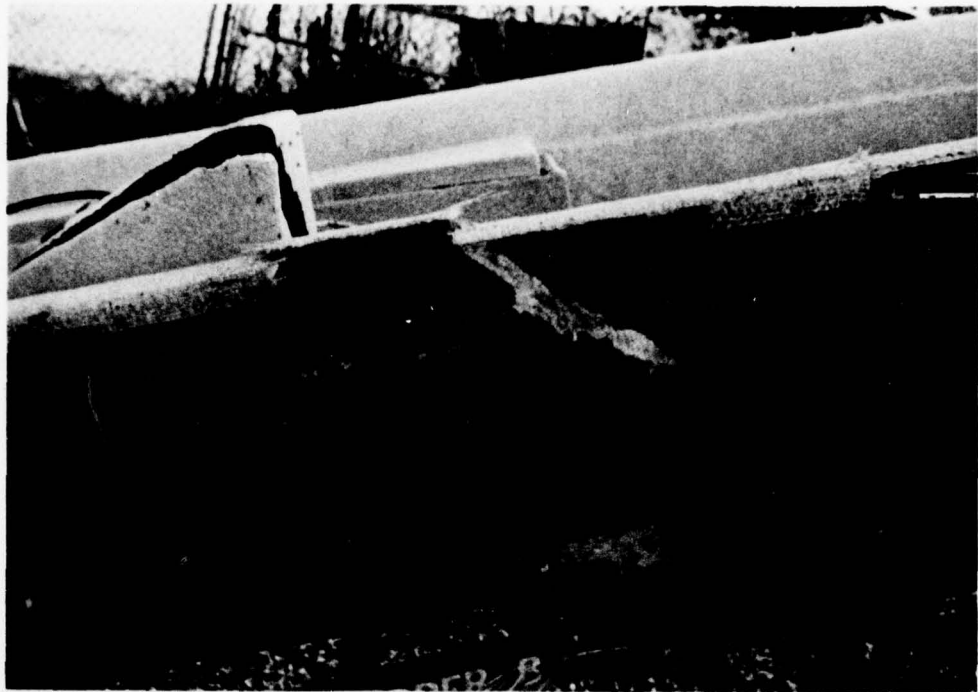
FIGURE 8. DAMAGE TO STARBOARD SIDE OF BOAT #2

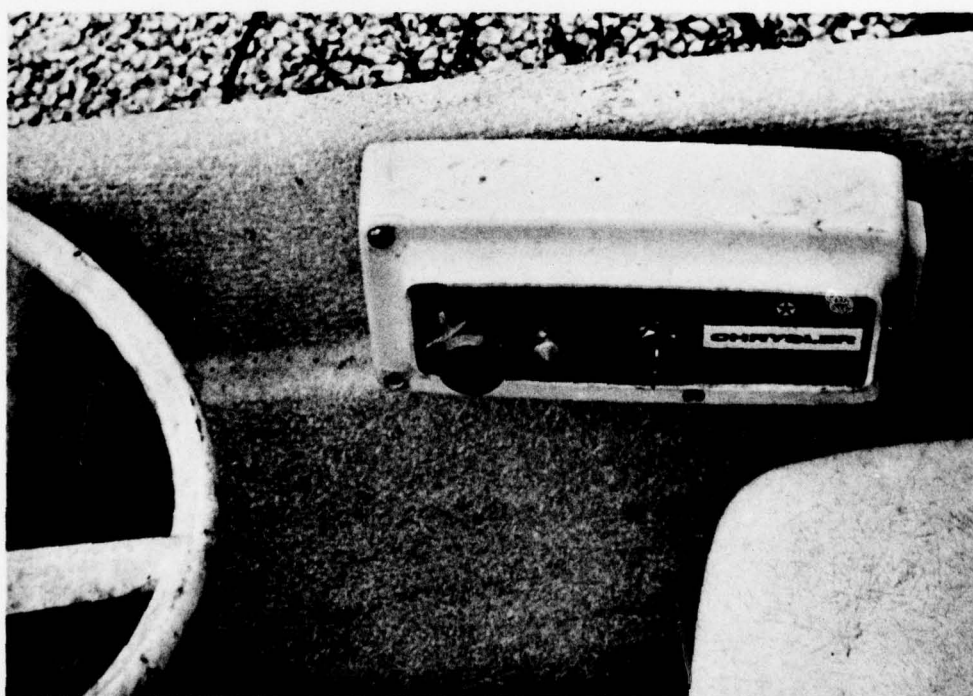
FIGURE 11. DAMAGE TO CONTROL BOX OF BOAT #2

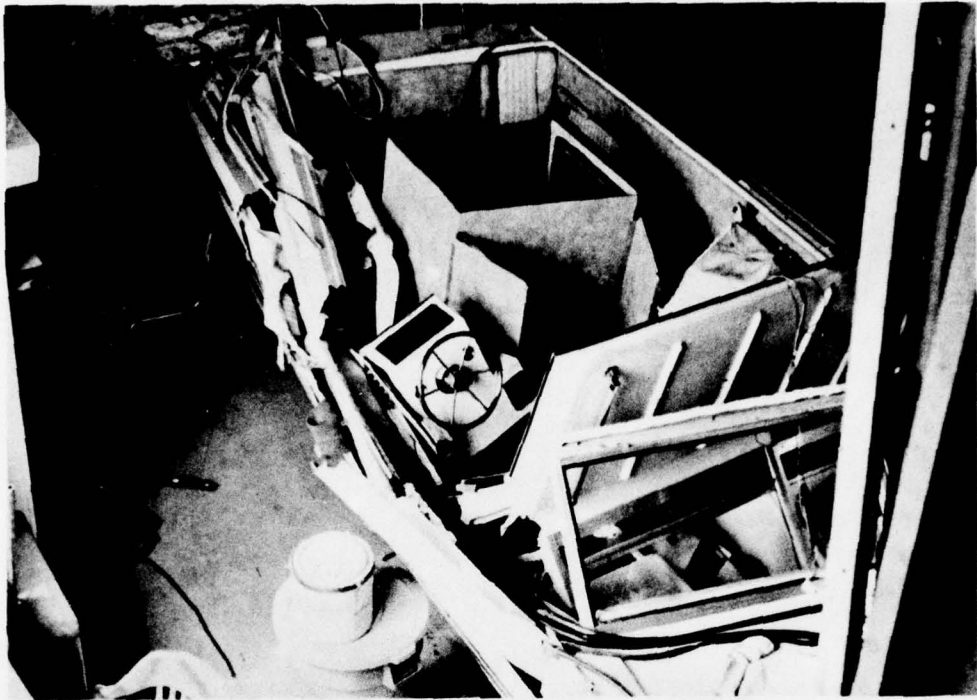
As Boat No. 2 punctured through the side and started to rip through Boat No. 1, it struck both the operator and passenger of Boat No. 2, knocking them overboard. Also, the windshield and bow of the boat crashed into and lifted/ripped the cabin roof and bow cover loose from Boat No. 1 with parts of the superstructure remaining on the bow of Boat No. 2 and parts going overboard. The windshield of Boat No. 2 protected the occupants of Boat No. 2 from the debris ensuing. That the sleeping boys were not injured is due to the fact that they were just forward of the steering console/cabin bulkhead which deflected Boat No. 2 slightly aft.

FIGURE 5. DAMAGE TO BOAT NO. 1

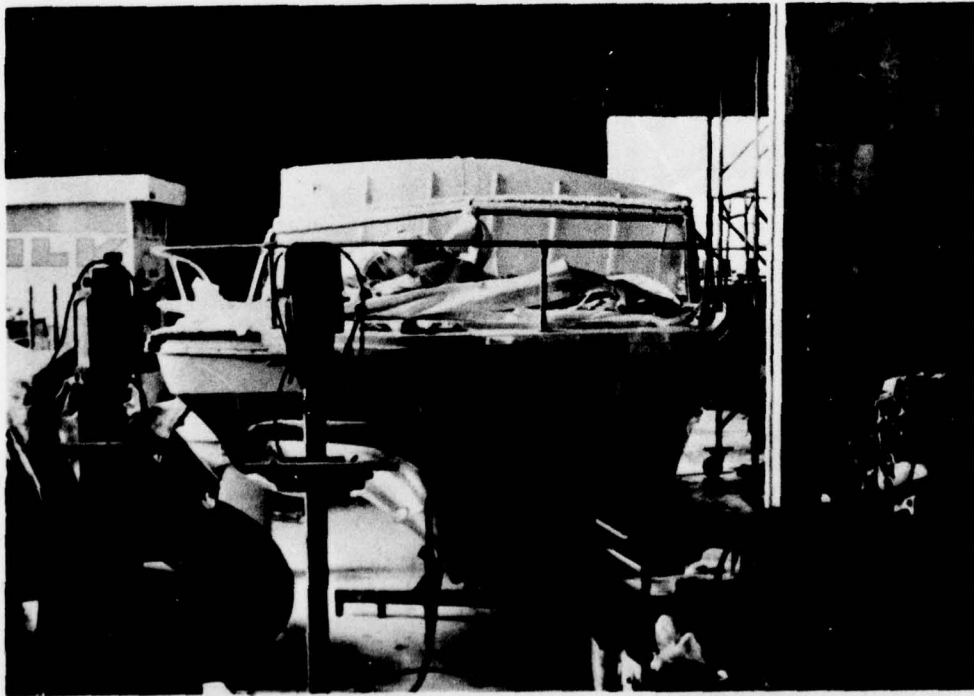
FIGURE 6. DAMAGE TO BOAT NO. 1

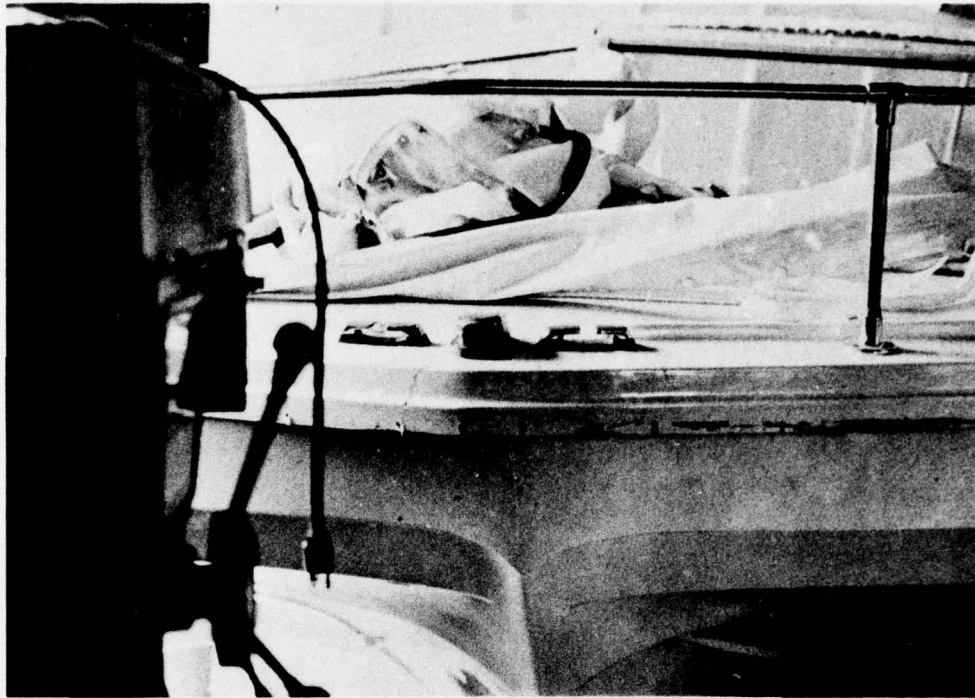
FIGURE 7. DAMAGE TO BOAT NO. 1

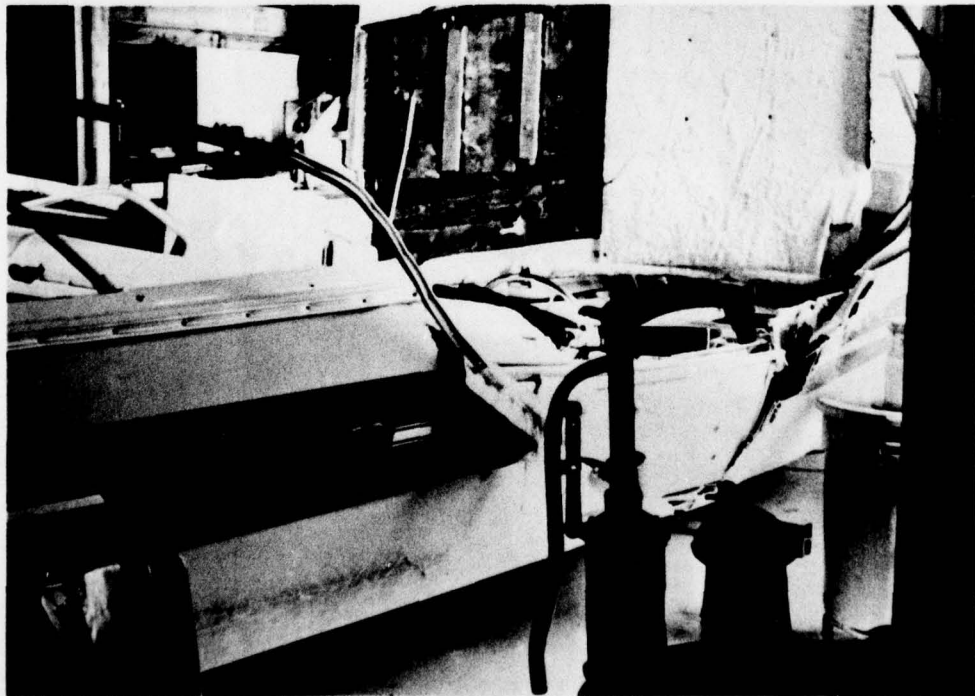
FIGURE 8. DAMAGE TO BOAT NO. 1

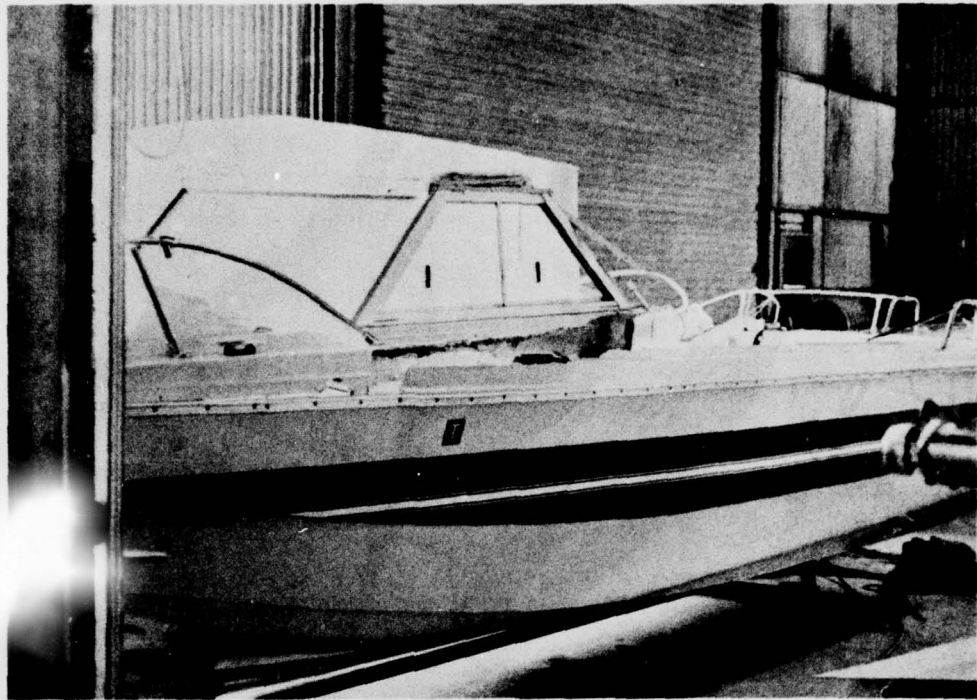
FIGURE 9. DAMAGE TO BOAT NO. 1

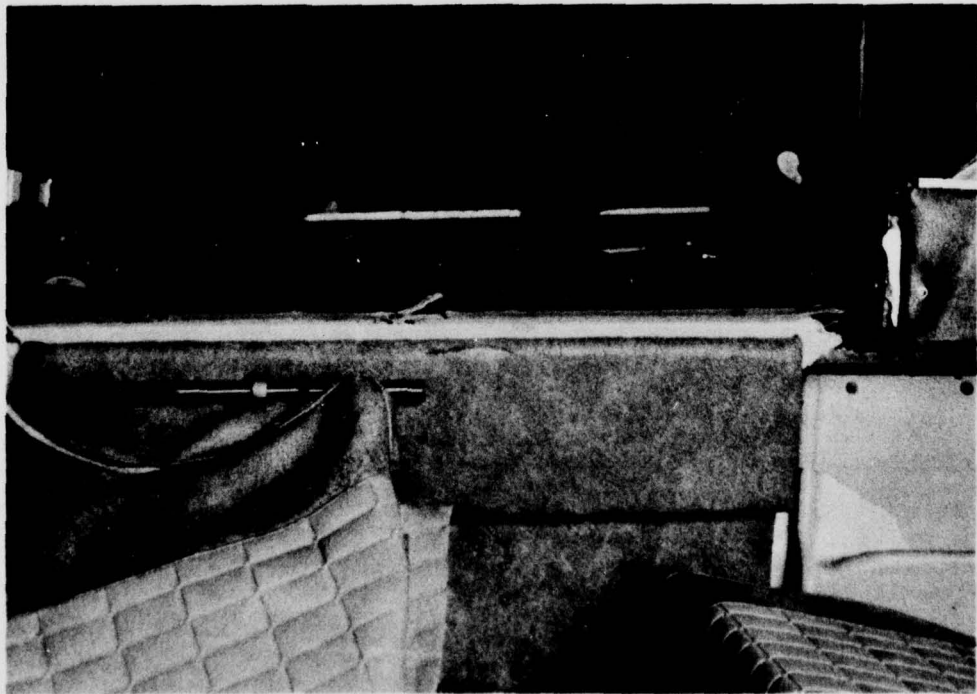
FIGURE 10. DAMAGE TO BOAT NO. 1

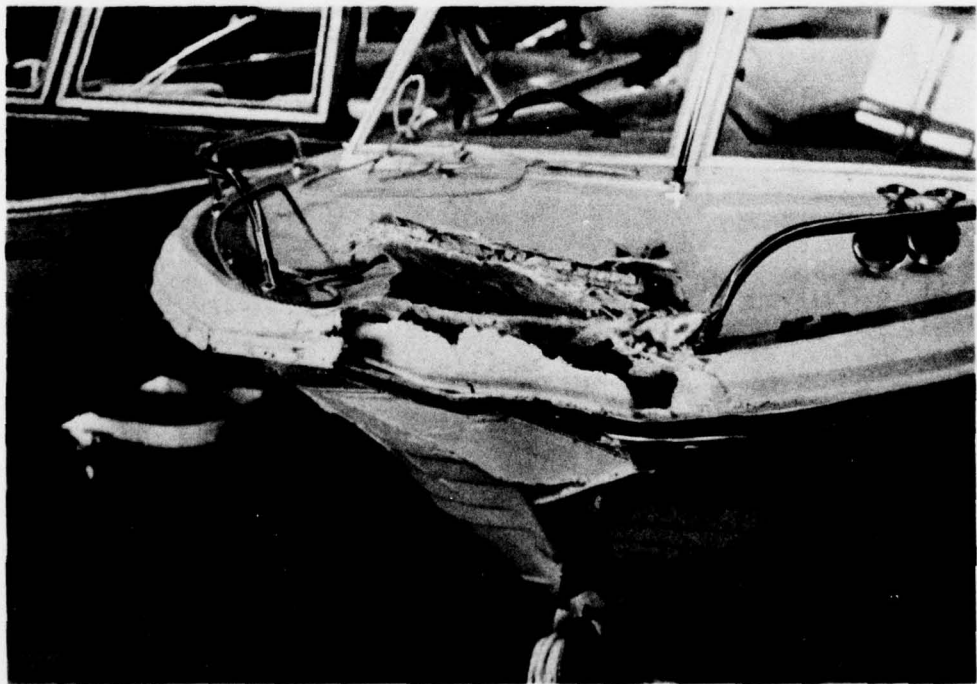
FIGURE 4. STRUCTURAL DAMAGE TO BOW

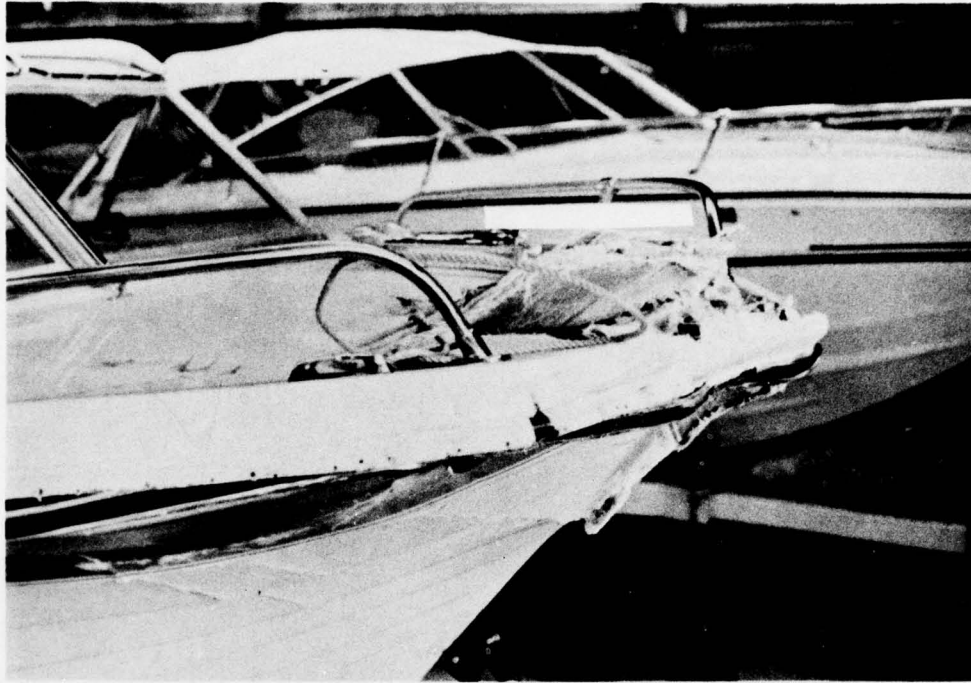
FIGURE 5. STRUCTURAL DAMAGE TO BOW (STARBOARD SIDE VIEW)

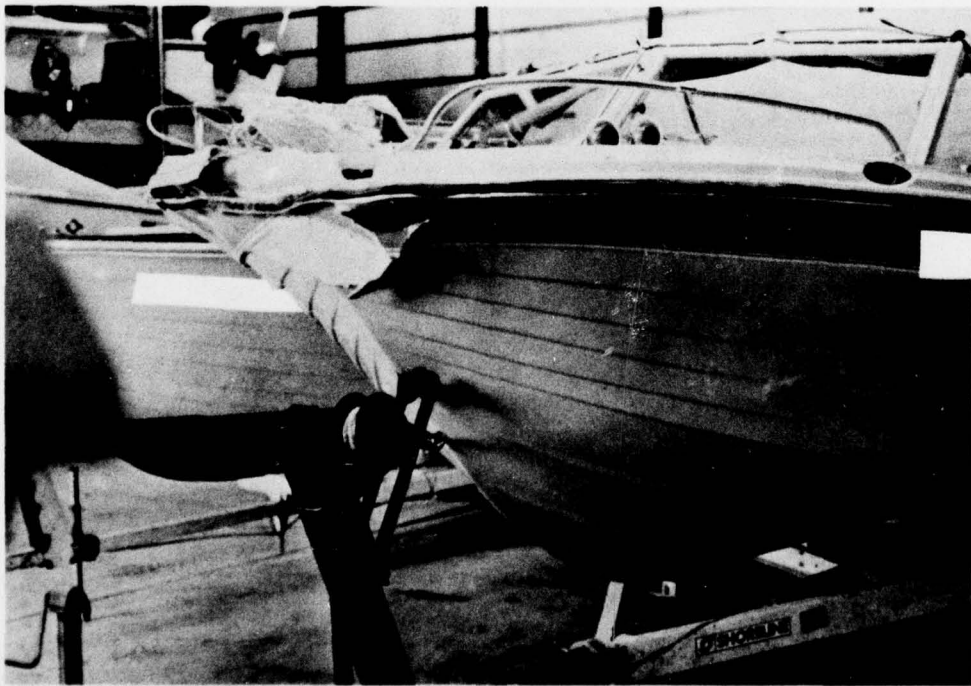
FIGURE 6. STRUCTURAL DAMAGE TO BOW (PORT SIDE VIEW)

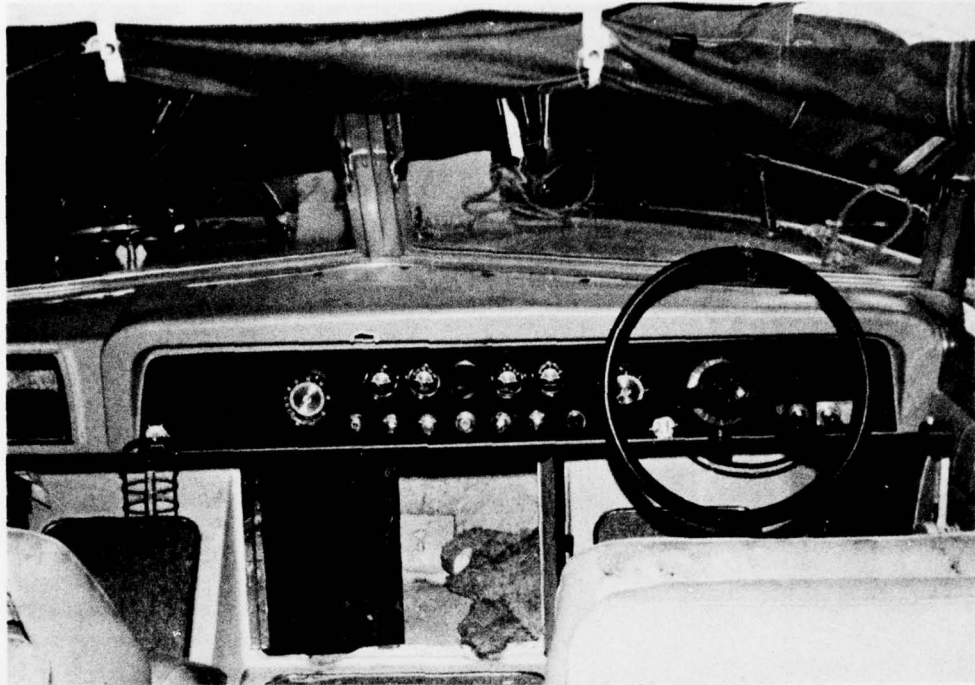
The operator was steering with his right hand when the boat suddenly turned to starboard. He did not have time to grab the wheel with his left hand and retard the throttle with his right hand before impact with the pier. The boat impacted the pier bow on. There was visual evidence that the operator was thrown forward into the approximate center of the instrument panel.

FIGURE 7. DAMAGE TO INSTRUMENT PANEL

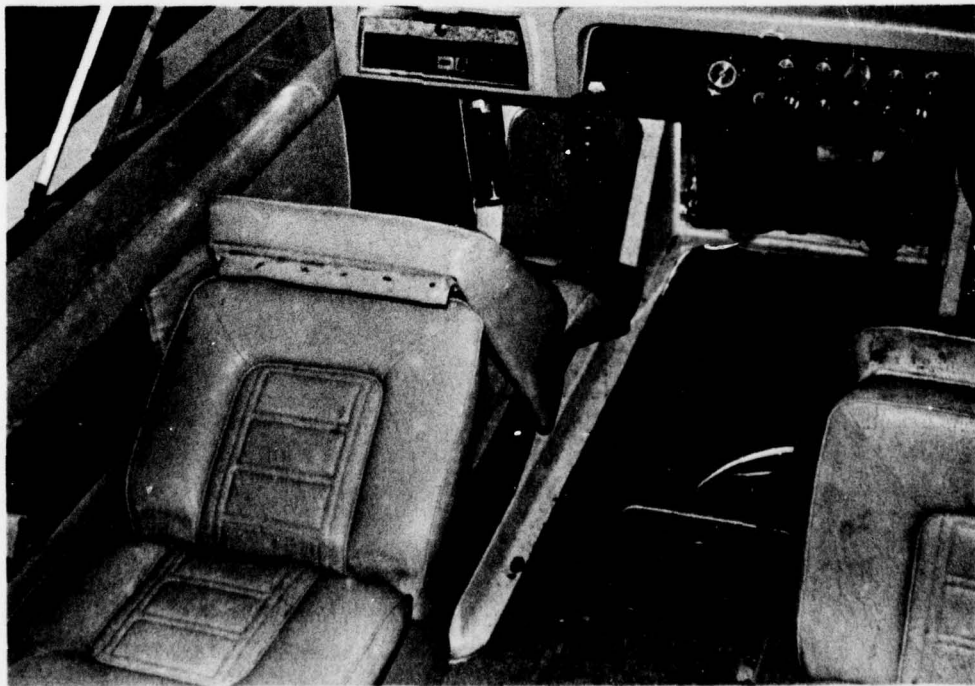
FIGURE 8. DAMAGE TO PORT SIDE SEATS

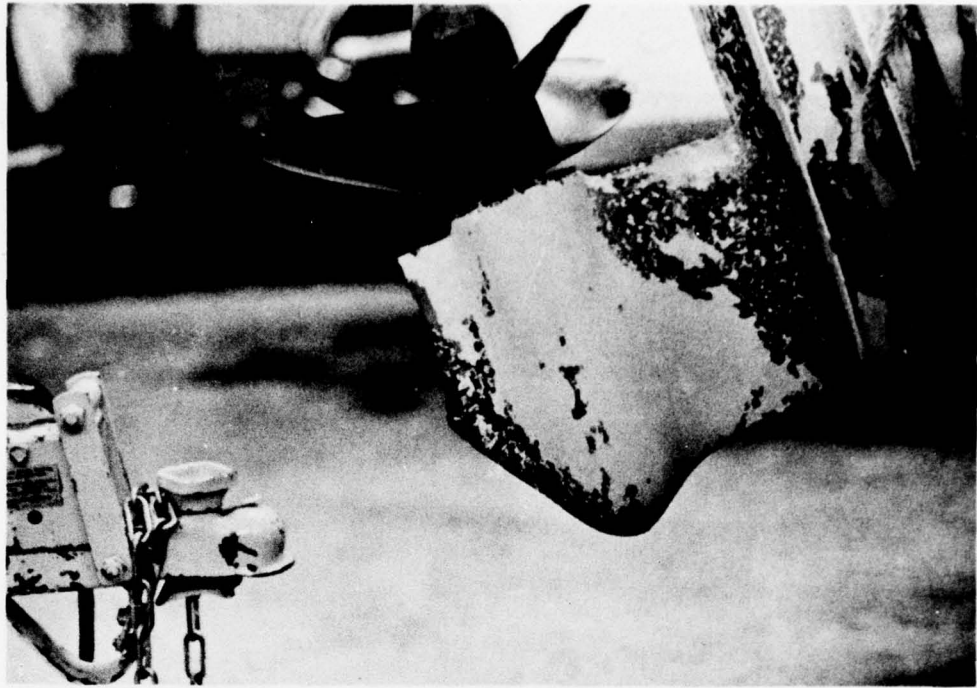
FIGURE 9. BROKEN LOWER UNIT SKEG

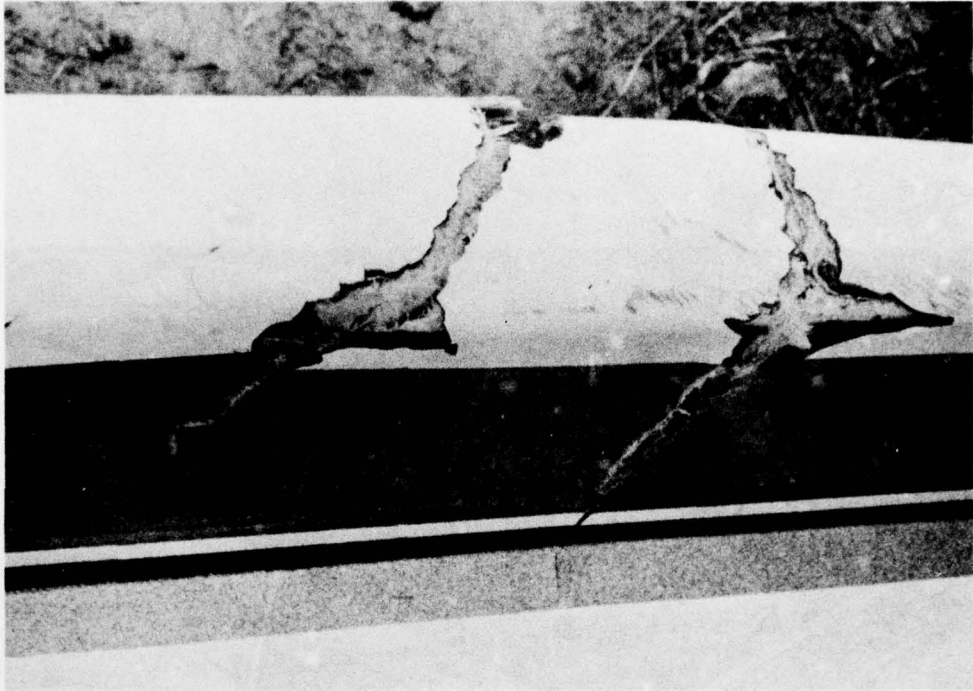
FIGURE 4. BOAT NO. 1 - DAMAGE ON PORT COAMING CAUSED BY BOW OF BOAT NO. 2

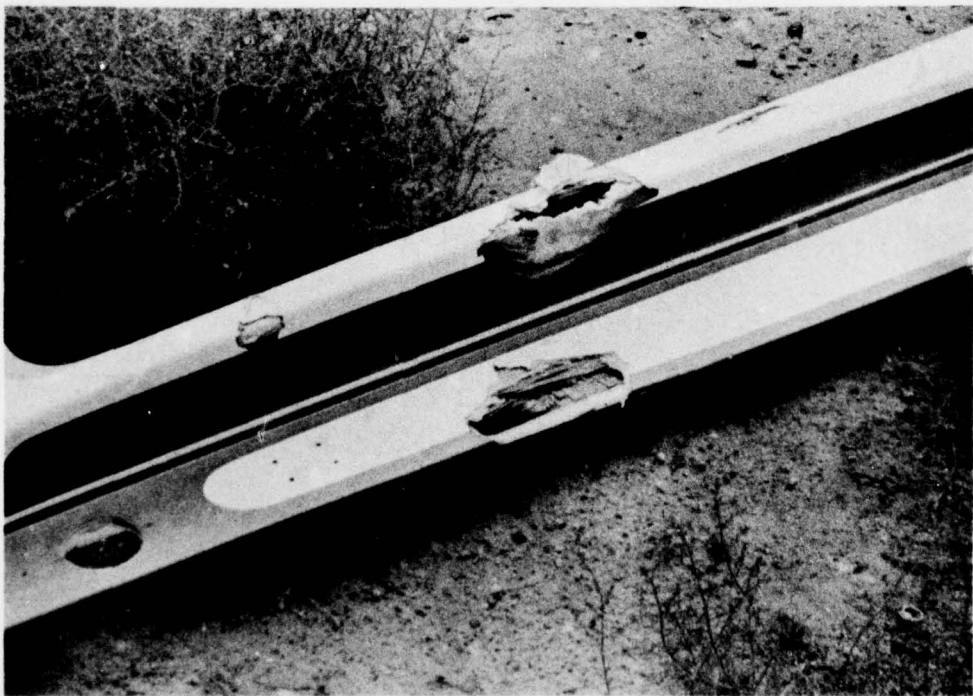
FIGURE 5. BOAT NO. 1 - DAMAGE ON STARBOARD COAMING CAUSED BY PROPELLER OF BOAT NO. 2

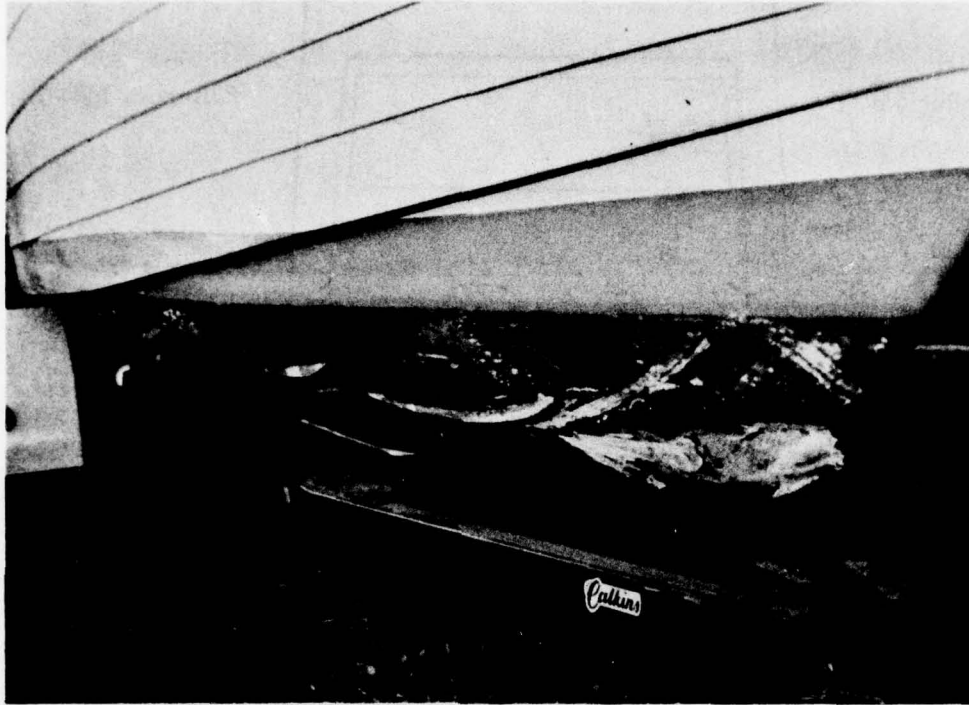
Because the boat was operating at a bow high attitude, the forefoot was at such an angle that it enabled the boat to slide up onto the breakwall. Thus, much of the energy was absorbed by the friction of the starboard portion of the bottom of the boat as it rode up onto the breakwall. Had the boat been going slower, it would have been running at a flatter angle. The stem may have been crushed, thus opening a larger hole for water to enter. If the boat had been going faster, it would also have been running flatter with the same results.

FIGURE 3. DAMAGED FOREFOOT

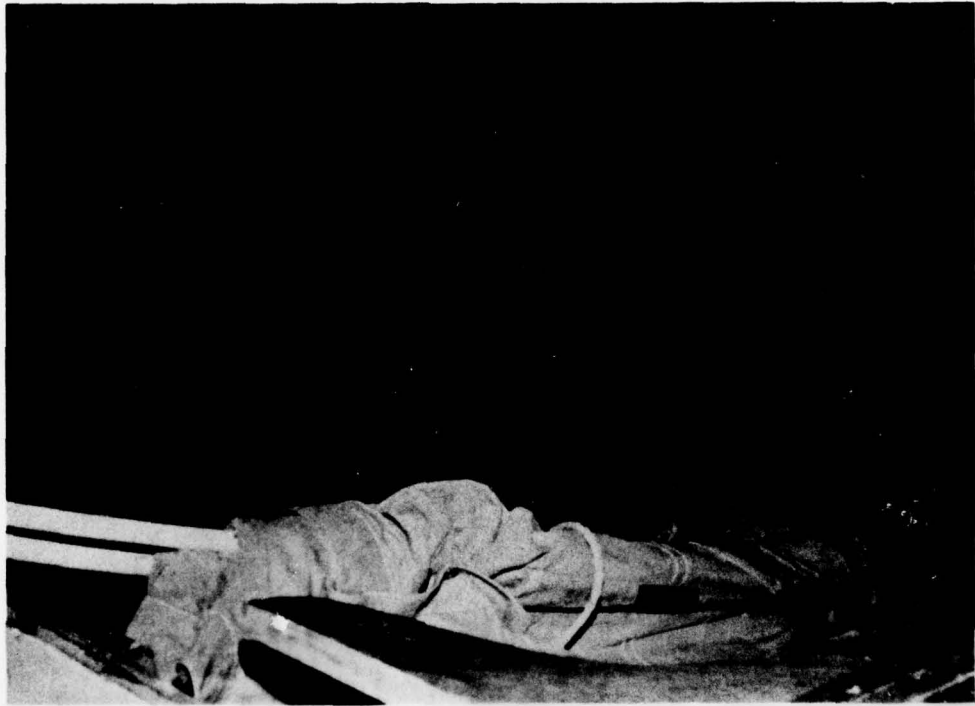
The bow of Boat No. 2 impacted the starboard side of Boat No. 1 near amidships and essentially perpendicular to the longitudinal axis. The impact ripped a large section out of the starboard side of Boat No. 1. The forward momentum of Boat No. 2 carried it across Boat No. 1 and into the water on the port side. As Boat No. 2 traversed across Boat No. 1, its weight pushed No. 1 down, causing it to begin flooding immediately. The bow of Boat No. 2 raised after impact, causing it to jump over Boat No. 1 as was evident from the minimal damage to the port side of Boat No. 1. Apparently, Boat No. 1 was pushed under water or sank immediately because the occupants of Boat No. 2 did not see it within seconds after the collision. Within a short time after sinking, Boat No. 1 rolled upside down and the bow section resurfaced.

FIGURE 4. STRUCTURAL DAMAGE TO STARBOARD SIDE

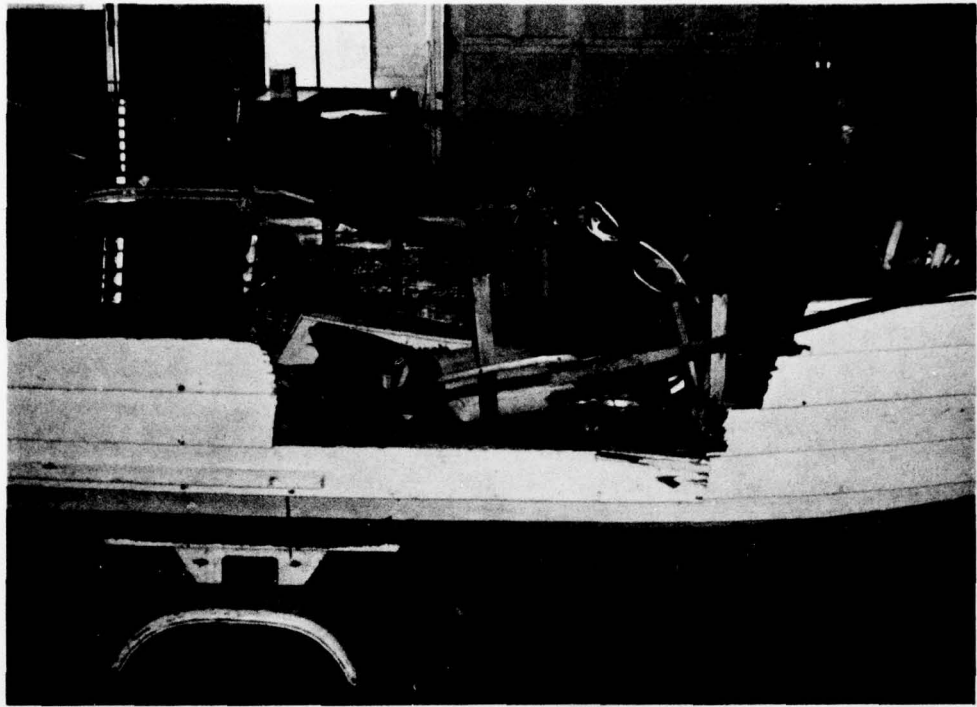
FIGURE 5. STRUCTURAL DAMAGE TO STARBOARD SIDE

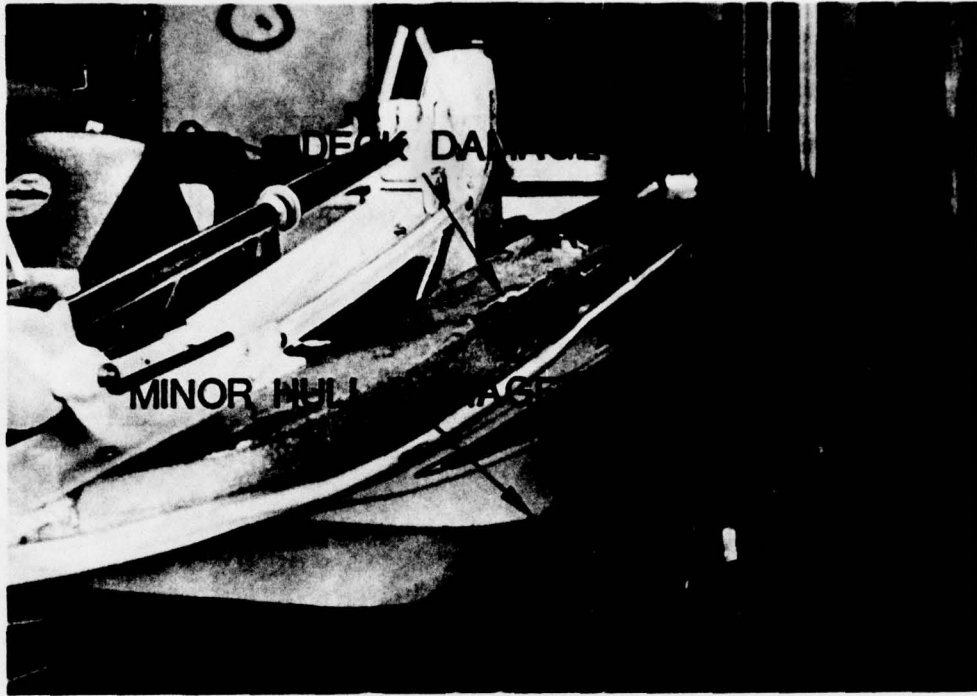
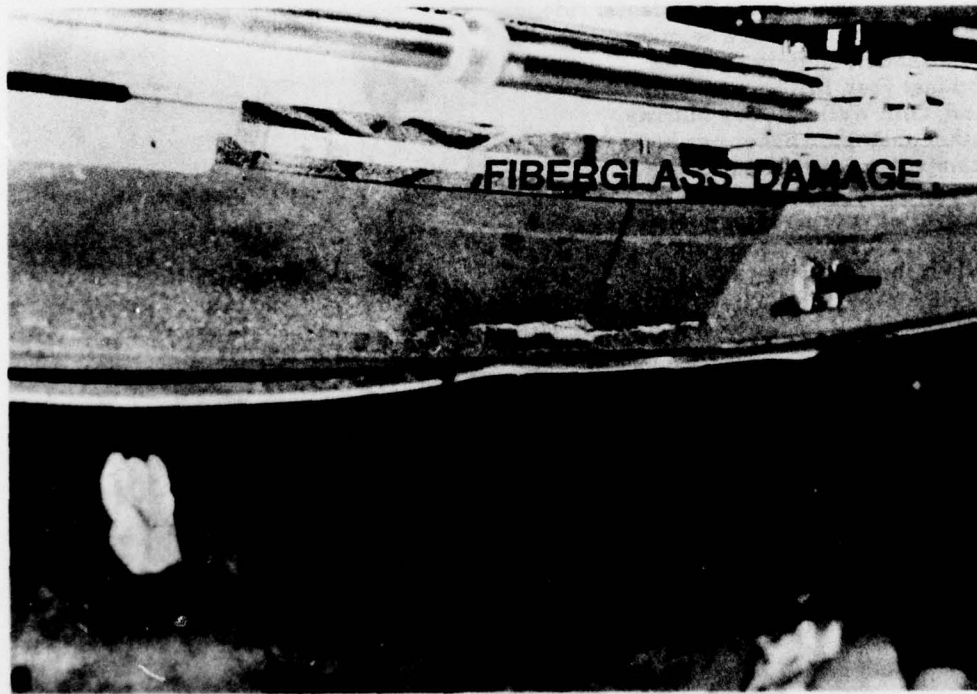
FIGURE 3. DAMAGE — BOAT NO. 1
