**DEVELOPMENT TESTS AND FLIGHT TEST OF GRAPHITE
COMPOSITE LANDING GEAR SIDE BRACE ASSEMBLY
FOR A-37B AIRCRAFT**

TECHNICAL REPORT AFFDL-TR-77-56
Final Report for the Period 15 May 1973 to 15 March 1977

20. ABSTRACT (Continue on reverse side if necessary and identify by block number) This report describes the successful development, in-house testing, and flight testing of a graphite/epoxy side brace for the A-37B aircraft landing gear.

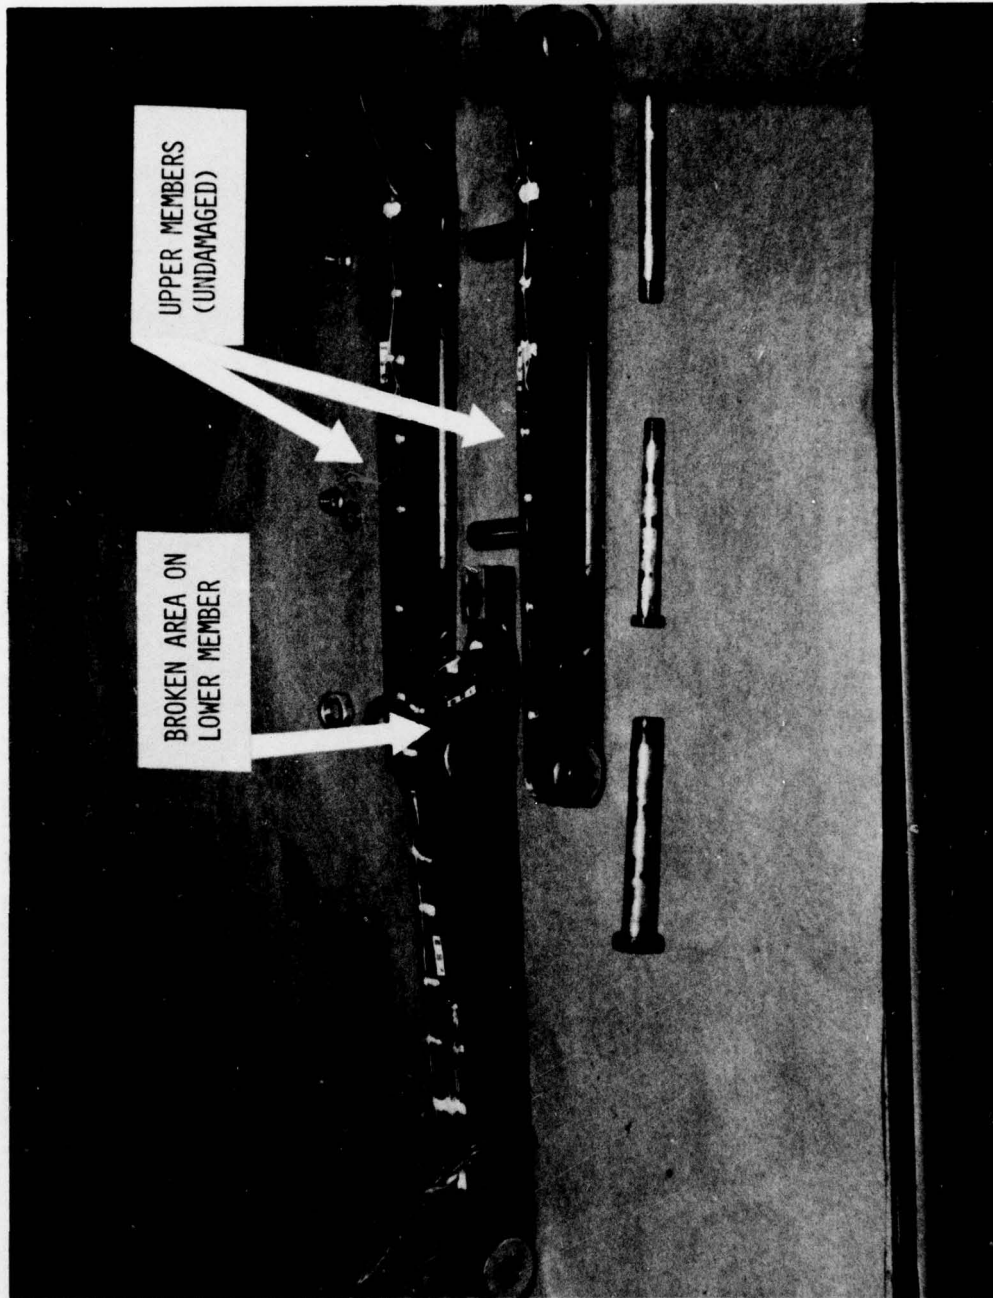
The S/N 1 lower member failed at 1.9 lifetimes into the fatigue test. Figures 6 and 7 illustrate the fatigue failure in the over-center "tang" area of the S/N 1 lower member. The S/N 1 upper members were not damaged, as shown in Figure 6, when the lower member failed, and thus the fatigue test was carried on with a substitute lower member (S/N 2). Figure 8 illustrates the fiber wrinkling which contributed to the fracture of the S/N 1 lower member (shown on the right). After the failure of the S/N 1 lower member, two additional strain gages (SG12 and SG13) were added to the overcenter "tang" area. Figure 9 illustrates the locations of all the strain gages on the side brace assembly. Strain gages SG12 and SG13 were located in the failure area of the S/N 1 lower member.

Figure 6. S/N 1 Upper and Lower Members After Failure of Lower Member at 1.9 Lifetimes

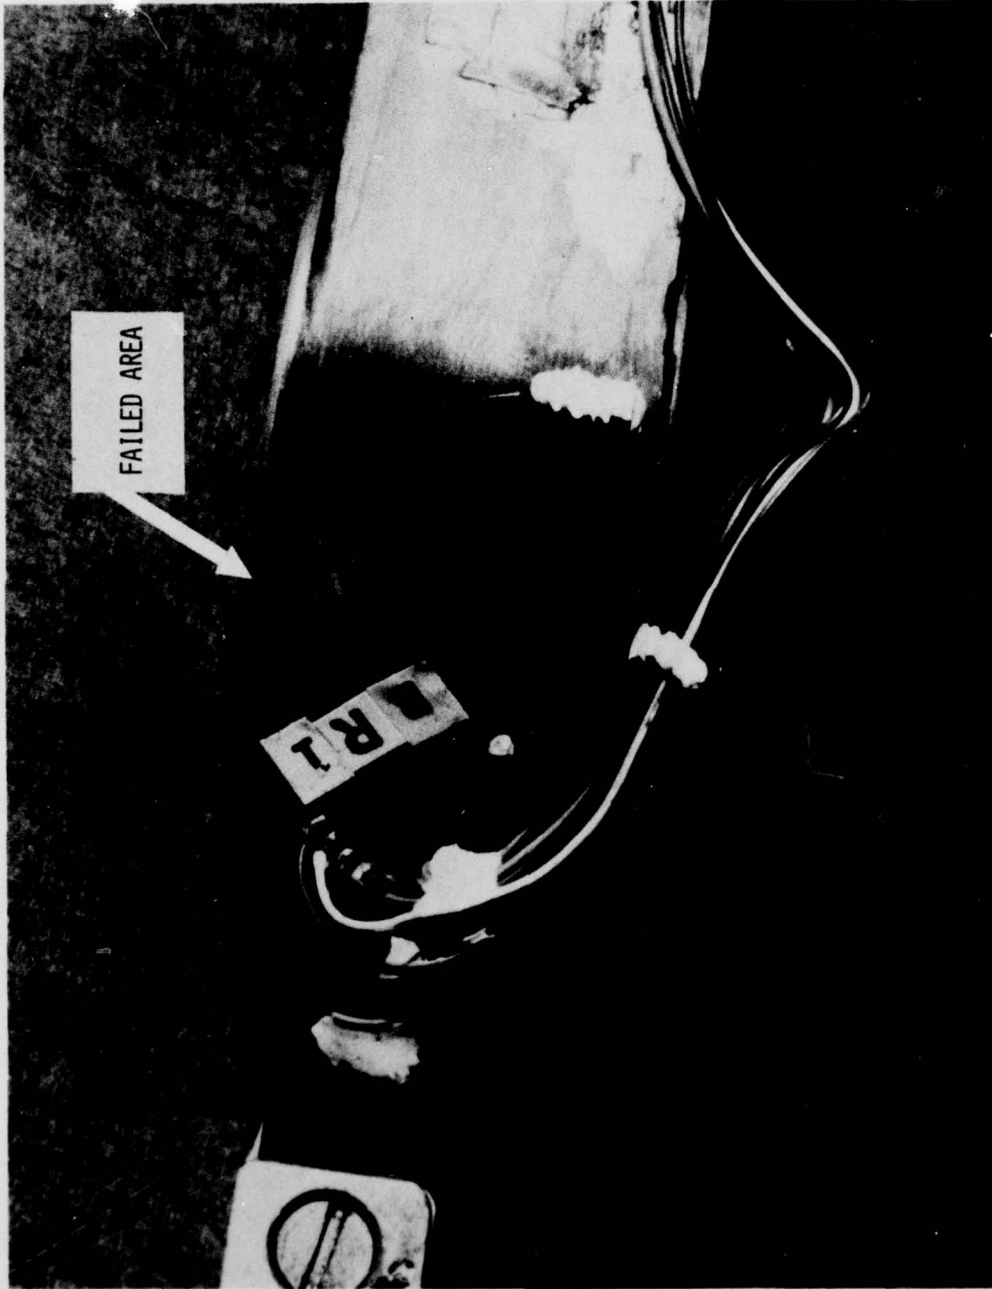
Figure 7. Fatigue Failure of S/N 1 Lower Member at 1.9 Lifetimes

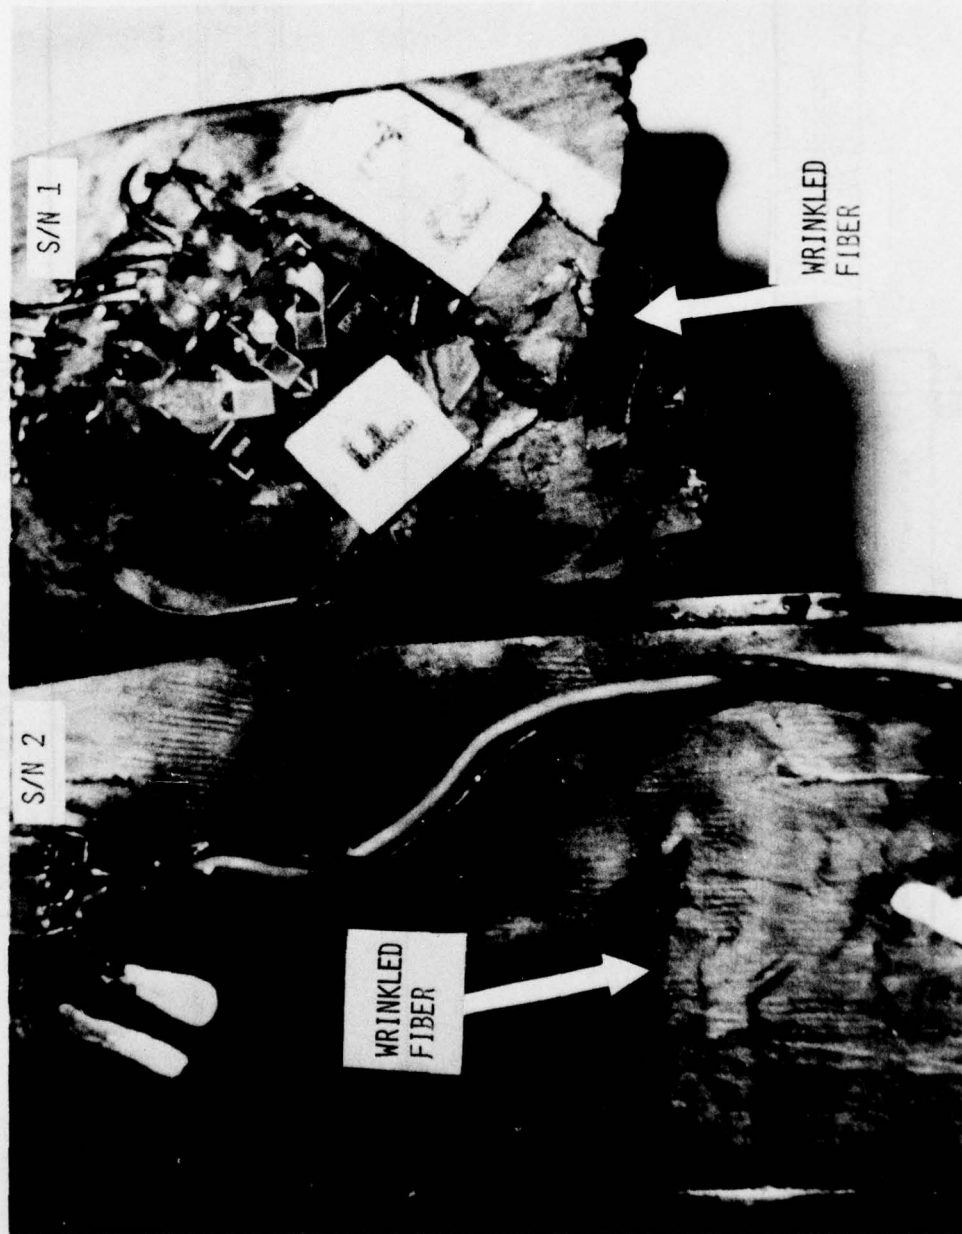
Figure 8. Comparison Between Broken S/N 1 Lower Member and Substitute S/N 2 Lower Member After 4 Lifetimes

Figure 8 illustrates the broken S/N 1 lower member (on the right) vs a similarly wrinkled surface on the S/N 2 lower member. As mentioned above, these wrinkled areas made the parts highly suspect from the beginning. Even with the obvious fiber wrinkling, the S/N 2 lower member withstood over four (4) lifetimes of the fatigue spectrum (Table 2). After approximately four (4) lifetimes of the fatigue test, some small cracks became evident in the chopped fiber regions of the S/N 1 upper members. One of these cracks is shown in Figures 12 and 13. The crack shown in Figure 12 was found after four (4) lifetimes and Figure 13 shows the same crack after five (5) lifetimes. After attaining over four lifetimes on the S/N 2 lower member and six lifetimes on the S/N 1 upper members, it was decided to increase the fatigue loads by 25%. When this was done, the assembly failed catastrophically at approximately 20,000 lbs compression. Strain data were being taken at the time of the failure and strain gage No. 12 registered approximately 2500 $\mu\epsilon$. Figure 14 shows the failed assembly. Figures 15 and 16 show the failed lower and upper members, respectively. It is difficult to determine which part in the assembly failed first, but it is believed that the S/N 2 lower member failed first. After this failure, the lower member was further redesigned in the tang area.

In addition, new fabrication procedures were employed in order to eliminate the fiber wrinkling.

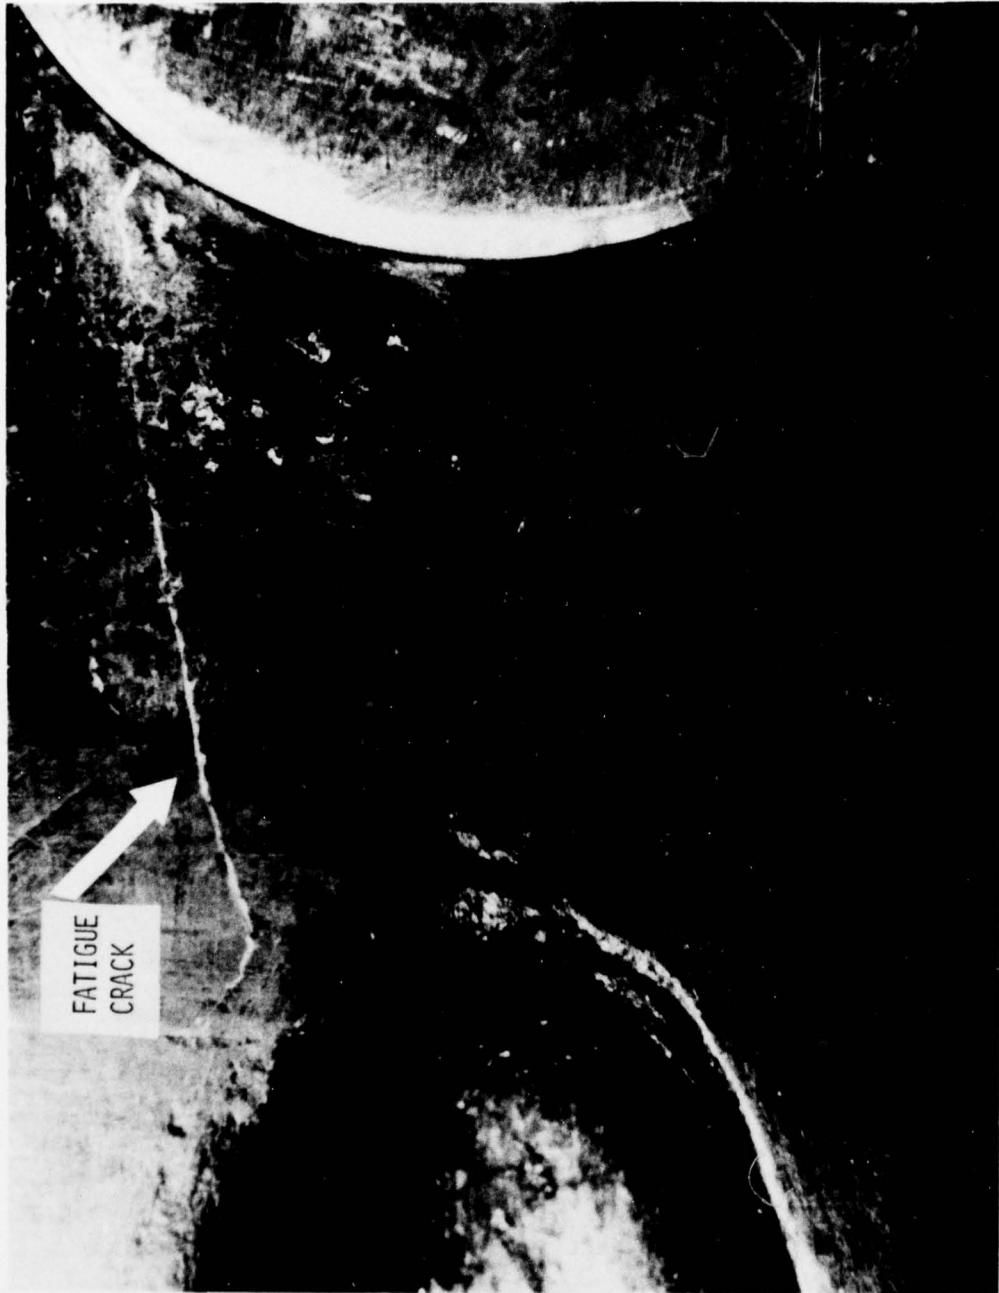
Figure 12. Fatigue Crack on S/N 1 Upper Member After 4 Lifetimes

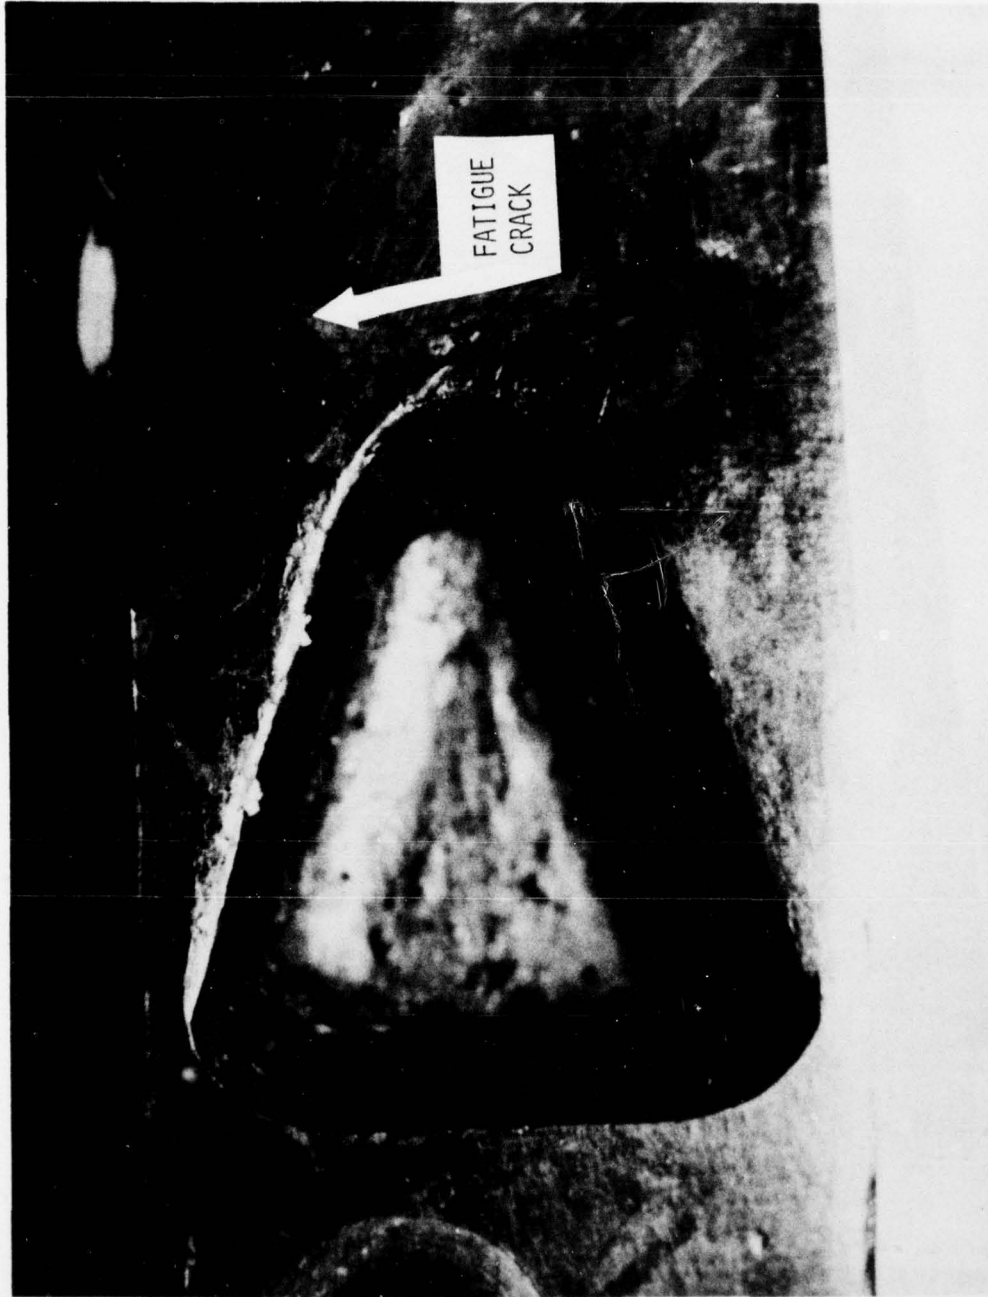
Figure 13. Fatigue Crack on S/N 1 Upper Member After 5 Lifetimes

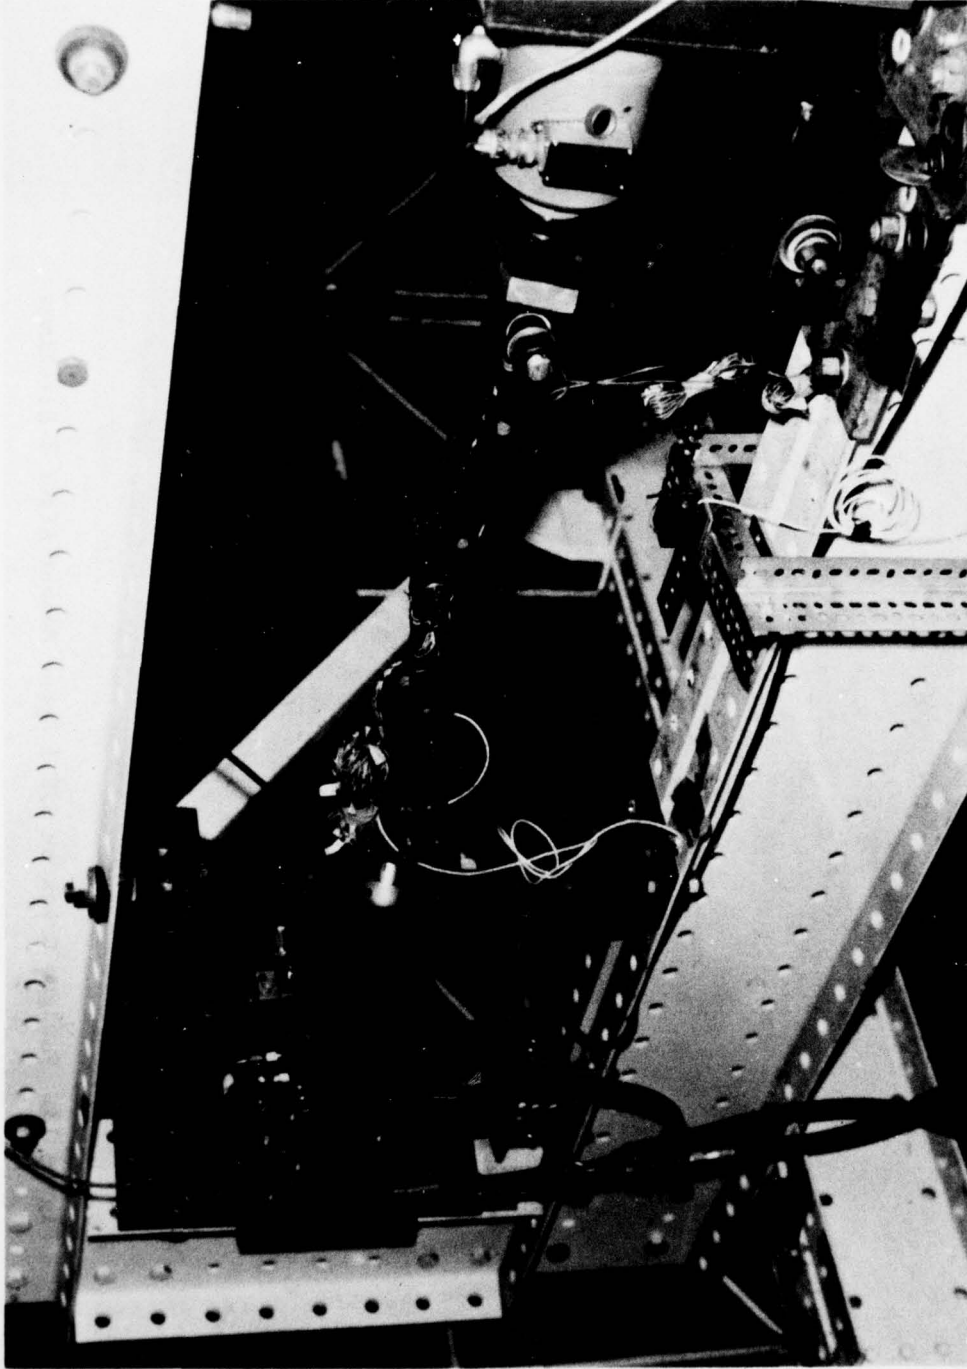
Figure 14. Failure of S/N 1 Uppers and S/N 2 Lowers After
25% Increased Load (6 Lifetimes on Uppers)

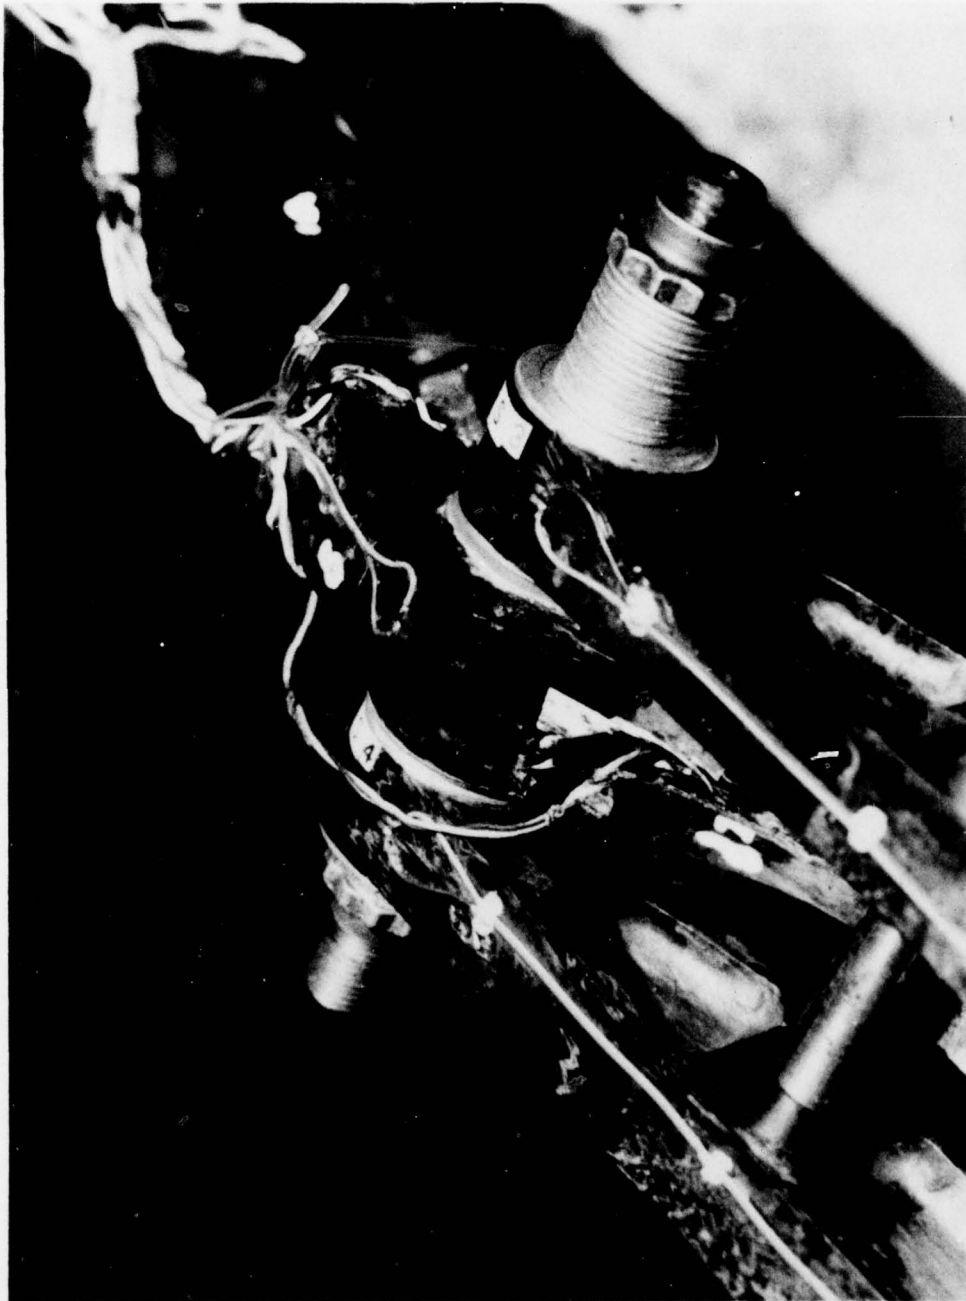
Figure 15. Failed S/N 2 Lower Member After 25% Increased
Load (4.1 Lifetimes on Lower Member)

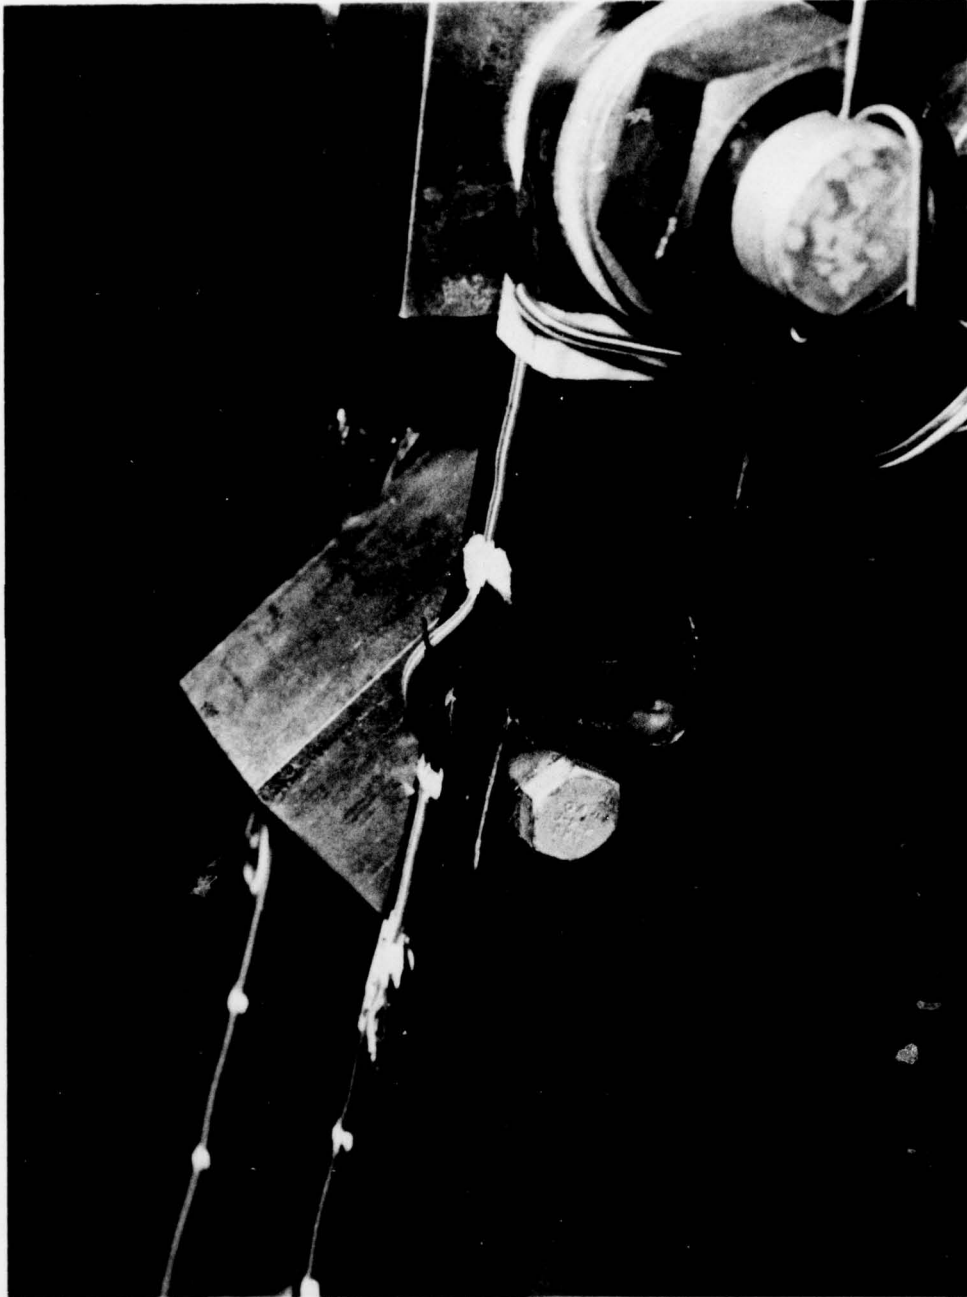
Figure 16. Failed S/N 1 Upper Members After 25%
Increased Load (6 Lifetimes on Upper Members)

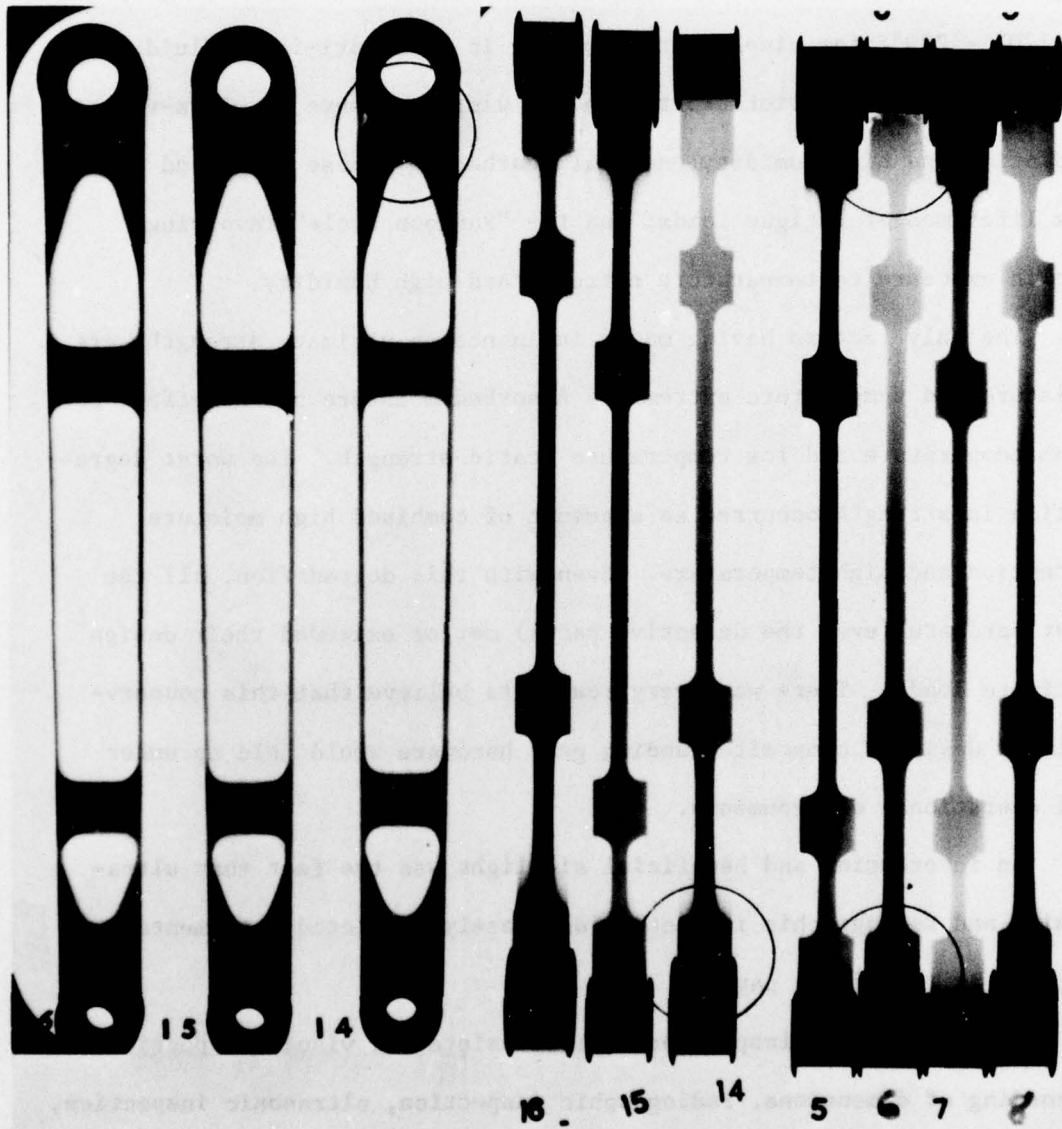
Non-destructive inspection (NDI) consisted of visual inspection, recording of dimensions, radiographic inspection, ultrasonic inspection, and an electrical resistance check. The most valuable information regarding detrimental flaws came from the radiographic and ultrasonic tests. X-ray exposures revealed areas lacking fiber (fiber wash or voids) near both bushings of SN6, and a similar area near the large bushing of SN14 (Figure 20). These were the two test items which

Figure 20. X-Rays Showing Fiber Wash and Voids (Light Areas)
Near Bushing of SN6 and SN14

were considered to have failed prematurely in the static compression test. They did not fail in the characteristic way at the small bushing, but rather at the large bushing in both cases.

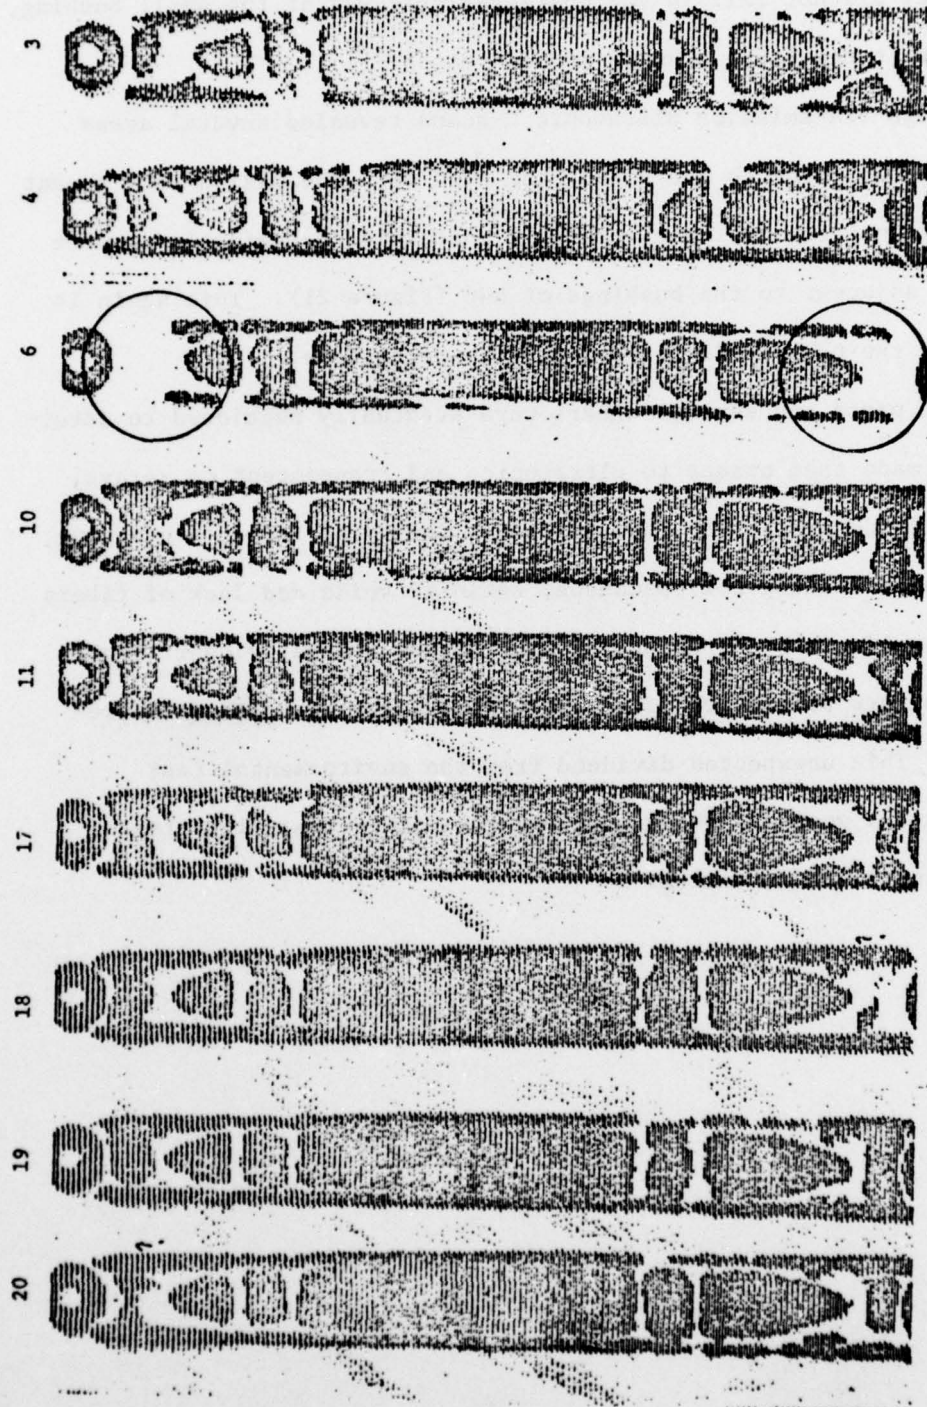
Through-transmission ultrasonic C-scans revealed several areas that remained opaque to the sound beam even with the maximum instrument gain. Most notable of these, probably containing delaminations, were the areas adjacent to the bushings of SN6 (Figure 21). This again is one of the two parts which failed below expectations.

Figure 21. Ultrasonic C-Scans Showing Possible Delaminations (Lights Areas) Near Ends of SN6

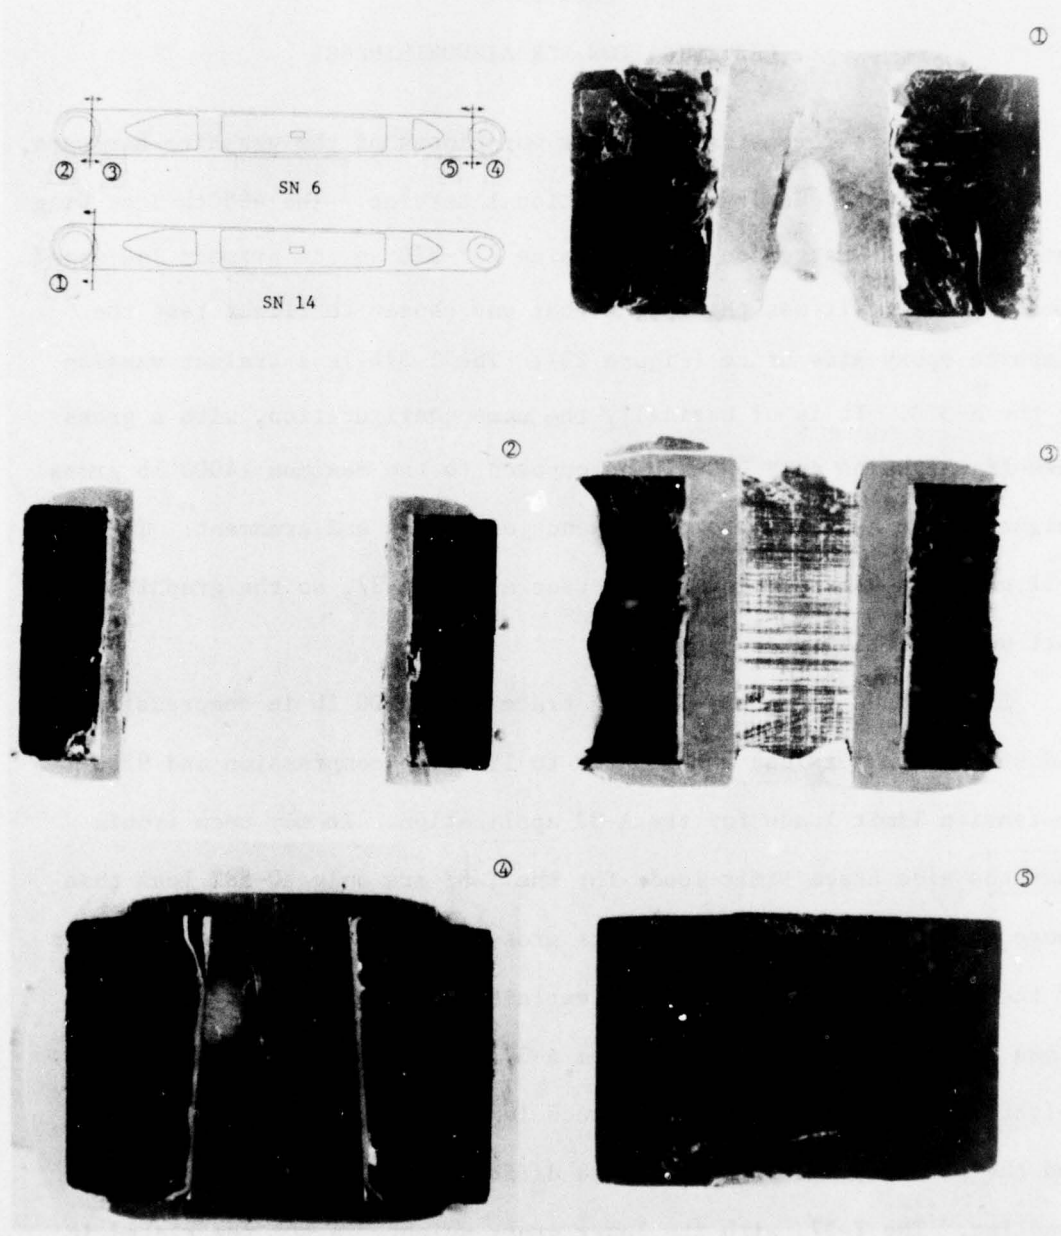
These parts and several others were eventually sectioned to determine what made them opaque to ultrasonics and transparent to x-rays, and possibly determine why they failed as they did. After sectioning, potting and polishing the specimens, definite voids and lack of fibers near the bushings of the defective side braces became evident (Figure 22). These are almost definitely what caused the parts to fail prematurely. This unexpected dividend from the environmental test program gave a good data base upon which to judge the flight test hardware and its NDI results.

Figure 22. Sectioned Views of Defective Side Braces Showing Voids, Lack of Fiber, and Some Fracture Damage from Static Tests

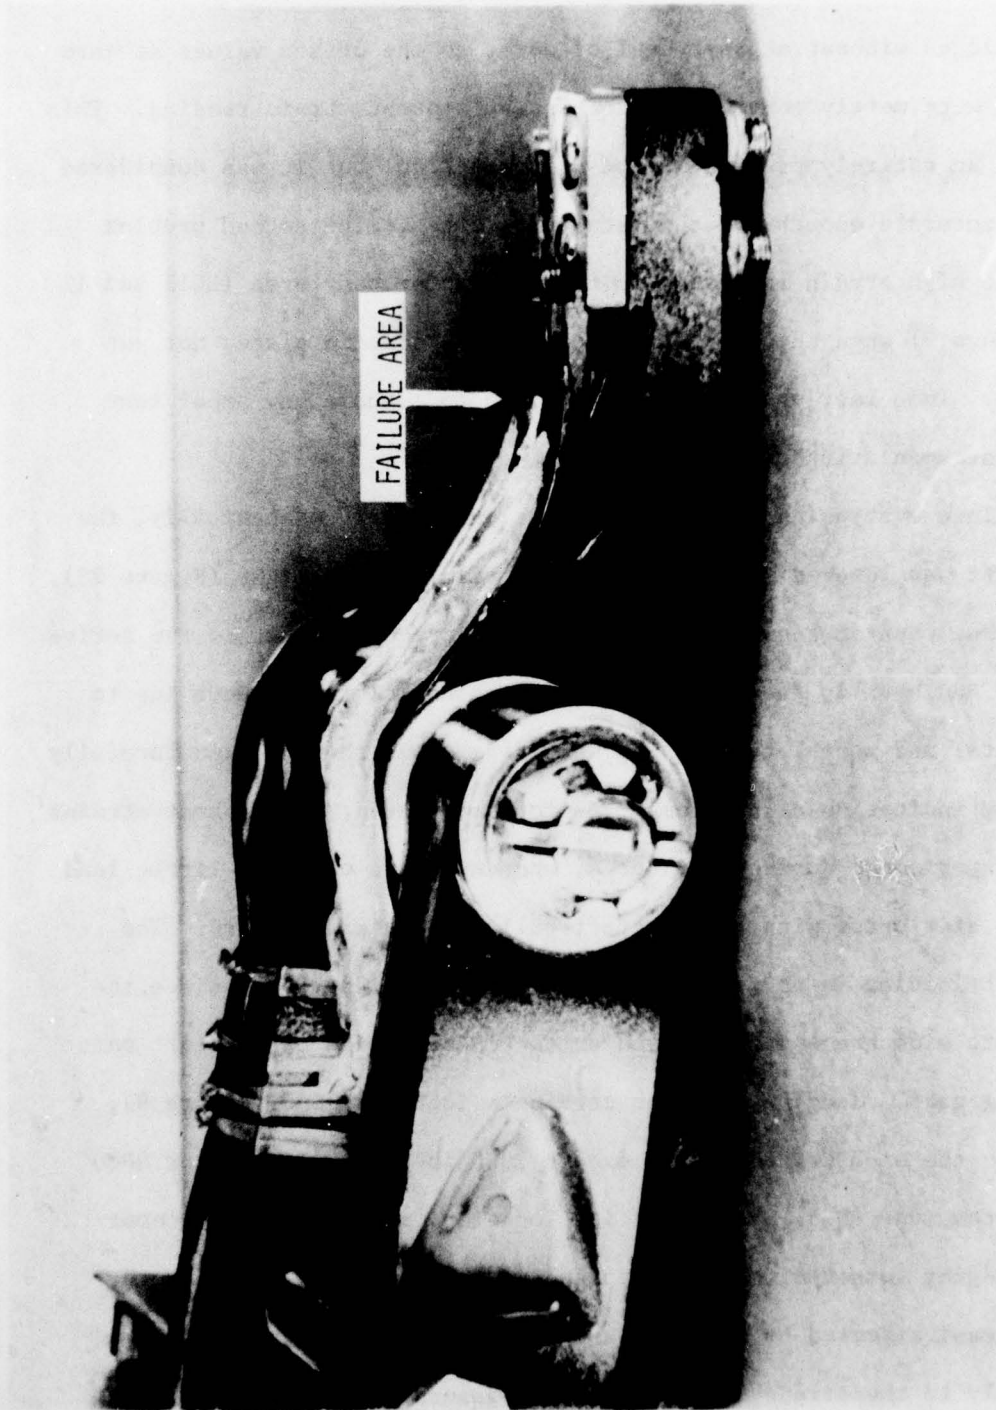
locking mechanism. This load is introduced through the upper cross bolt and positively locks the side brace in its overcenter position, once the gear is down and locked. It was a fairly simple matter to modify the proof test fixture to introduce this preload. An initial side load that gave a 1000 $\mu\epsilon$ reading at SG12 was applied to the side brace for subsequent proof tests. During the proof test of the flight test side brace, the load tester became uncontrolled and caused the assembly to be overloaded in compression. The lower side brace failed in the tang area at a compressive load estimated to be in excess of 30,000 lb. Unfortunately the strain recorder was not operating at the time, so there was no record of maximum strains achieved before failure. This unintentional destructive test did, however, corroborate the area likely to fail first and the mode of failure (Figure 26). Following this setback, the second fully instrumented graphite side brace was successfully proof tested, generating more realistic strain values with the initial side load. A plot of strain versus load is presented in Appendix B.

Figure 26. Failed Lower Member of Side Brace, Result of Overload During Proof Test
