Report SAM-TR-77-19

**OPTICAL EVALUATION OF F/FB-111
FIELD-SERVICE-TEST WINDSHIELDS**

September 1977

Progress Report for Period 17 April 1975-16 November 1976

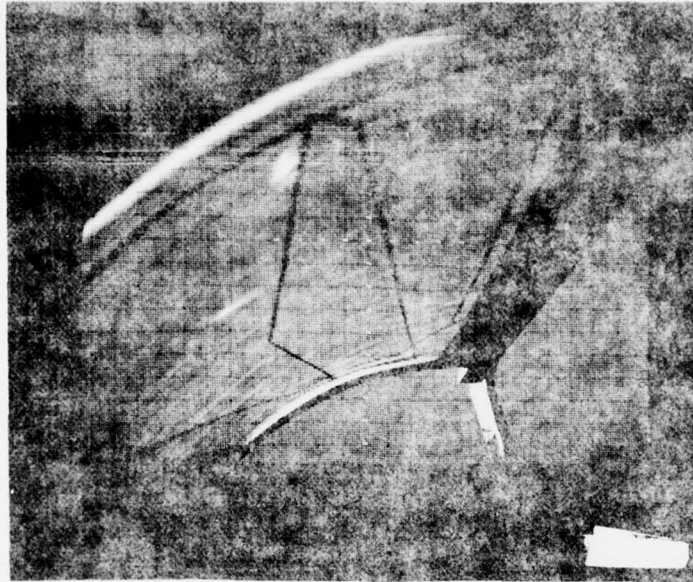
Distortion effects were obtained by evaluating a grid board photographed through the windshield (Fig. 3). Lensing and displacement grading values were determined by the procedure described in General Dynamics Report FZM-12-10952A, "Optical Evaluation of the F-111 Windshield," 20 May 1970. This procedure was successful, for the most part, in resolving aircrew visual complaints in the glass windshields.

Figure 3. Grid-board distortion photograph--prefield test.

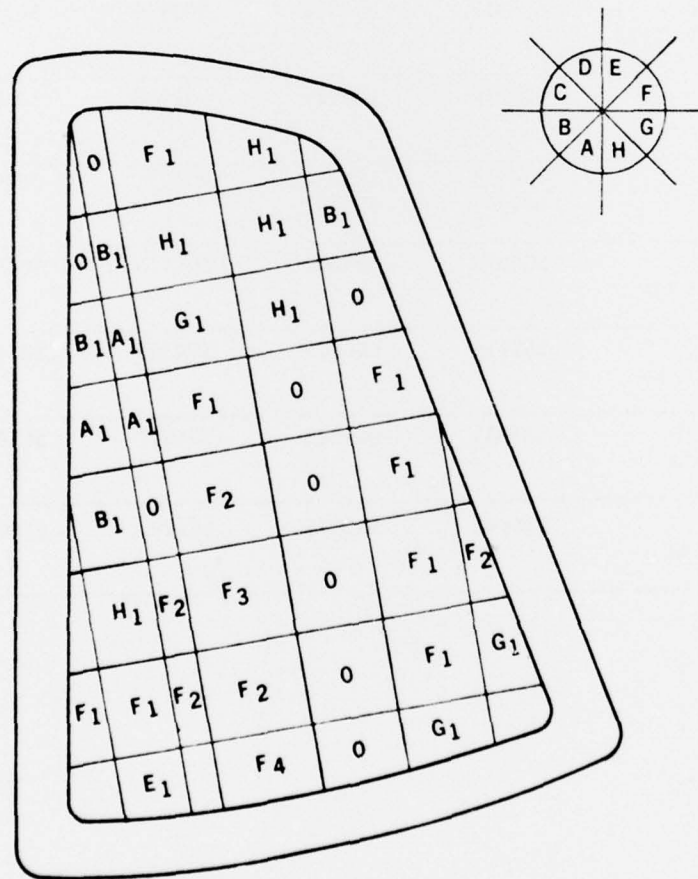
Figure 4. Pre-service-test deviation map.

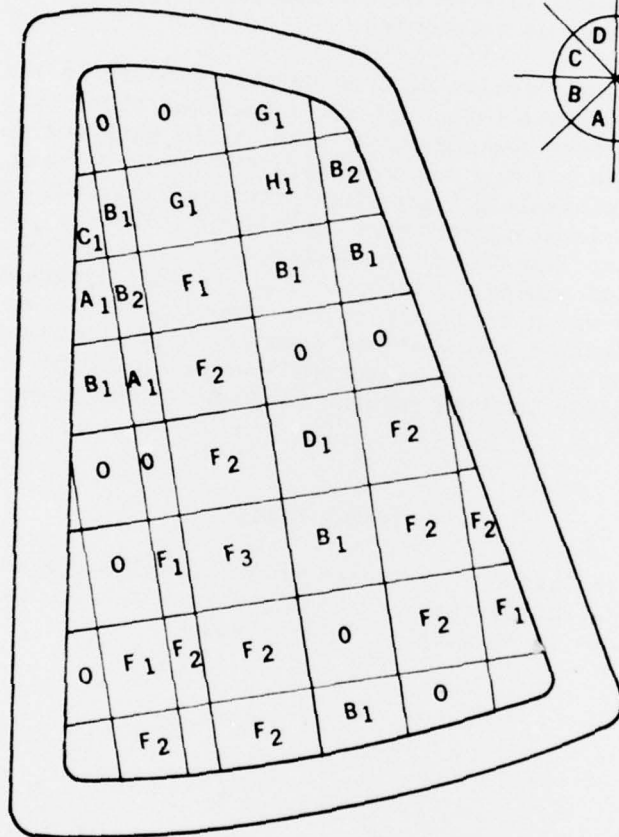
Postservice evaluations of seven windshields are included in the data section (see Table 1). As had been forecasted, haze values of these sets increased due to exterior surface erosion caused by the flight environment and improper cleaning procedures. Surface scratching is presumed to be the primary causative factor, since hand polishing of windshields 503929 and 504995 reduced the haze. Comparisons of prism-deviation maps of three windshields (504990, 504995, 503931) before and after field use are within instrument-error tolerance, indicating no change in optics due to aging or environmental factors. Figures 4 and 5 are pre- and postservice maps of one typical windshield (504995). Distortion photographs before and after field use of the three windshields also show no changes.

Figure 5. Post-service-test deviation map.
