**MEMBRANE ENCAPSULATED SOIL LAYER  
(MESL) FOR CONTINGENCY AIRFIELDS**

**U. S. ARMY ENGINEER WATERWAYS EXPERIMENT STATION  
SOILS AND PAVEMENTS LABORATORY  
P. O. BOX 631 VICKSBURG, MISSISSIPPI 39180**

APRIL 1977

**FINAL REPORT FOR PERIOD  
MAY 1976-FEBRUARY 1977**

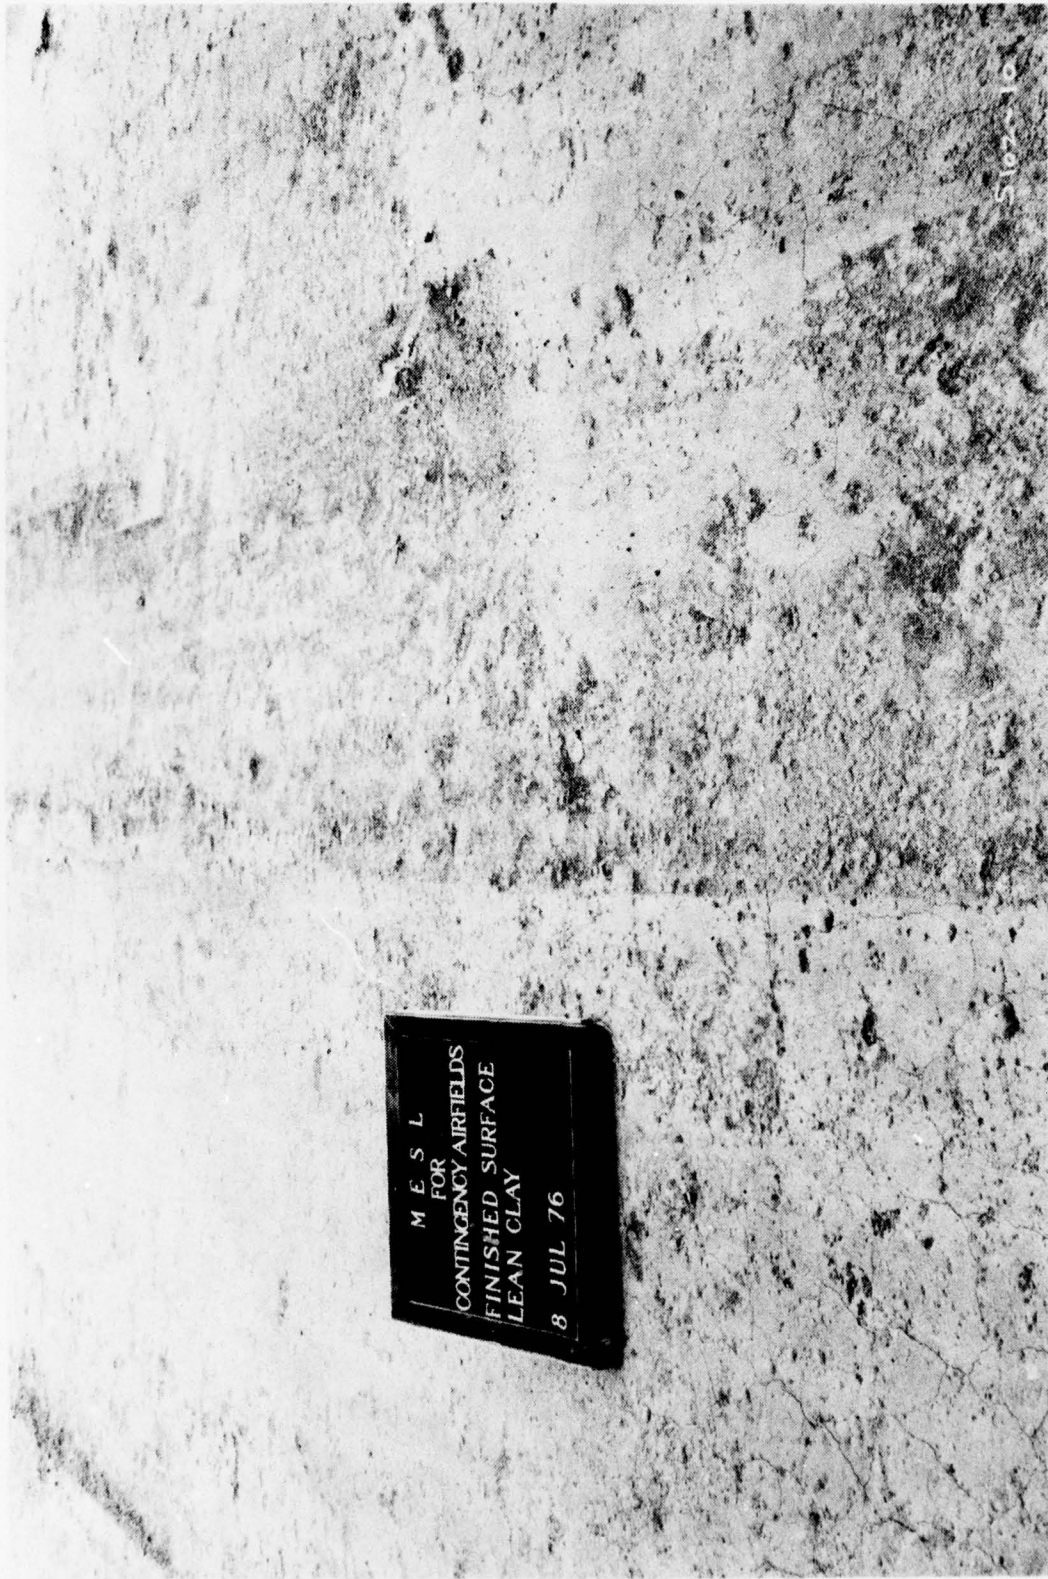
Figure 15. Cracks in Surface of Finished Lean Clay

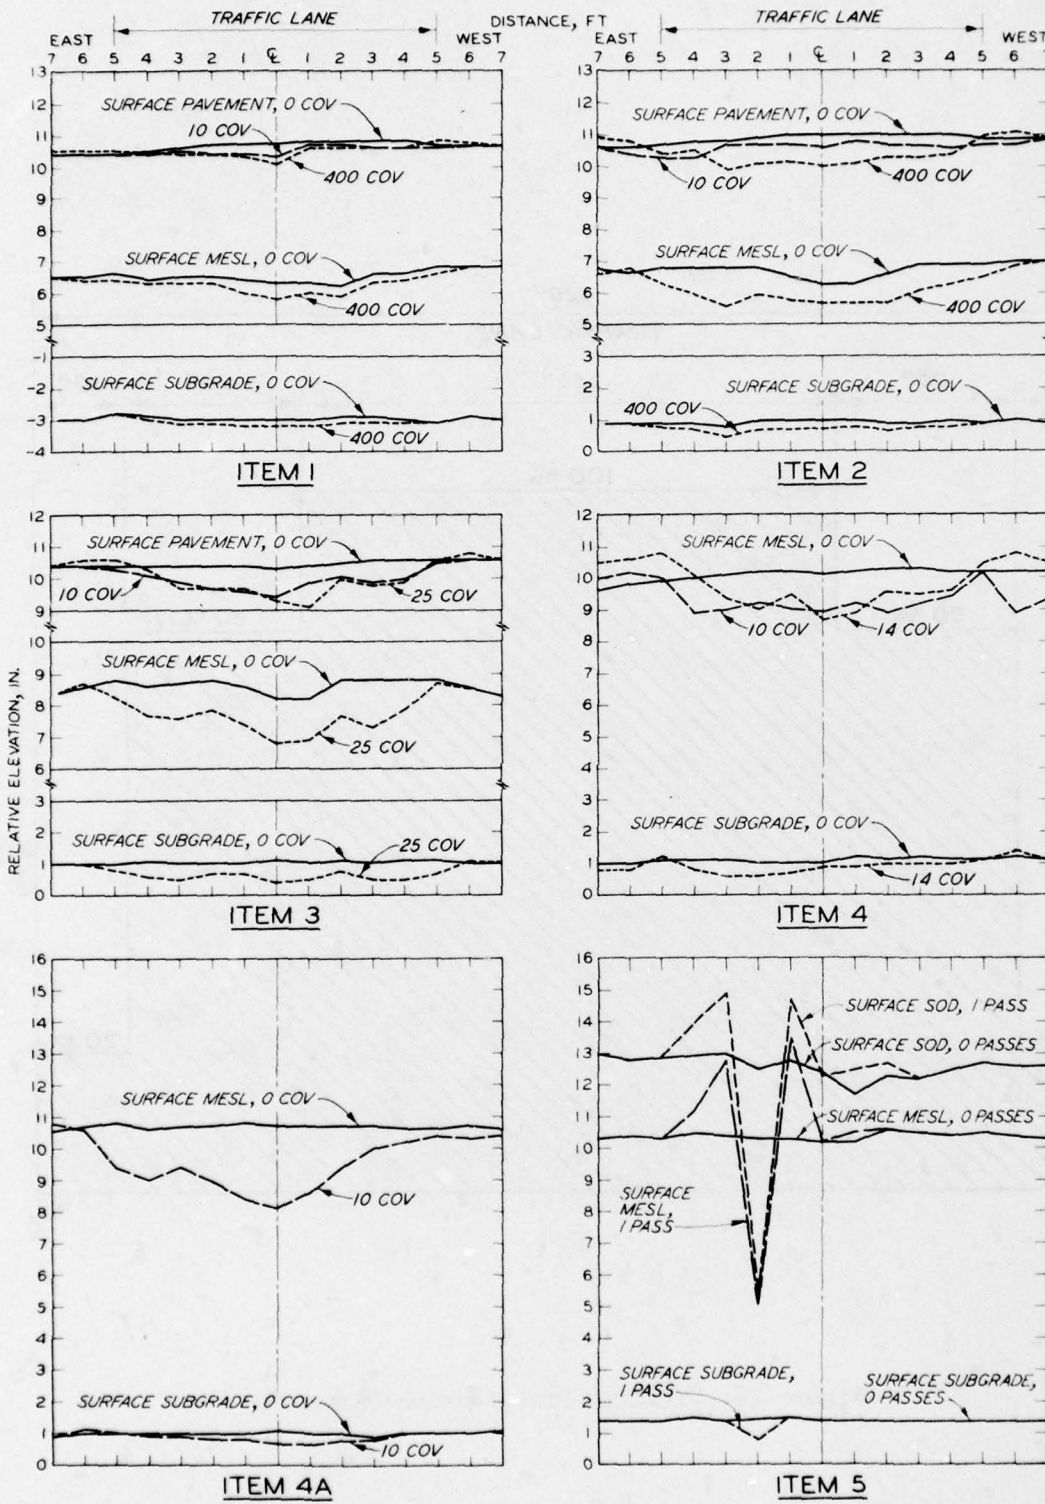
Figure 27. Typical Cross-Sections

The profile of the test trench (Figure 27) shows that deformation at the surface of the pavement and the surface of the MESL was approximately the same and that the surface of the subgrade had about 0.6 inches less deformation than the surface of the MESL. In-place tests show that the density in the MESL increased 7.5 lb/cu ft, the water content decreased 0.5 percent, and the CBR increased from 24 to 27. Tests were conducted in an area where water applied to the pavement surface had not penetrated through cracks.

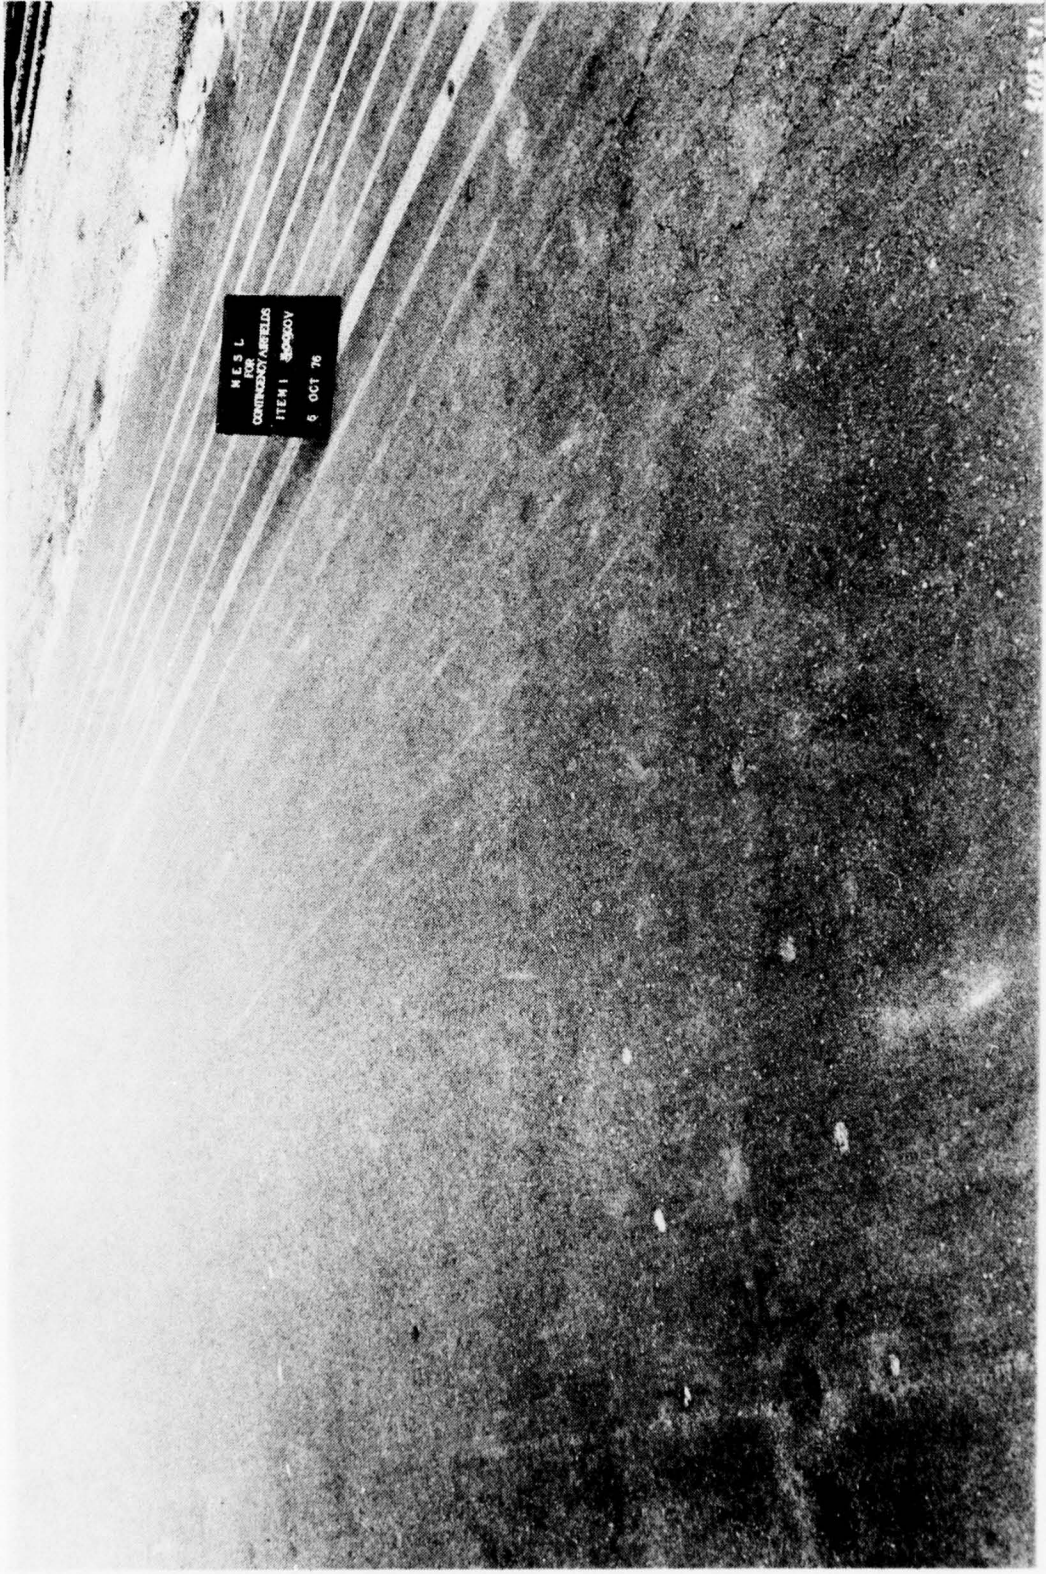
Figure 30. Item 1 After 400 Coverages

Figure 29 shows item 1 prior to traffic. Typical cross sections taken at 0, 10, 200, and 400 coverages are shown in Figure 27. No cracking was noted in the item up to 200 coverages. After 200 coverages, water was applied, and the pavement kept wet during the second 200 coverages. Traffic was terminated after a total of 400 coverages without failure of the item. At the end of traffic, a few minor hairline cracks were noted in the surface of the pavement, but they did not extend through the asphaltic concrete. Figure 30 shows the overall view of item 1 at termination of traffic. Approximately 0.7 inches of deformation was measured at the center of the traffic lane at termination of traffic (Figure 31).

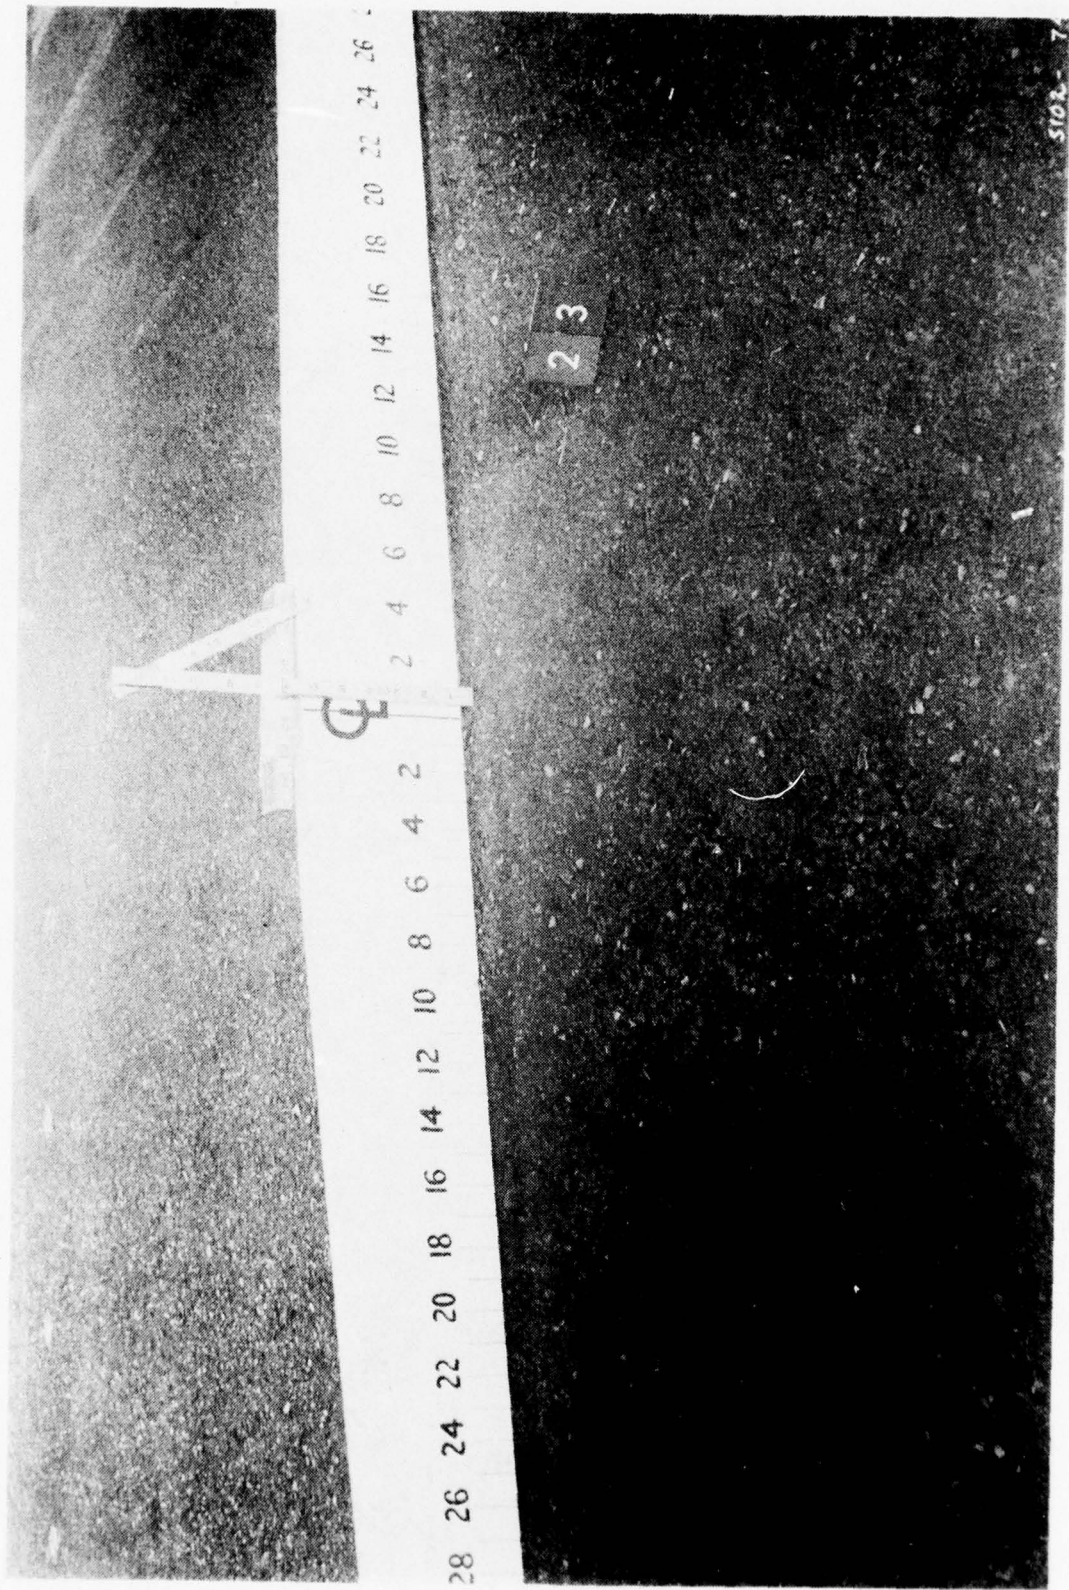
Figure 31. Deformation in Traffic Lane, Item 1, 400 Coverages

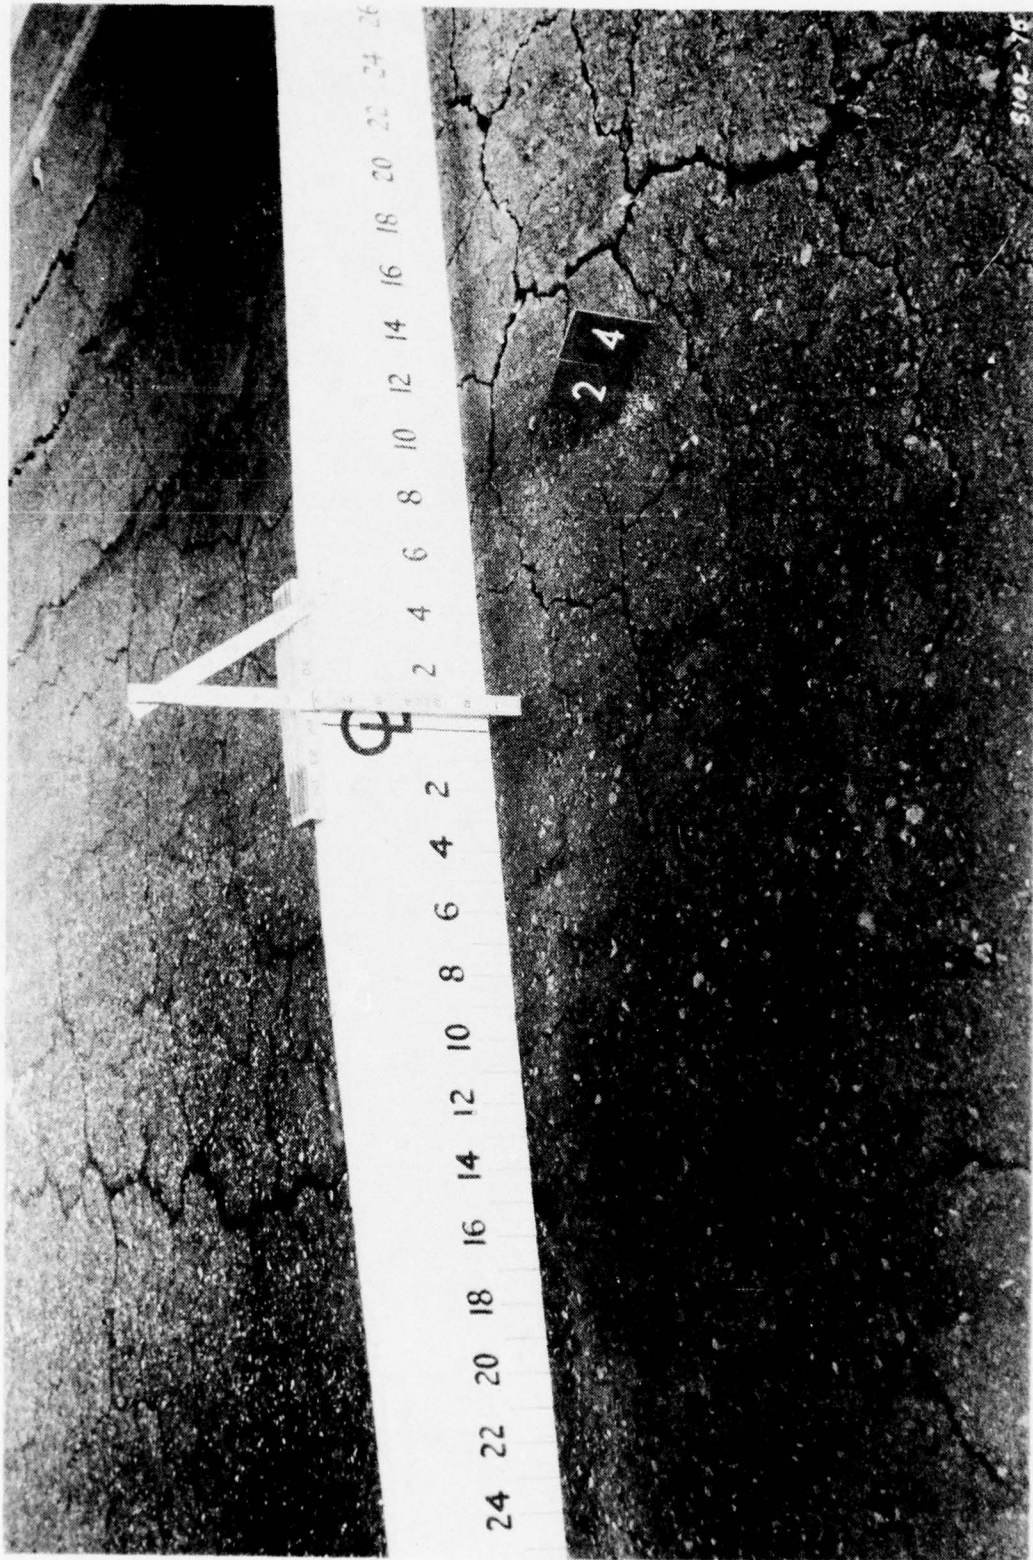
Figure 32 shows item 2 prior to traffic. Typical cross sections taken at 0, 10, 200, and 400 coverages are shown in Figure 27. At 40 coverages small hairline cracks were noted in the surface of the asphaltic concrete. At 200 coverages these cracks were more pronounced but did not extend through the asphaltic concrete. Figure 33 shows the cracks at 200 coverages and deformation of approximately 0.75 inches at the centerline of the traffic lane. After 200 coverages water was applied and the pavement kept wet during traffic for the next 200 coverages. During the last 200 coverages, cracks progressed through the asphaltic concrete and in isolated areas through the top membrane of the MESL; therefore, the item was considered failed at 400 coverages. Figure 34 shows an overall view at 400 coverages, and Figure 35 shows deformation of approximately 1 inch that had occurred at the centerline of the traffic lane.

Figure 35. Deformation in Traffic Lane, Item 2, After 400 Coverages

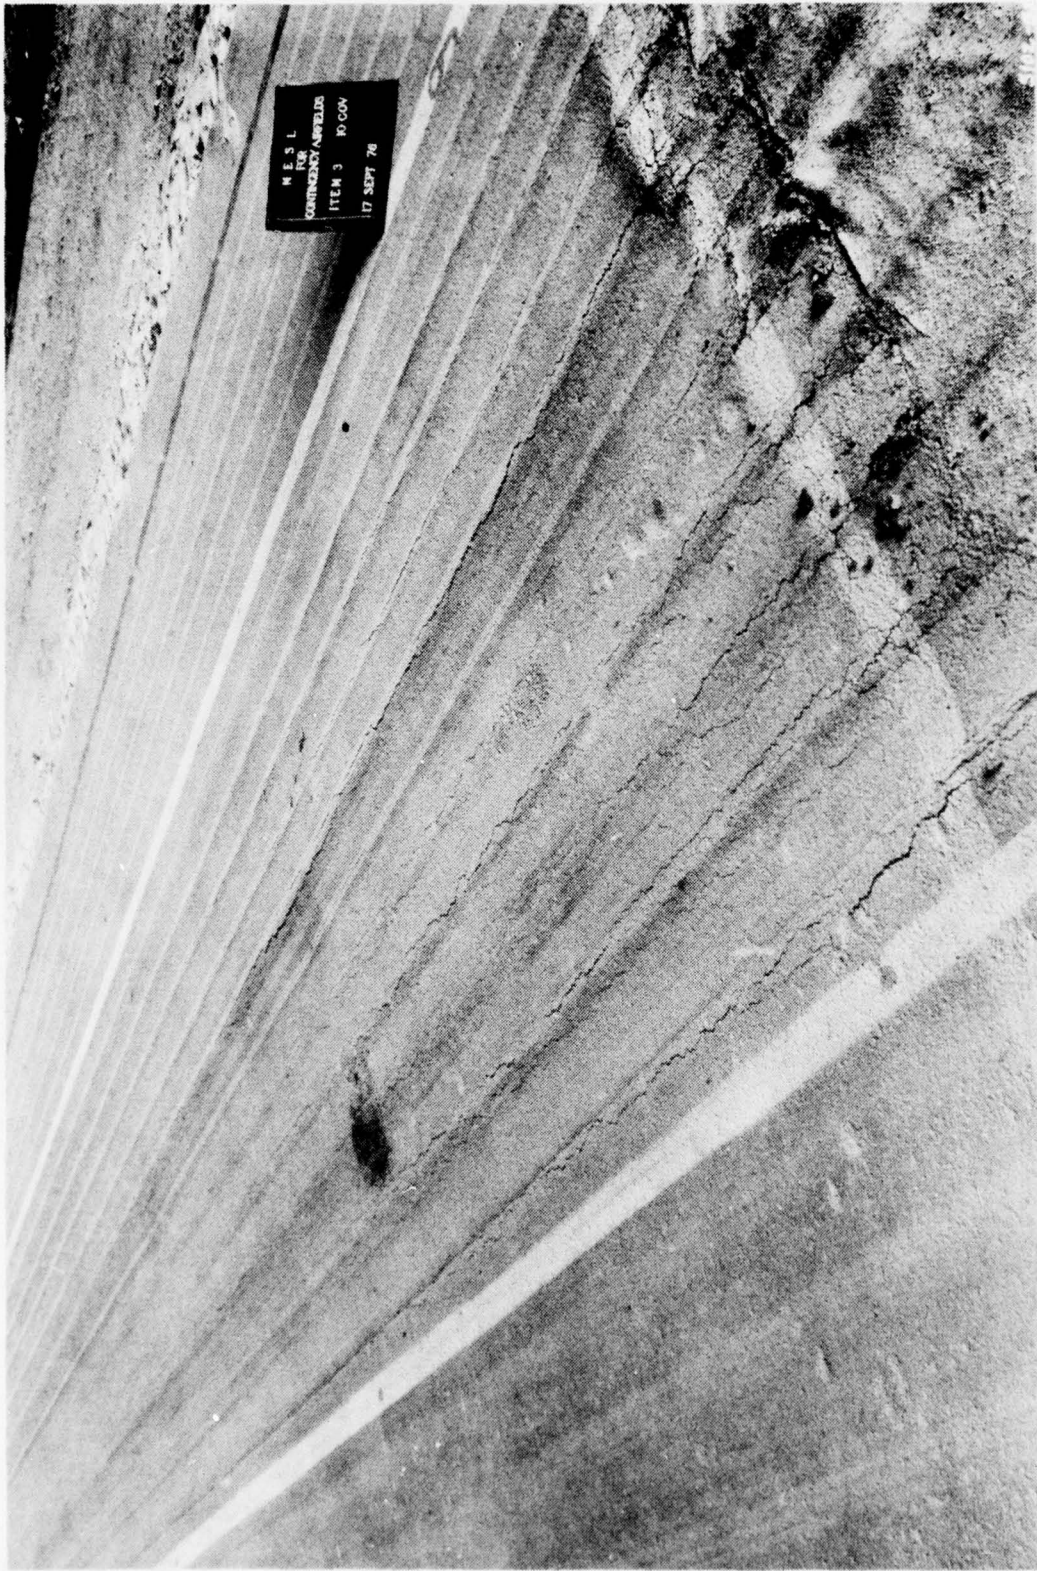
Figure 37. Item 3 After 10 Coverages

Figure 36 shows item 3 prior to traffic. Typical cross sections taken at 0, 10, and 25 coverages are shown in Figure 27. Hairline cracks were noted at two coverages and continued to develop with traffic and at 10 coverages were severe, as shown in Figure 37. Deformation at the centerline varied up to about 1.5 inches as shown in Figure 38. Traffic was continued to 14 coverages, then water was applied to the item. Lean clay was observed pumping through cracks in isolated areas; therefore, cracks had penetrated into the

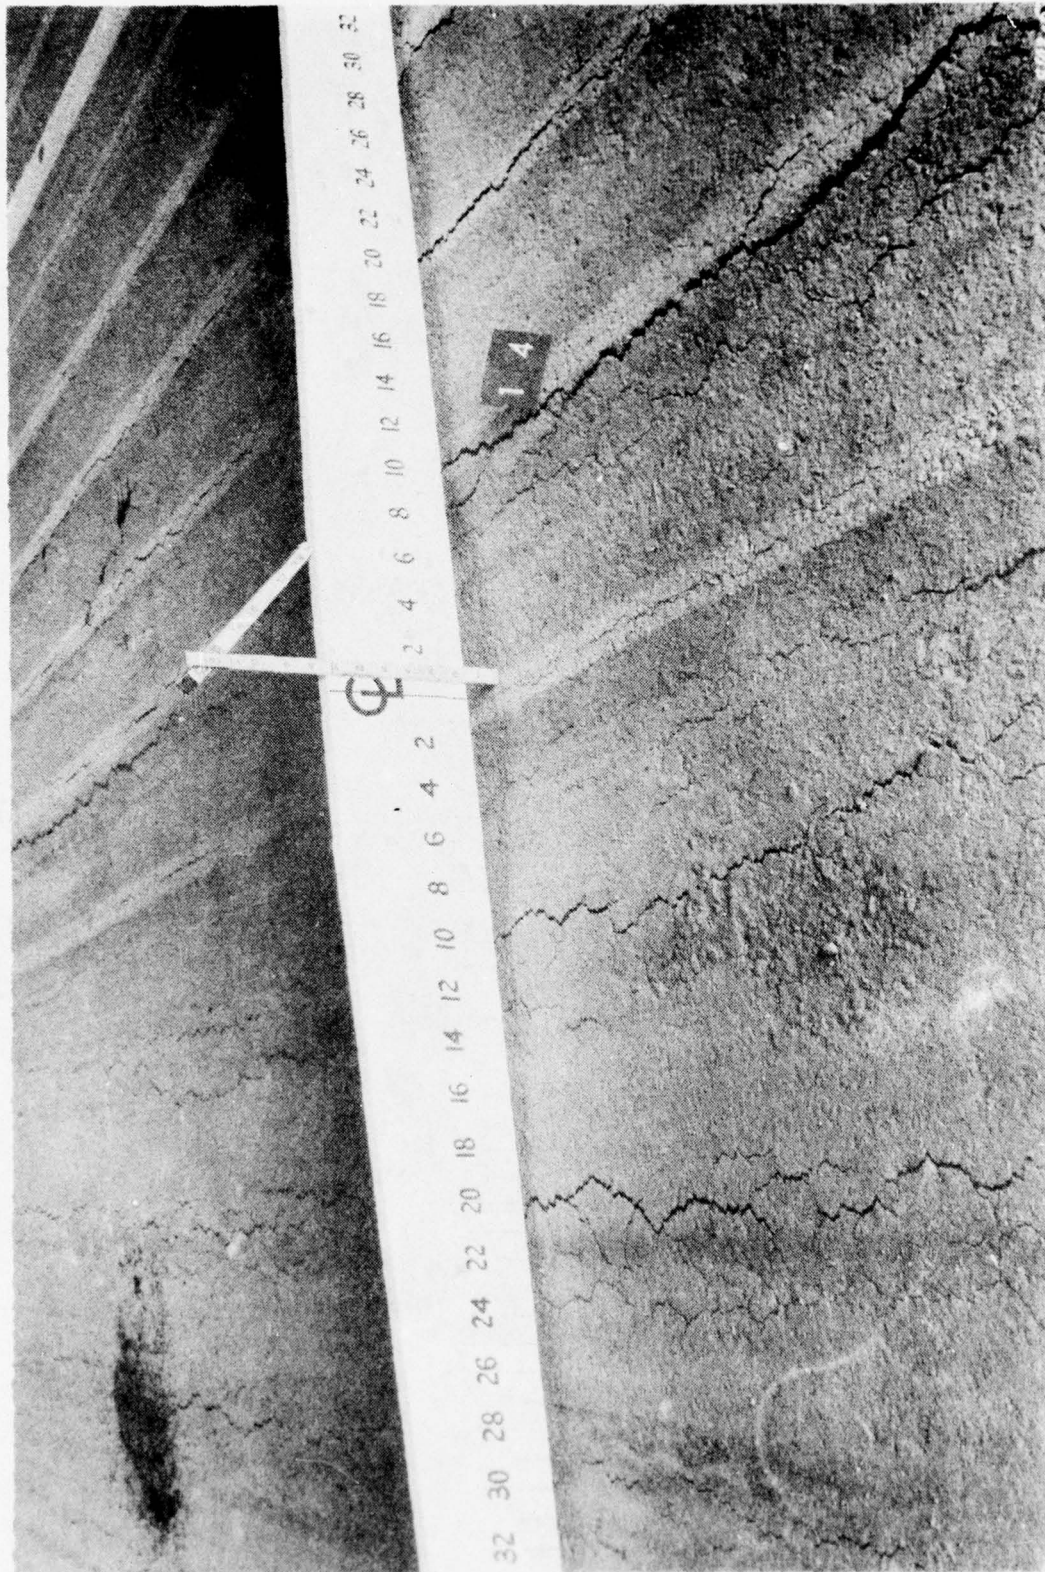
Figure 38. Deformation in Traffic Lane, Item 3, After 10 Coverages

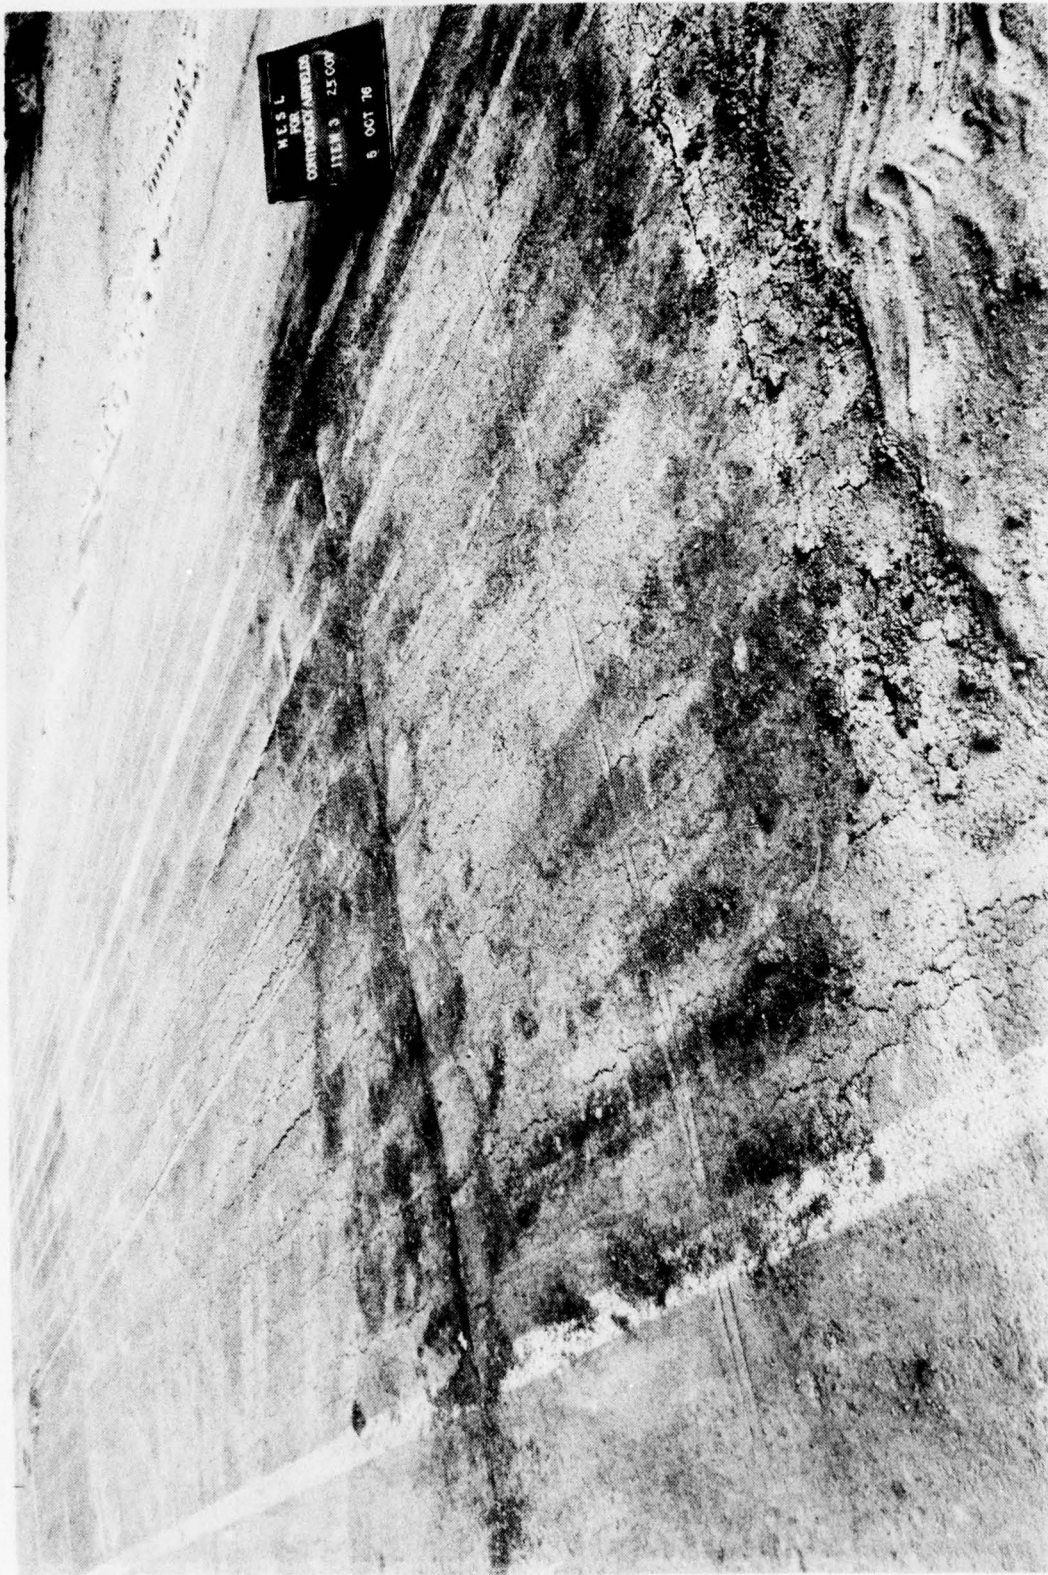
Figure 39. Item 3 After 25 Coverages

MESL. The item was considered failed at 14 coverages, but traffic was continued to 25 coverages. Figure 39 shows the condition of item 3 at termination of traffic.

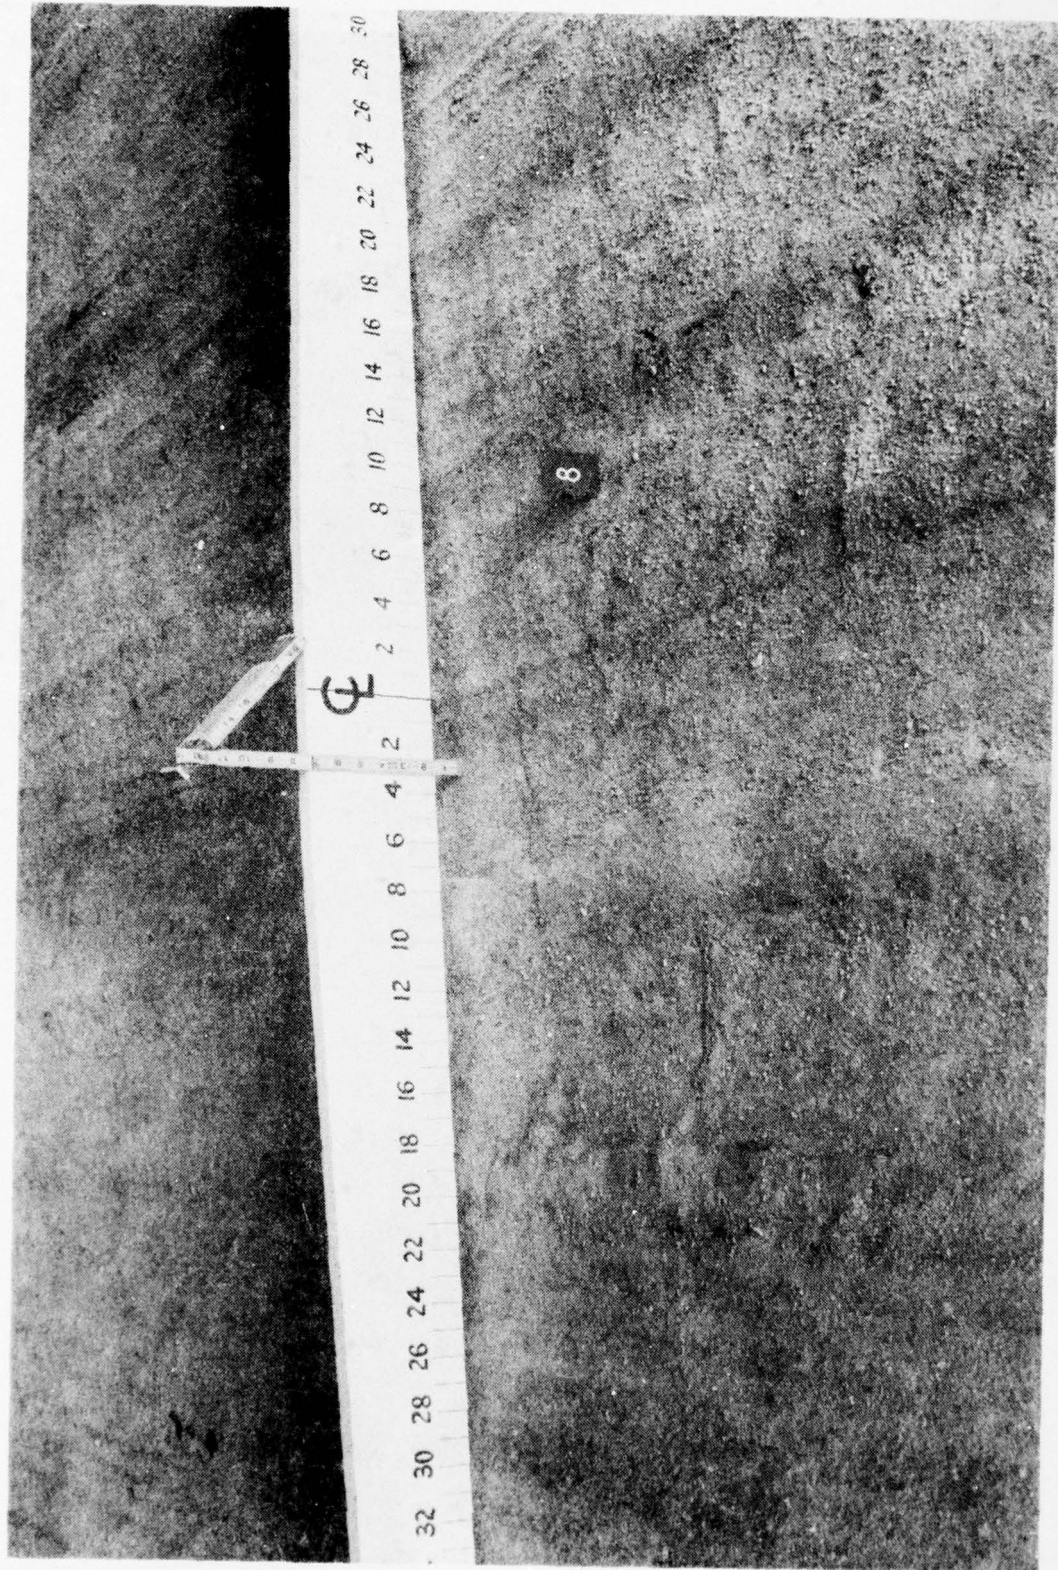
Figure 40 shows item 4 prior to traffic. Typical cross sections taken at 0, 10, and 14 coverages are shown in Figure 27. Slight wrinkling of the surface membrane and consolidation of approximately 1.5 inches, as shown in Figure 41, were noted on one-third of the item nearest to item 3 at two coverages. At six coverages wrinkling progressed to the point that it appeared to be no longer waterproof. Traffic was continued, and at 10 coverages deformation of about 3.5 inches was measured as shown in Figure 42. Wrinkling of the surfacing material was more pronounced, and the item was considered failed. Figure 43 shows the overall condition of the surface at 10 coverages. To verify that the surface was no longer waterproof, water was applied to part of the surface, and four more coverages of traffic were applied. During these coverages, it was evident from rutting that the lean clay had become wet and lost strength so traffic was terminated at 14 coverages.

Figure 41. Deformation in Traffic Lane, Item 4, After 2 Coverages

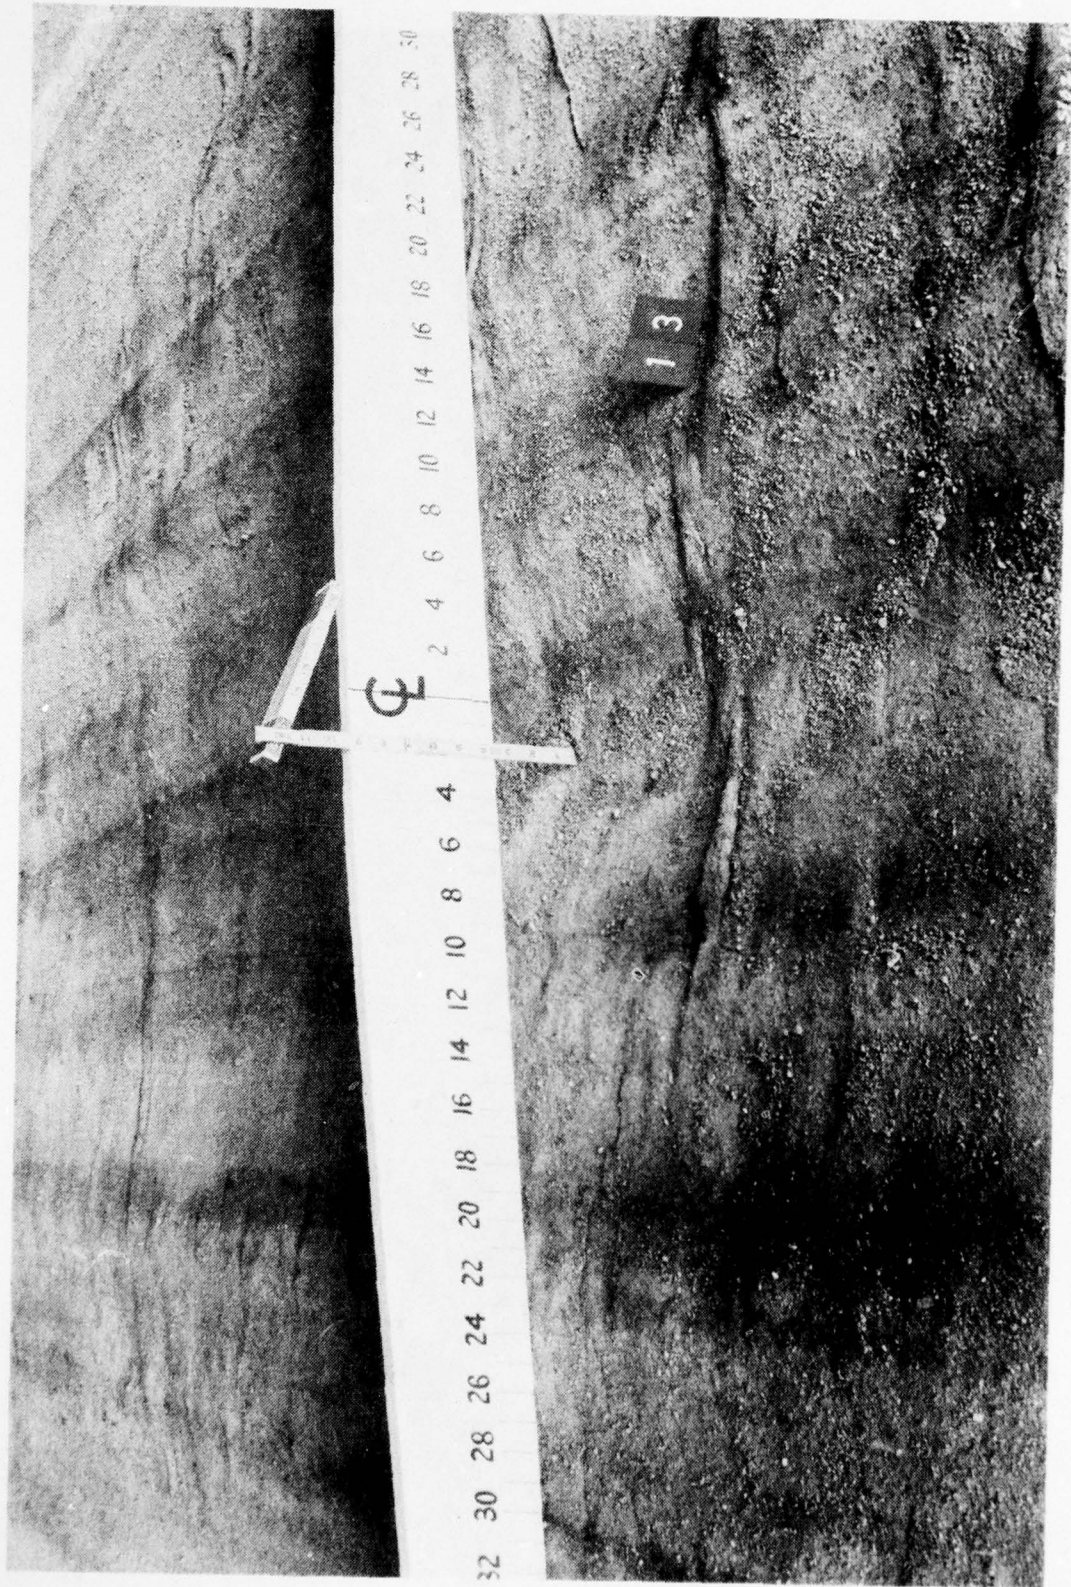
Figure 42. Deformation in Traffic Lane, Item 4, After 10 Coverages

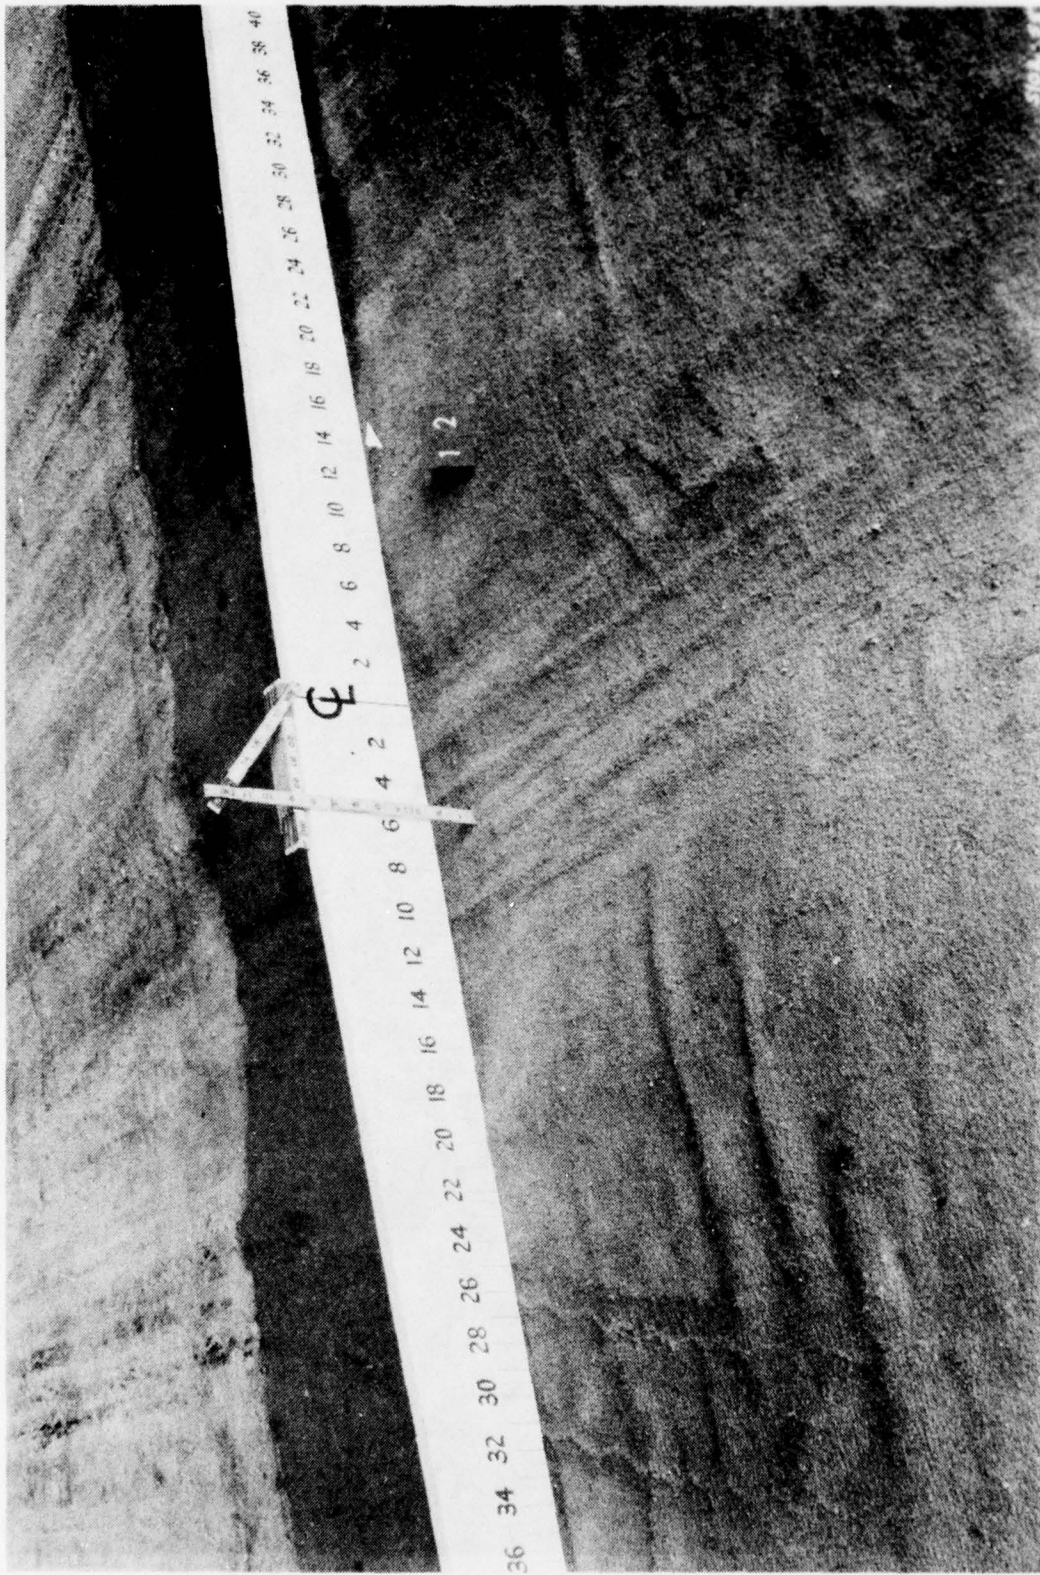
Figure 44 shows item 4A prior to traffic. Typical cross sections are shown in Figure 27. The half of the item located adjacent to the sod section, item 5, was affected by water migrating into the MESL from item 5. Wrinkling of the surface of the artificial turf occurred under traffic, and the material pulled loose from the surface of the MESL causing it not to conform to permanent deformation in ruts. No tears or other damage were noted in the material under traffic. After 10 coverages of traffic, permanent deformation of 2.5 inches, as shown in Figure 45, was measured. Traffic was terminated after 10 coverages, and the item considered failed due to the material tearing loose from the MESL surface and rut depth approaching depth required for failure. Figure 46 shows the surface after 10 coverages.

Figure 45. Deformation in Traffic Lane, Item 4A, After 10 Coverages

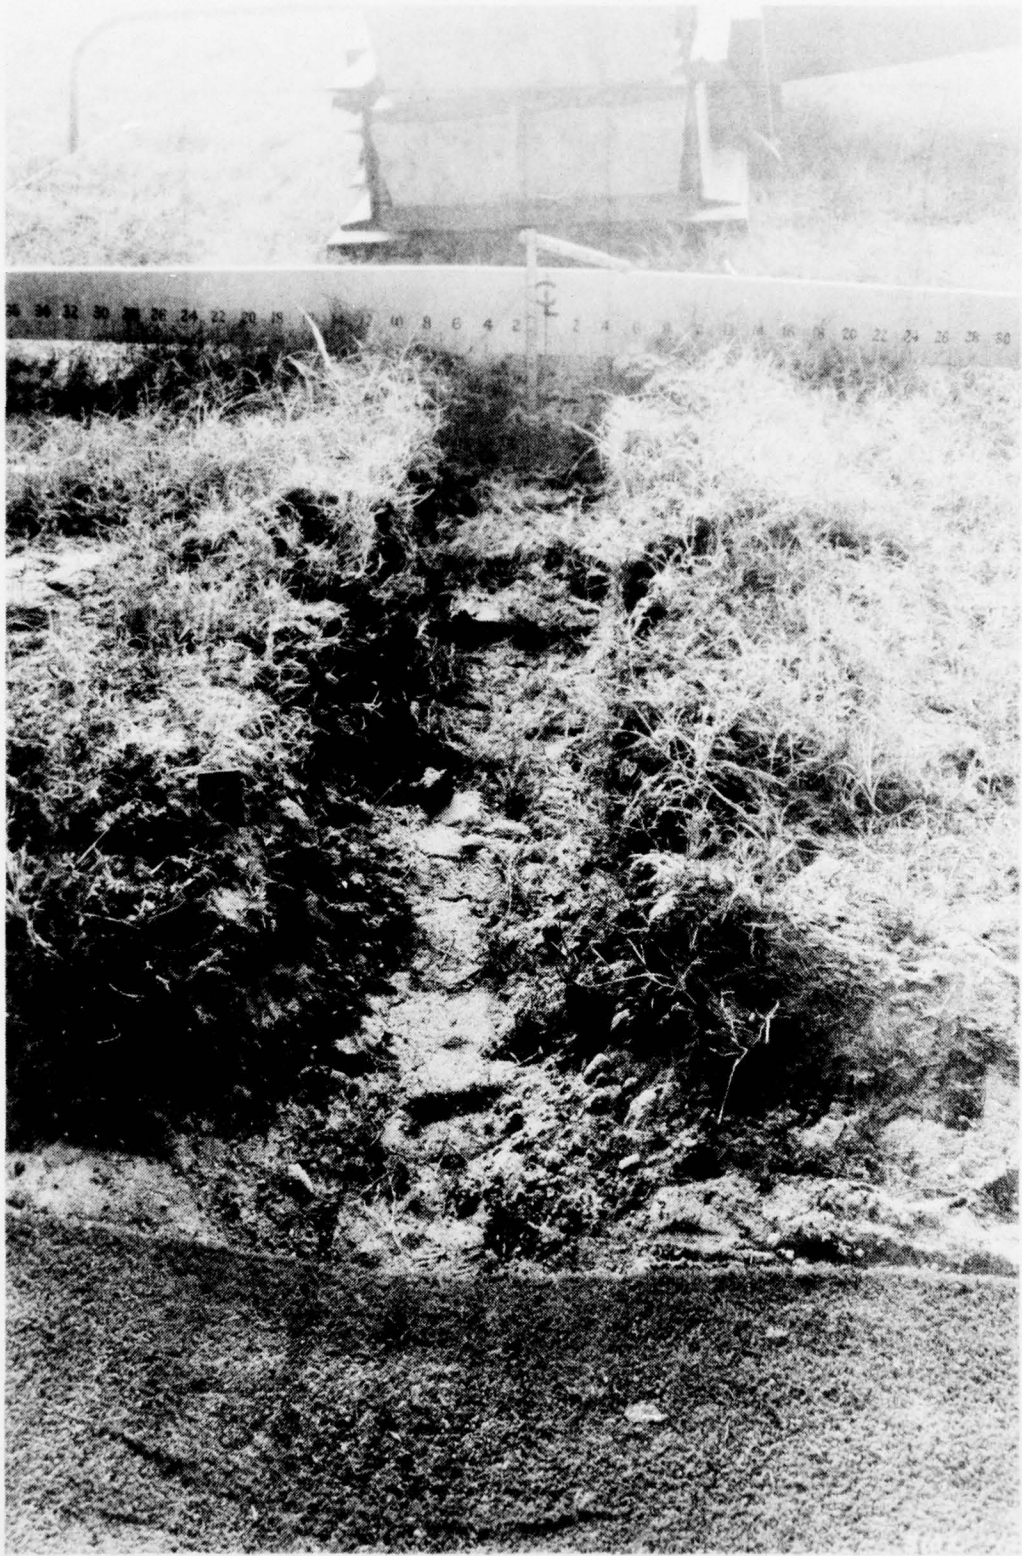
Figure 47 shows item 5 prior to traffic. The item failed on the first pass of the load cart during the rolling-wheel drawbar pull test. A rut depth of about 4 inches, as shown in Figure 48, developed as the load cart was towed onto the item. Moisture had penetrated through the surface of the MESL into the lean clay, causing a loss in strength of the MESL.

Figure 48. Rut in Item 5 After One Pass

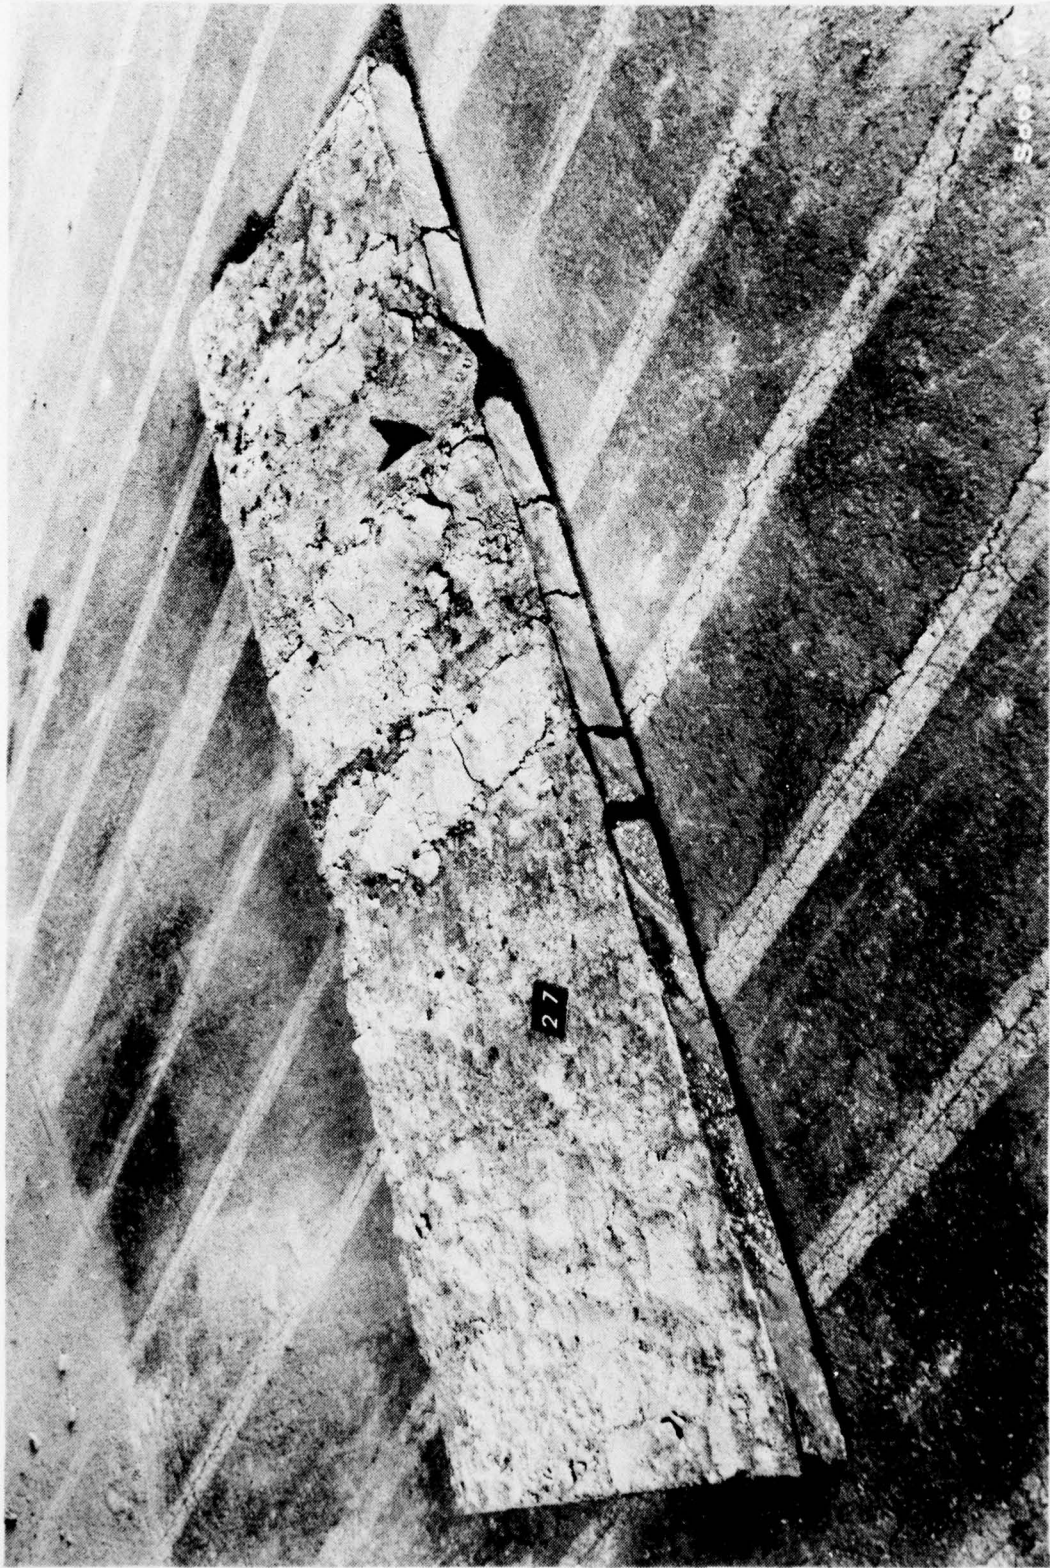
In-place tests on the subgrade show that the water content and density were about the same after traffic as during construction, but the CBR had increased from 7 to 9. Figure 52 shows the slab of asphaltic concrete removed from the test trench, cracks that developed the full depth of the pavement, and wet lean clay that adhered to the top membrane when asphaltic concrete was removed. Figure 53 shows that the polyethylene membrane at the bottom of the MESL was intact but began to fold at the edge of the traffic lane.

Figure 52. Wet Material That Adhered to Polypropylene Surface When Asphalt Concrete Slab Was Removed, Item 3
