**MEMBRANE ENCAPSULATED SOIL LAYER  
(MESL) FOR CONTINGENCY AIRFIELDS**

**U. S. ARMY ENGINEER WATERWAYS EXPERIMENT STATION  
SOILS AND PAVEMENTS LABORATORY  
P. O. BOX 631 VICKSBURG, MISSISSIPPI 39180**

APRIL 1977

**FINAL REPORT FOR PERIOD  
MAY 1976-FEBRUARY 1977**

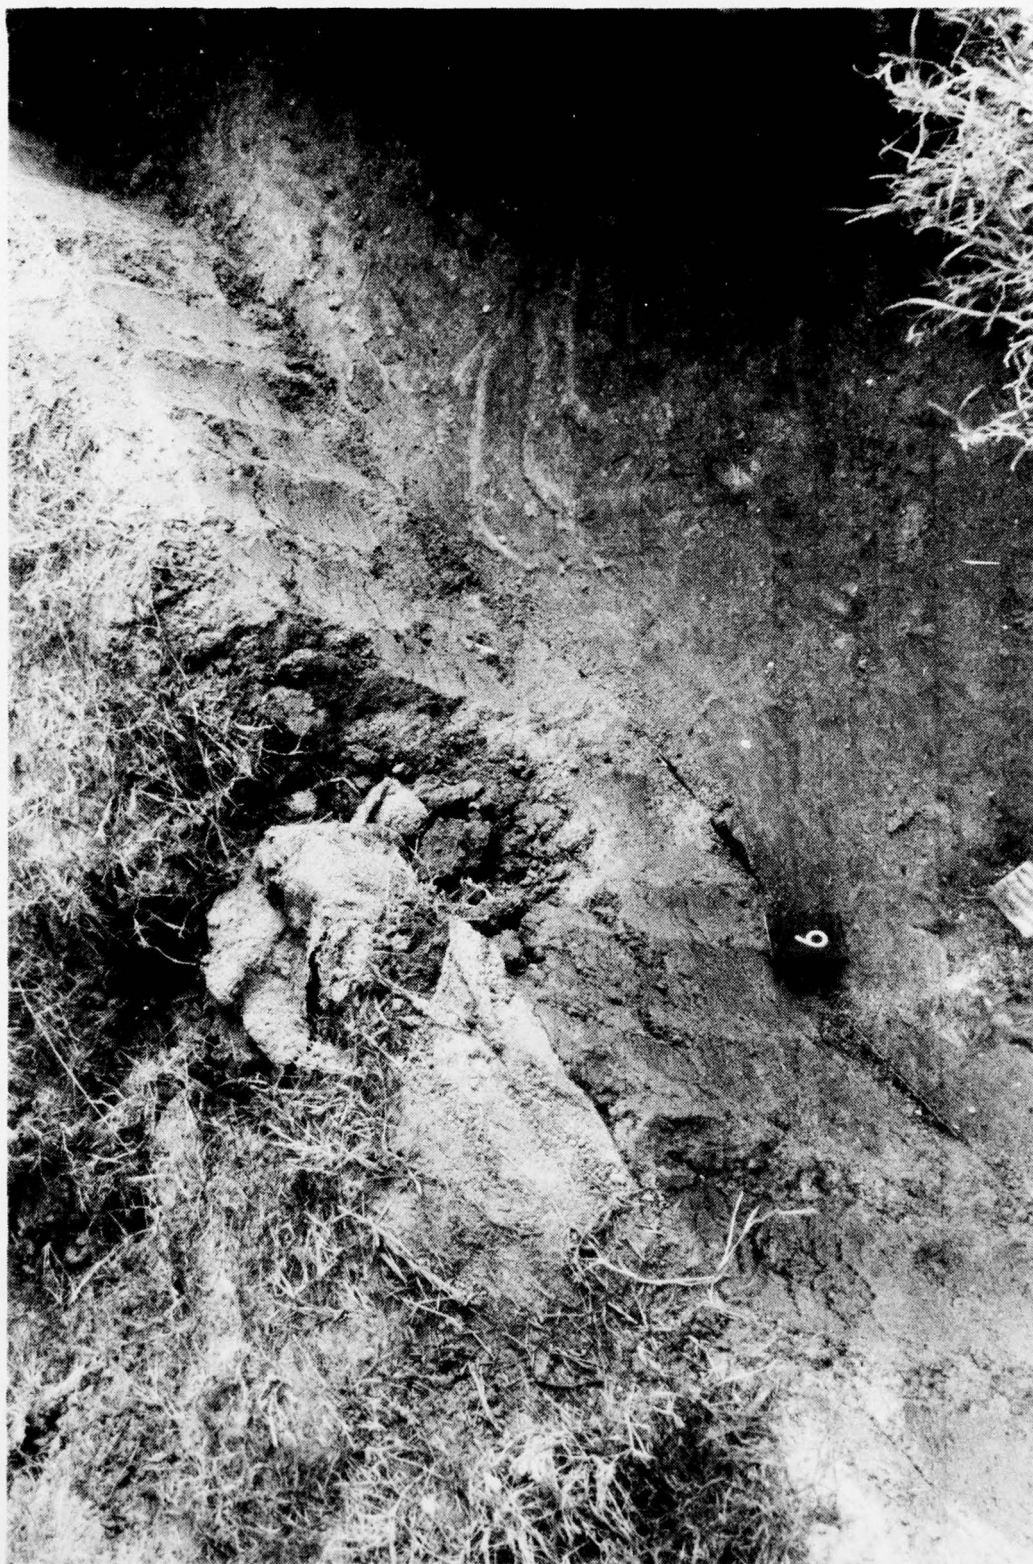
Figure 54 shows the test trench and the rut that occurred at one pass. The polyethylene membrane on the bottom of the MESL was not torn. Failure in this item was caused by water that was applied to the sod soaking through the top membrane of the MESL and saturating the lean clay causing a loss in strength of the encapsulated soil.

5. A MESL is susceptible to infiltration of water when overlaid with a layer of wet material such as the sod used in this study.

Figure 54. Rut in MESL, Item 5, After One Pass of Load Cart
