HEADQUARTERS STRATEGIC AIR COMMAND
DIRECTORATE OF AIRCRAFT MAINTENANCE
AIRCRAFT ENGINEERING DIVISION
(Hq SAC/LGME)
OFFUTT AIR FORCE BASE, NEBRASKA 68113

ENGINEERING REPORT NO. P-206
TF30-P-7 INSTALLED TRIM CORRECTION

14 January 1977

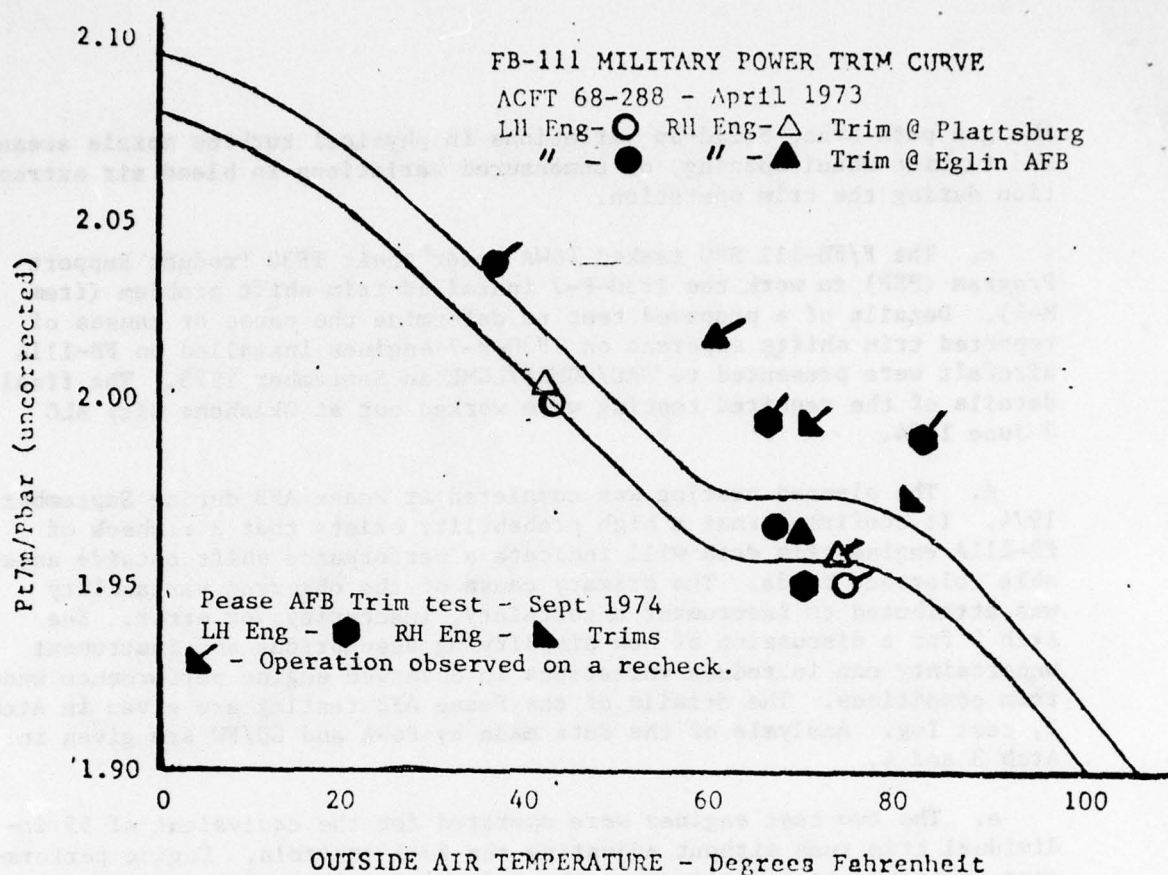
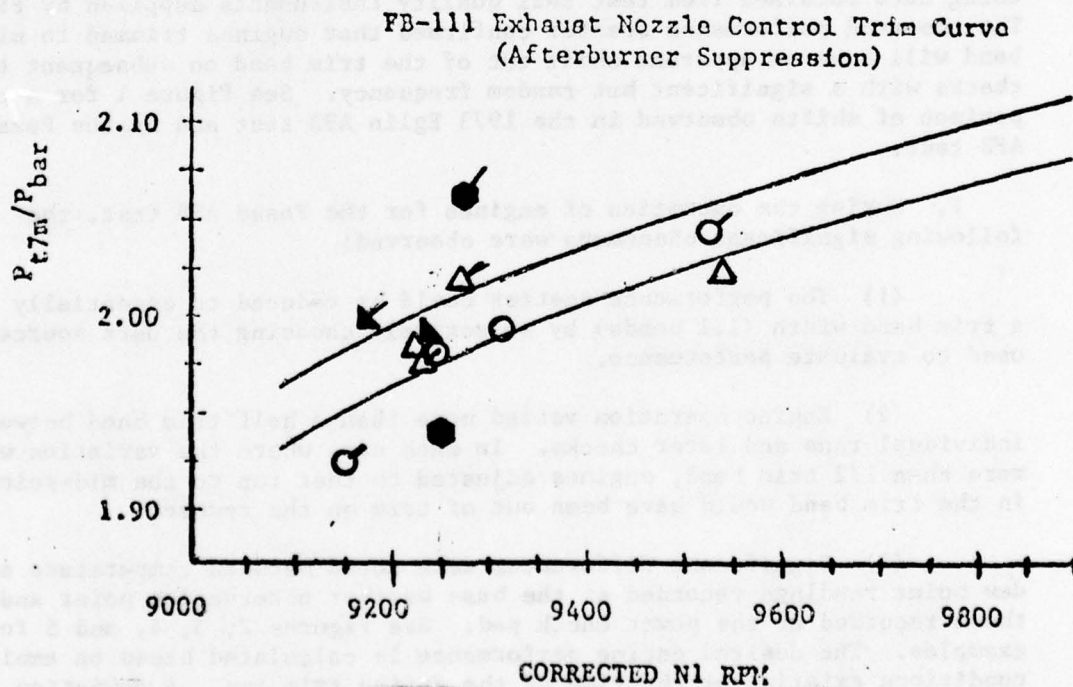
e. The two test engines were operated for the equivalent of 55 individual trim runs without adjusting the fuel controls. Engine performance scattered essentially over the trim band tolerance when evaluated using data obtained from test cell quality instruments supplied by P&WA. The observed performance scatter confirmed that engines trimmed to mid-band will have an apparent shift out of the trim band on subsequent trim checks with a significant but random frequency. See Figure 1 for a comparison of shifts observed in the 1973 Eglin AFB test and in the Pease AFB test.

Figure 1 -- Comparison of FB-111A observed engine performance from April 1973 Eglin AFB trim test and from September 1974 Pease AFB trim test.

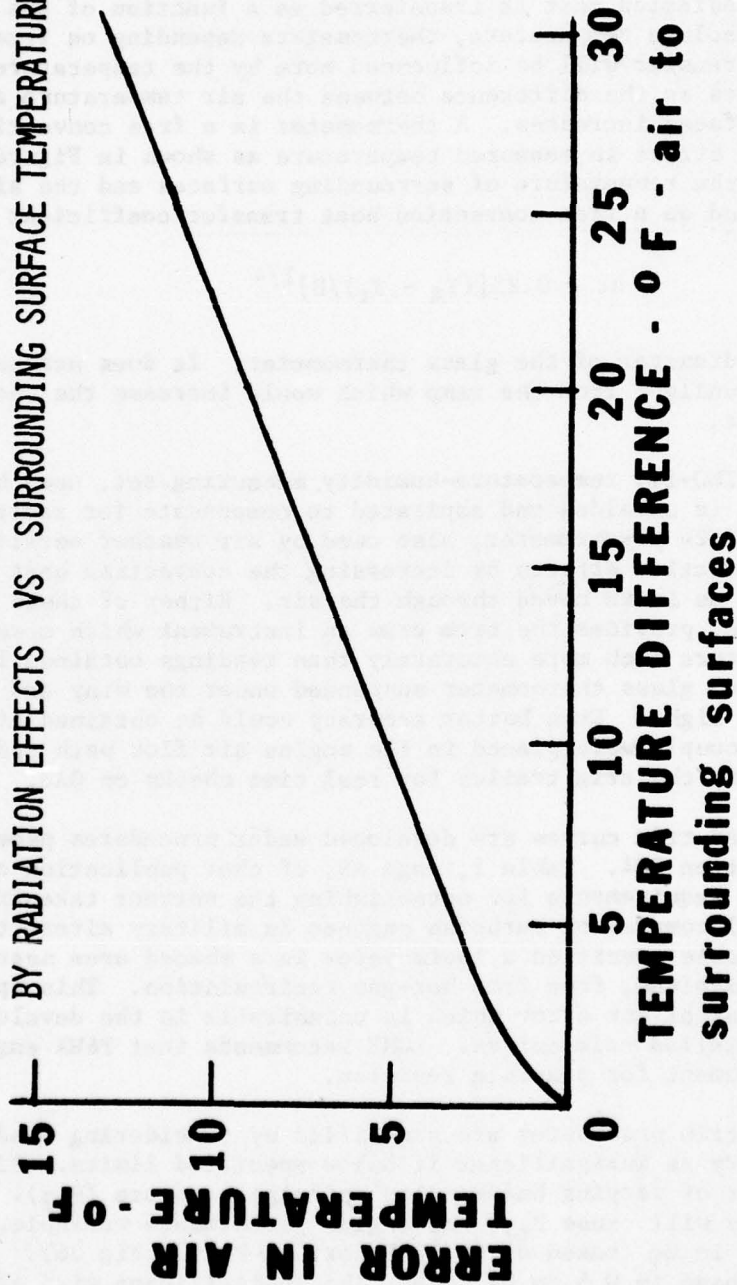
e. Outside air temperature instrumentation specified by P&WA instructions 504 for development of installed trim curves is subject to significant errors from direct radiation and reflected solar energy. (The instructions specify a $\pm 1^\circ\text{F}$ thermometer hung in a shaded area free from hot gas recirculation near the test stand or airplane.) Errors in the measurement of outside air temperature cause unwanted variation in the developed trim curves.

ERROR IN OAT MEASUREMENT WITH A GLASS THERMOMETER CAUSED BY RADIATION EFFECTS VS SURROUNDING SURFACE TEMPERATURES.

FIGURE 6. RADIATION EFFECTS ON A GLASS THERMOMETER HUNG IN THE SHADE FOR THE PURPOSE OF MEASURING AMBIENT AIR TEMPERATURE. REFLECTED SOLAR ENERGY IS ASSUMED TO BE ZERO. NATURAL CONVECTIVE HEAT TRANSFER COEFFICIENT IS OBTAINED FROM

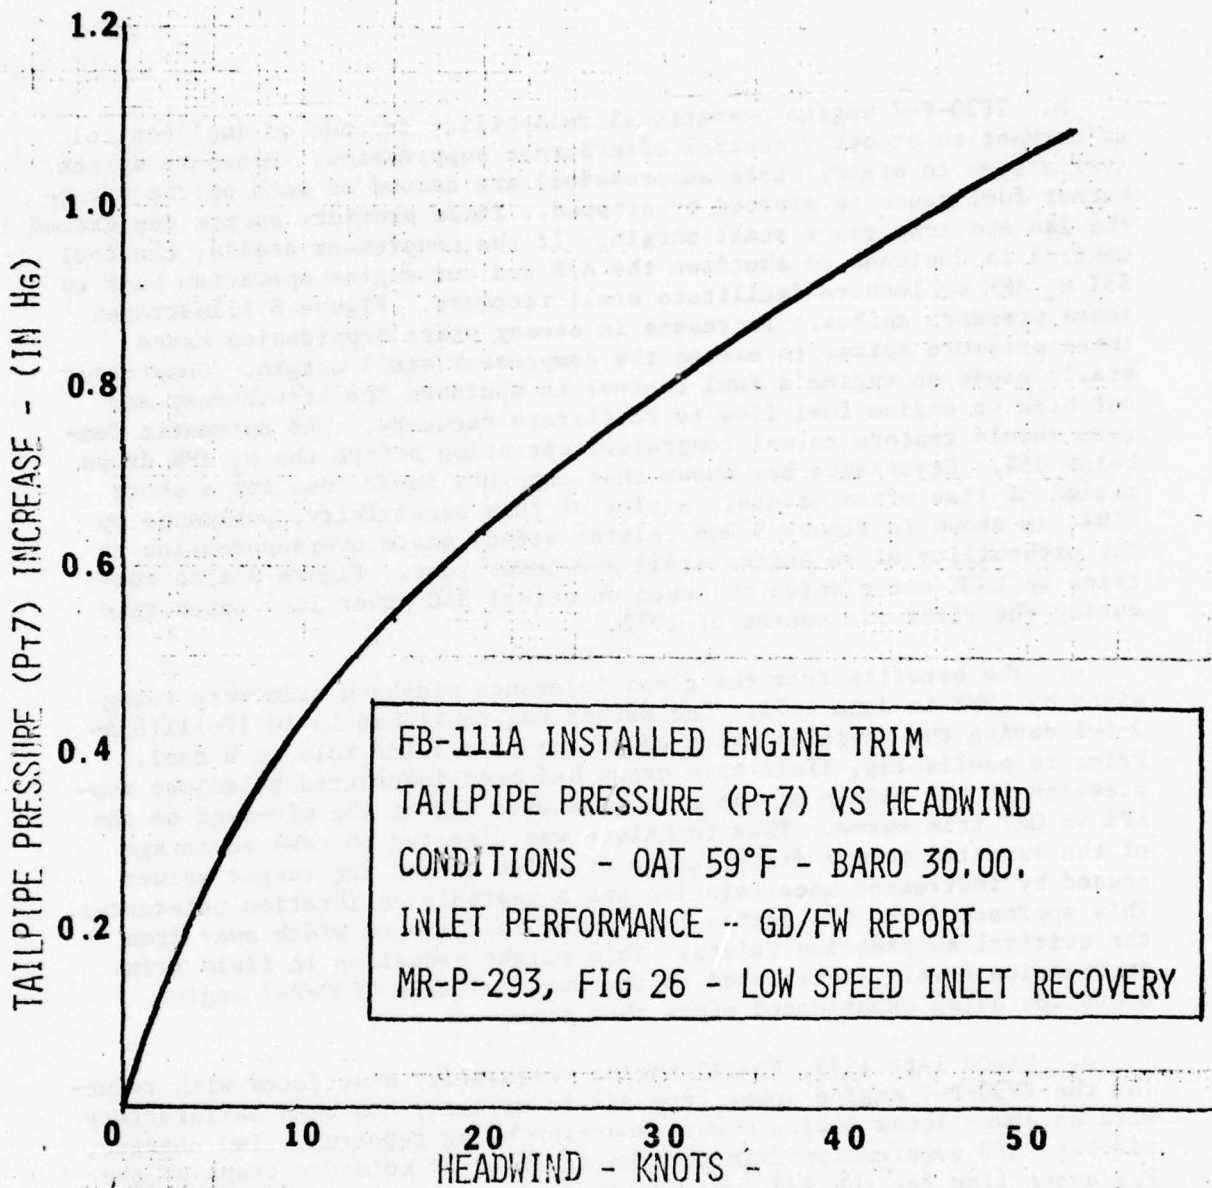
FIGURE 7

l. Engine trim procedures are simplified by considering wind effect on inlet recovery as insignificant if below specified limits. Figure 7 shows the effect of varying headwind on tailpipe pressure (P_{t7}). A headwind of 15 knots will cause P_{t7} , the engine performance variable, to increase by 0.5 in Hg (based on GD/FW Report MR-P-293, Fig 26). The allowable trim band in 0.5 in Hg wide. The insignificant wind effect assumption is necessary to provide an acceptable maintenance procedure and is justified by the fact that it produces an undertrim. Cross wind effects, however, can cause decreases in inlet recovery which, theoretically, will cause overtrims. The relative effects of crosswind on inlet recovery are presently undefined.

A Trimshift of one band width will be apparent between zero wind and 15K headwind conditions. Current trim procedures are simplified by assuming that wind effects are negligible and can, therefore, be neglected. This curve shows the change in tailpipe pressure in inches of mercury that headwinds will cause. The effect of crosswinds on inlet recovery is not presently defined.

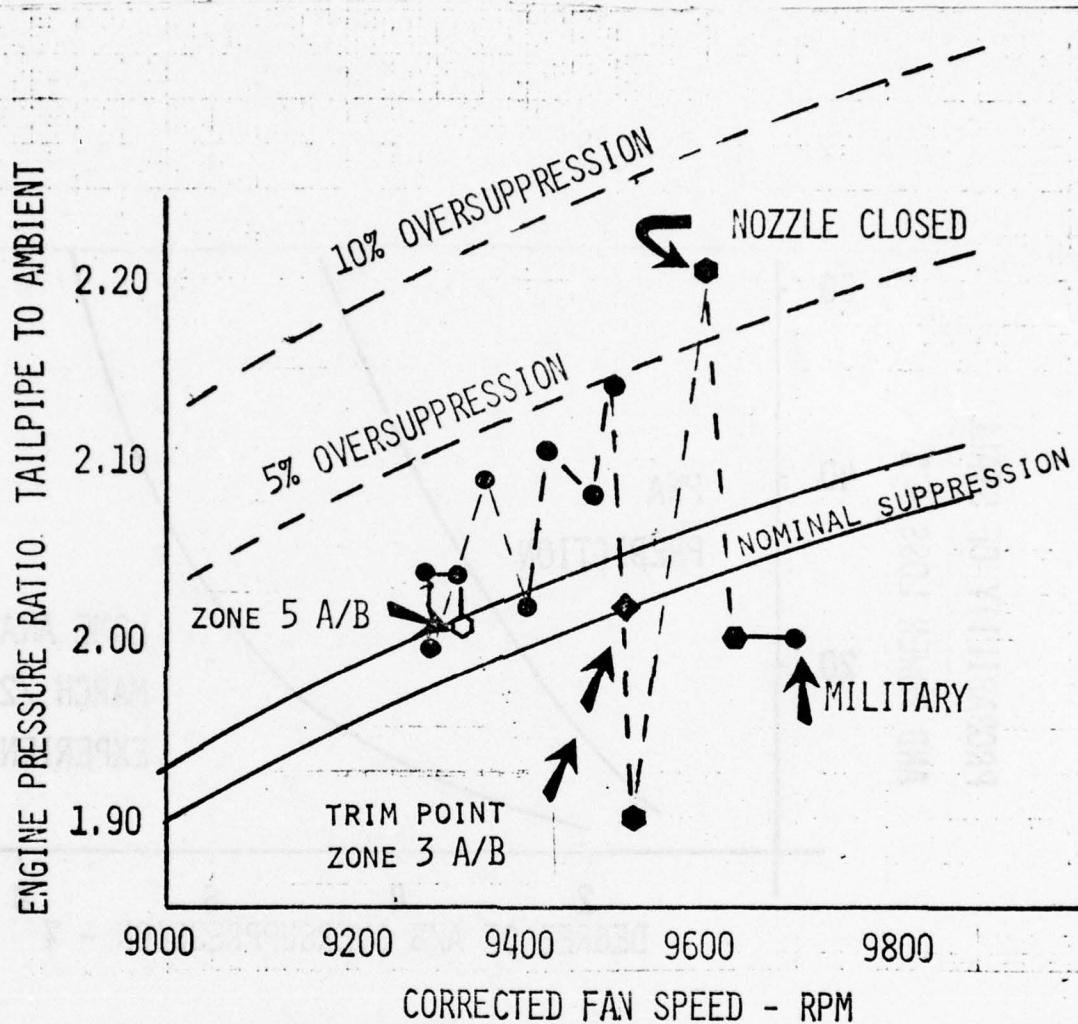
FIGURE 8. EPR and RPM dynamics during snap throttle retard from maximum A/B to military power for a TF30-P-7 engine trimmed to the bottom of the suppression band.

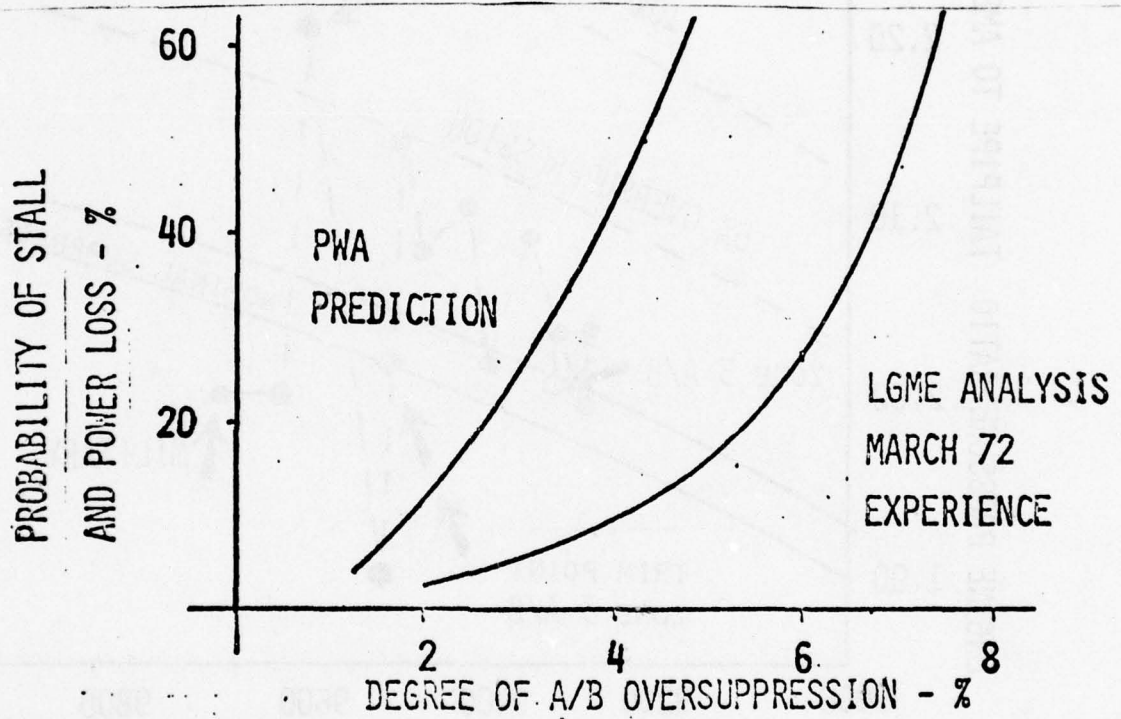
m. TF30-P-7 engine operational reliability depends on fuel control adjustment to properly control afterburner suppression. Pressure spikes (variations in steady state suppression) are caused as each of the afterburner fuel zones is started or stopped. These pressure surges can exceed the fan and compressor stall margin. If the compressor stalls, the fuel control is designed to shutdown the A/B and cut engine operation back to 85% N_2 RPM or less to facilitate stall recovery. Figure 8 illustrates these pressure spikes. Increases in steady state suppression cause these pressure spikes to exceed the compressor stall margin. Compressor stalls cause an engine's fuel control to shutdown the afterburner and cut back on engine fuel flow to facilitate recovery. The automatic feature should restore normal compressor operation before the N_2 RPM drops below 85%. Experience has shown that complete power loss for a short period of time often occurs. A plot of this sensitivity, published by P&WA, is shown in Figure 9 and relates steady state oversuppression to the probability of an engine stall and power loss. Figure 9 also contains an LGME curve which is based on actual SAC power loss experience during the first six months of 1972.

Figure 9. Comparison of power loss probability associated with the degree of A/B oversuppression predicted by P&WA and SAC FB-111A experience during the winter of 1971 - 1972.

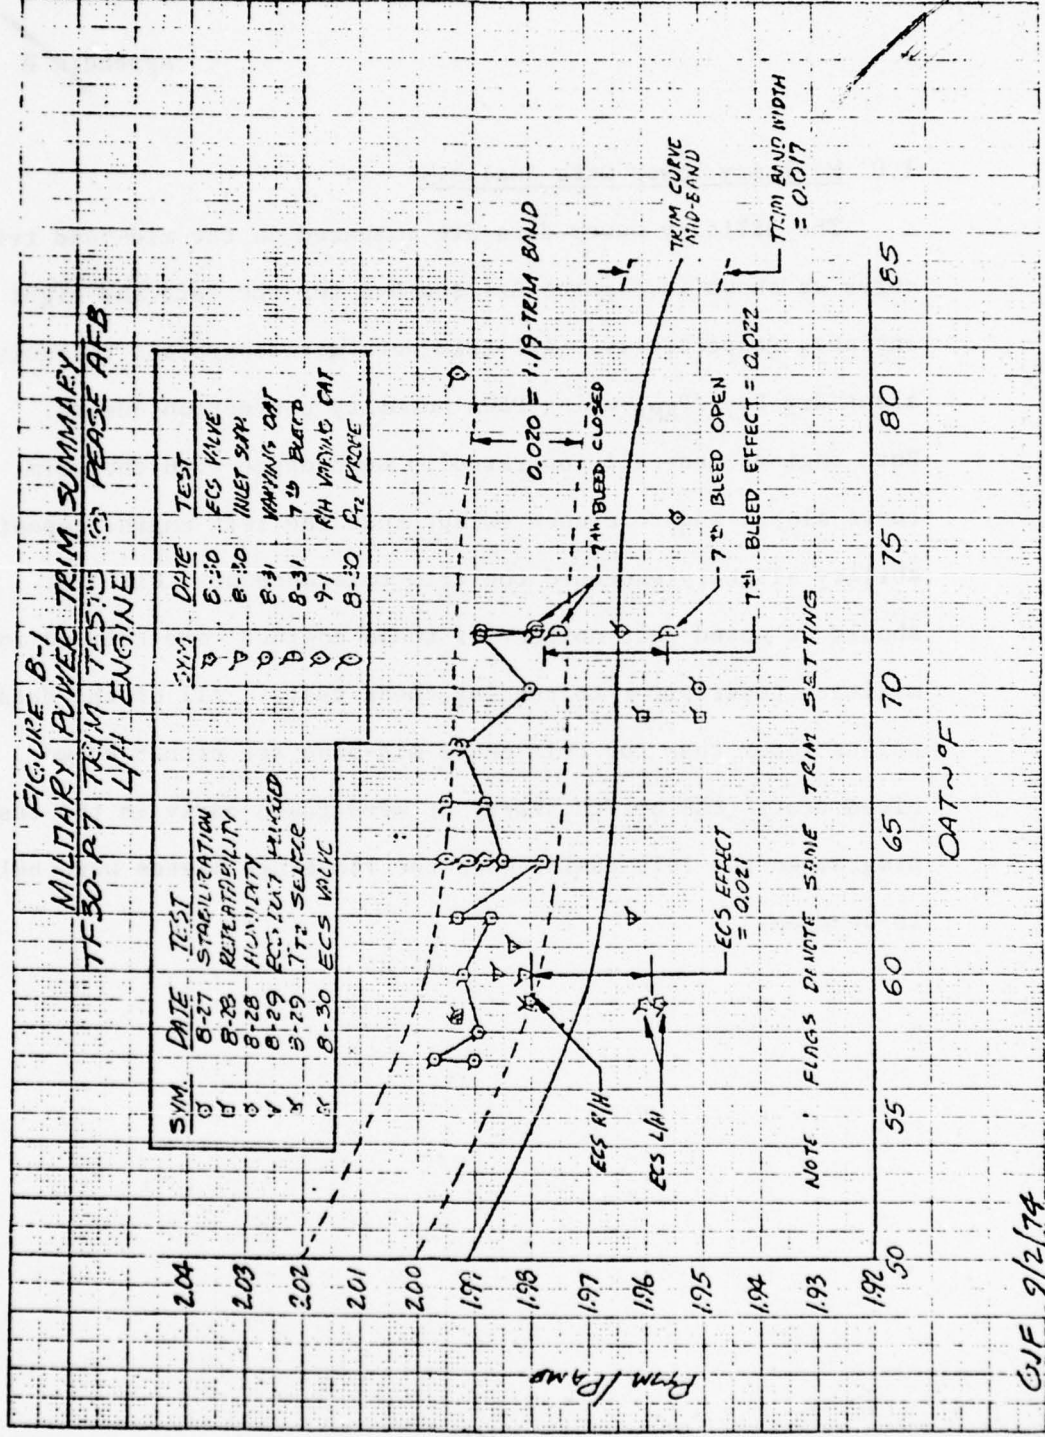
FIGURE B-1
MILITARY POWER TRIM SUMMARY
TF50-A7 TRIM TESTS LYH ENGINE
PERSE AFB

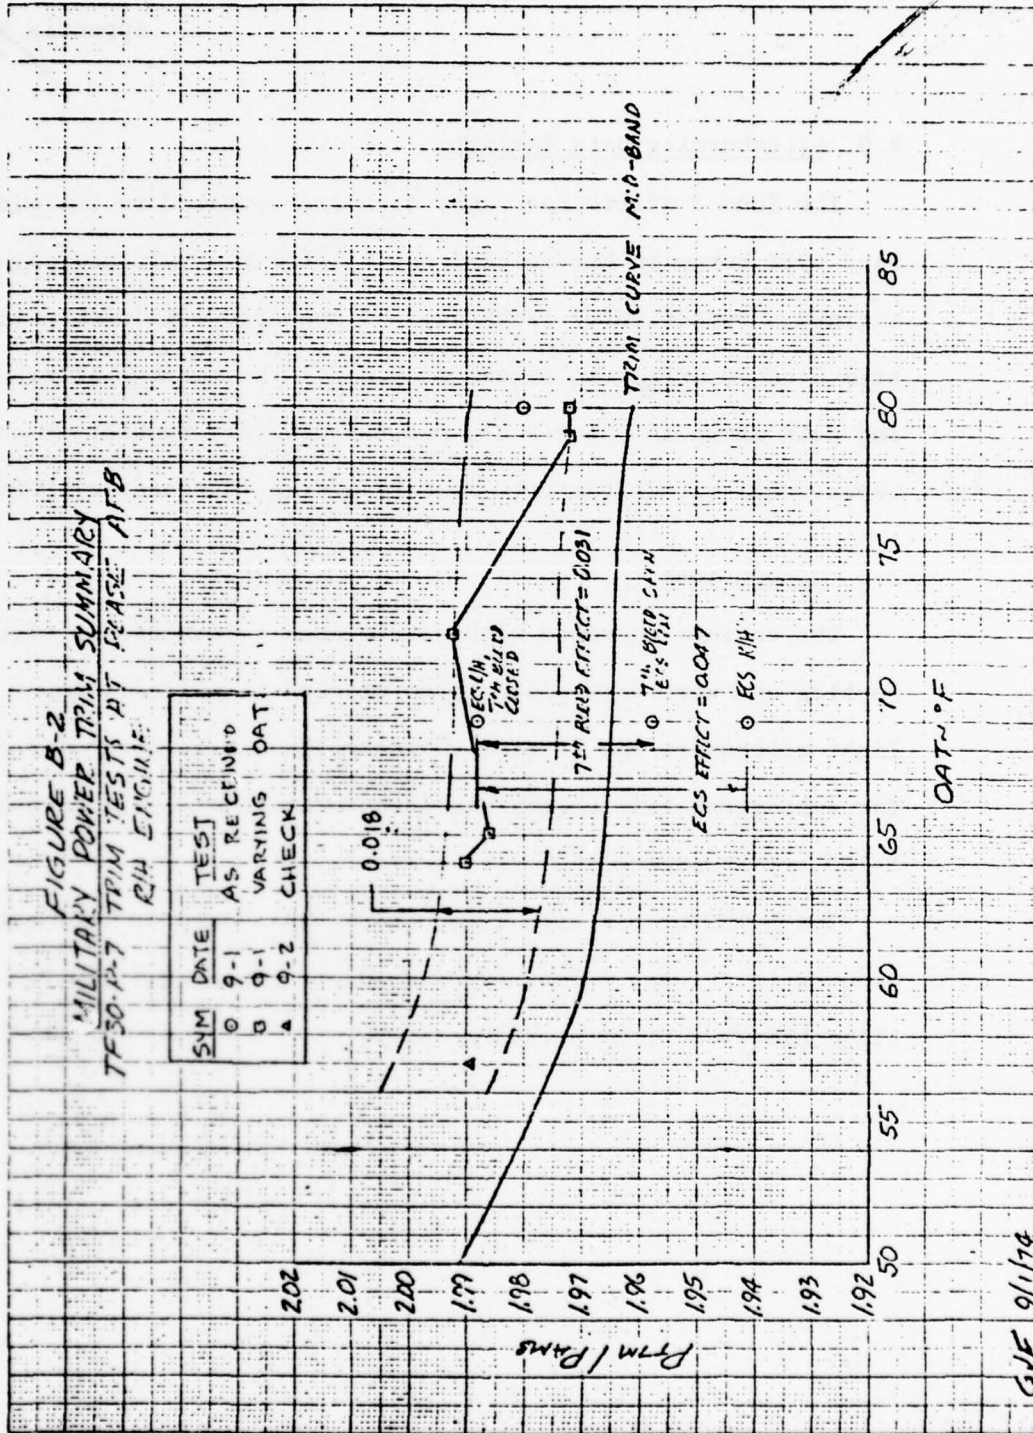
FIGURE B-2
MILITARY POWER TRIM SUMMARY
TF30-P-7 TRIM TESTS AT CRUISE ATB
R1A ENGINE

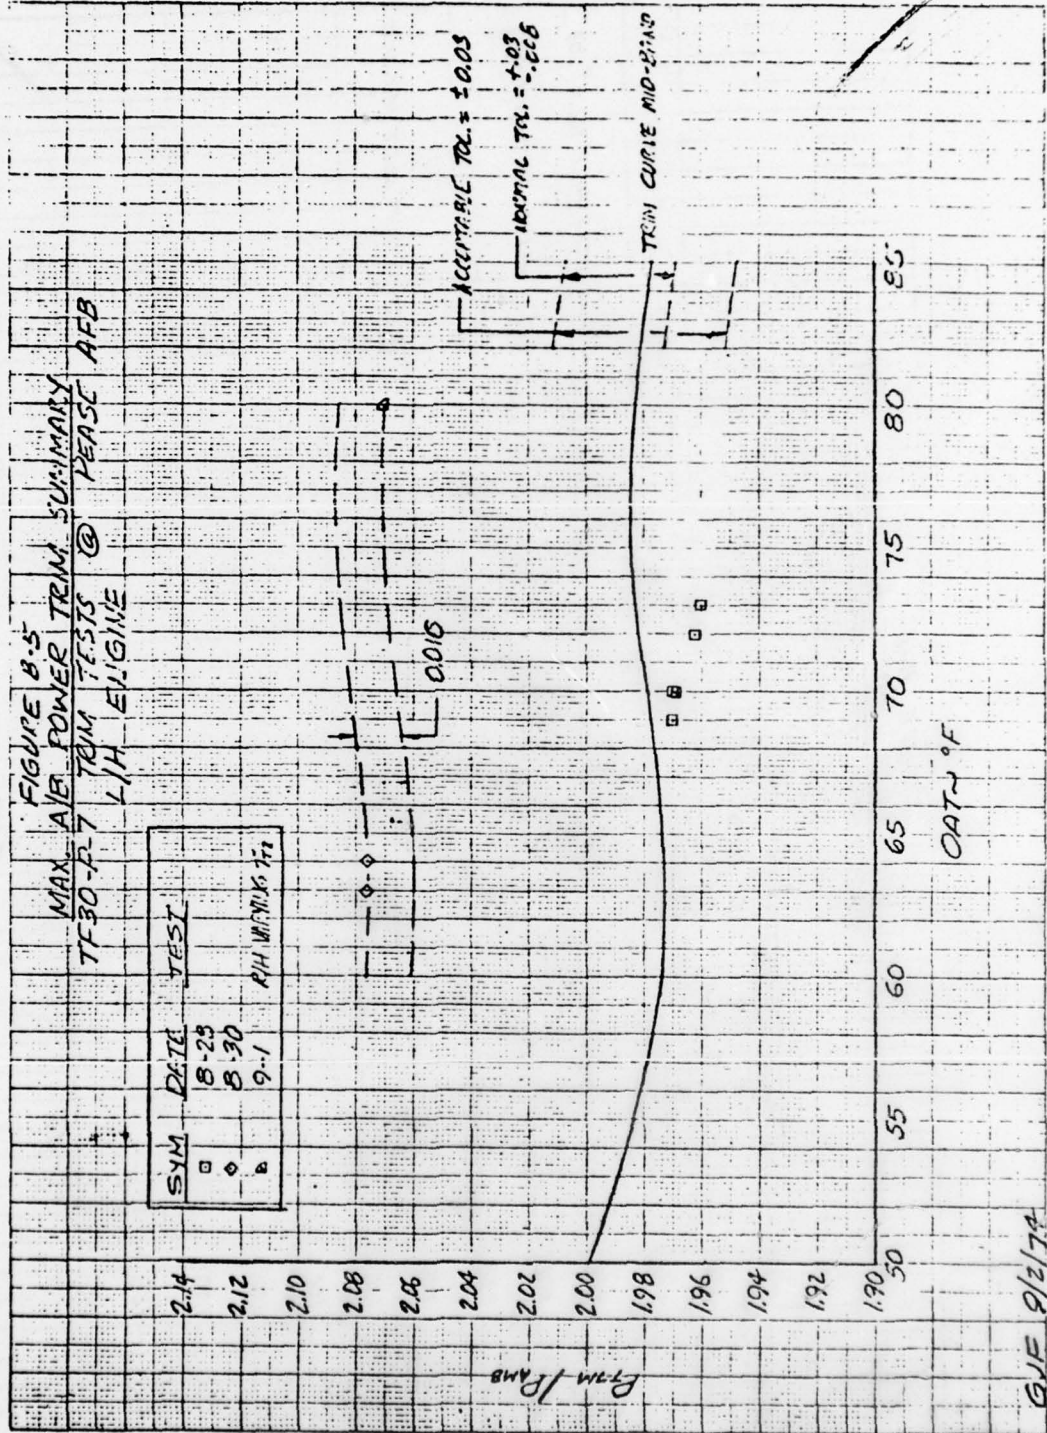
FIGURE B-5
 MAX AIR POWER TRIM SUMMARY
 TF30-P-7 TRIM TESTS @ YEASE AFB
 L/H ENGINE
