Technical Report 260

**FIELD TEST OF A MESL
(Membrane-Enveloped Soil Layer)
ROAD SECTION IN CENTRAL ALASKA**

July 1975

CORPS OF ENGINEERS, U.S. ARMY

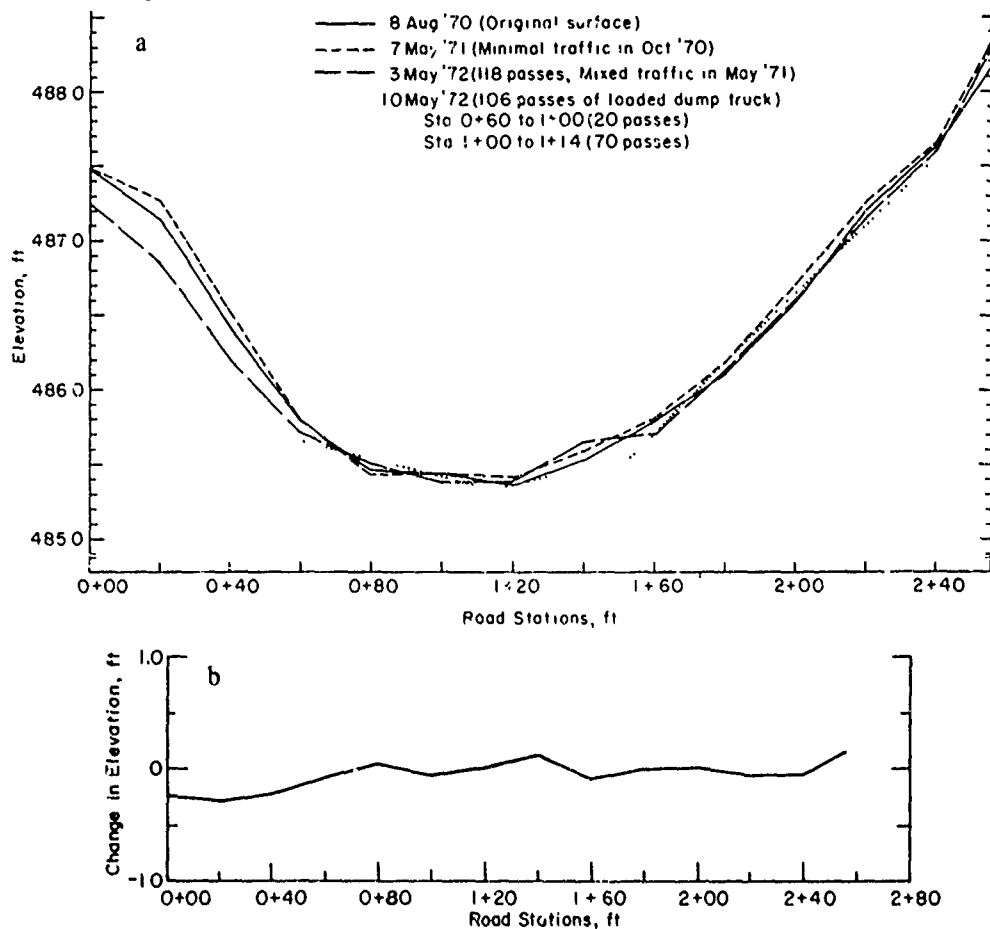
Figure 10. MESL road surface elevations and elevation changes at centerline.

Figure 10 shows the centerline elevations of the MESL during this reporting period. The centerline elevation had changed a maximum of 2 in. along the section from station 0+60 to 2+56. No post-traffic centerline elevations were taken from stations 0+00 to 0+60, but it appears that a settlement of 3.75 in. or more had occurred in that portion of the MESL. In general the centerline had settled, except at the locations of deep wheel track rutting.

Figure 10 shows the change in centerline elevation of the MESL. From the construction completion date to 3 May 1972, before the spring traffic tests were completed, the MESL elevation increased 0.17 ft at station 2+56, and settled 0.29 ft at station 0+20. These are the maximum differences in centerline elevation noted until that time. After traffic

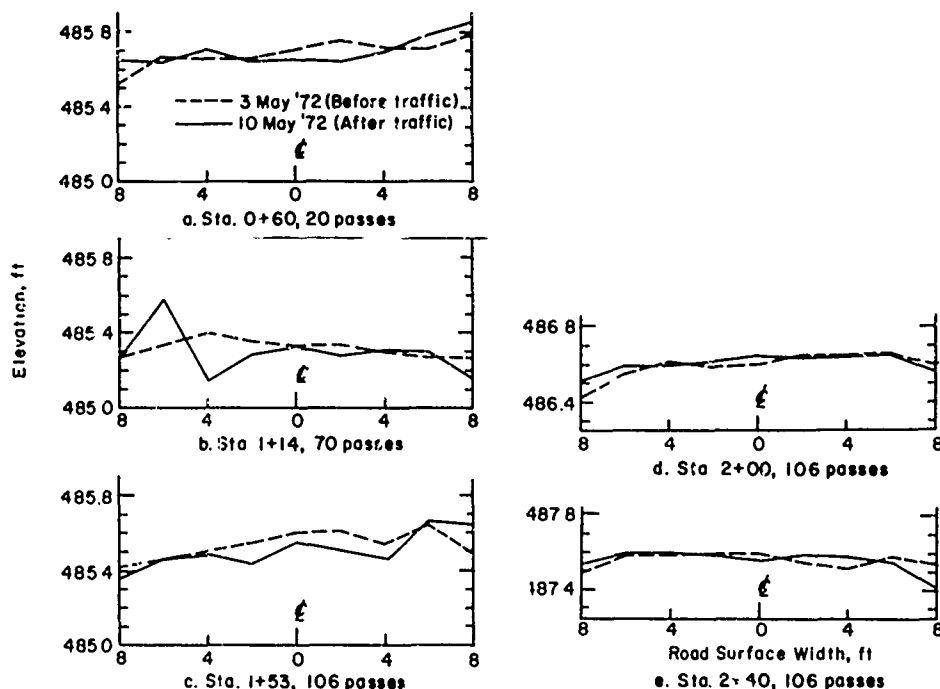
Figure 11. MESL road surface (cross section) elevations, before and after test traffic, May 1972.

Cross-section elevations at five stations were taken before and after the May 1972 traffic testing (see Fig. 11). Station 0+60 was the location of an extensive soft spot where trafficking was limited to 20 passes; stations 1+14 and 2+40 were sites of recent CBR tests; station 1+53 appeared to have a separation of the lap seal in progress; and station 2+00 was chosen as a representative portion of the best part of the MESL test road. The cross sections generally show that the northern end of the road experienced less surface distress than the southern and middle sections during the traffic tests. These data for Figures 10 and 11 are listed in Tables III and IV, respectively.

Data for the complete period (1970-1972) show that the average change in cross section elevation for station 0+60 was -0.09 ft; for station 2+00, +0.09 ft; and for station 2+40, -0.06 ft. Although data for other stations are incomplete, the fact that these locations gave better performance does not necessarily mean that the areas that look most degraded have changed the most in elevation. As mentioned, station 2+56 increased in elevation 0.17 ft at the centerline, probably due to frost heave in the wet silt subgrade, and station 0+20 had settled 0.29 ft after trafficking.

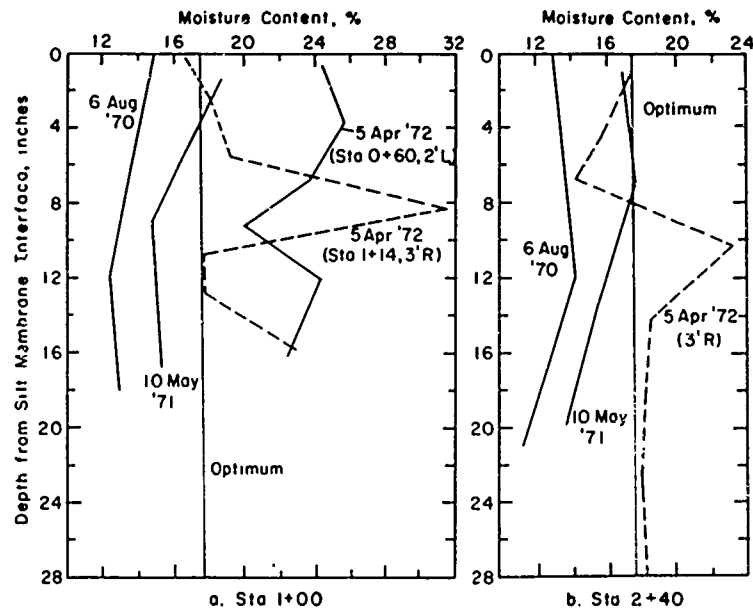
Figure 12. Moisture content in MESL at centerline. Optimum moisture content (17.5%) is from the CE-12 compaction test.

The frozen silt cores taken in April and May 1972 contained some ice lenses. The ice formation tended to occur at the 8- to 13-in. depth level, indicating that some moisture migration had occurred. Table V and Figure 12 show the definite increase of moisture content at this level (for these frozen cores) as compared with other non-frozen cores.

Since both the increase in moisture content (see Fig. 12) and the rutting in the middle part of the MESL were excessive, this portion of the section is considered to have failed after two freezing and thawing seasons with the indicated trafficking. In contrast, the northern part of the MESL, from stations 1+60 to 2+56, is not significantly rutted, although the moisture content has increased to an average of 21%, and this portion can be considered in satisfactory, serviceable condition. The results of the latest Benkleman beam tests (Table II) also indicate the relatively better condition of the northern portion of the MESL section.
