**HYDROFLUIDIC STABILITY AUGMENTATION SYSTEM (HYSAS)
OPERATIONAL SUITABILITY DEMONSTRATION**

Honeywell Inc.
1625 Zarthan Avenue
St. Louis Park, Minnesota 55416

October 1977

Final Report for Period March 1973 - March 1977

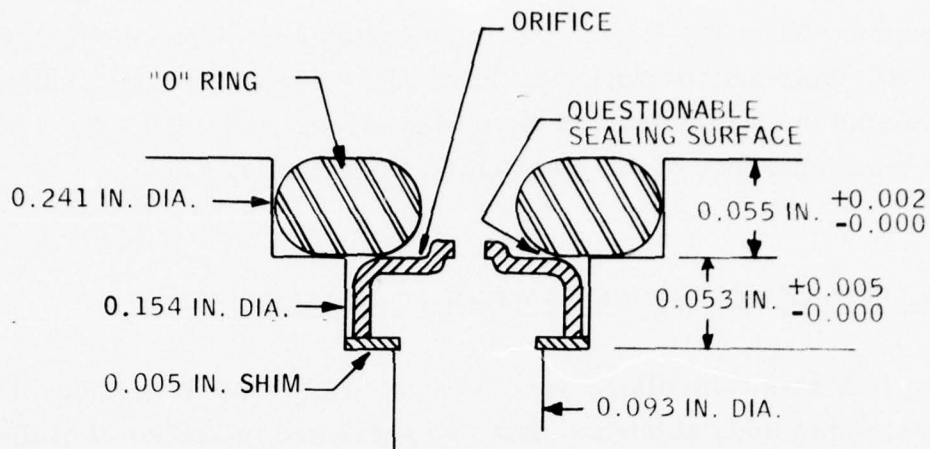
Figure 11. Sealing of Orifice Cup - Operational Suitability Design.

Under some conditions internal leakage occurred around the orifice restrictors, resulting in inconsistent calibration data. The configuration of the orifice installation is shown in Figure 11. The 0.005-inch-thick shim was added to maintain tighter contact between the "O" ring and the orifice cap. This general configuration is not recommended for future designs.

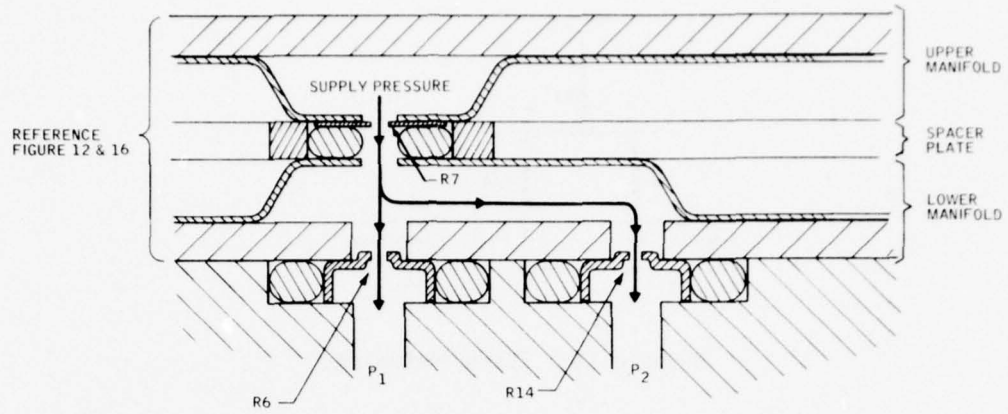
Figure 14. Original Bias Resistor Configuration.

The cause of a large, unexplained offset at the output of the high pass was determined to be the physical orientation of the bias resistors as shown in Figure 14. Because the flow through R7 impinged directly on R6, the recovered pressure at P1 is greater than at P2 even though R6 and R14 are equal. Figure 6 shows the location of these resistors in the circuit. This problem was solved by pressing a diverter plug into the lower manifold baseplate as shown in Figure 15 to prevent impingement of the stream from resistor R7 onto resistor R6.

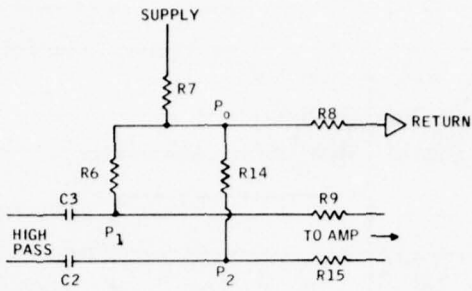
Figure 16. Bias Network.

Another bias circuit problem was uncovered while testing the system over a wide fluid temperature range. In the circuit shown in Figure 16, pressure P_1 usually equals P_2 and is lower than P_0 . Under some temperature conditions, the pressure levels at P_1 and P_2 would increase such that they would become as large as P_0 . In this case the pressure drop across R6 and R14 would be zero, and the resistance of R6 and R14 would be nearly zero. This would result in a short across the high

pass and very low system gain. The problem was solved by blocking resistor R8 and eliminating resistor R7, thereby ensuring a positive flow through bias resistors R6 and R14 at all times.

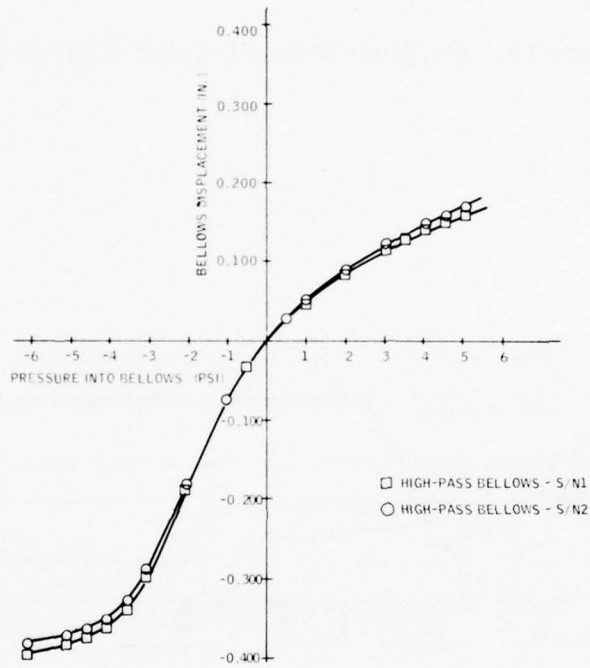
Figure 17. Nonlinear Bellows.

A nonlinear lag bellows that could change the lag time constant by a factor of three depending upon the amount of offset in the preamplifier presented another problem. This same bellows was tested on another program and was found to have the characteristic shown in Figure 17. Spring rate at 2 psid in compression was less than 10 psid per inch of deflection. This increases to 30 psid per inch at a pressure of 2 psid in extension. Nominal operating point for a lag is 0 psid (neither compression or extension); however, for a high pass the operating point can be biased to operate in the linear portion of the curve, which is about 2.5 psid in compression. A more expensive electroformed bellows with a linearity of about ± 5 percent was ordered for the lag circuit when the magnitude of the problem was realized.

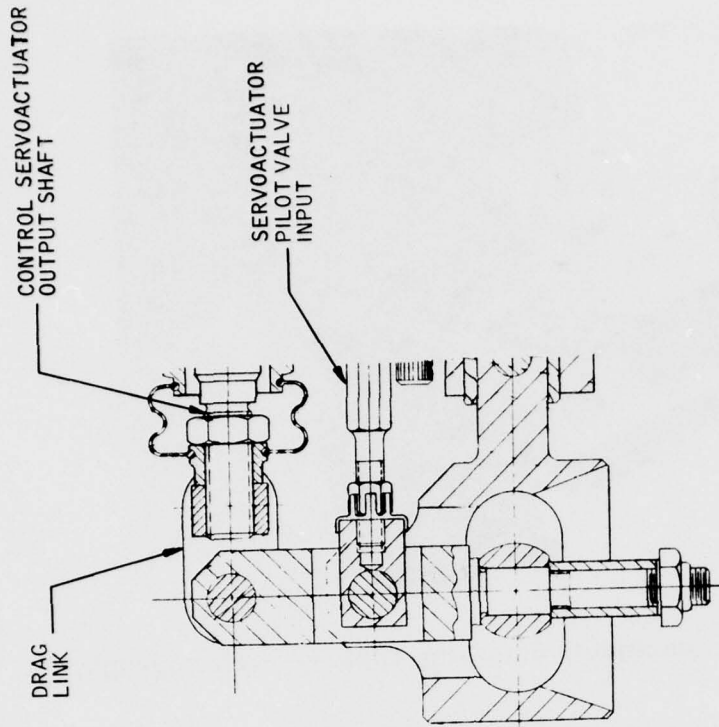
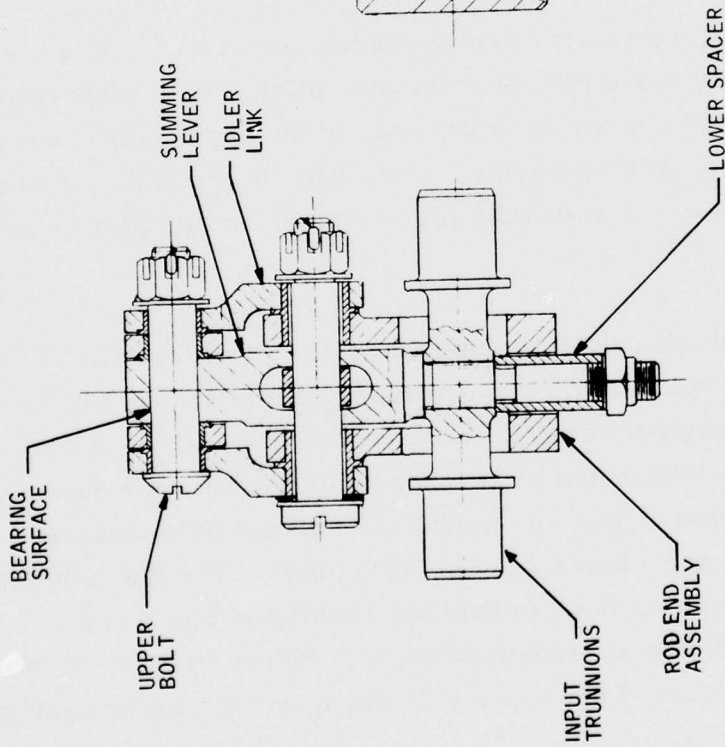
Figure 32. Servoactuator Summing Linkage - Sketch.

upper bolt caused the control servoactuator output to "kick" back into the pedals rather than move the servoactuator pilot valve. Experiments showed that proper shimming in the area of the upper bolt could prevent friction-producing misalignments. Inspection of the unit also showed that there was some wear between the lower spacer and its slot in the rod end assembly.

Review of the linkage design included a review of the results of the described tests, results of previous flight tests on a very similar design, and data on the original design. It was concluded that the force feedback problem could be eliminated by incorporating the changes outlined in Figure 33. The upper bolt was modified to accept an aluminum bronze bushing, thereby providing a good bearing surface for the center link. The 15-5PH sleeve was used to hold the bushing in place and to provide proper spacing for the upper bolt linkages. Shims were to be used to maintain proper alignment of the upper bolt linkage. The lower spacer was

replaced with a smaller diameter unit to prevent contact. It was anticipated that this retrofit would solve the binding problem; however, it was also recognized that this was an interim configuration and that a complete redesign would be required on future builds of similar hardware. A stress analysis on the revised design showed that the new bolt design was acceptable under all static, dynamic, and ultimate load conditions. All summing linkage in the field was modified to incorporate the described changes in August 1975.

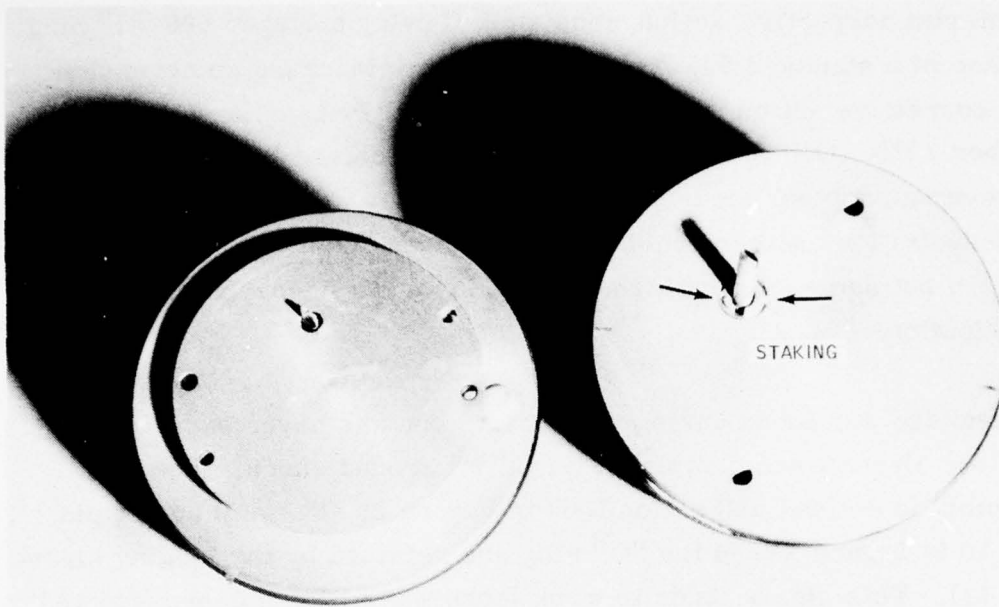
Figure 34. Staking of BIT Locking Sleeve.

BIT leakage was found during installation but was never experienced after the aircraft had completed its initial ground check. The BIT assembly is defined as Section D-D in Figure 2. The null adjust pin (No. 10 in Figure 2) and the "O" ring are retained by the locking sleeve (No. 11). This sleeve tends to work loose when BIT is depressed and released repeatedly (i. e., when the null adjust pin is rotated repeatedly). To correct the problem, this sleeve was permanently "staked" using a center punch on all units. This "staking" can be seen in Figure 34. All of the OH-58 units and some of the TH-57 units received this modification before they were shipped. The remaining TH-57 units were modified on site in Pensacola.

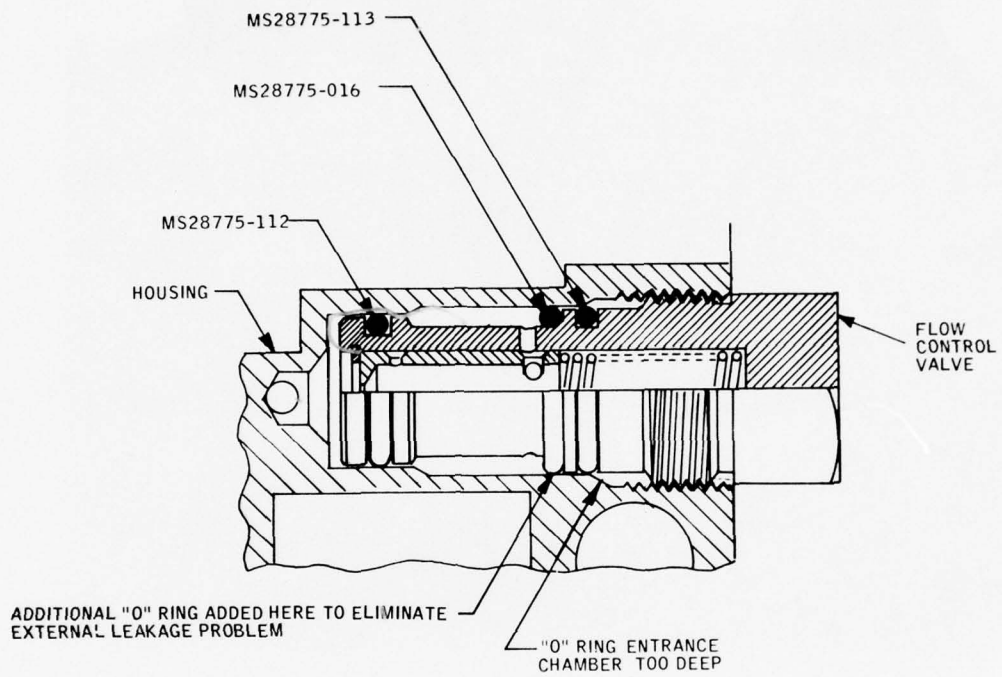
Figure 35. Flow Control Valve Installation.

Flow control valve leakage resulted because the "O" ring entrance chamfer was machined too deep in the controller housing. "O" ring compression was sufficient on most units, preventing any leakage; however, some slight leakage was experienced on a number of other units. Figure 35 is a sketch of the flow control valve installation. An additional "O" ring was incorporated in the location shown in Figure 35 on Pensacola controllers during October of 1975. OH-58 units received this corrective action only when they were returned to Minneapolis or when they showed signs of leakage. Flow control valve leakage was the subject of HMRs B02009 and B02028.

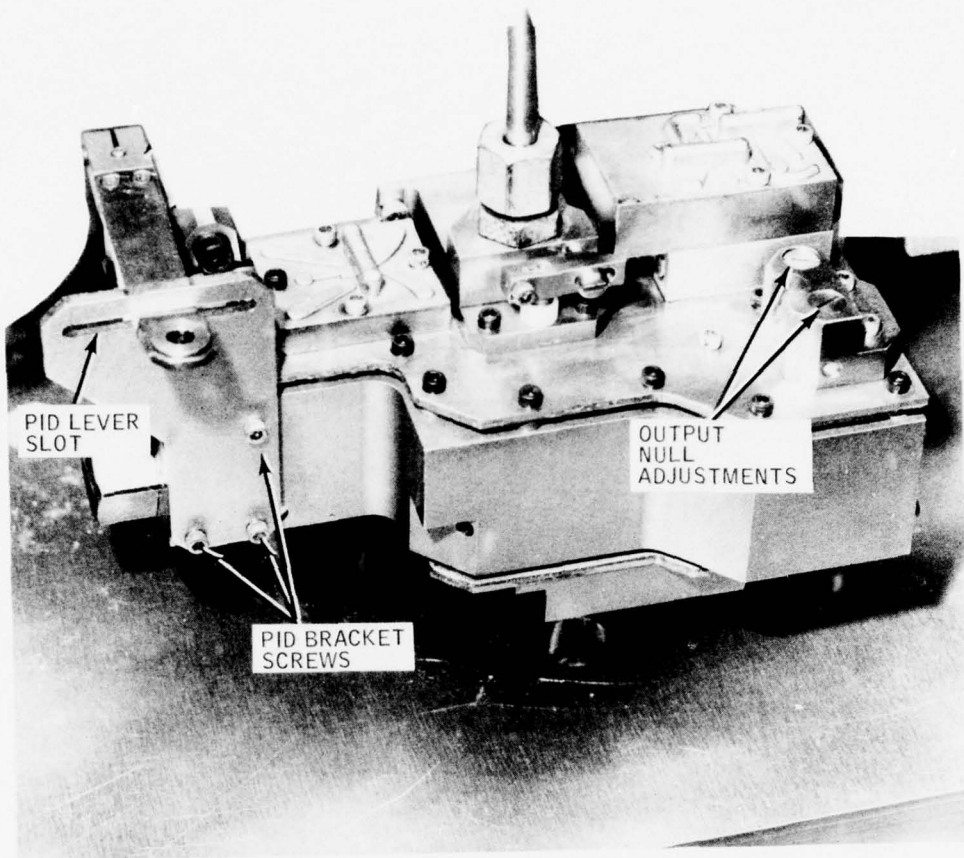
Figure 36. Yaw Axis Controller.

Most of the mishandling problems occurred during the shipment of yaw axis controllers mounted on their servoactuators. Shearing off of the PID bracket screws, Figure 36, was the most common occurrence and is reported in HMRs B02003, B02006 and B02013. This servoactuator assembly is relatively heavy and subject to damage during packing, shipment, and unpacking. The exact point where and how the malfunction occurred has not been determined. Improved packaging greatly reduced the mechanical damage experienced during shipment; however, some servoactuator assemblies are still damaged when they are returned from the field.

Slippage of an output null adjustment (Figure 36) is the suspected cause of malfunction B02053. This adjustment is secured by friction, and a rubber base adhesive is applied after controller calibration is completed. Positive locking means will be used in future applications.

sometimes manipulated quite forcefully to obtain required alignment during installation. Both the PID bracket and the servovalve can be easily redesigned to be more tolerant of abuse. In production, the packaging would also be redesigned to prevent shipping damage.
