AFFDL-TR-77-12

## **PRESSURE CYCLING FATIGUE TESTS OF F-111 CREW MODULE GLASS TRANSPARENCIES**

Experimental Branch  
Structures Division

TECHNICAL REPORT AFFDL-TR-77-12

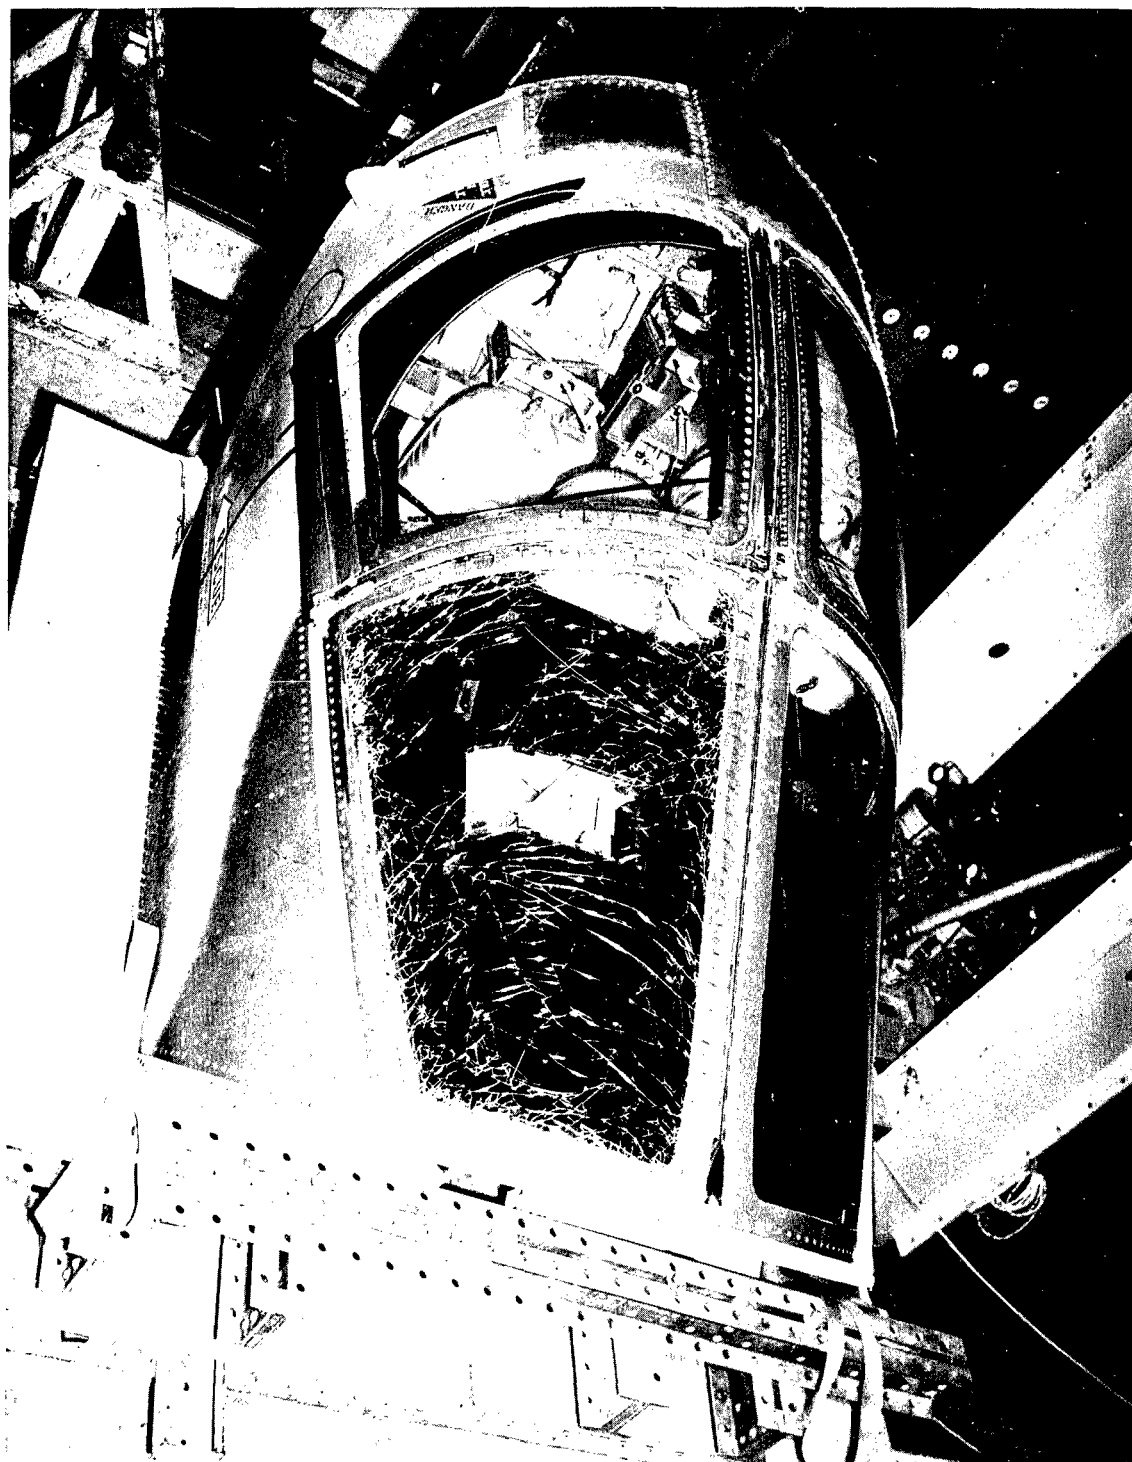
Two complete ship-sets of transparencies were used in this program. The first set had been used in service and had debonded areas in the edge members (Figure 1). The right windshield arrived with its outer titanium edge member strap removed and an attempt was made to rebond it using a technique developed by the Air Force Materials Laboratory (MAAE) and reported in Air Force Materials Laboratory Technical Memorandum MAA 69-9 Rev-1. The outer laminate failed in the final cool down phase of this repair procedure. The failure initiation point was found to be in an area in which a glass chip had been pulled during removal of the titanium edge member. Since one laminate is theoretically capable of carrying all design loads and no replacement with the proper shim was available, this windshield was used in the first part of the program. This ship-set of debonded transparencies, including the right windshield with its failed outer laminate, is shown installed in the module in Figure 1. (The pressure bottles inside the module were used to take up volume to reduce pumping time.) The transparency serial numbers were:

Figure 1. Ship-Set of Debonded Transparencies with the Outer Laminate of Right Windshield Crazed in Edge Member Repair Procedure, Installed in Crew Module

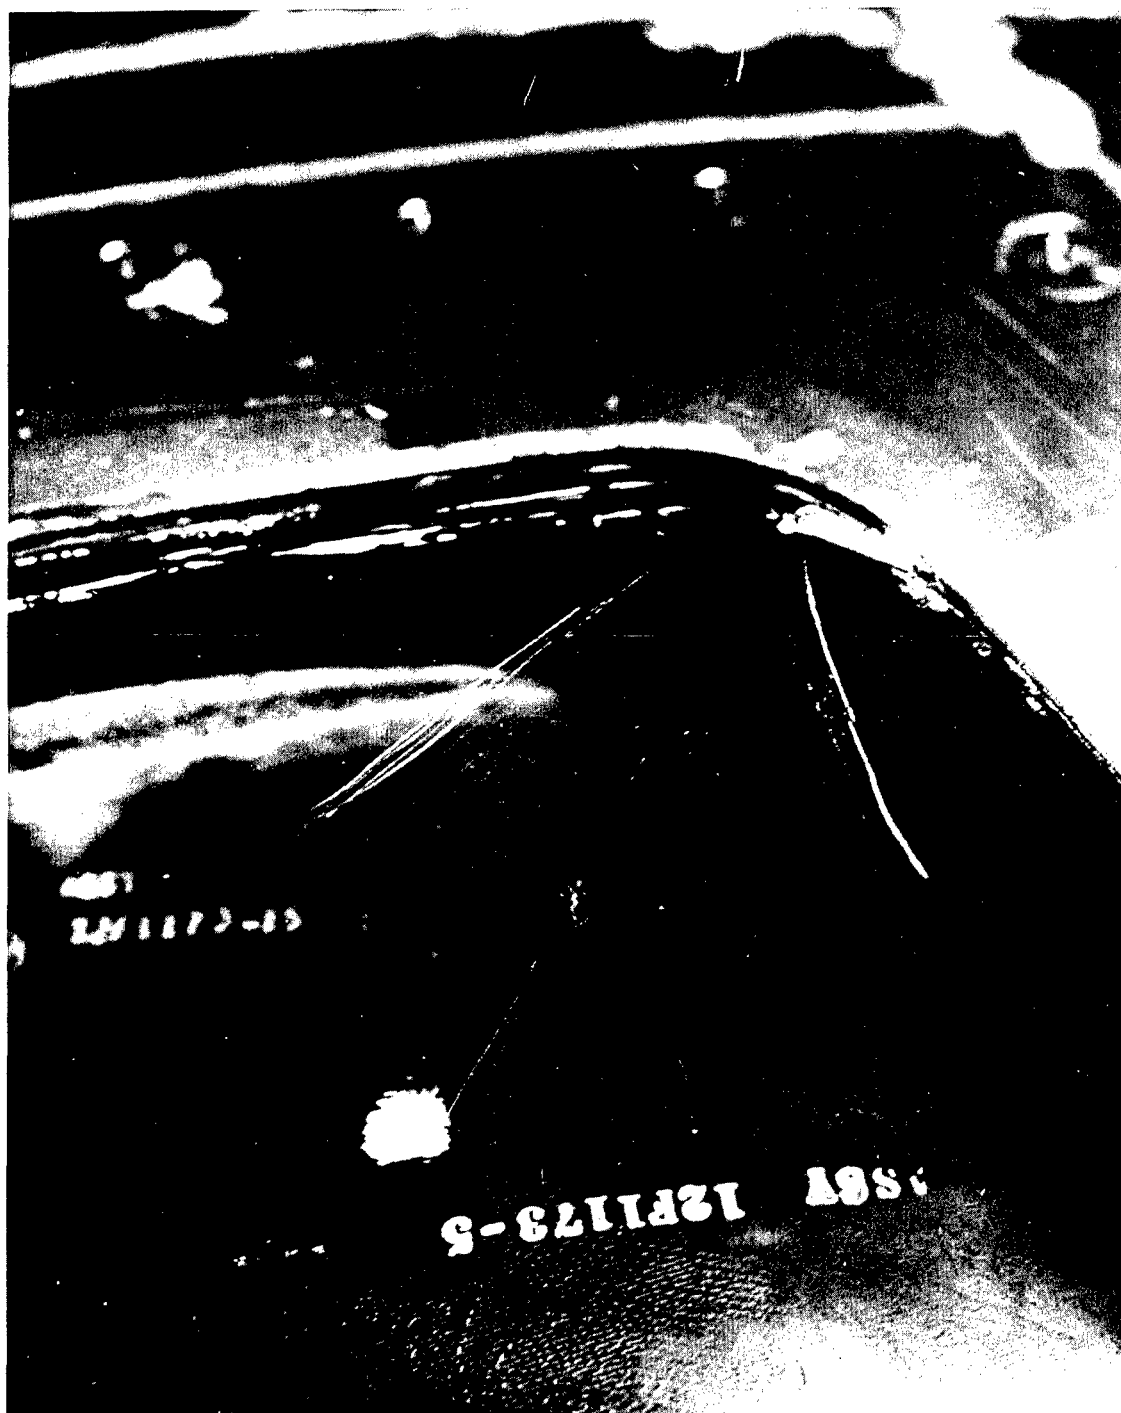
Radial scratches (Figure 3) and cross scratches (Figure 4) were added to the transparencies at the end of four lifetimes of testing to evaluate their tendency to start cracks. Ten more loading blocks representing 2000 service hours were conducted with no apparent crack initiation.

Figure 3. Radial Scratches on Transparencies

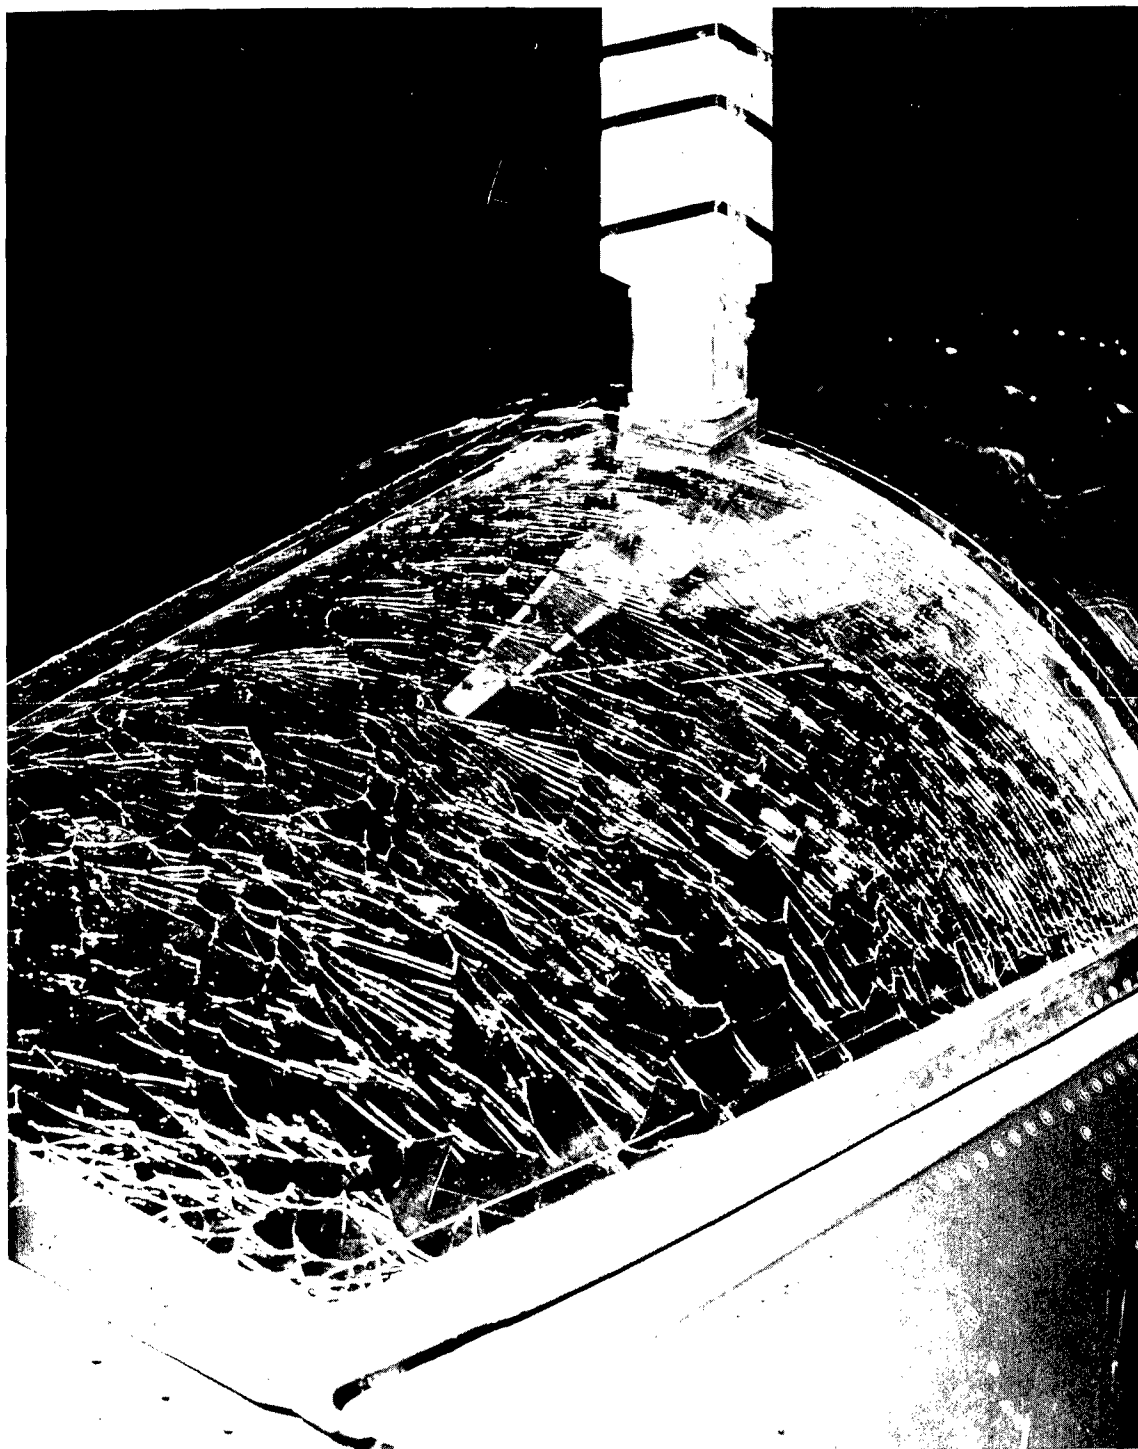
The left windshield failed in the blunt object impact test when struck by a fifty pound weight from a free-fall height of 16.5 feet. The internal pressure of the module was kept at ambient. The failure is shown in Figure 18, with the striker block still in the test position.

Figure 18. Blunt Object Impact Test Failure

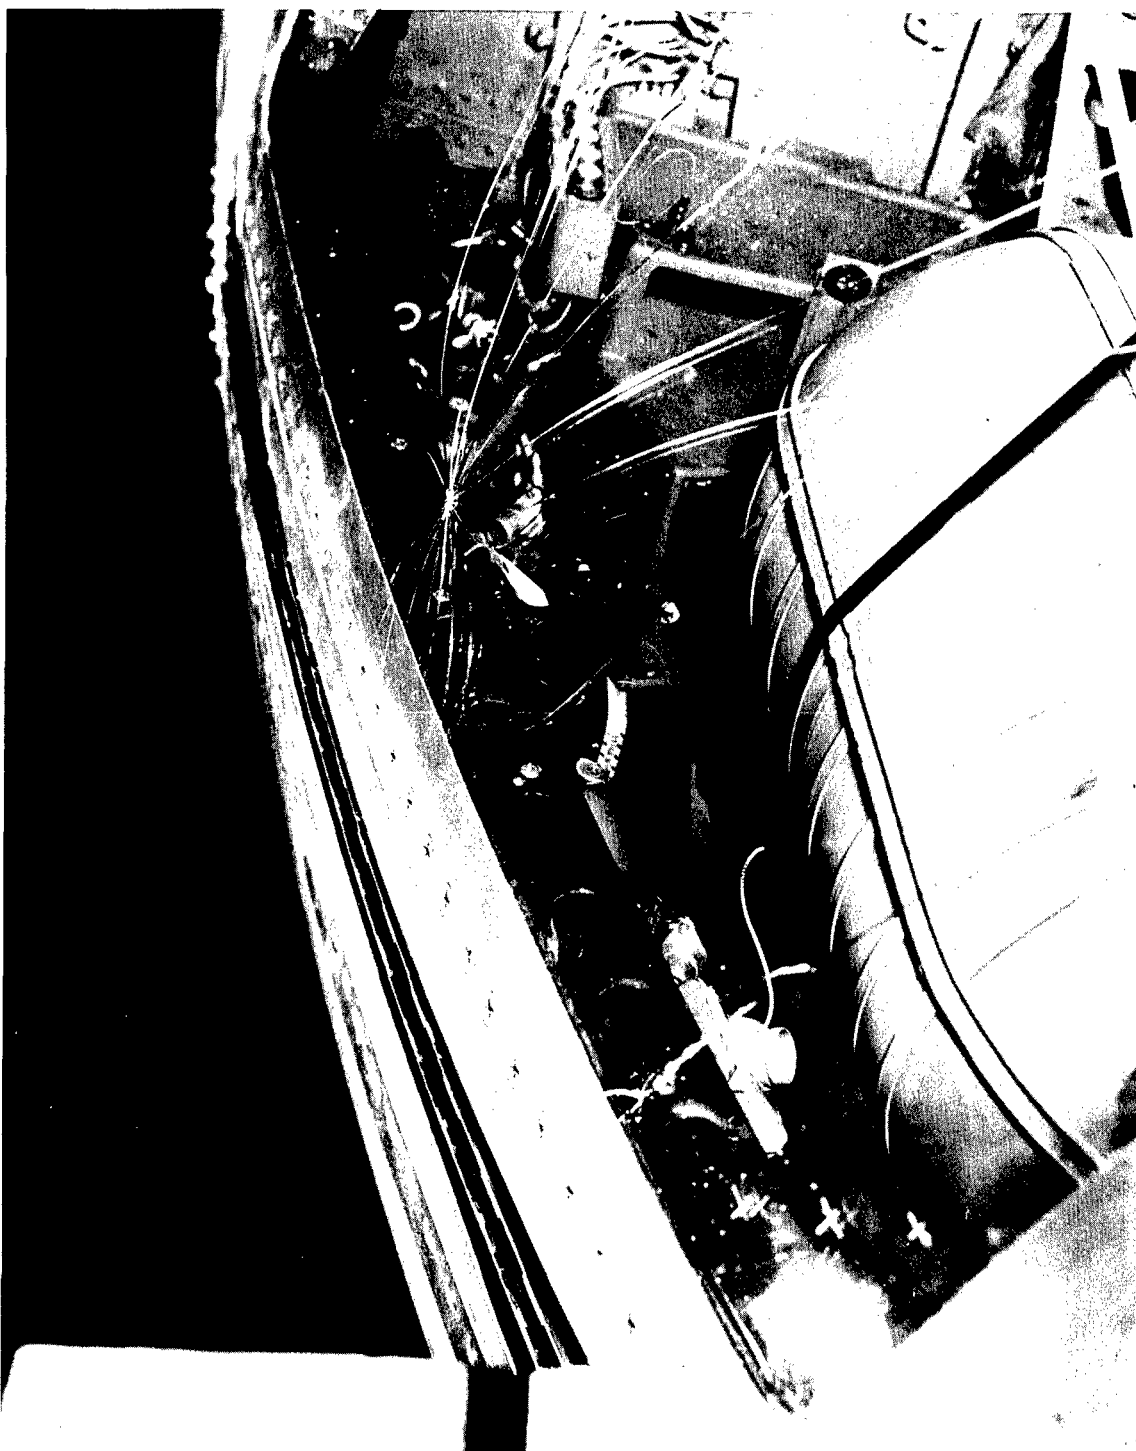
The left canopy failed when struck by a 1 pound 6-1/2 ounce plumb bob from a height of 6 inches in the sharp object impact test. This failure is shown in Figure 19. The internal pressure was kept at ambient.

Figure 19. Sharp Object Impact Test Failure

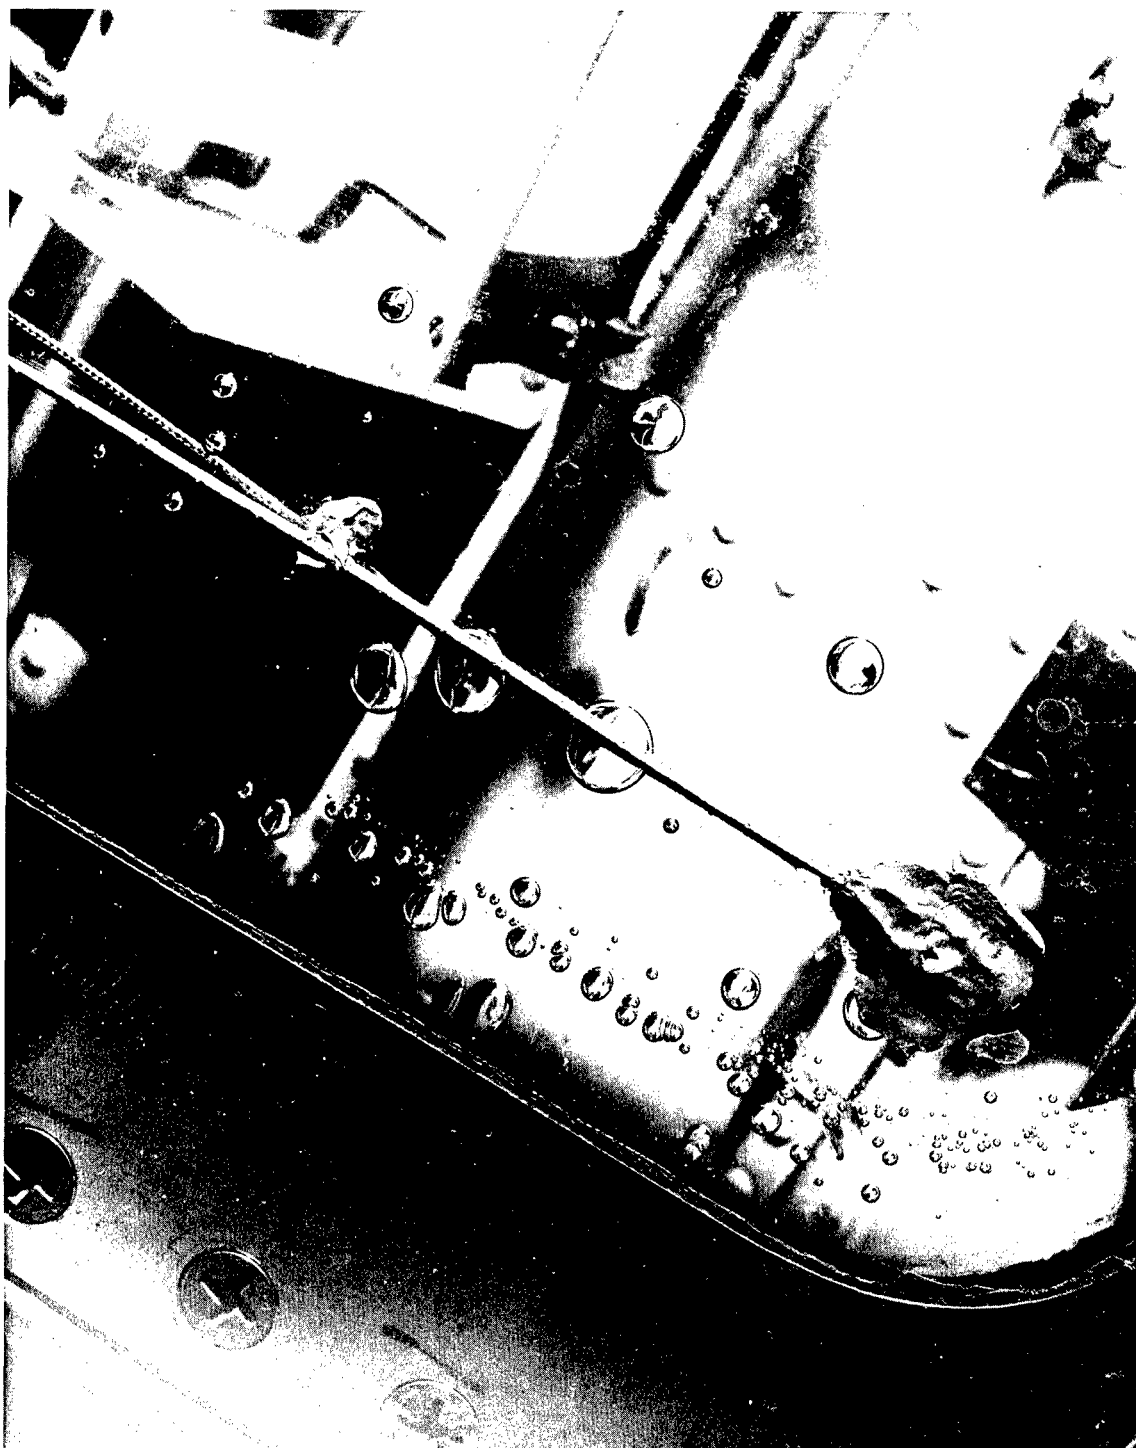
At the end of one lifetime of simulated usage the only damage noted, besides the continued chipping of the failed outer laminate of the left canopy, were bubbles forming in the interlayer at the forward end of both right and left windshields. The bubbles are shown in Figure 20.

Figure 20. Bubbles in the Interlayer at the End of One Lifetime of Testing

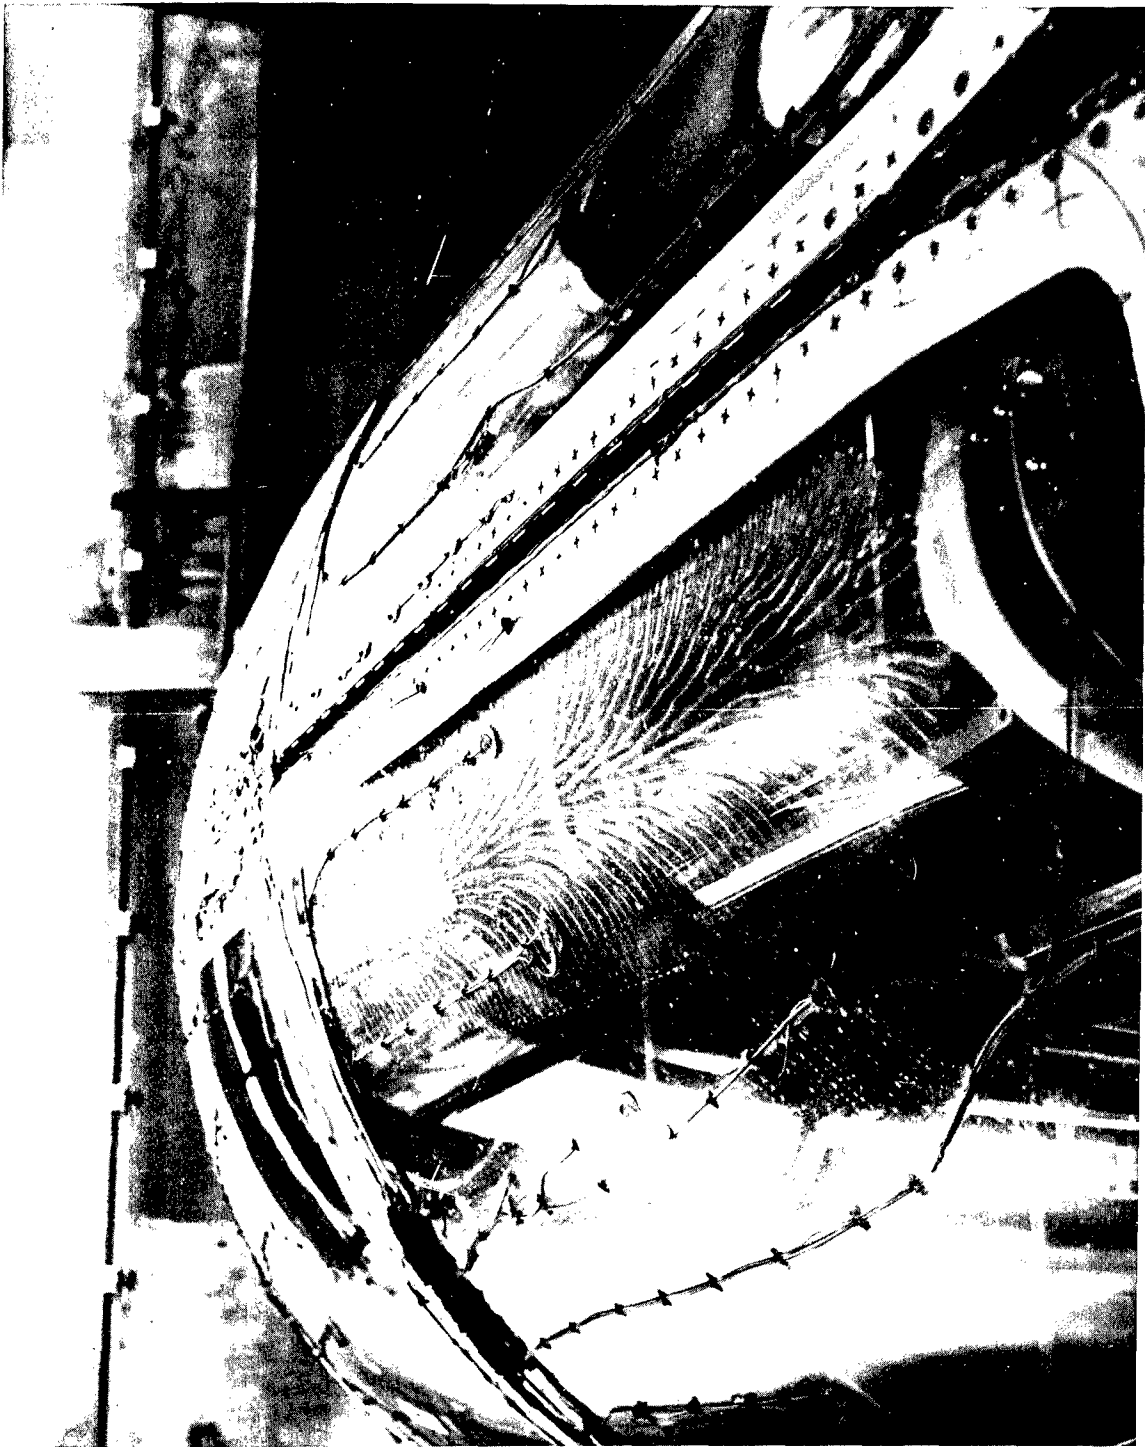
At the end of the third lifetime (12000 hours) a large leaf-like delamination had appeared in the interlayer of the right windshield. This delamination is shown in Figure 21. A section of the outer laminate of the left canopy had fallen out exposing the C.I.P. (Figure 22).

Figure 21. Leaf Shaped Delamination of the Right Windshield Interlayer at the End of the Third Lifetime of Testing

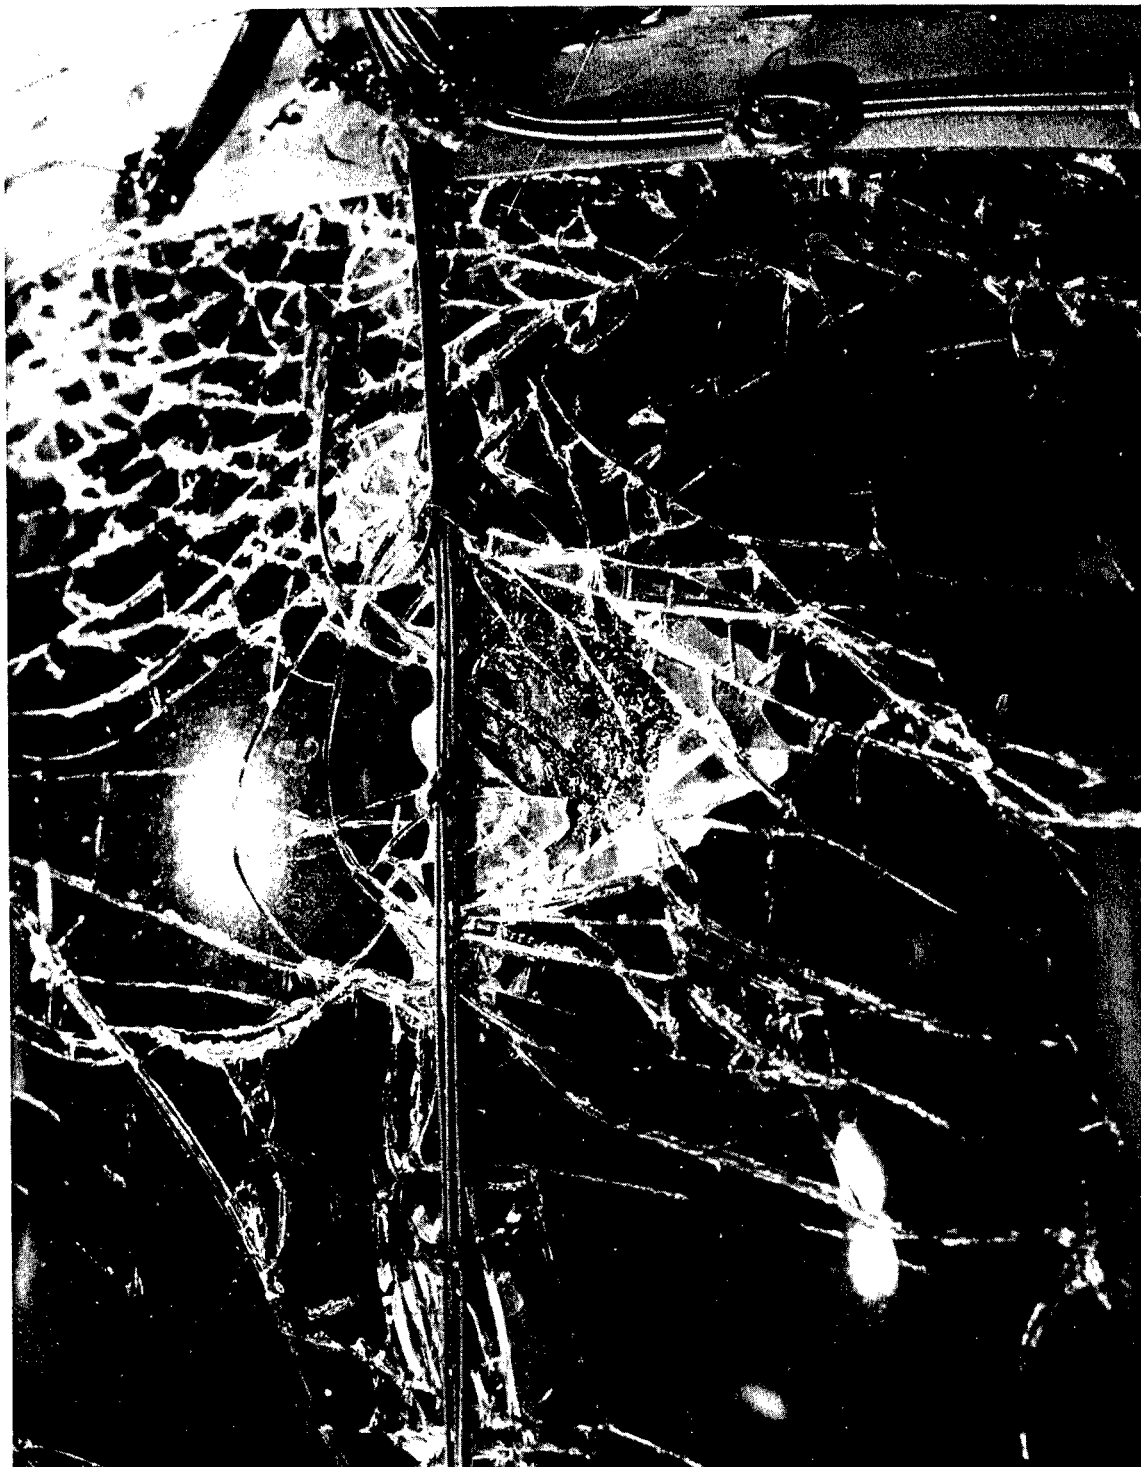
Figure 22. Exposed Cast-In-Place Interlayer of the Left Canopy  
at the End of Three Lifetimes of Testing

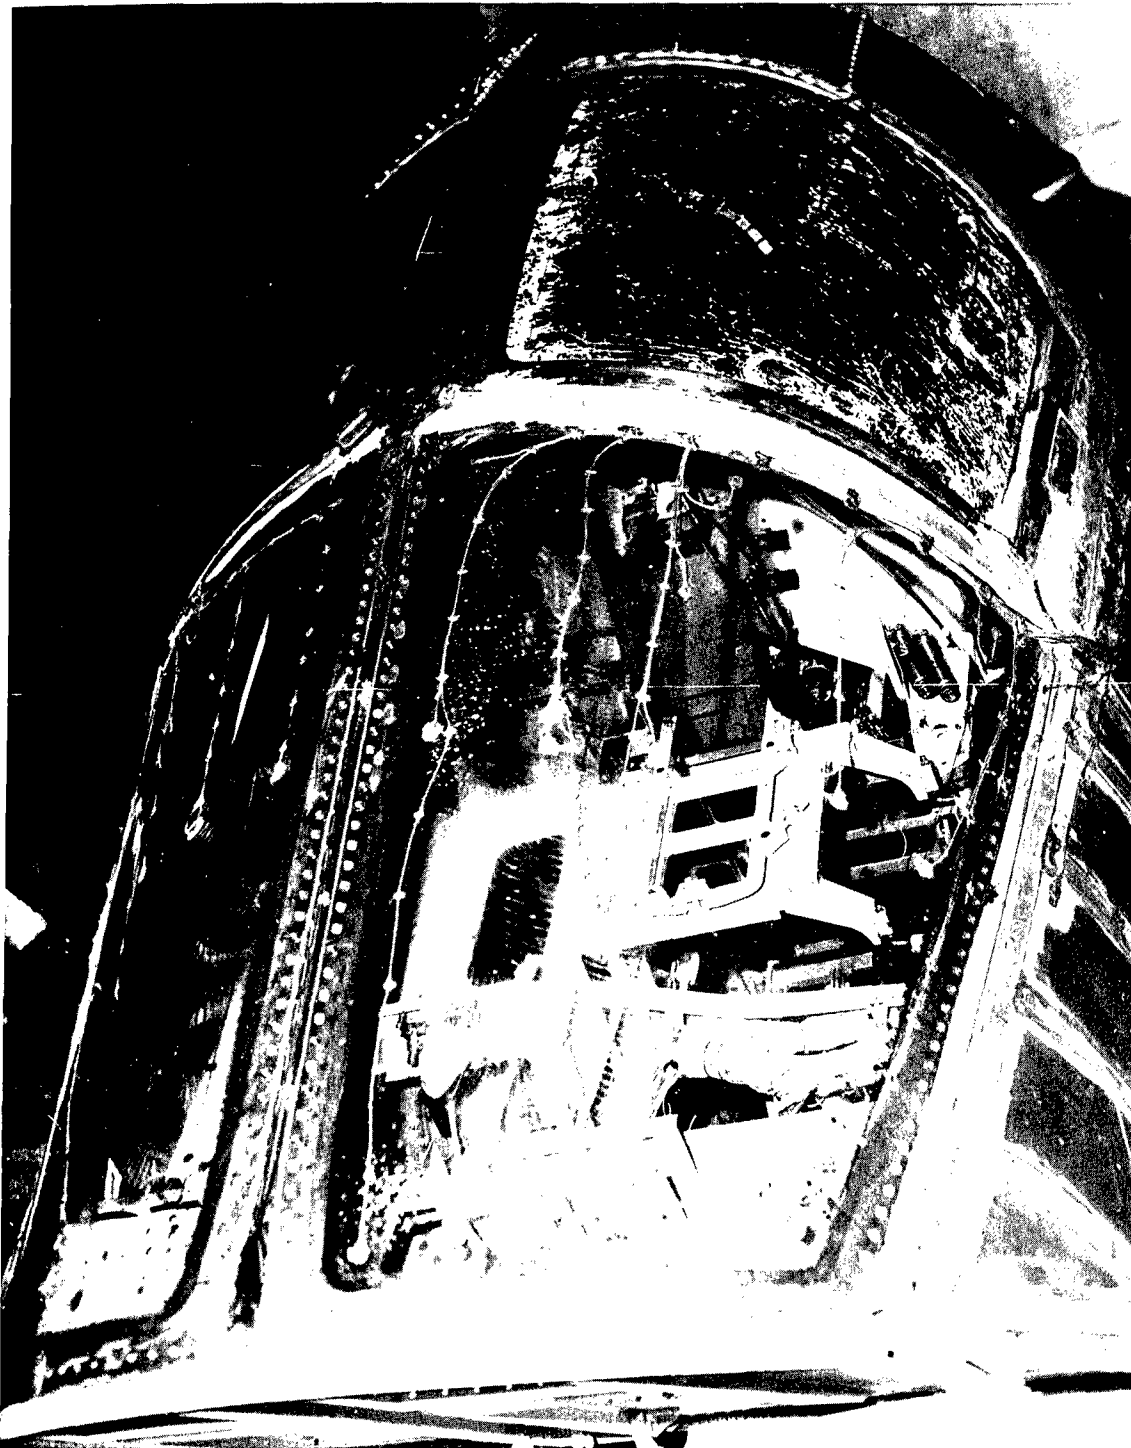
At the end of the fourth lifetime (16000 hours) a leaf-like delamination had appeared in the left windshield (Figure 23) and a second one started in the right windshield. Although the optical qualities were very much deteriorated the transparencies were still structurally sound. It should be noted however, that no attempt was made in this program to measure the optical properties of the transparencies.

Figure 23. Leaf Shaped Delamination in the Interlayers of Both Windshields at the End of Four Lifetimes

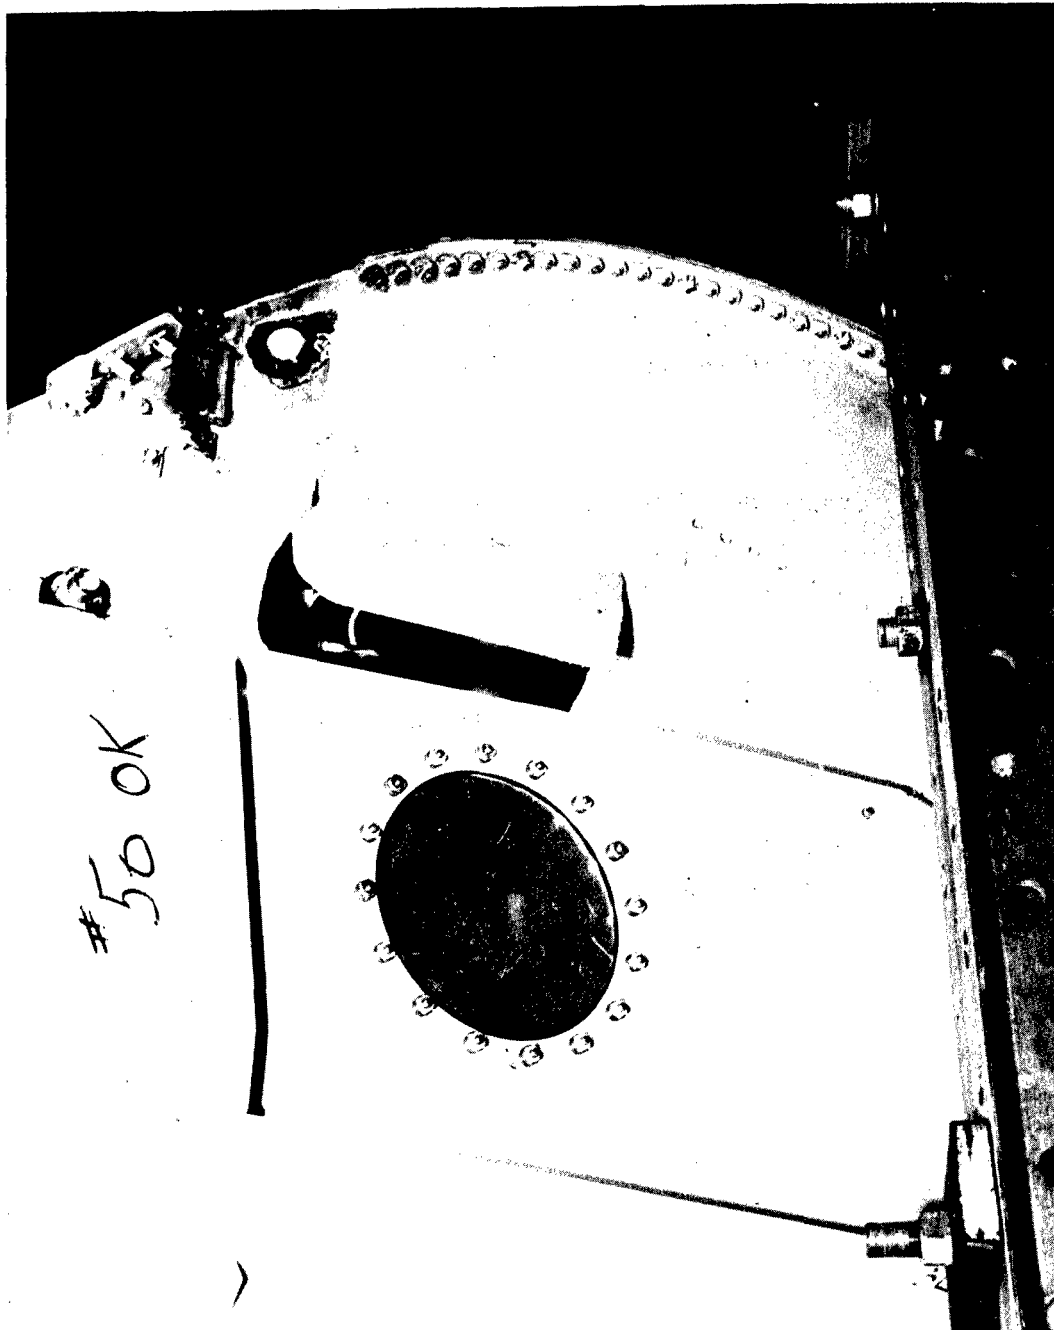
A static pressure test for both positive and negative pressure was conducted to determine the residual strength after the fatigue test. The escape module was pumped down to -13.5 psig (the limit of the test system) and returned to ambient pressure. The module was then tested hydrostatically to +20 psig, at which point the forward bulkhead failed. This is shown in Figure 31.

Figure 31. Hydrostatic Failure of the Forward Bulkhead of the Crew Module
