1. Report No. USCG-16732/71895	2. Government Accession No.	3. Recipient's Catalog No. 11	
4. Title and Subtitle Marine Board Casualty Report SS SANSINENA (Liberian); Explosion and Fire in Los Angeles Harbor, California on 17 December 1976 with loss of life.		5. Report Date 25 Nov 1977

16. Abstract - On 17 December 1976 the Liberian tanker SANSINENA, moored at berth 46, Union Oil Terminal, Los Angeles Harbor, California, exploded and burned while taking on ballast and bunkers. The casualty resulted in six members of the SANSINENA's crew known dead, and 22 injured. Two crewmembers and one terminal security guard are missing and presumed dead. Also approximately 36 personal injuries were suffered by the general public.		13. Type of Report and Period Covered MARINE CASUALTY REPORT, 17 December 1976	
This report contains the U. S. Coast Guard Marine Board of Investigation report and the Action taken by the Commandant to determine the probable cause of the casualty and the recommendations to prevent recurrence.		14. Sponsoring Agency Code	
The Commandant concurred with the Marine Board that the probable cause of the casualty was the ignition of a hydrocarbon vapor cloud over the afterde

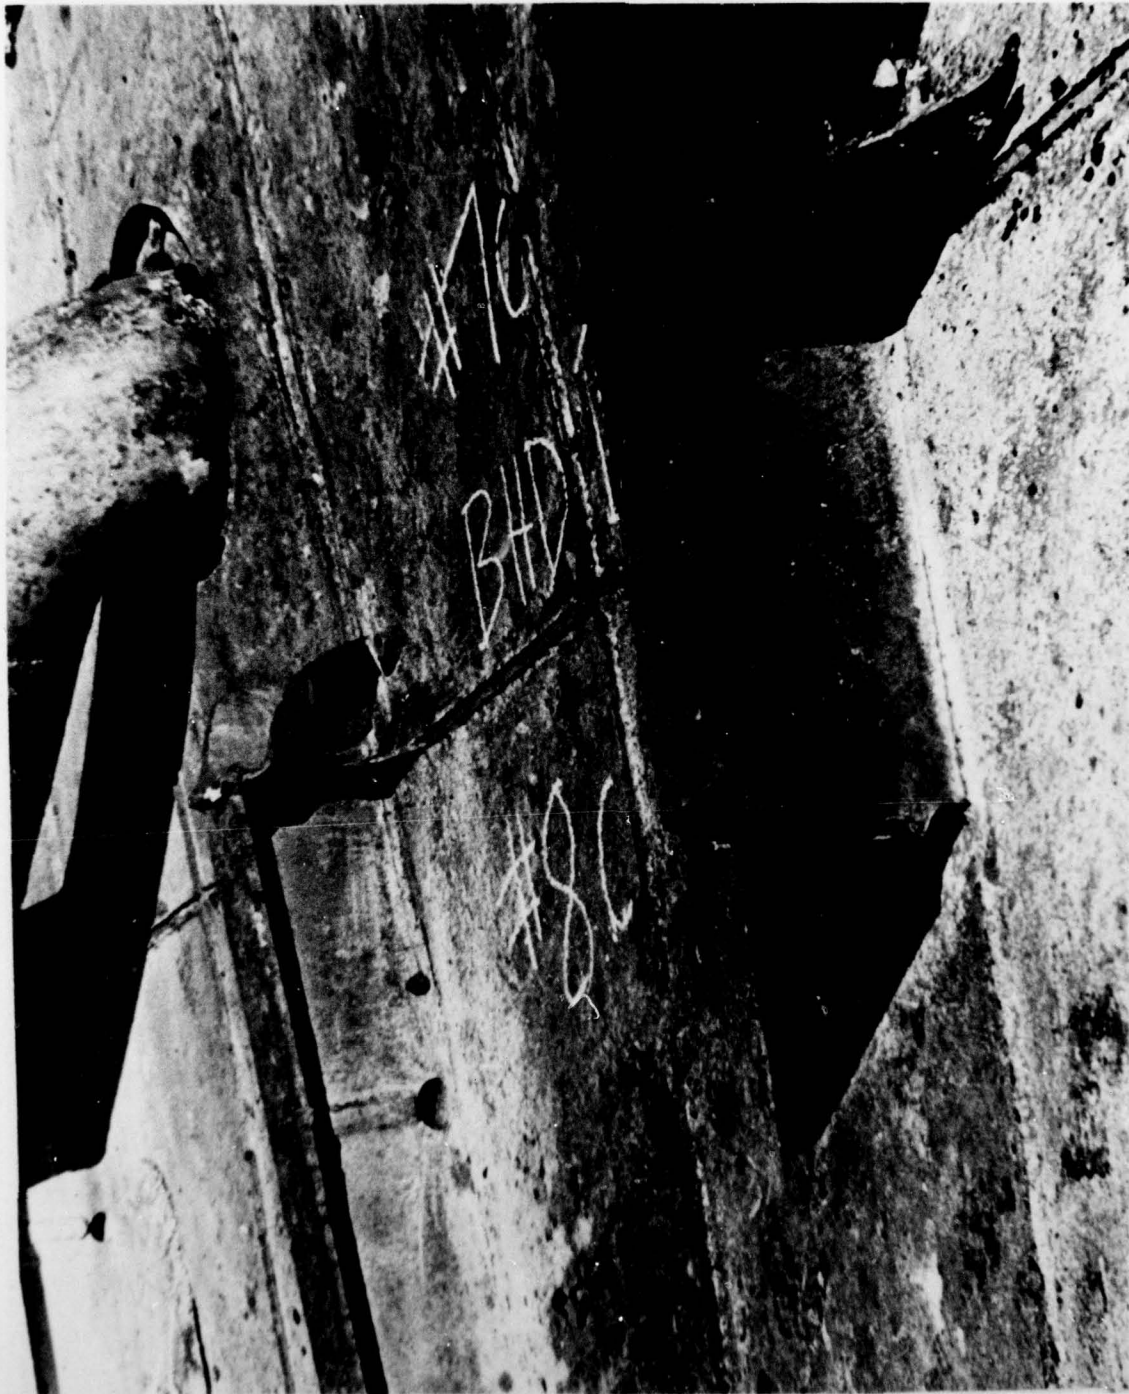
tank were bent forward, all abaft #10 tank were bent aft. (Figure 5.) There were no bits of the #10 longitudinal bulkheads left attached. However, a close examination of the broken continuous fillet welds along those bulkhead lines revealed that on the outboard sides the remaining welds were lower on average and were beveled outward from the bulkhead's former position, while the opposite broken fillets were higher and were slightly "hooked" toward where the bulkhead had been. (Figure 6 typical.) The bulkhead fragments indicated clearly the direction of bulkhead displacement. There were consistent findings that the beveled fillets were on the side toward which the bulkhead fragments were bent, with the slightly "hooked" edge higher on the opposite fillets.

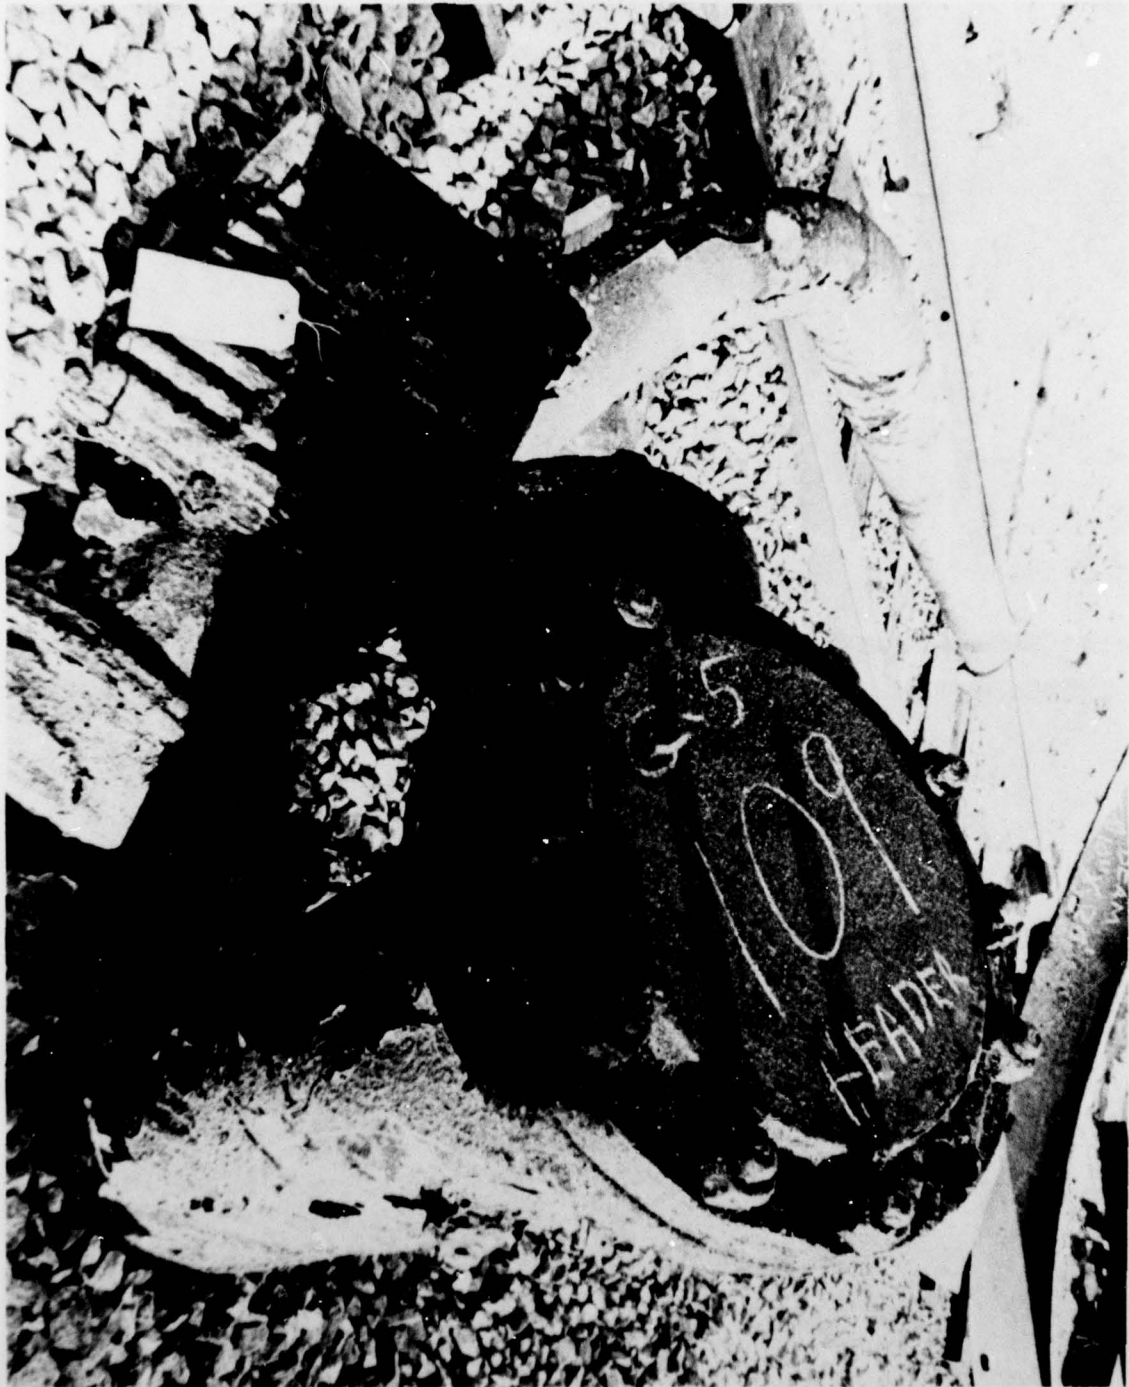
The integrity of the cargo vent system was compromised by numerous wastage holes on the underside of the cargo vent piping, a missing washout nipple cap, and a missing drain plug. The lack of integrity in the cargo vent piping further negated the dissipating effect of the weather head vent stacks at the top of the kingposts and contributed to the accumulation of hydrocarbon vapors on deck in the cargo tank area. The inspection procedures of the cargo vent system by the shipboard personnel, classification society inspectors, inspectors for the Government of Liberia, and company inspectors were inadequate to detect the relatively extensive deterioration that existed on the underside sections of the cargo vent piping. Furthermore, this lack of integrity allowed the vent piping to serve as a path of transmission for a flame to enter the cargo tanks.

d. Examination of pieces of the cargo tank vent piping, including the branch lines and the common header revealed numerous areas of localized wastage. Several pieces were found with holes wasted through on their undersides. (See figures 7 through 8 for examples.) Examination of the area surrounding these holes revealed that the holes were primarily the result of internal corrosion. Much of this piping had a very heavy buildup of exterior paint, as much as 1/8-inch thickness in places. Various samples of the cargo vent piping and a typical P/V valve were analyzed by the Aerospace Corporation in an effort to characterize the corrosion behavior. Generally, uniform corrosion of the bottom portion of the vent piping was noted to be at least twice and at some places up to four times the normally expected corrosion rate for galvanized steel in a marine environment. Further, localized deeper pits and holes in the vent header pipes in the vicinity of P/V valve connections were attributed to either galvanic action between the steel pipes and copper products from the P/V valves or action of a hydrochloric acid solution in areas of initial breakdown of the protective zinc coating. The analysis also concluded that the corrosion holes studied were covered by a thick external paint coating prior to the explosion.

6. The recommendation that every cargo venting system at an age of 10 years be surveyed to determine its material condition, including the removal of all P/V valves and audiogauging of the underside of the piping directly under the P/V valves is concurred with in part. The Merchant Marine Technical Division will conduct a detailed physical and metallurgical examination on a representative number of tank vessels in various trades over the next 5 years to determine needed inspection intervals. In the interim the program of examining tanker venting systems, which was initiated as a result of this casualty, will be continued. Also, the scope and interval of examinations to be conducted aboard tankers is being thoroughly discussed at IMCO and a proposal will be presented at the Plenipotentiary Conference
