MISCELLANEOUS PAPER S-78-2

BANK DISTRESS OF LOW WATER WEIRS ON BIG CREEK, LA.

Soils and Pavements Laboratory
U. S. Army Engineer Waterways Experiment Station
P. O. Box 631, Vicksburg, Miss. 39180

February 1978
Final Report

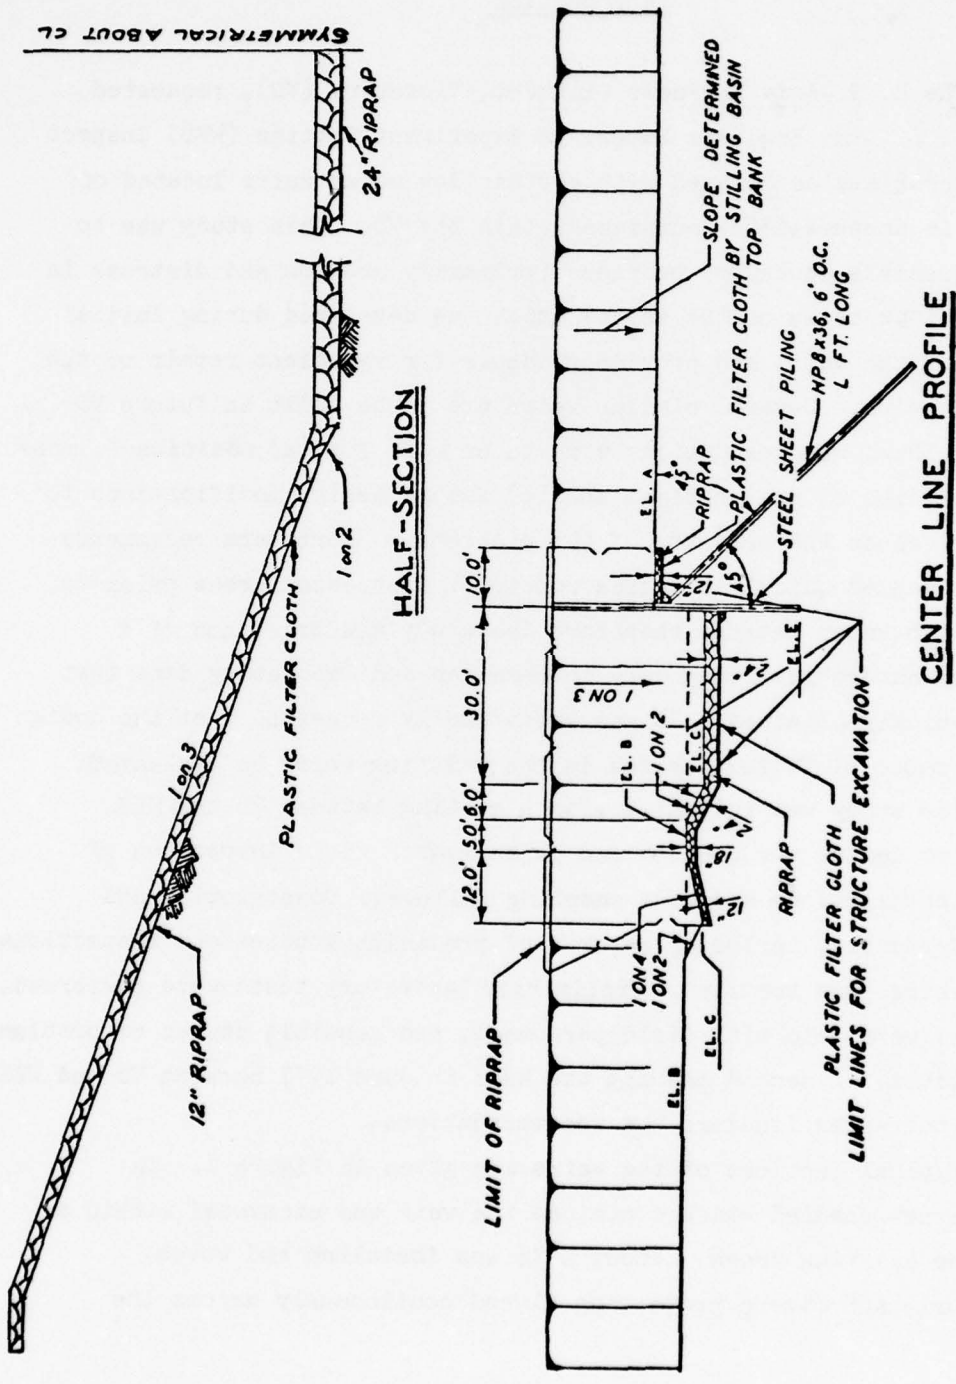
Figure 1. Typical weir cross sections

3. Typical sections of the weirs are given in Figure 1. In general, a new channel which contained the weir was excavated within a bend of the existing creek. Sheet pile was installed and woven filter fabric and riprap protection placed continuously across the

channel both upstream and downstream of the sheet pile. The riprap was placed directly on the fabric. It was evidently placed properly since no damage to the fabric was apparent during field inspection. The slope protection downstream of the sheet piling forms a stilling basin with an end sill. After the sheet pile and slope protection were installed, the excavation was connected with the creek and the old channel blocked to allow flow only through the weir.

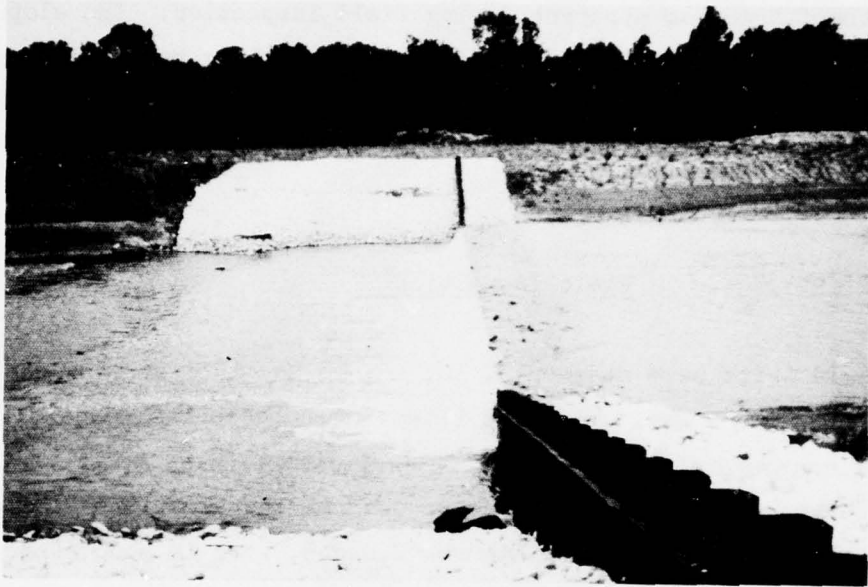
Figure 2. Item 30A weir

4. Field trips were made on 9, 10, and 18 May 1977 by personnel of the VD and WES. On 9 May, two weirs (Item 30A, Steele Bayou and Satartia weir) and a drainage structure (Little Sunflower Drainage Structure) were visited. The purpose of the trip was to observe installations similar to the Big Creek weirs. The weirs, Figures 2 and 3, were in good shape having only minor erosion in the adjoining unprotected bank areas. Both were in a clay soil, had been in operation for two or more years, and had the same general design as those on Big Creek. The drainage structure, Figure 4, had been built in a blocked channel and had not been put into operation. There has been no flow through the structure but water is ponded on each side in the associated blocked channels. The surrounding levee has been overtopped during floods. Slope protection on one side of the structure consisted of two different types of protection, side by side, extending from top of bank on one side across the channel bottom and to the top of bank on the opposite side. The protection nearest the structure was a granular filter on the natural soil overlain by riprap. The adjoining protection was a woven filter fabric overlain by an articulated concrete mattress. The concrete blocks of the latter section had experienced surface displacement and channels and voids were apparent beneath the concrete blocks and fabric. The area of granular filter and riprap protection exhibited no signs of distress. The soil inspected beneath and near the distressed section appeared to be a silty sand or sandy silt.

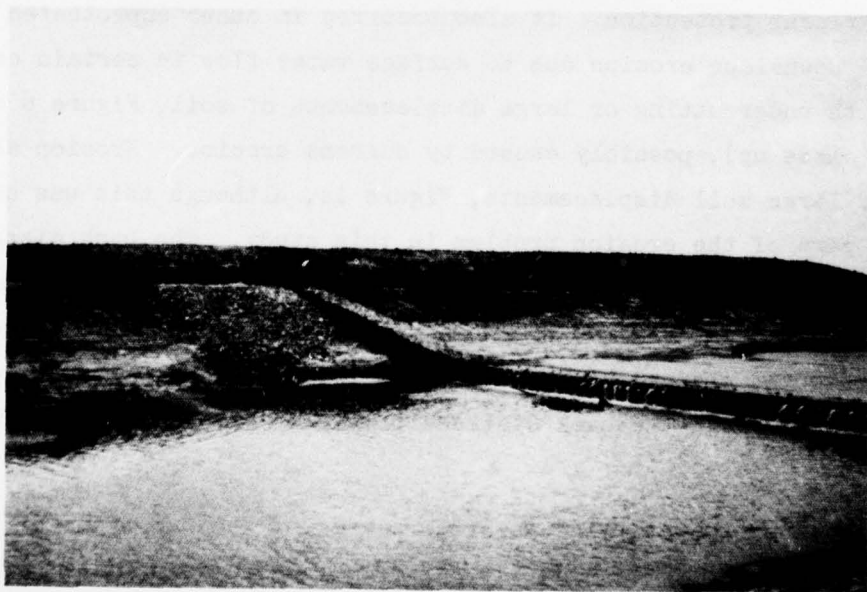
Figure 5. Reach 1 - Weir 1

divided into two reaches, Reach 1 containing two weirs, (Reach 1 - Weir 1 and Reach 1 - Weir 2), and Reach 2 containing four weirs numbered in the same manner. Figures 5 through 9 are general views of the weirs taken in May 1977.

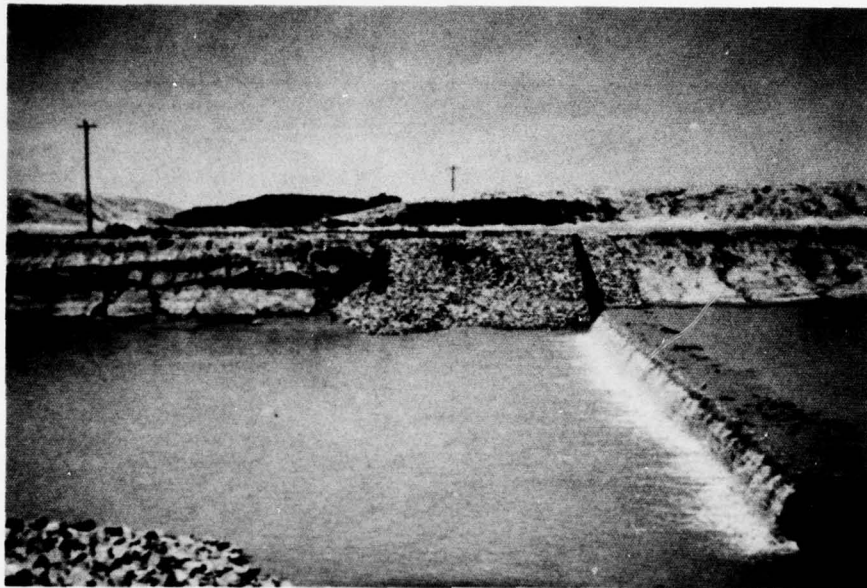
Figure 6. Reach 1 - Weir 2

12. Bank distress (riprap, fabric, and soil displacement) is evident in Figures 6, 8, and 16. Downslope bulges were visible in two cases: one, a bulge in the filter fabric near the water line on the right bank of Reach 2 - Weir 3, could be made to pump out muddy water by stepping on it, Figure 17; the second is shown in the outward displacement of riprap at the water line immediately downstream of the sheet pile on the right bank of Reach 1 - Weir 2, Figure 6. Possible explanations of the bank distress include:

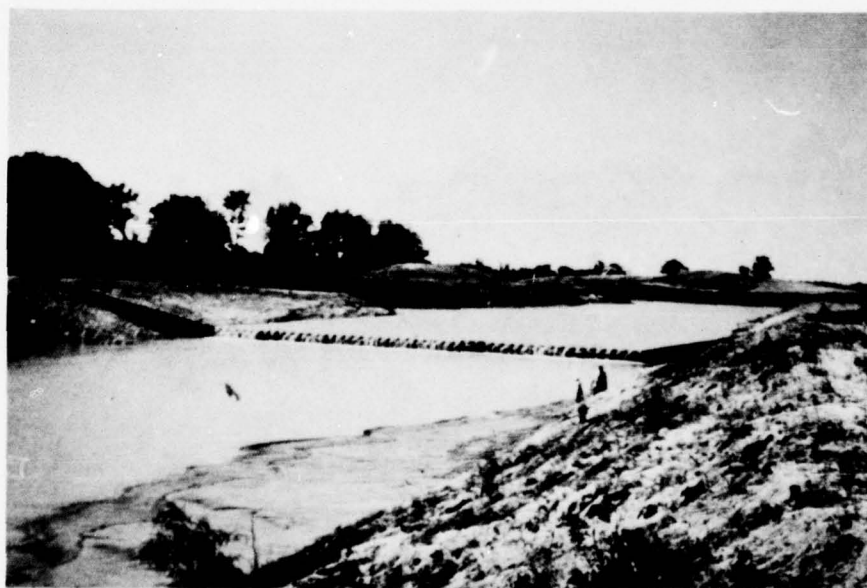
Figure 7. Reach 2 - Weir 1

Weir 2 of Reach 2 is not shown, but was in a generally good condition similar to Weir 1, Reach 2. The general condition of each weir is described in Table 1. The weirs were visited again on 18 May and soil samples were taken from locations listed in Table 2.

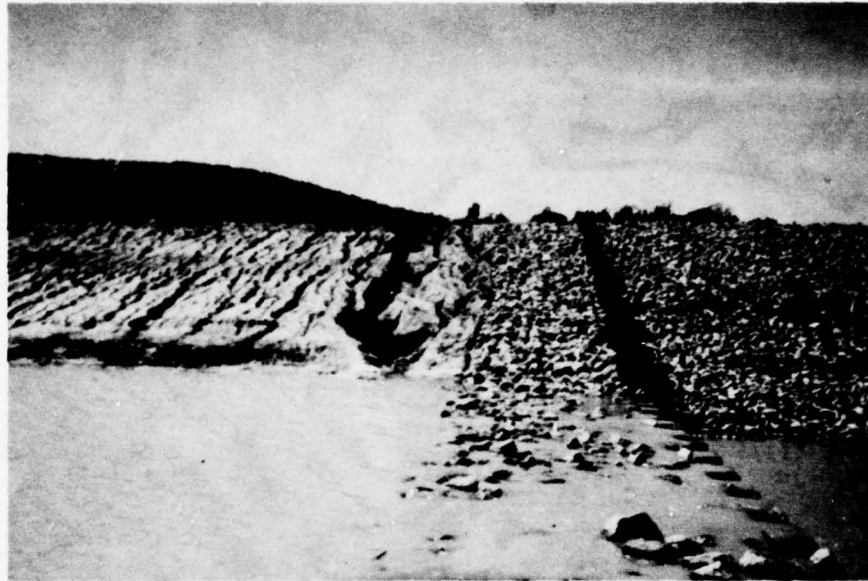
Figure 10. Erosion in unprotected bank
Reach 2 - Weir 3

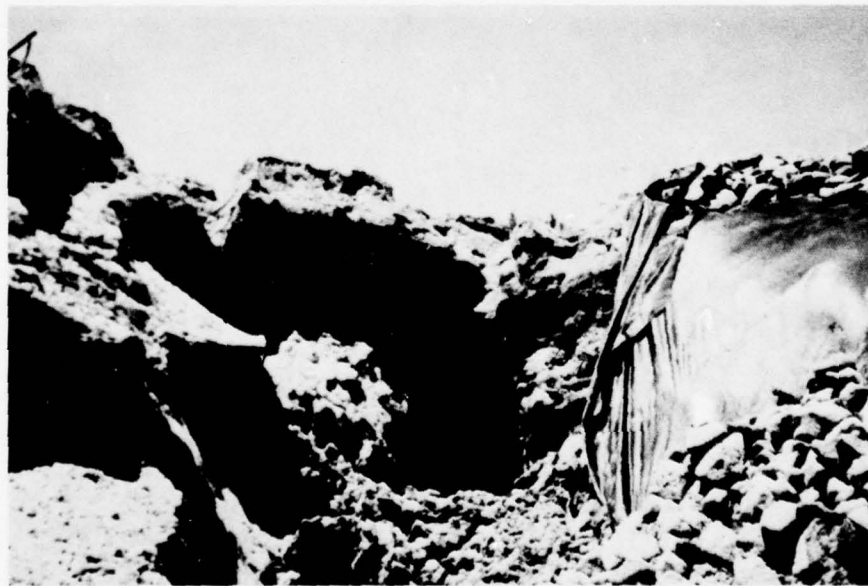
Figure 11. Edge of downstream riprap showing soil
and riprap loss Reach 1 - Weir 2

10. The erodibility of the soils was obvious from visual inspection at almost all the weirs. Soils common to this area include relatively fine silts and silty sands with little or no cohesion. The downstream edge of the slope protection is an area of concentrated erosion. The downstream end sill is carried across the bottom and up each side of the channel. The riprap and filter cloth slope protection terminate at the downstream toe of the end sill. This produces a "vee" or "trough" up the channel bank, one side having slope protection and the other side none, Figure 13. In the more erodible soils, this configuration would tend to accelerate erosion if surface runoff has access to the vee. These soils would also be more susceptible to undercutting and current erosion in the unprotected bank just downstream of the fabric and riprap. This logically would progress back to and under the fabric and riprap. This has apparently happened at several of the weirs. The erosion has removed soil from beneath the downstream

edge of the filter fabric, causing displacement of the fabric and subsequent displacement and loss of riprap, Figure 11.

- 19. To alleviate the erosion problem, it is recommended that:
 - a. The "vee" shaped area extending up the bank at the downstream edge of the riprap should have protection (filter fabric and riprap) on both sides. This could be accomplished by extending slope protection another 5 to 10 ft downstream.
 - b. Surface water should be routed away from the channel banks in the area of the weir and its slope protection including a short distance upstream and downstream of slope protection. This could be accomplished by a slight slope away from the channel and/or a small protective berm just back of the top of bank.
 - c. Conventional erosion protection measures (soil stabilization with vegetation, lime, soil cement, etc.) could be used just upstream and downstream of the weir on the unprotected slopes.

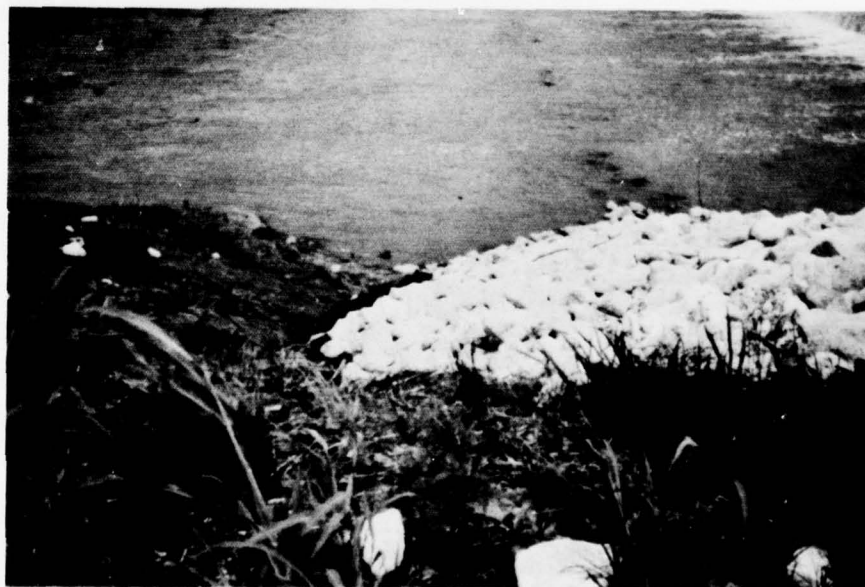
Figure 13. View of "vee" at downstream edge of riprap. End sill is visible just at water surface across channel

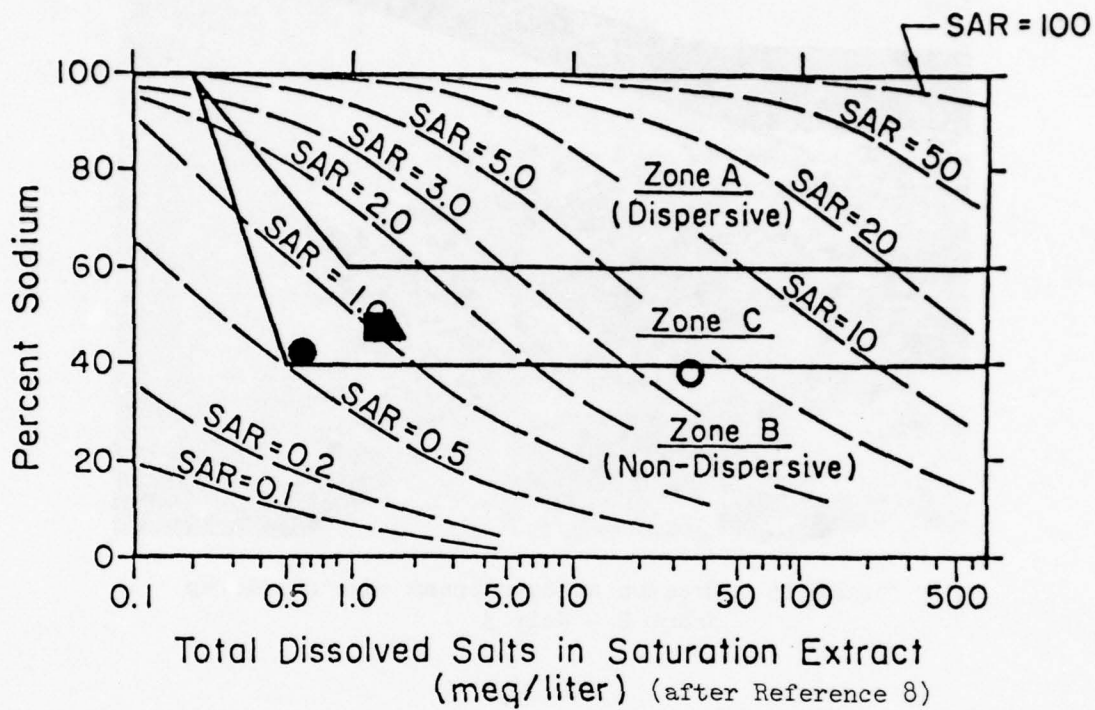
11. Laboratory soil chemistry tests were performed on soil pore water samples from each of the Big Creek weirs to determine if the soils tended to be dispersive, Appendix A. Dispersive soils are defined as highly erodible fine-grained soils.⁸ Results are plotted on the graph, Figure 14 taken from reference 8. Most of the samples were located in Zone C (neither definitely dispersive or nondispersive). Samples from Reach 2 - Weir 2 and Reach 2 - Weir 3 are not plotted since they are nonplastic and therefore should not contain sufficient colloids to support dispersive erosion. However, such soils are known to have low resistance to erosion.⁹ Figure 15 shows some of the major erosion with resulting loss of riprap along the downstream edge of Reach 2 - Weir 3. The sample from Reach 1 - Weir 1 (which had only experienced minimal erosion), plotted in Zone B (nondispersive). Further definition of the dispersiveness of soils is possible by performing a pinhole test.⁹ This test was not performed during this preliminary study.

Figure 14. Relationship between dispersion and soil pore water chemistry based on pinhole erosion tests and experience with erosion in nature (Reference 8)

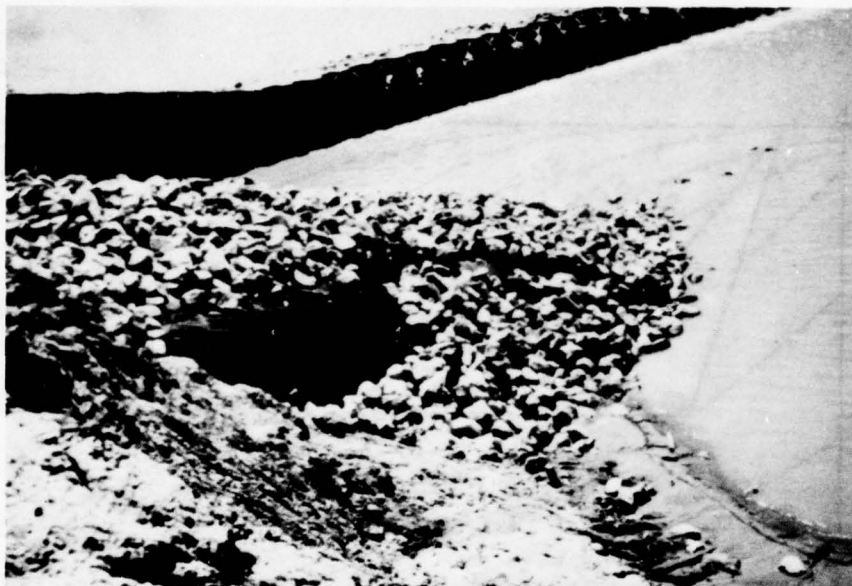
Figure 15. Erosion at downstream edge of riprap
Reach 2 - Weir 3

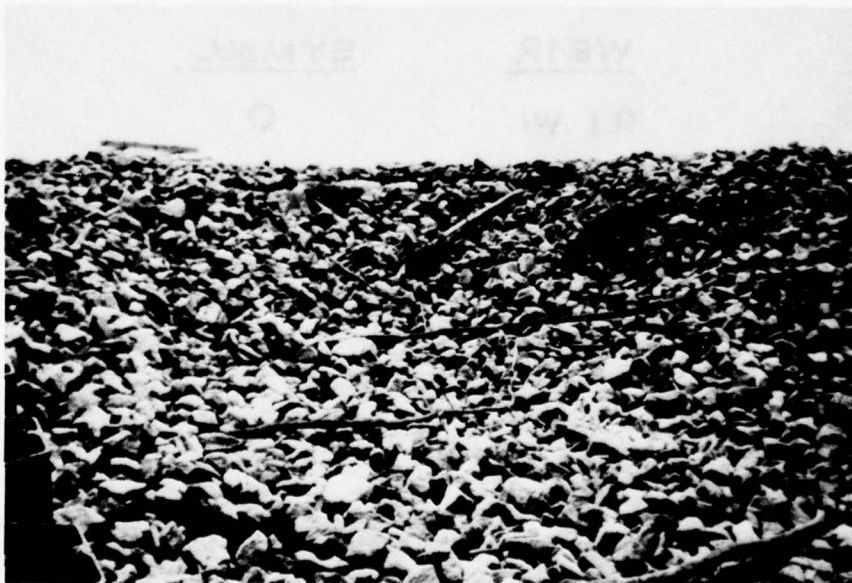
Figure 16. Bank distress at Reach 1 - Weir 2

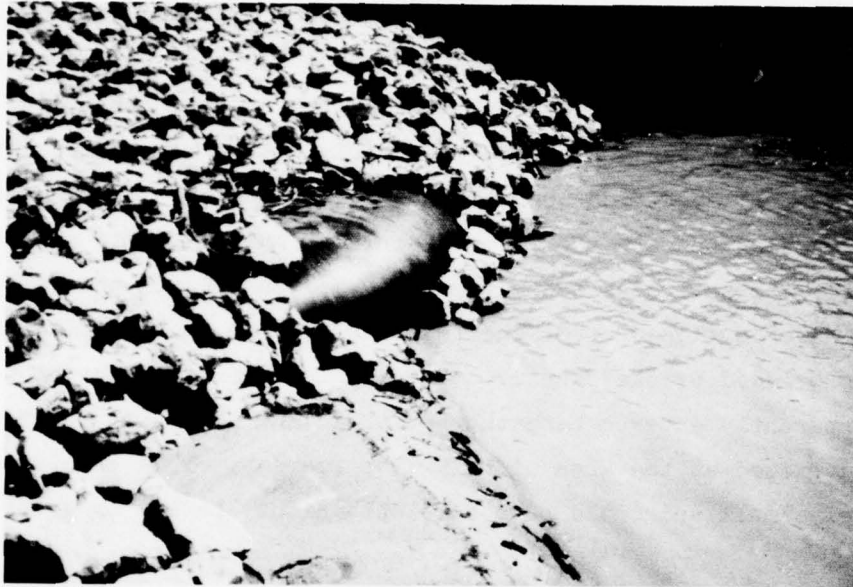
Figure 17. Bulging of filter fabric Reach 2 - Weir 3

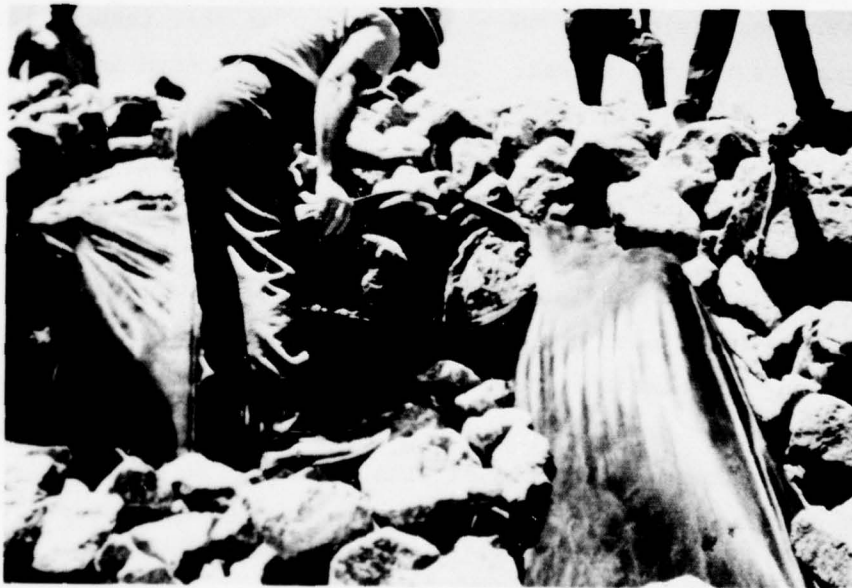
Figure 18. Erosion beneath cloth possibly prior to soil displacement Reach 1 - Weir 2
