AFML-TR-77-112

**INFLUENCE OF SUBSURFACE DEFECTS ON FATIGUE  
PROPERTIES OF TITANIUM ALLOYS**

UNITED TECHNOLOGIES CORPORATION  
Pratt & Whitney Aircraft Group  
Government Products Division  
West Palm Beach, Florida 33402

Technical Report AFML-TR-77-112  
Final Technical Report for the Period 1 March 1975  
Through 1 March 1977

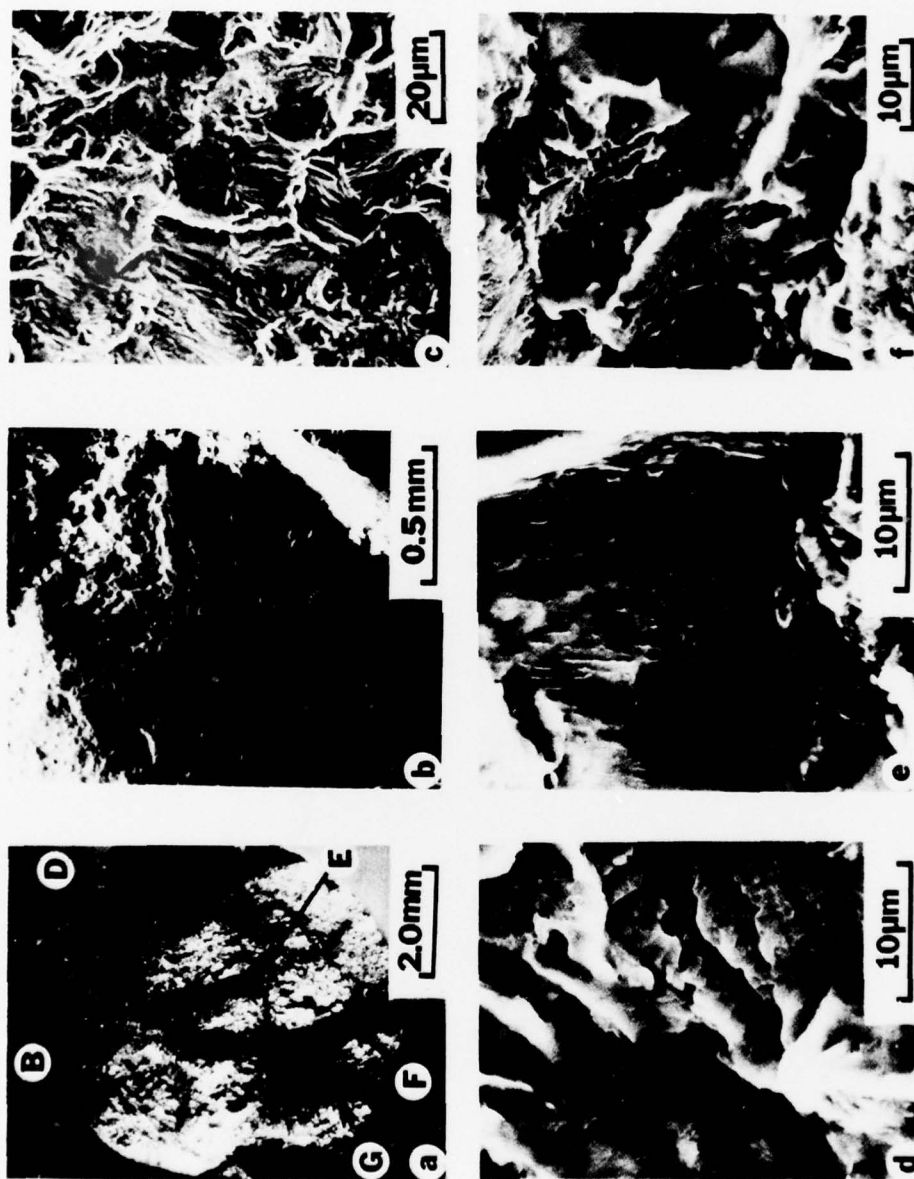
Figure 4 Scanning Electron Micrographs of the Fracture Surface of the Ti-6Al-4V Specimen No. 10 (Pore Only). The micro-structure is given in Figure 2(a). (a) General appearance of the entire fracture surface. Note the circumferential shear lip and the five subsurface nucleation sites B, D, E, F and G. Facet B is shown in greater detail in (b), while the typical striation observed at its periphery is illustrated in (c). The striations observed at the periphery of facet D is shown in (d), (e) and (f).

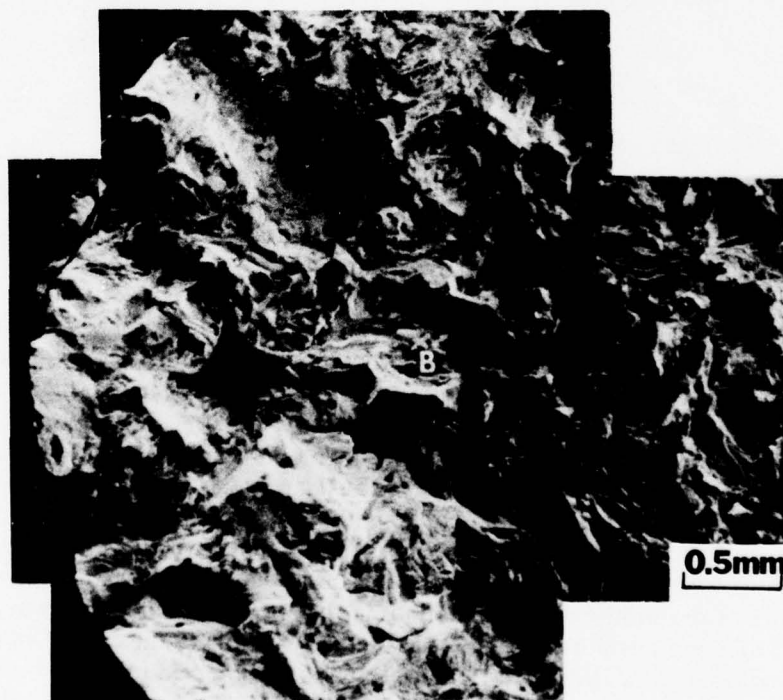
Figure 5 Scanning Electron Fractographs of Hydride-Seeded Ti-6Al-4V with Acicular Microstructure shown in Figure 2(b). (a) Subsurface fracture initiated at the seeded pore (partially exposed) indicated by an arrow. (b) Fracture initiated at the seeded pore near the surface. Striations observed on facets A and B are illustrated in Figure 6.

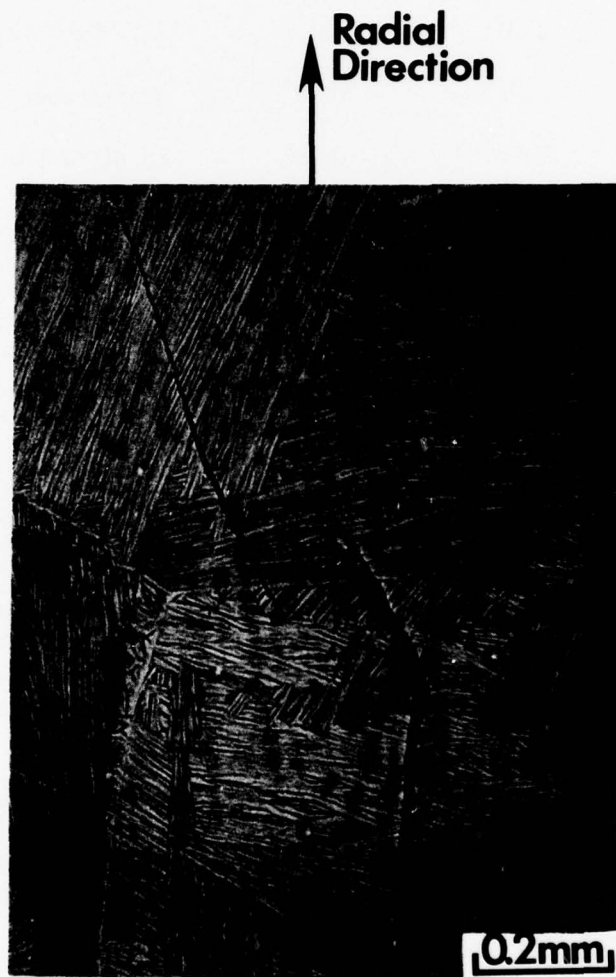
Figure 11 Microstructure and Cracks Observed at the Defect-Prone Area of the IMI 685 Forging Which had 62 Stress Cycles Before Retirement From Service

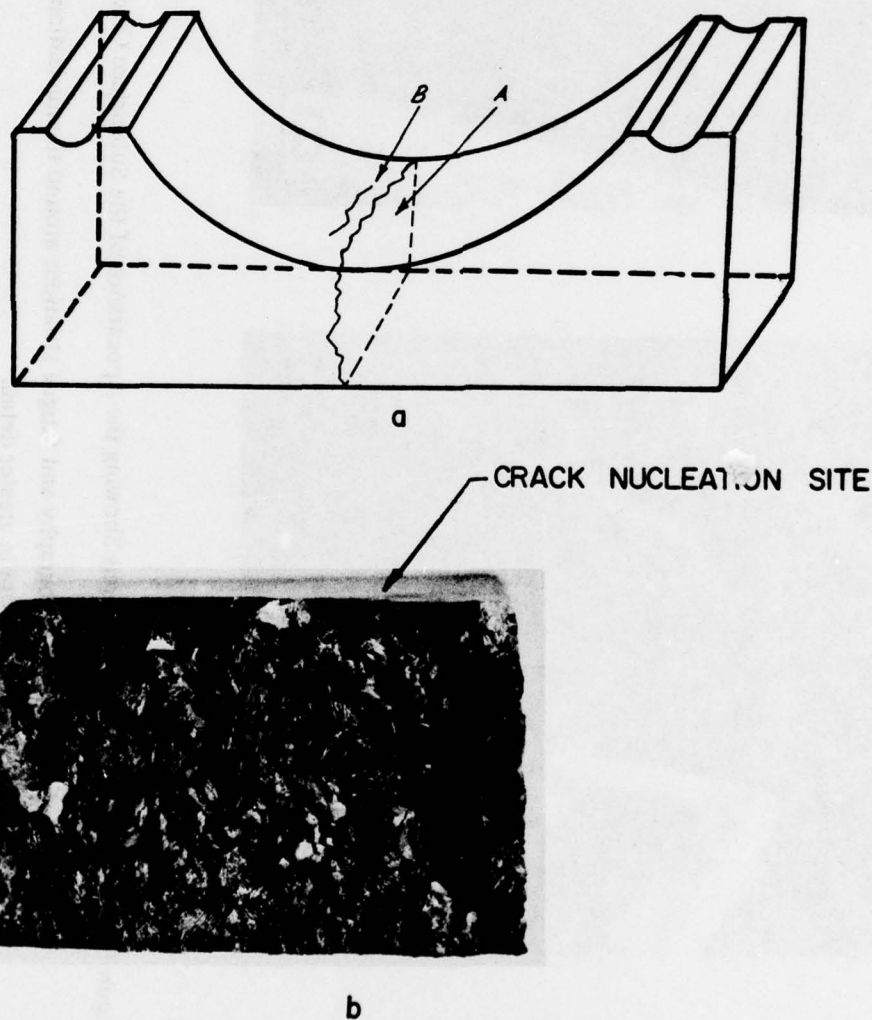
Optical examination of the surface of the bend specimen prior to testing revealed no surface cracks. Testing was performed by bending under a stress range of 0-95 ksi which was monitored by a strain gage. A rectangular wave form was used with a hold time of 10 minutes at maximum stress. In order to accelerate failure the stress was increased when a crack had formed which intersected the specimen surface. The specimen failed after 1840 cycles. Two cracks had formed during the test and their locations are indicated in Figure 14a. The general appearance of the fracture surface of the major crack is shown in Figure 14b which also indicates the general position of the fracture origin. Scanning electron fractography revealed that the crack origin was slightly subsurface as shown in Figure 15 which also illustrates the cleavage-like topography adjacent to the origin. No material discontinuities such as pores were formed at the initiation site. The second crack (B) was also exposed by sectioning and the fracture surface was found to be very similar to that of the major crack. Again no features typical of a rosette failure origin were found in this crack. These bend tests were an attempt to provide a rosette failure for analysis as quickly as possible. It is obvious that such specimens are not suitable for studying subsurface failures so all further testing was performed on specimens loaded in tension.

Figure 14 (a) Schematic Diagram Showing the Locations of Cracking in the IMI 685 Bend Specimen after LCF Testing and (b) Appearance of the Fracture at Location A

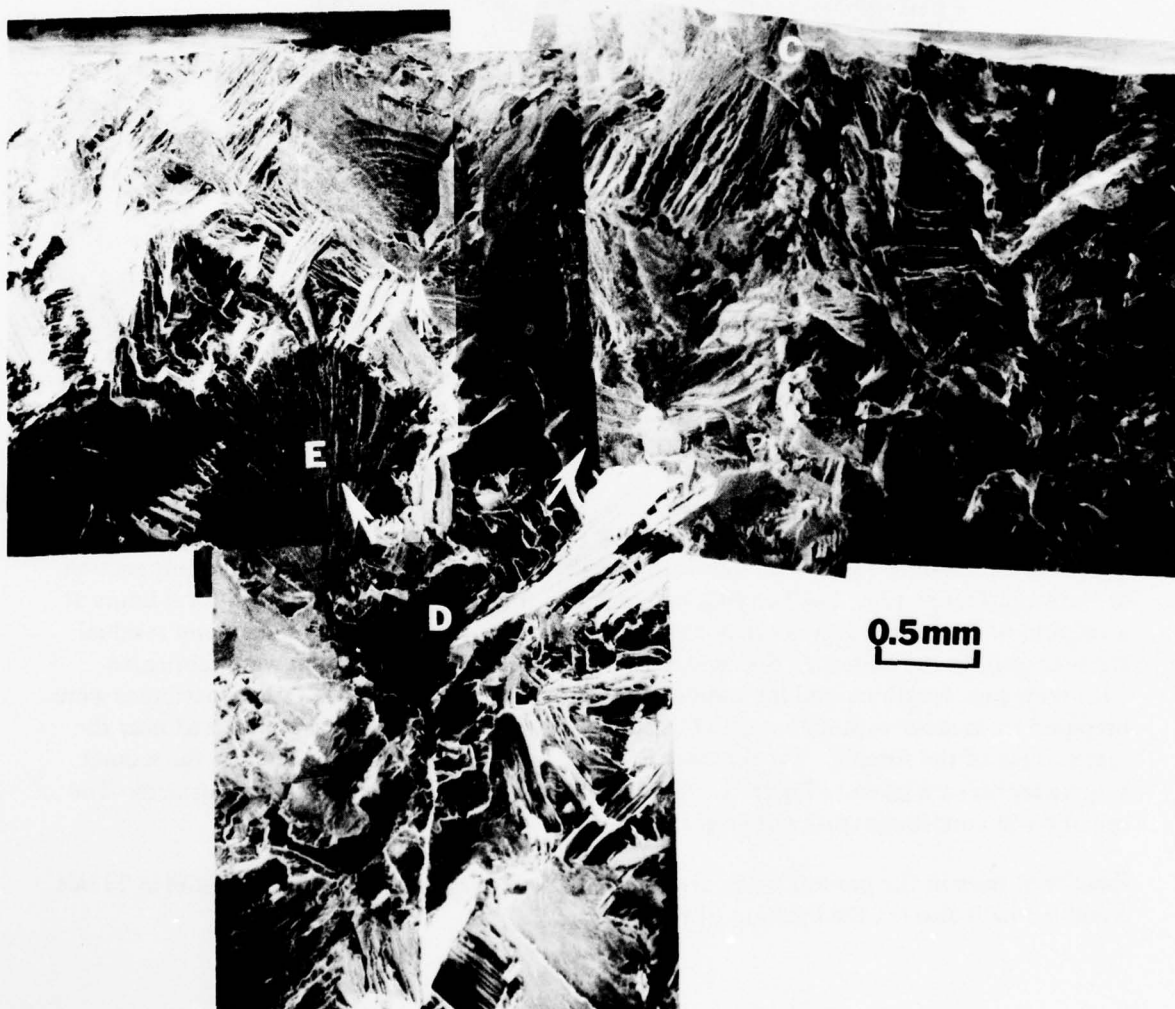
The LCF tension specimen (#2) was tested at a stress range of 5-100 ksi with a dwell of 10 minutes at maximum load, i.e., at a cyclic frequency of about 6 cycles per hour. Fracture occurred after 292 cycles. As will be shown this is obviously well below the fatigue capability of this alloy in a defect-free condition. Several cracks were observed on the surface of this specimen after machining and it was anticipated that these may have influenced the failure of the specimen. A careful comparison of the gage surface before and after fracture indicated that none of the pre-existing cracks had propagated. The fracture surface is shown in Figure 16 and again the general cleavage-like appearance is evident. The curvatures of "river markings" and the fatigue striations observed at the edge of region D and at regions E and C indicated that the fracture origin was located at region D. Small pores characteristics of the rosette origins were not observed although brittle-type striations were present in region D. As will be described later, this type of markings is typically observed near the origin of rosette failure. Although the major fraction of the fatigue surface was cleavage-like, isolated patches of striations were observed.

Figure 16 Scanning Electron Micrographs Illustrating the General Appearance of the Fracture Surface in the IMI 685 LCF Tension Specimen No. 2. Striations on regions C and E can be traced to an origin at region D. Arrows indicate directions of crack propagation.

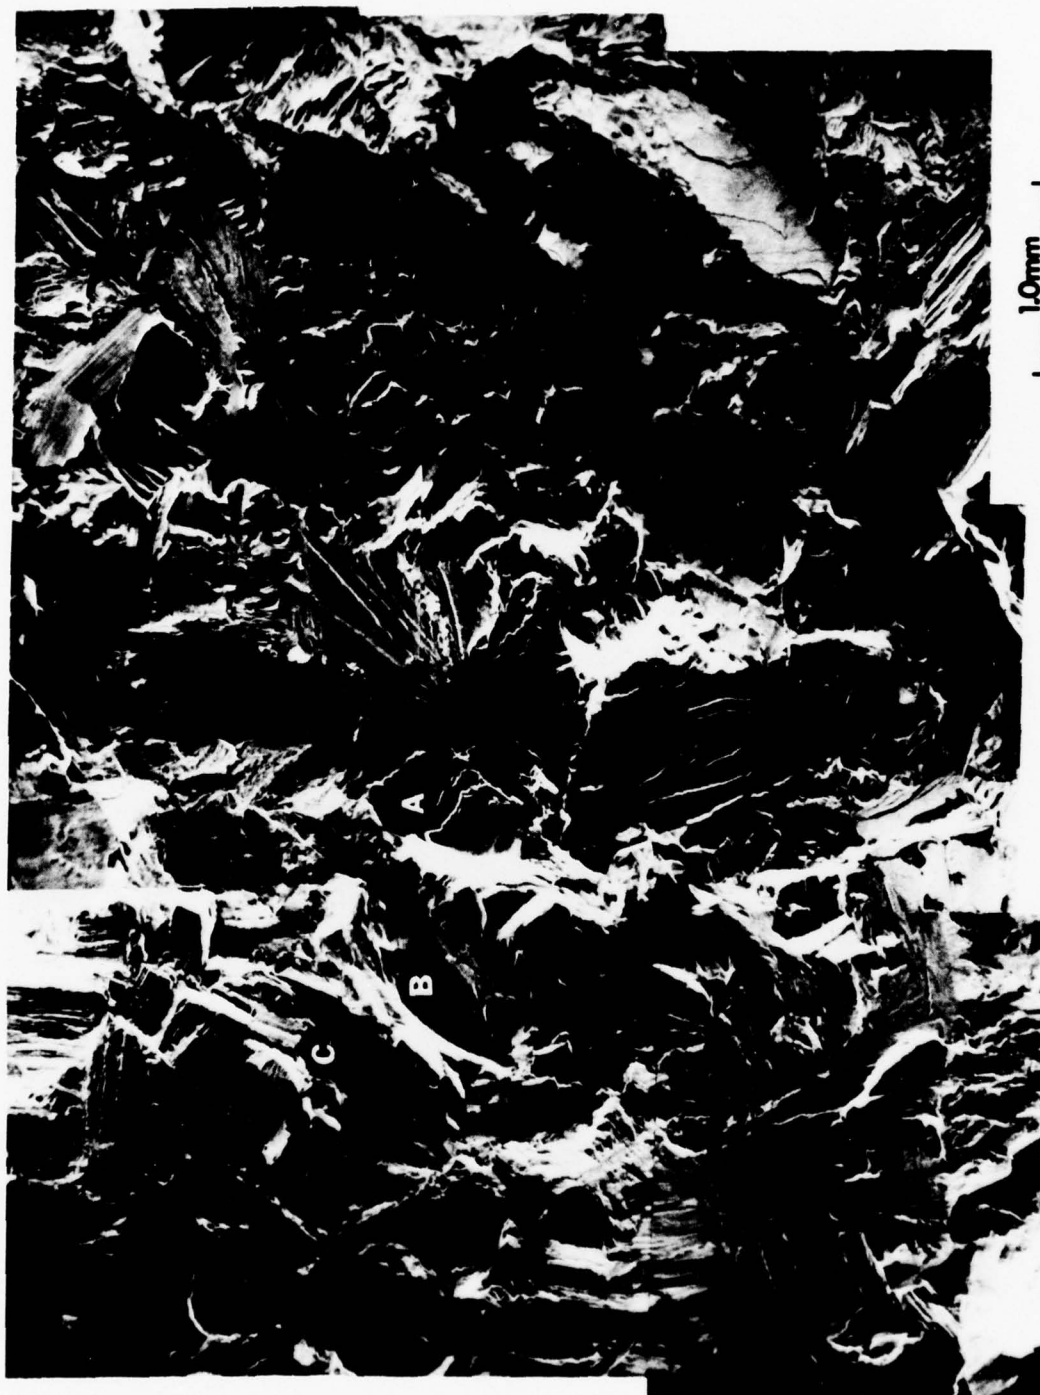
The topography surrounding the "fish eye" is highly irregular and consists of cleavage-like facets. Fatigue striations were observed on a small number of facets labelled A, B, and C in Figure 19. Those observed on facet A are shown in Figure 23. The measured striation spacings on these facets will be presented later with reference to other crack growth data (Section II.2.c(1)). The dimensions of all the facets are about the same as those of the acicular alpha colonies in this material. The crack grew to a diameter of approximately 0.3 inch before overload failure occurred. It is clear that the crack front at the onset of unstable fracture was rather irregular as areas of overload failure were intermixed with cleavage and striated facets at the periphery of the crack.

Figure 19 Scanning Electron Fractograph of the Rosette-Fracture Observed on IMI 685 Specimen No. 4. Details of the 'fish eye' fracture origin are shown in Figure 20. Striations have been observed on facets A, B and C. Those on facet A are shown in Figure 23.

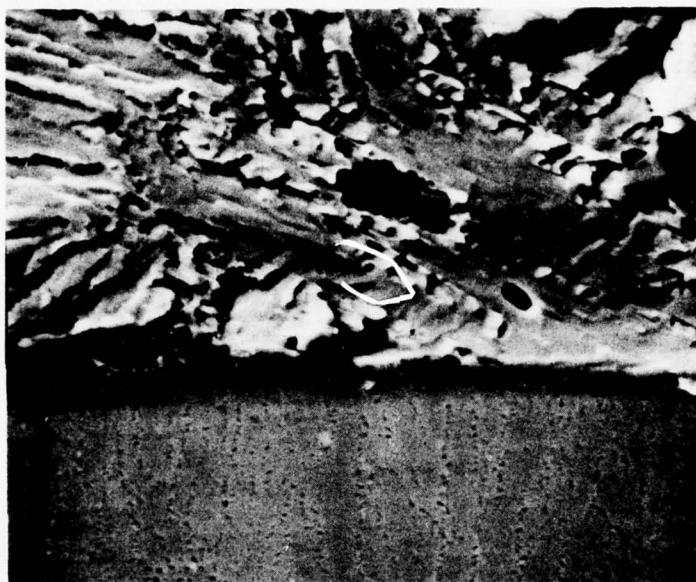
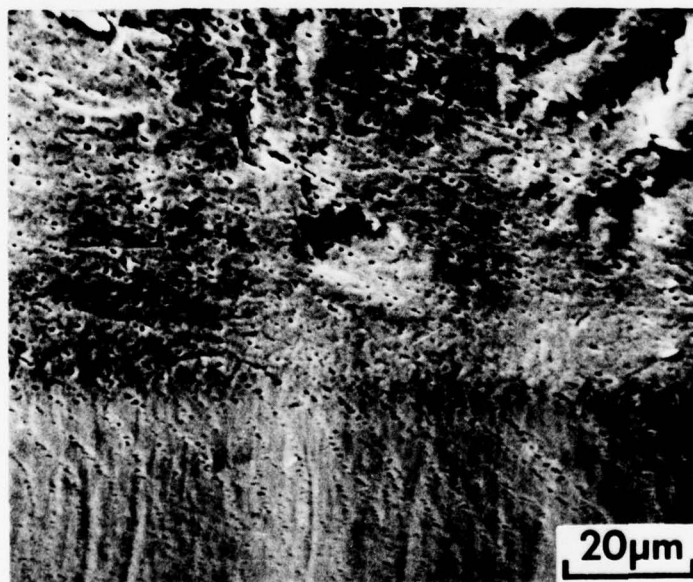
Figure 20 (a) The Topography of the 'fish eye' Crack Nucleation Site  
 (b) Detailed Appearance of the Central Pore and its Surrounding. Note the presence of the "brittle-type" striations on the 'fish eye'.

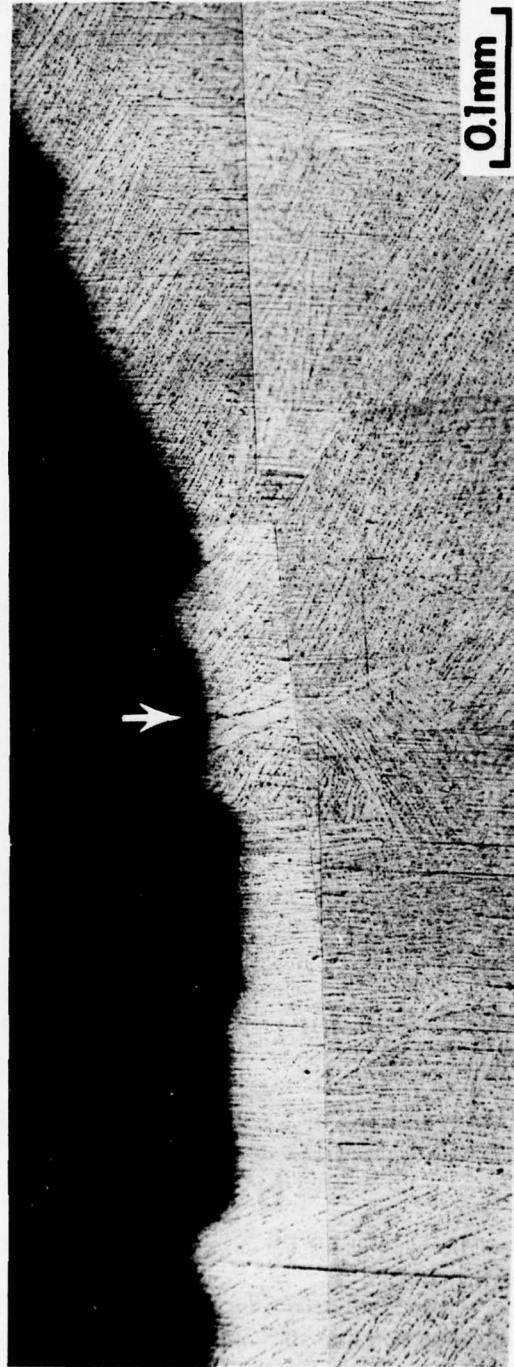
Figure 22 Microstructure at a Longitudinal Section Through the Central Pore (Location Indicated by the Arrow)

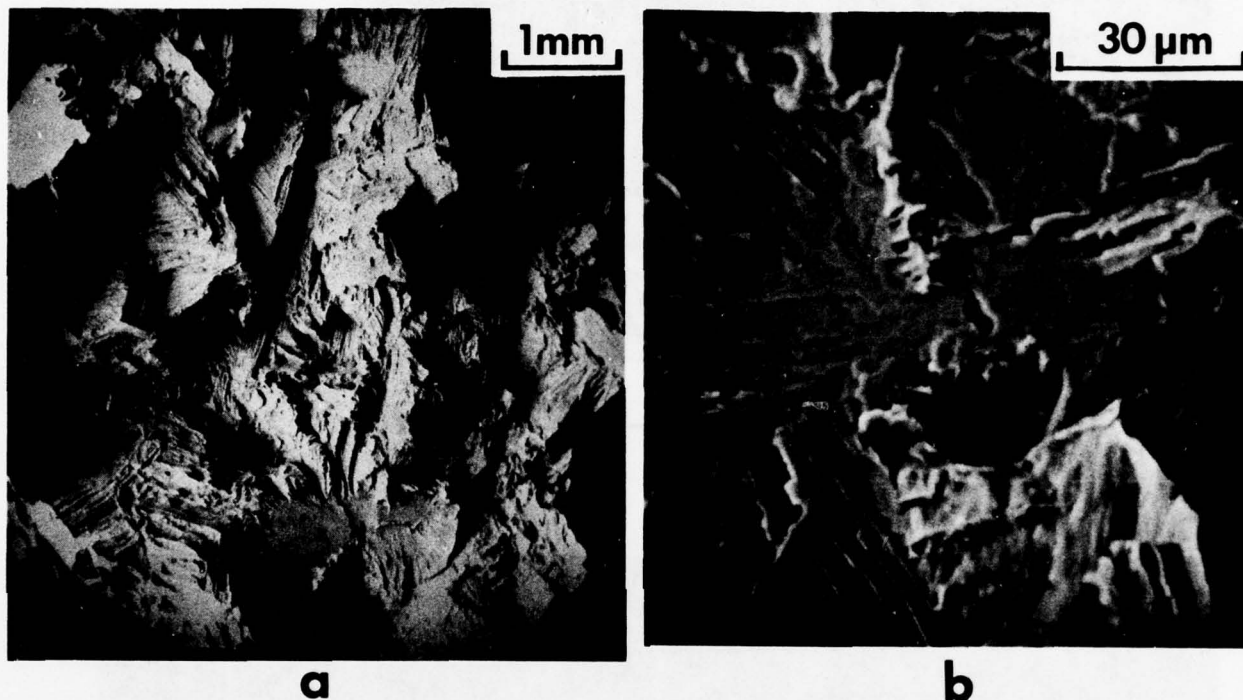
Figure 24 (a) General Appearance of the Fracture Surface of Specimen No. 25.  
(b) The Fracture Origin which is Located Between the Two Fan-Shaped Facets, showing the Small pore and the Brittle-Type Striations.

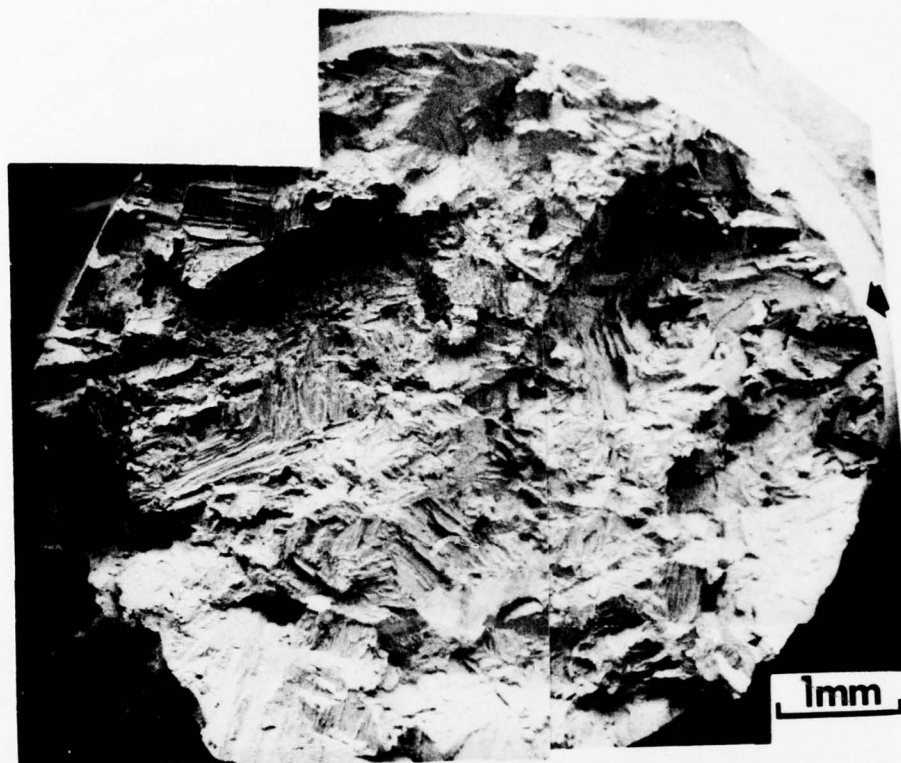
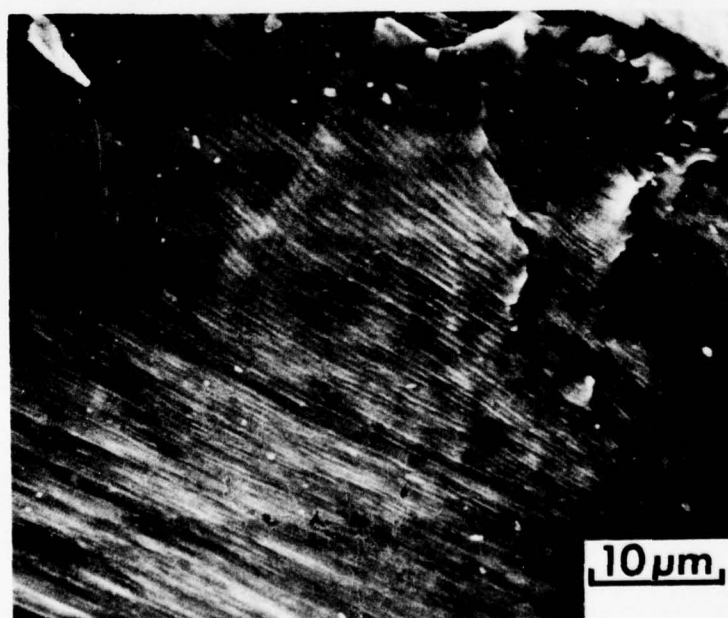
Figure 26 (a) The General Appearance of the Fracture Surface of Specimen No. 45. The surface crack origin is indicated by an arrow. Note the absence of large cleavage-like facets at the fracture origin.  
 (b) Fatigue Striations Observed Near the Fracture Origin.

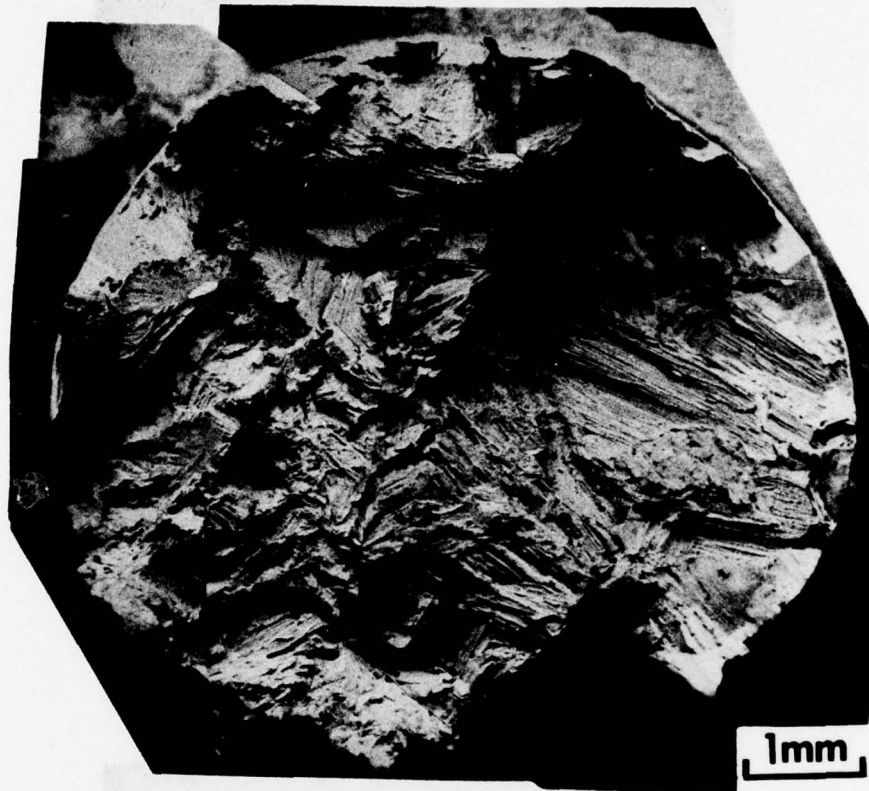
Figure 33 The General Appearance of the Fracture of Specimen No. 9. The stress had been incrementally increased four times before fracture. No crack-front marking due to the unloading is apparent on the fracture surface.

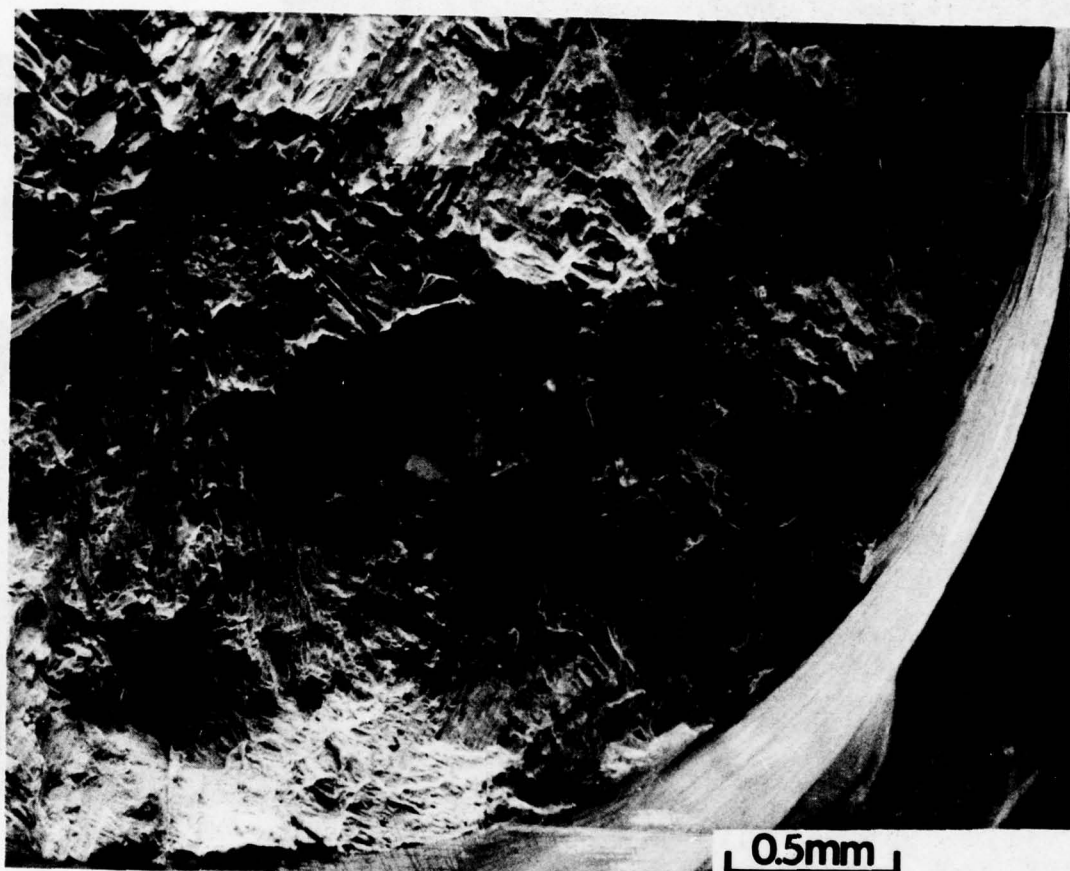
Figure 38 The Appearance of the Fracture Surface of the Nitrided-Seeded Specimen No. 41. The microstructure is given in Figure 37a. Fracture initiated at the seeded pore which can be located at the upper left corner.

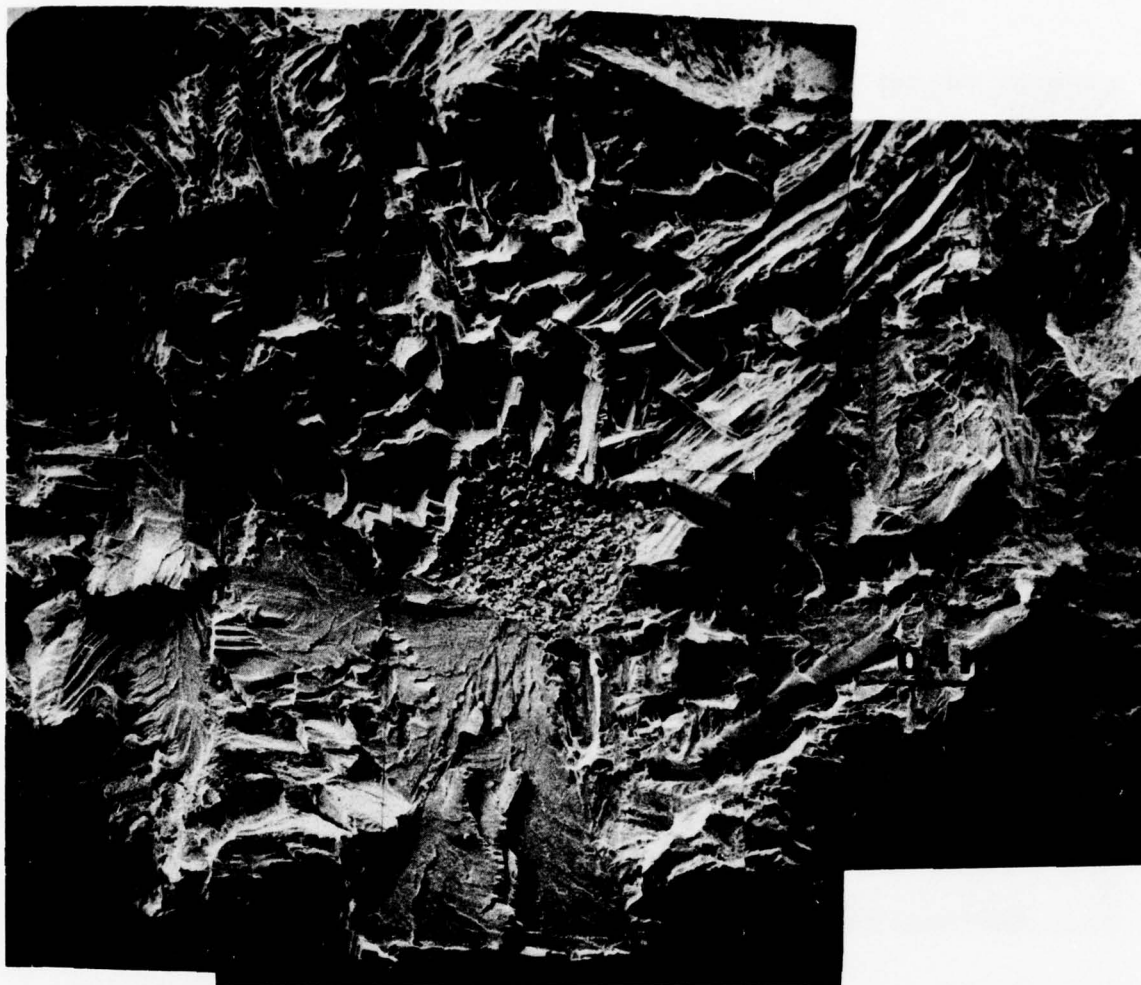
Figure 39 Fracture Appearance of the Dwell-Tested Specimen (No. 38) Which Contains A Nitride-Seeded Pore

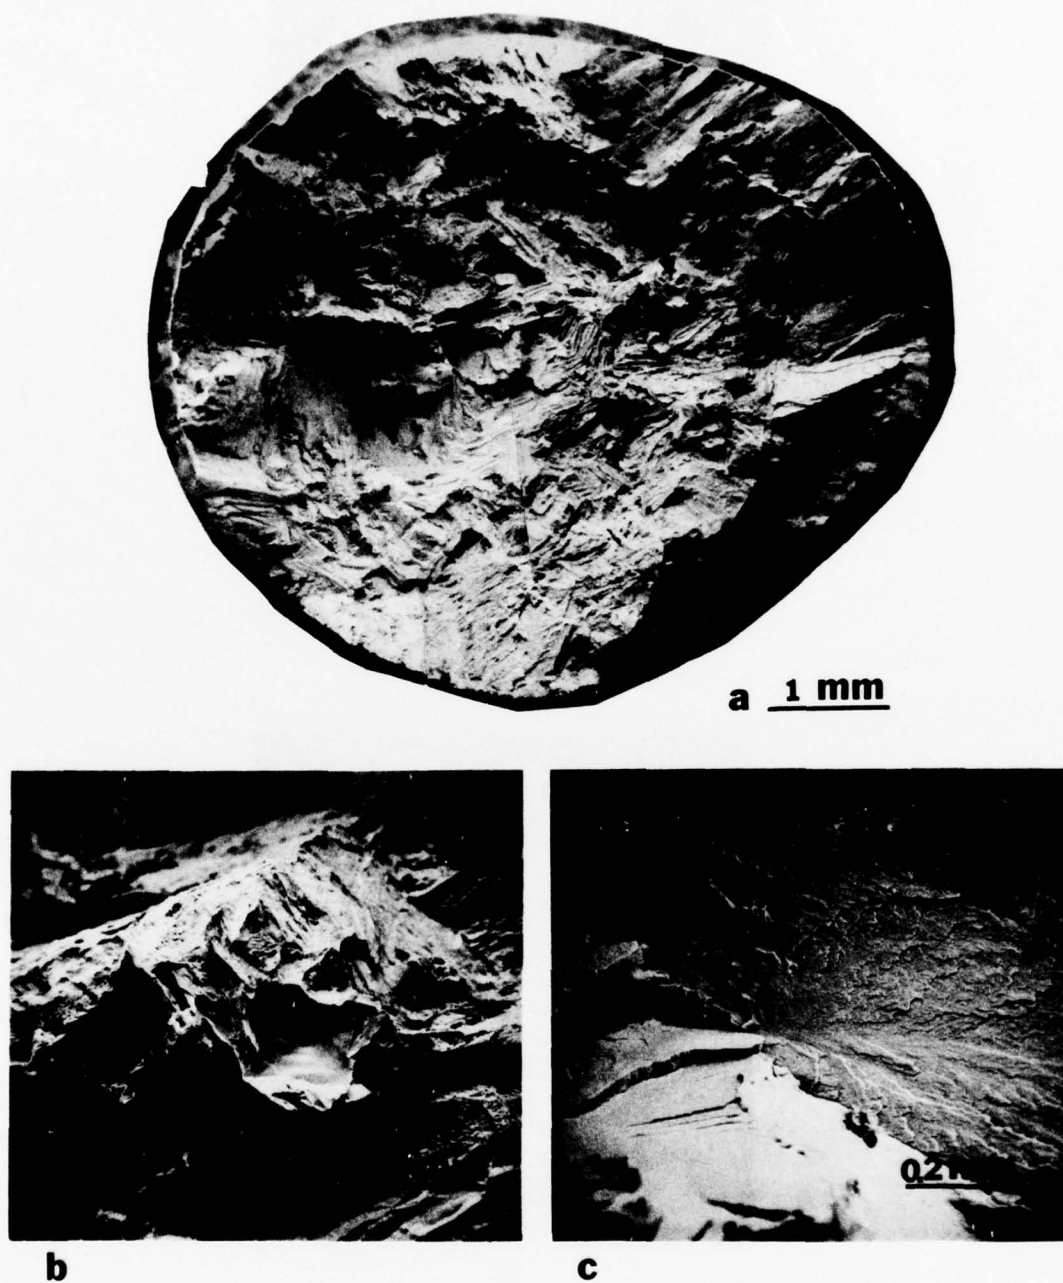
Figure 41 (a) General Fracture Appearance of the Dwell-Tested Specimen (No. 31) Which Contains a Clean Pore. The pore (indicated by the upper arrow) is partially exposed and is located at the overload failed region.  
 (b) The Clean Pore Shown at Higher Magnification.  
 (c) The Fracture Origin which is Indicated by the Lower Arrow in (a).

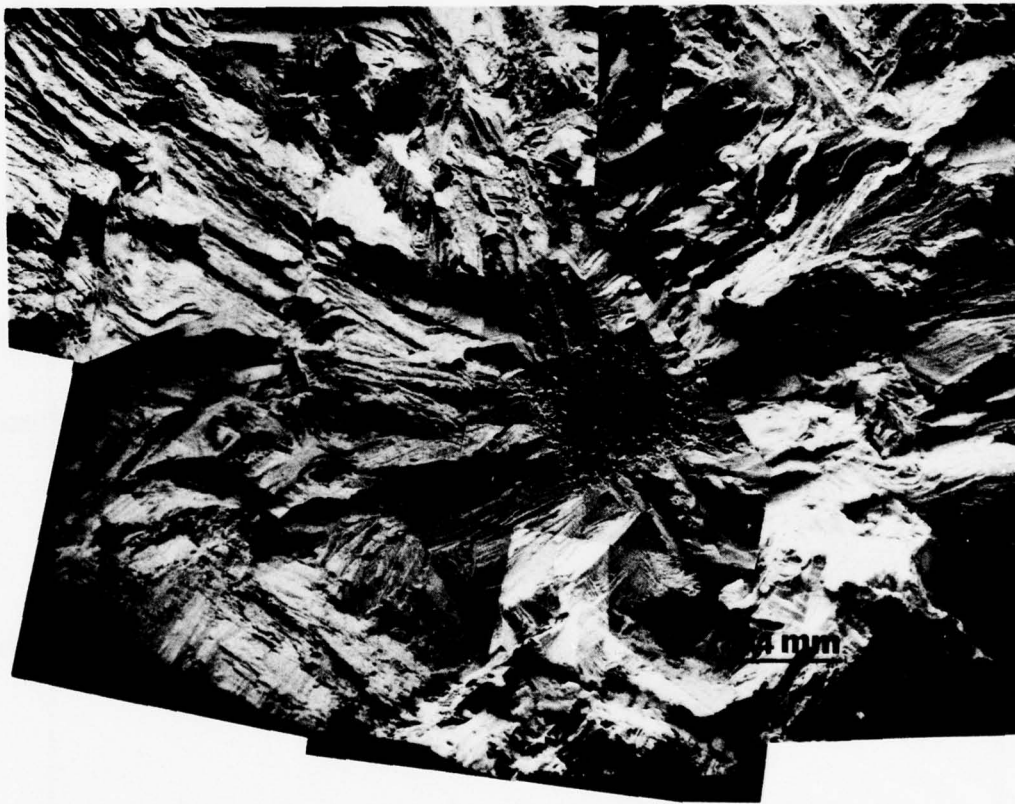
Figure 42 Fracture Appearance of the High Frequency-Tested (12 cpm) Specimen (No. 39) Which Contained a Nitride-Seeded Pore

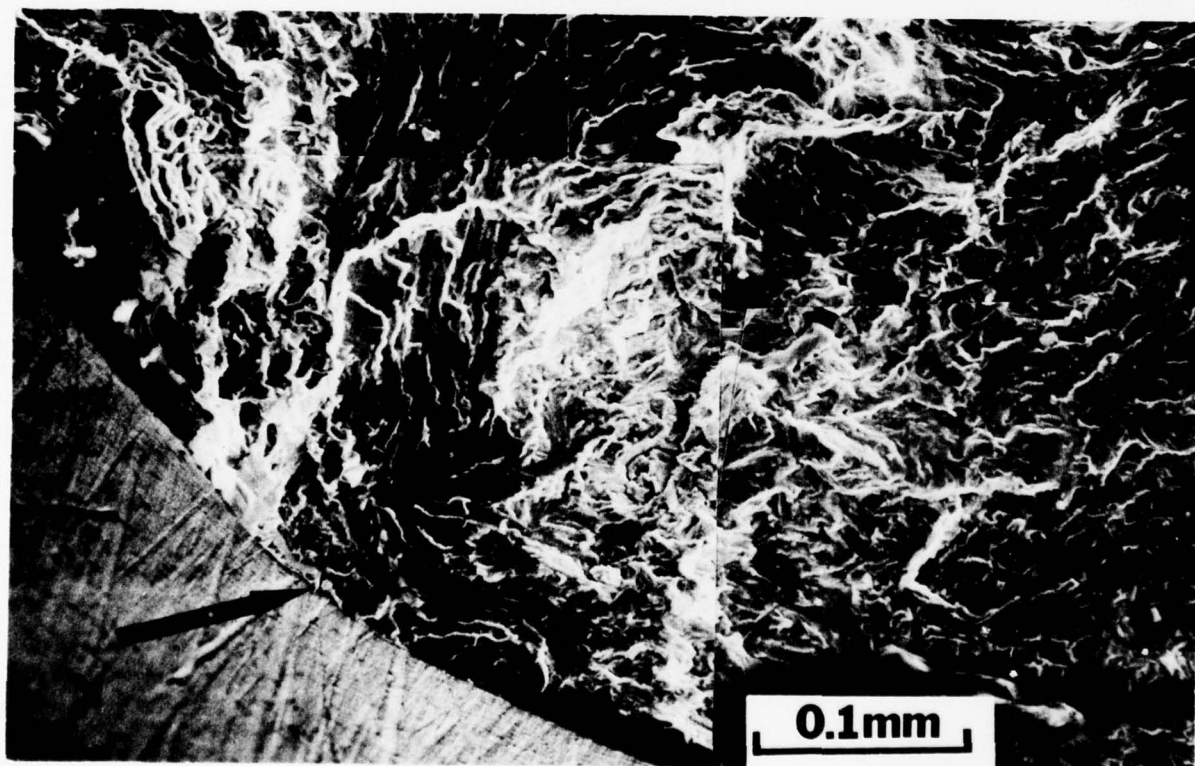
Figure 46 Scanning Electron Micrograph of the Fracture Surface Around the Fatigue Crack Origin in the Specimen Machined from a Defective Ti-6Al-2Sn-4Zr-2Mo Flat Disk (see Figure 44). The nucleation site which is shown in greater detail in Figure 47(a) is indicated by an arrow.

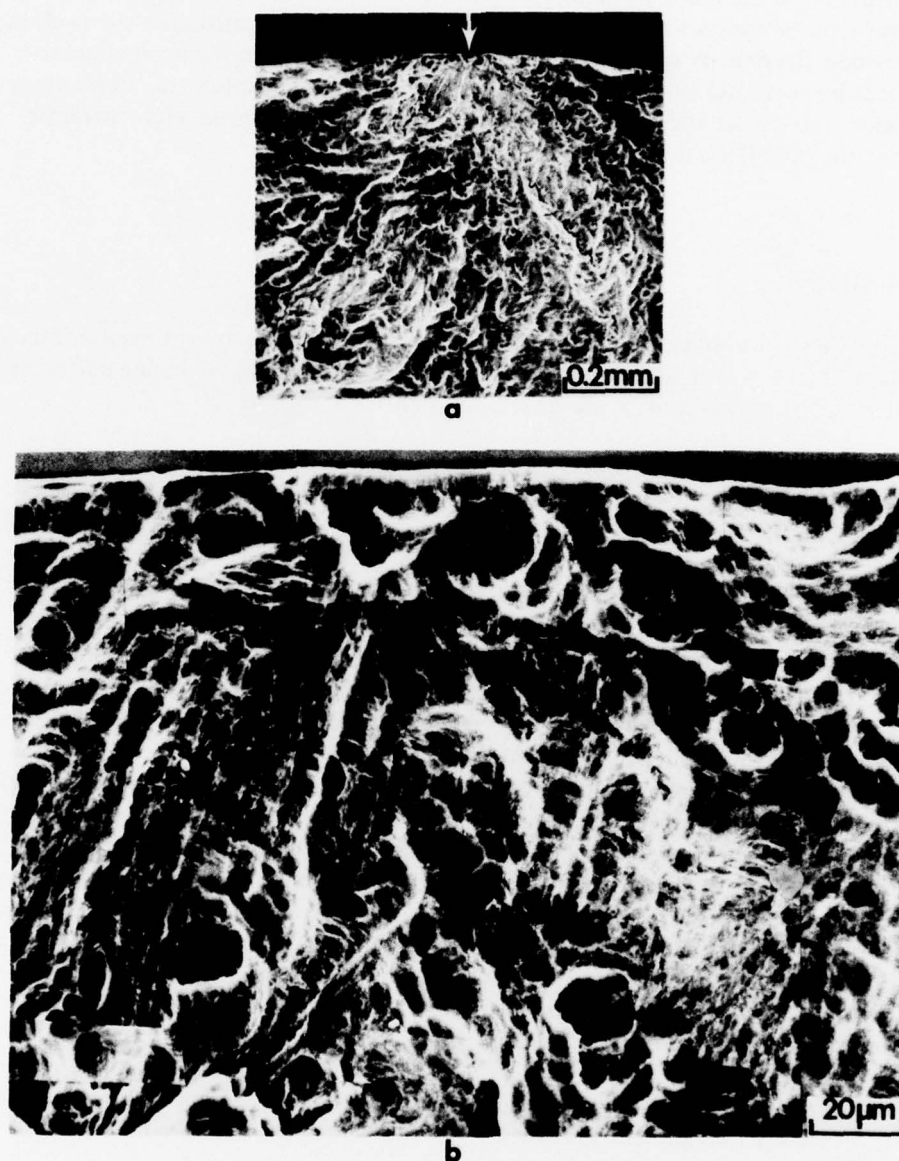
Figure 73 Crack Nucleation Site in a Beta-Flecked Specimen  
(a) General Appearances of the Fracture Surface, Arrow Indicates the Crack Origin.  
(b) Microstructure at the Fracture Origin.
