TECHNICAL REPORT NO. 226

AN EVALUATION OF THE RUST CONDITION OF
TRUCK, 1/4 TON; M151 SERIES

FEBRUARY 1978

AMERICAN MATERIAL SYSTEMS ANALYSIS ACTIVITY
ARMEDEN PROVING GROUND, MARYLAND

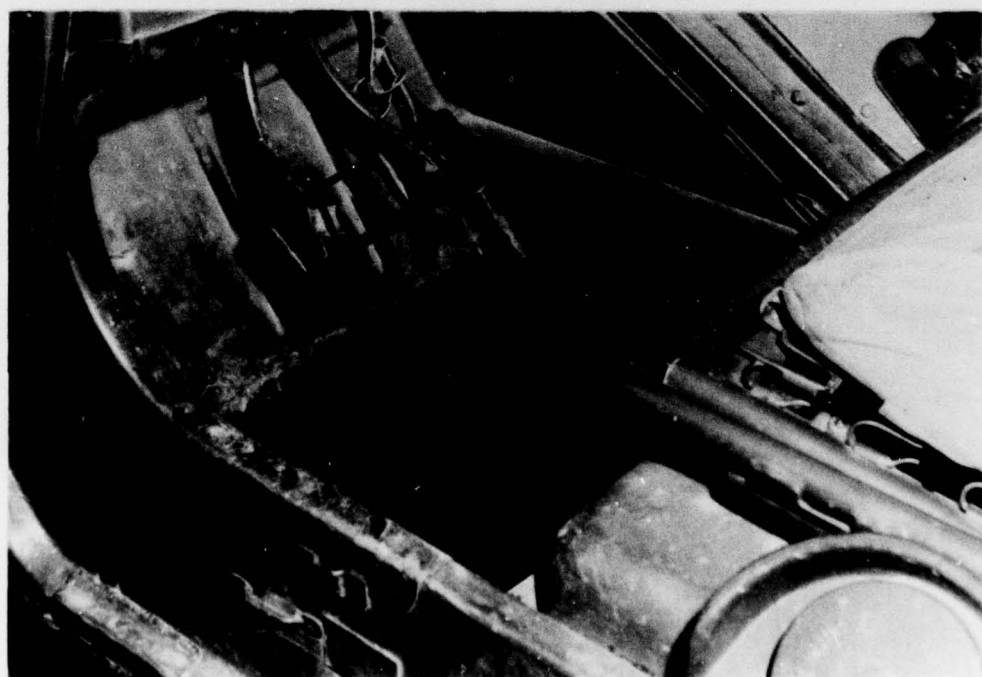
Photograph 1.1 - Front Floor Pans Showing Accumulation of Water.

(2) Drain holes should be enlarged and relocated so as to assure full drainage of water from the front floor area, regardless of the attitude of the vehicle when parked (See Photograph 1.1).

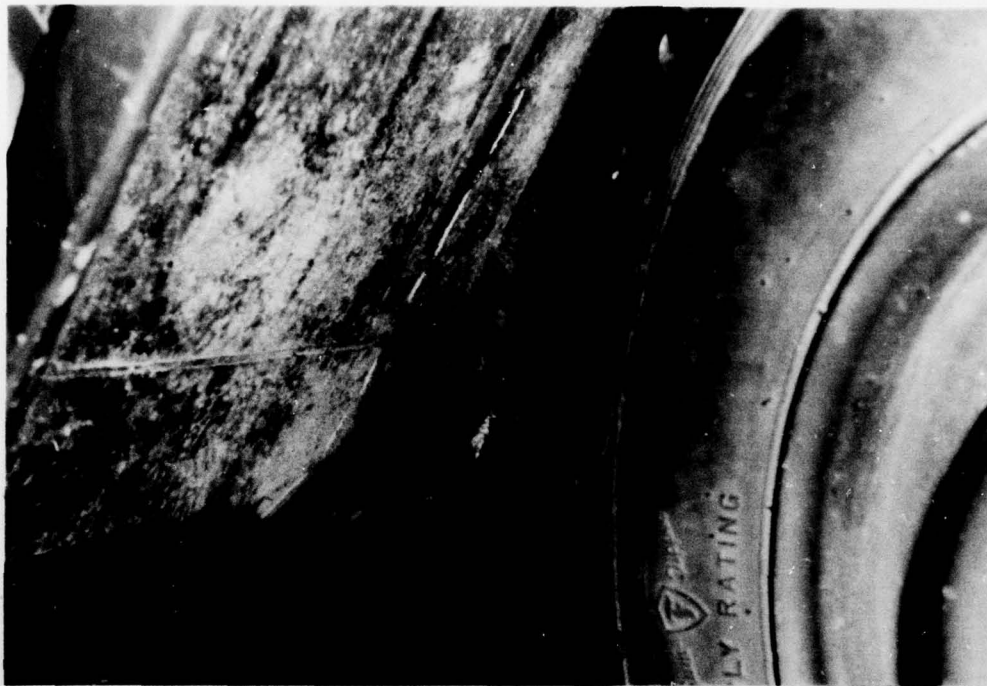
Photograph 4.3 - Typical Example of Moderate Rust Condition.

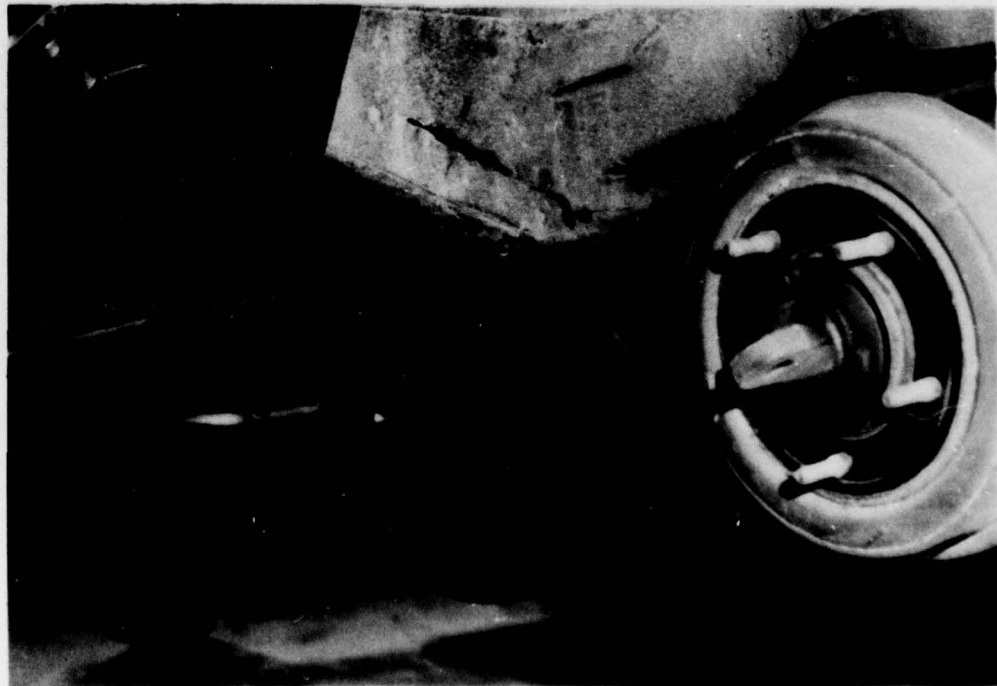
Photograph 4.5 -Typical Examples of Very Heavy Rust Condition.

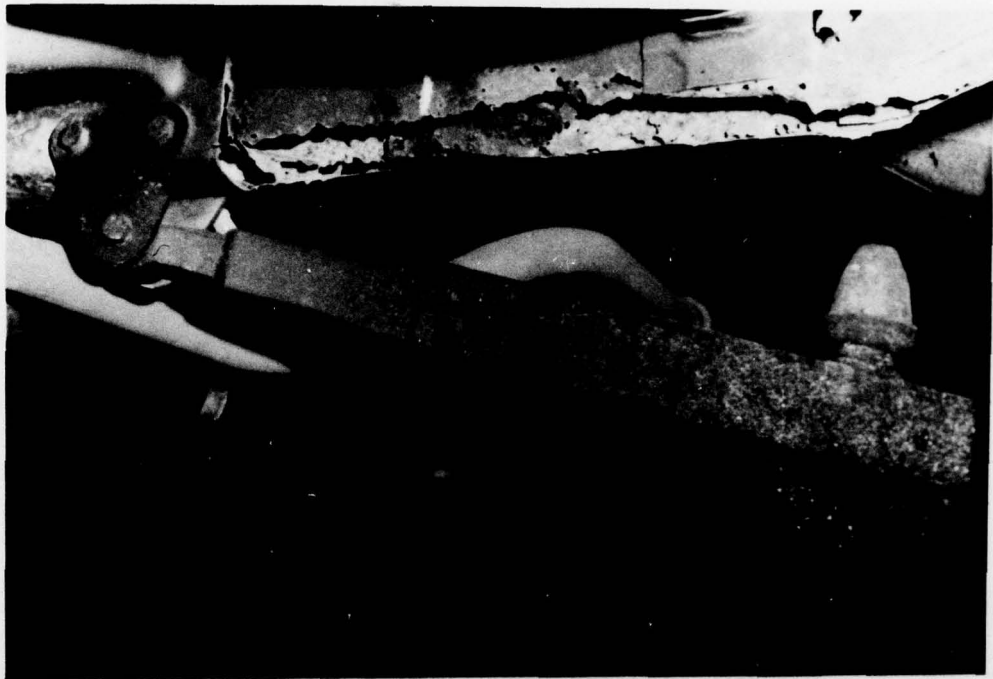
Photograph 6.1 - Typical Example of Severely Rusted Rear Cross Member.

Utilizing some of the procedures outlined in TM-9-2320-218-34 for repairing structural damage, Ft. Meade applied them to repairing severely rusted frame/cross members. In general, the method involved covering the rusted area with pre-formed or pre-shaped steel plates and electric welding them in place. Photographs 6.1 and 6.2 show a rear cross member and the left front, respectively, prior to being repaired. Photograph 6.3 shows pre-formed steel plates being welded over the left underside of the cross member. The method of capping the cross member, which is outlined in the above referenced TM, is shown in photograph 6.4. Photograph 6.5 shows a typical example of the left and right underside of a 1/4 ton truck after the front and rear cross members have been repaired, primed, and painted.

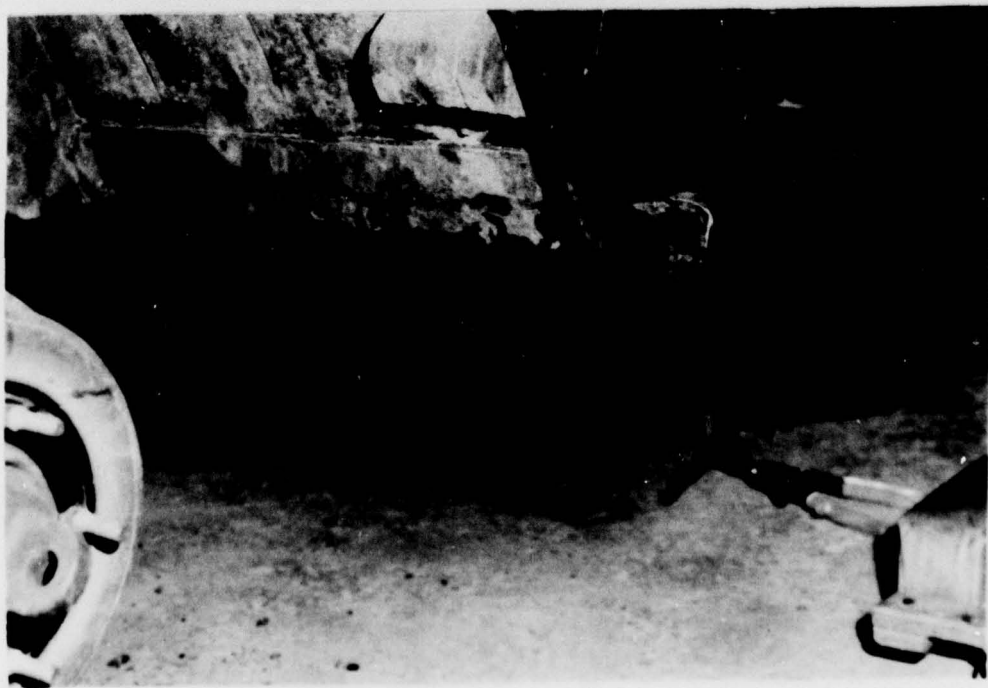
Photograph 6.2 - Typical Example of Severely Rusted Left-Front Cross Member.

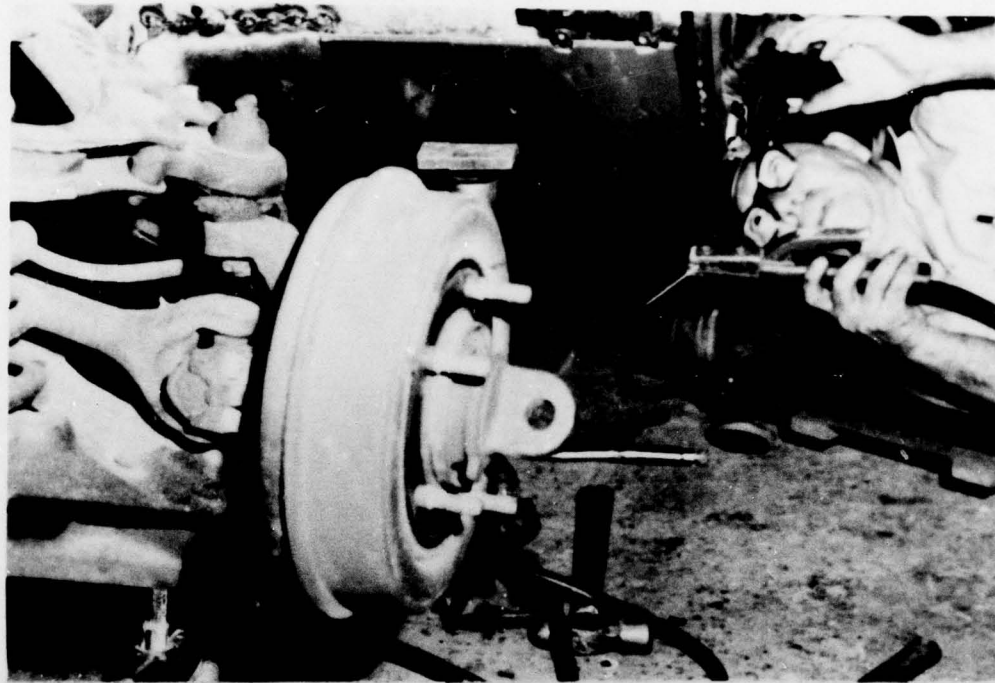
Photograph 6.3 - Preformed Steel Plates Being Welded to Left Underside of Front Cross Member.

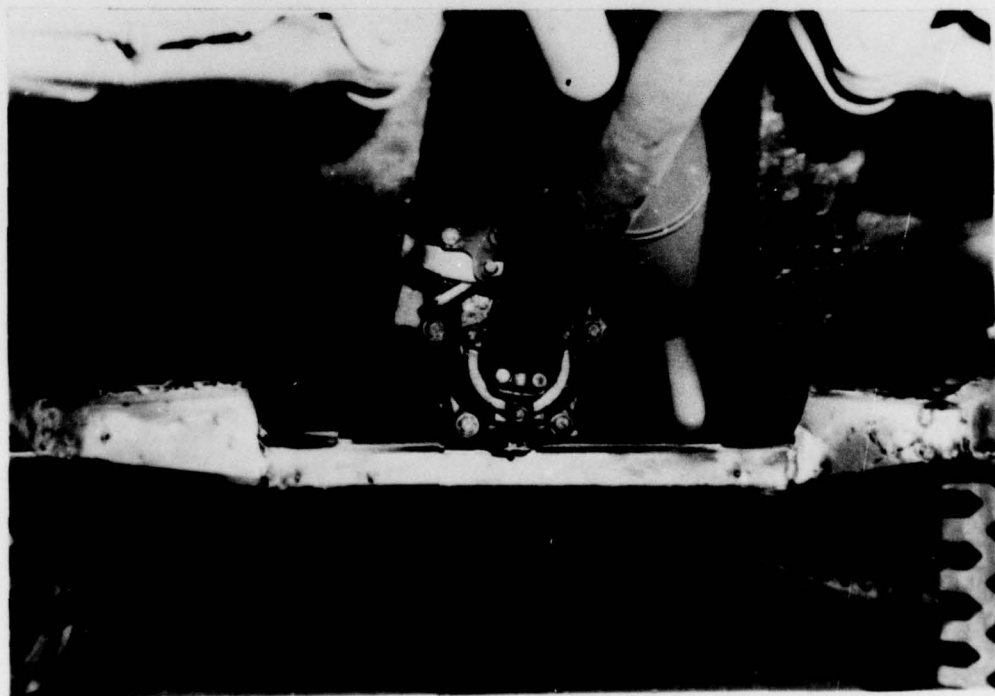
Photograph 6.4 - Capping of Cross Member Under Transmission as Per TM-9-2320-218-34.

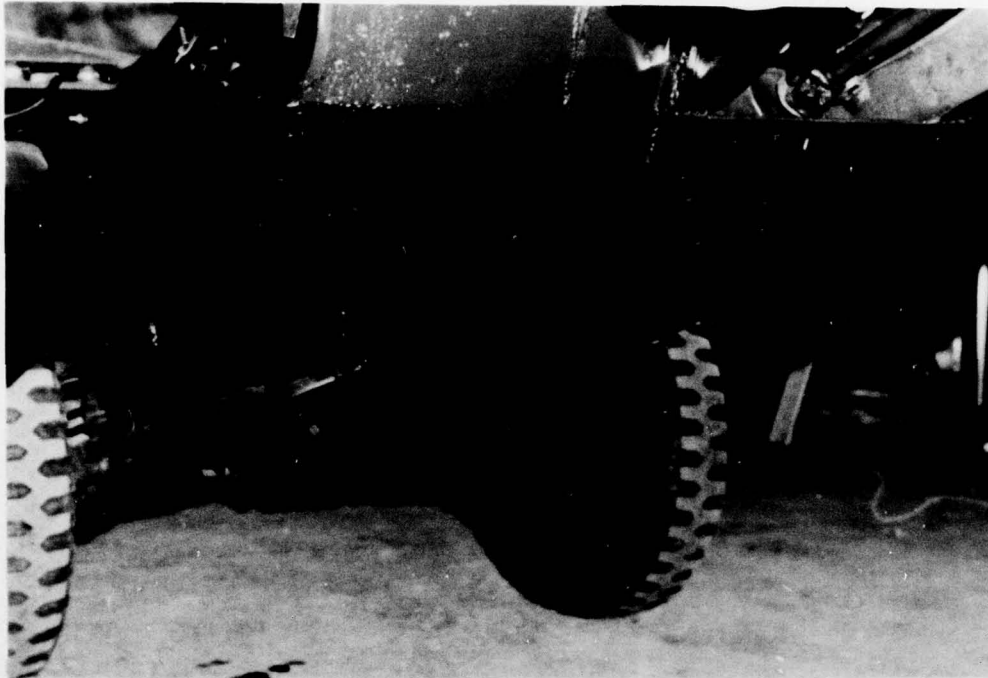
Photograph 6.5 - Left and Right Underside Showing Front and Rear Cross Members as Repaired.
