LACV-30 AUXILIARY POWER UNIT INVESTIGATION

Robert P. Kaiser  
Bell Aerospace Textron  
P.O. Box 1  
Buffalo, New York 14240

June 1977

Final Technical Report for Period September 1976-January 1977

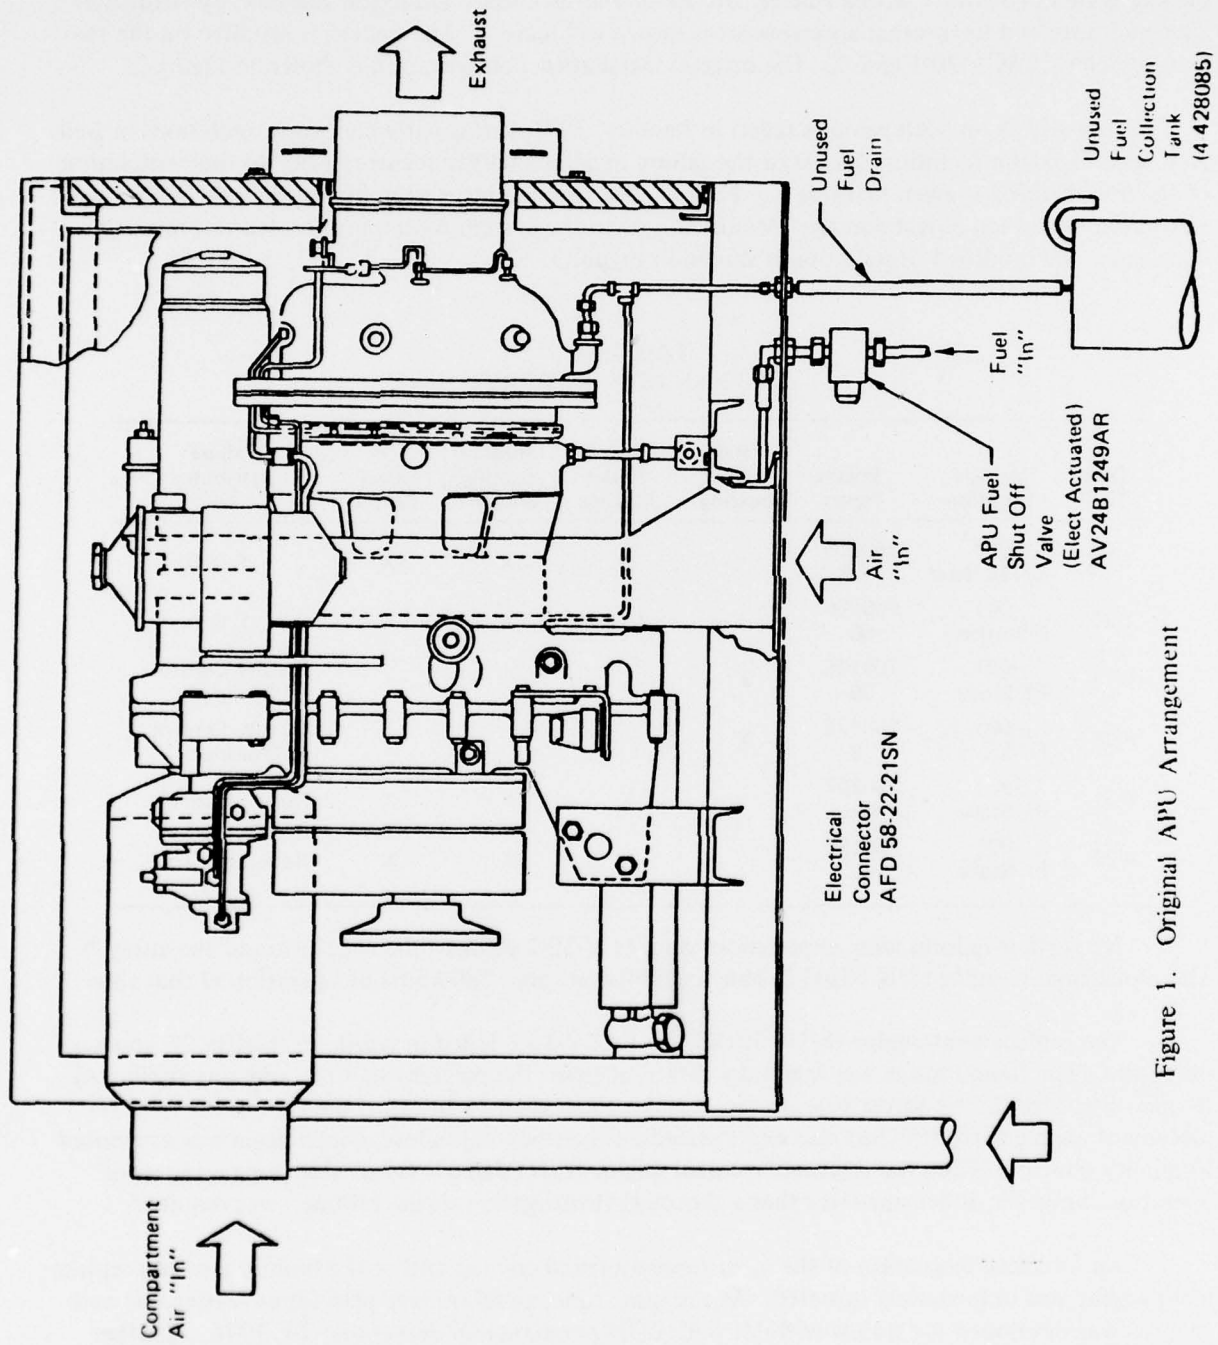
Figure 1. Original APU Arrangement

It is concluded that the original APU module arrangement reinforced or excited engine rotor shaft 1F vibrations to potentially destructive amplitudes, and that the vibration was the probable cause of most or all of the LACV-30 APU failures.

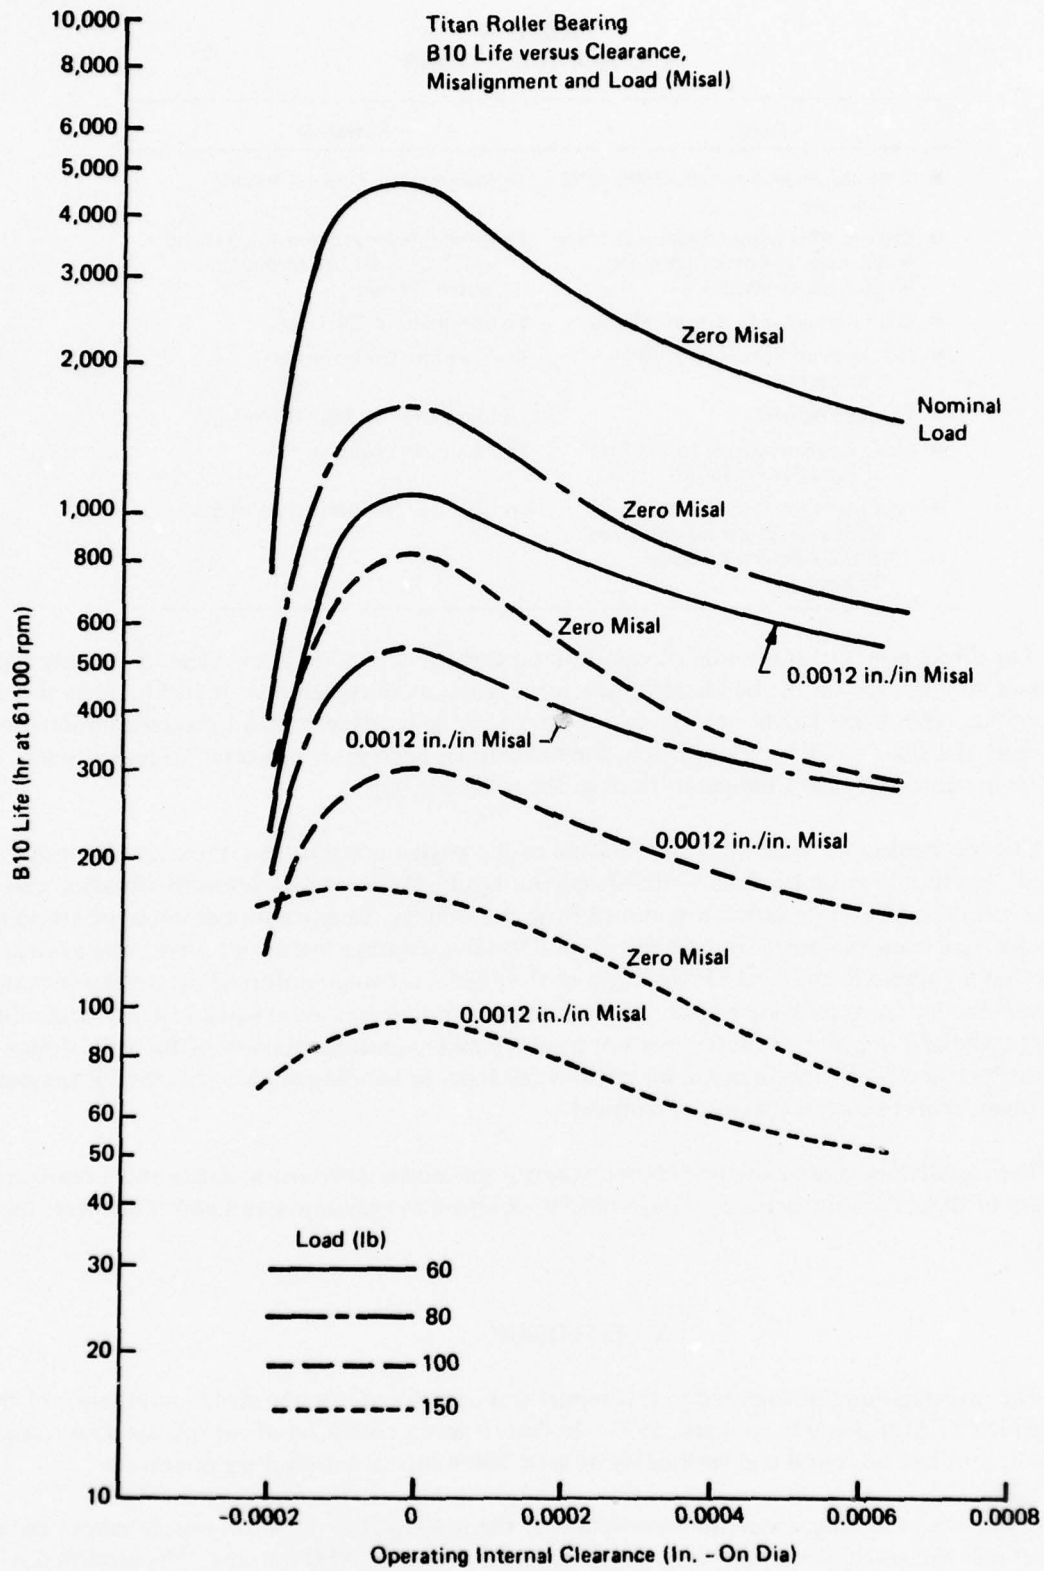
Figure 6. Bearing Life Chart

Evidence that the levels of excursion measured are destructive to the roller bearing is ample. The rise in bearing race temperature invariably accompanying the vibration is an indication that the bearing is absorbing more energy, either from skidding or from induced misalignment, even though the temperature levels are not destructive of themselves. The presence of 5-mil peak-to-peak excursions at the bearing support snout results in peak loads on the bearing on the order of 200 pounds, at the support spring rate of 80,000 pounds per inch. As may be seen from the bearing life chart of Figure 6, loads of this magnitude combined with misalignment result in bearing life measured in hours rather than thousands of hours.
